Inspection Photos
Location Name: BM Federal #13-12
API: 05-081-07395

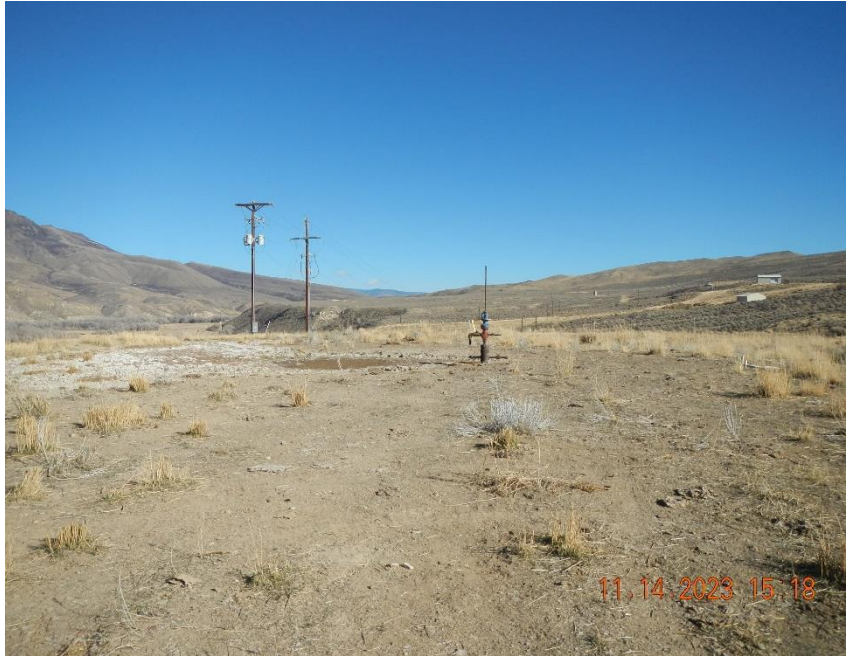
BM Federal #13-12 location photo.

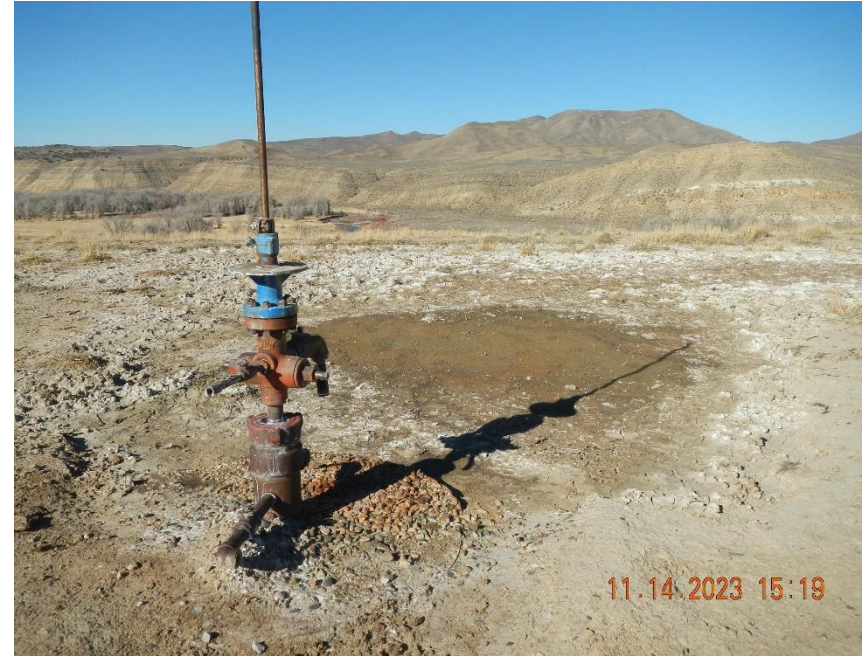
BM Federal #13-12 well head and impacted area.

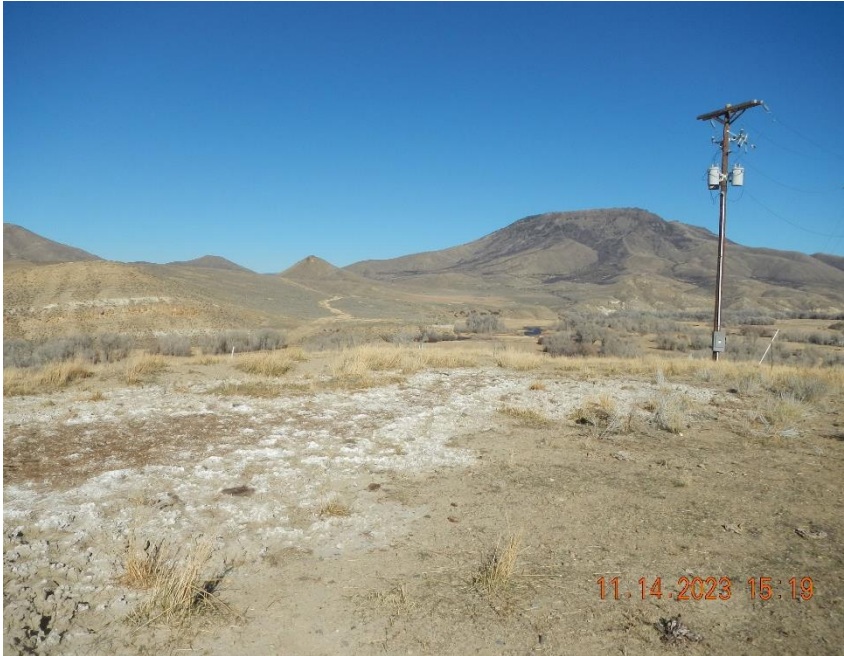
Stained and damp soil. View to the northeast.

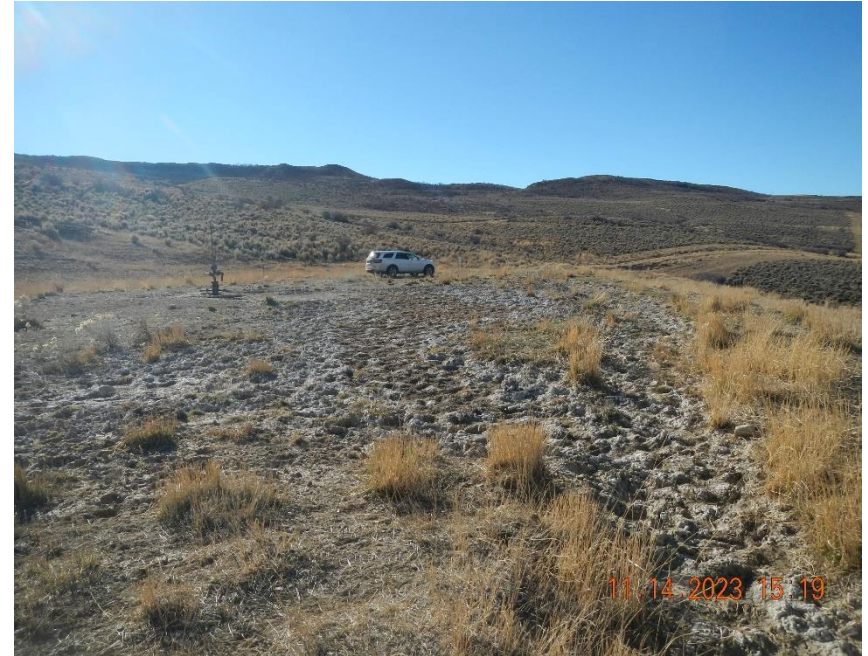
Stained and damp soil. View to the west/southwest.

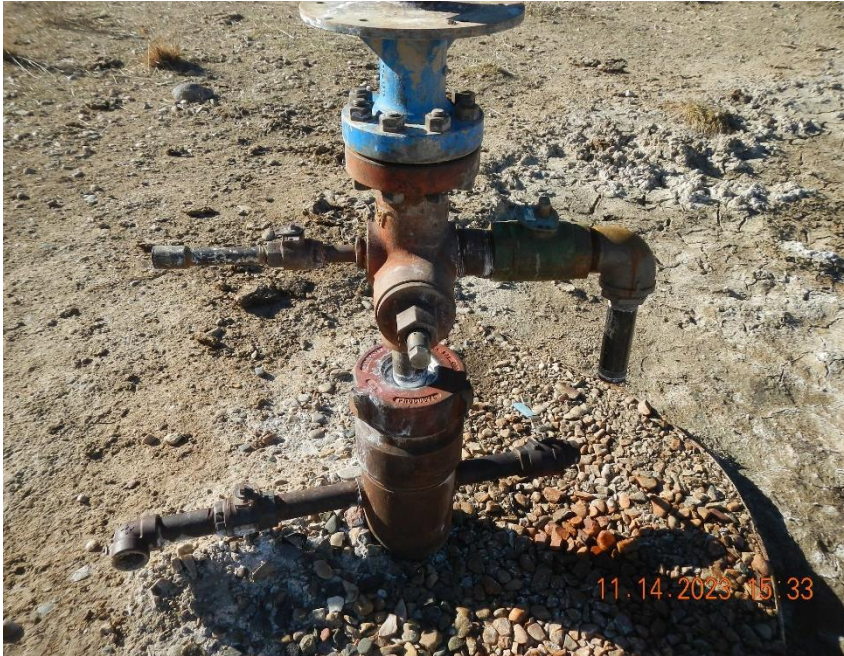
Close up of BM Federal #13-12 well head. All valves appeared to be in the closed position during this inspection.

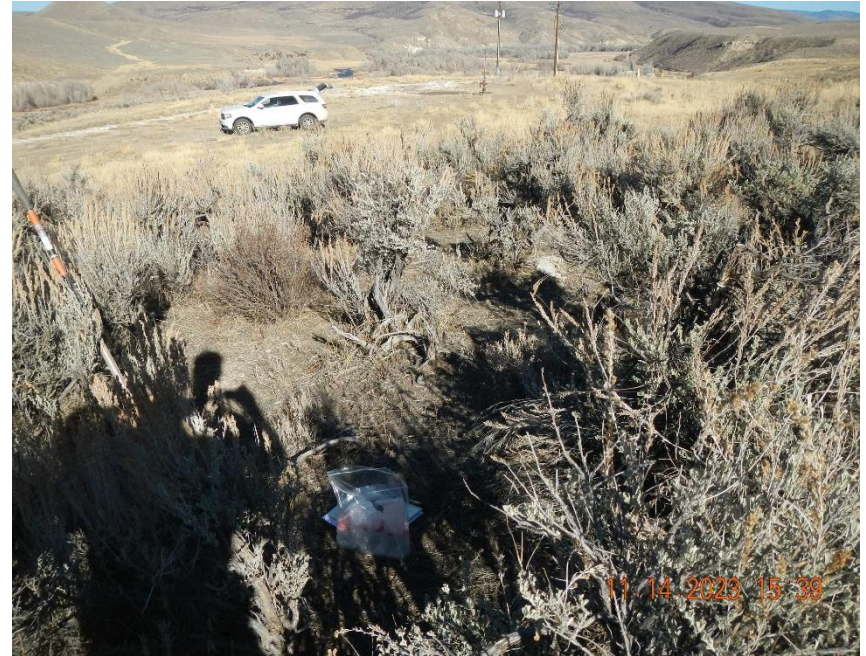
Background soil sample location.

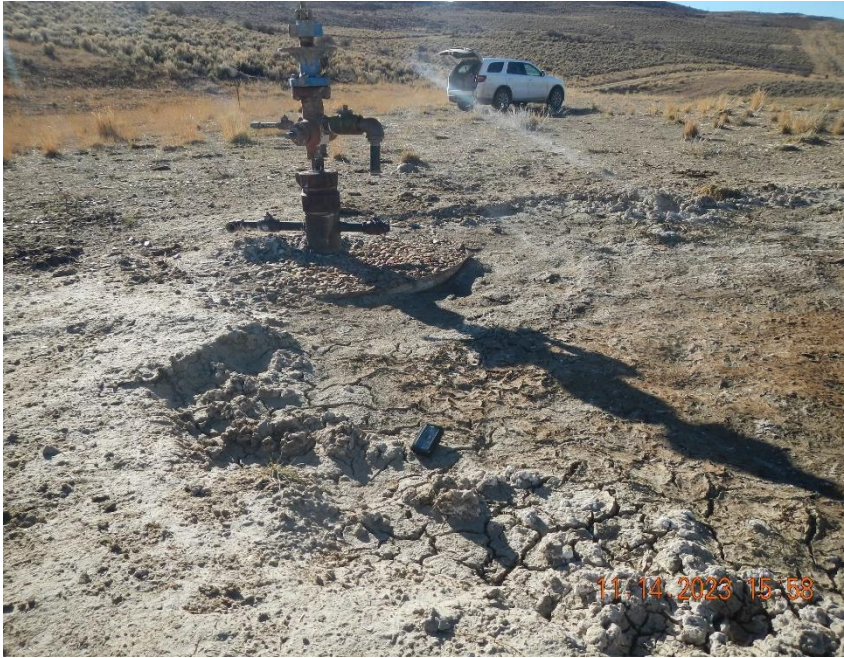
Impacted soil sample location.

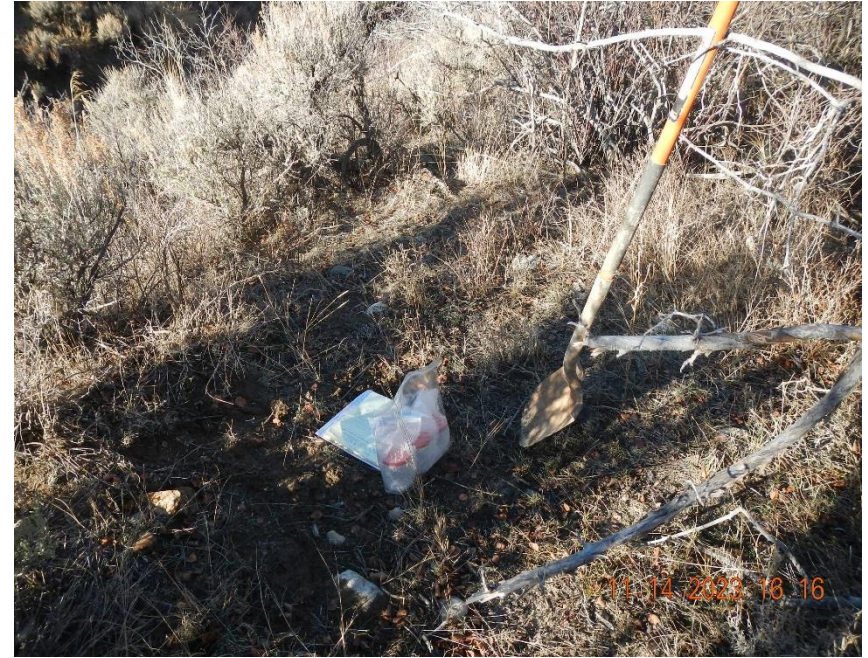
Soil sample taken beyond apparent terminus of flow path.

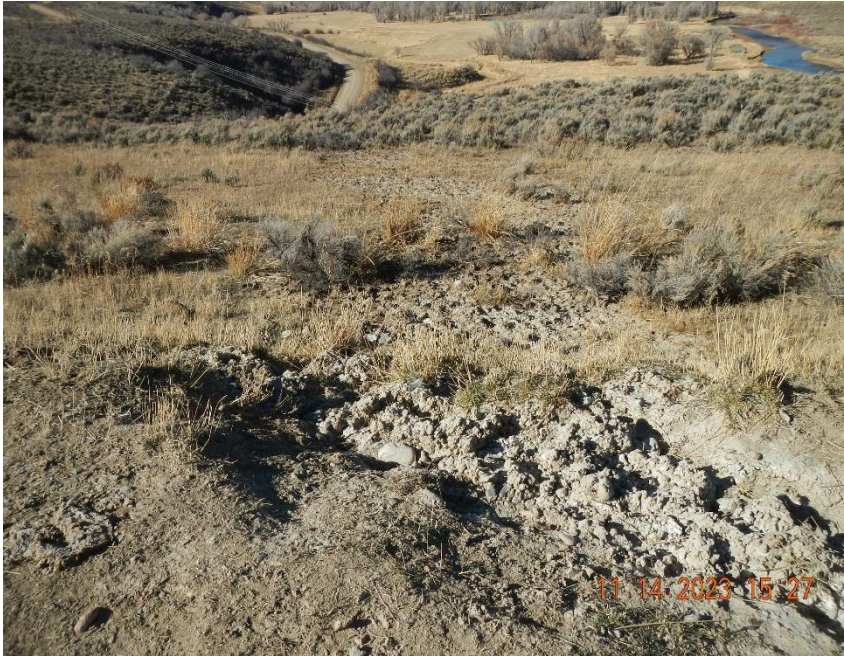
Stained soil and vegetation. View to the northwest.

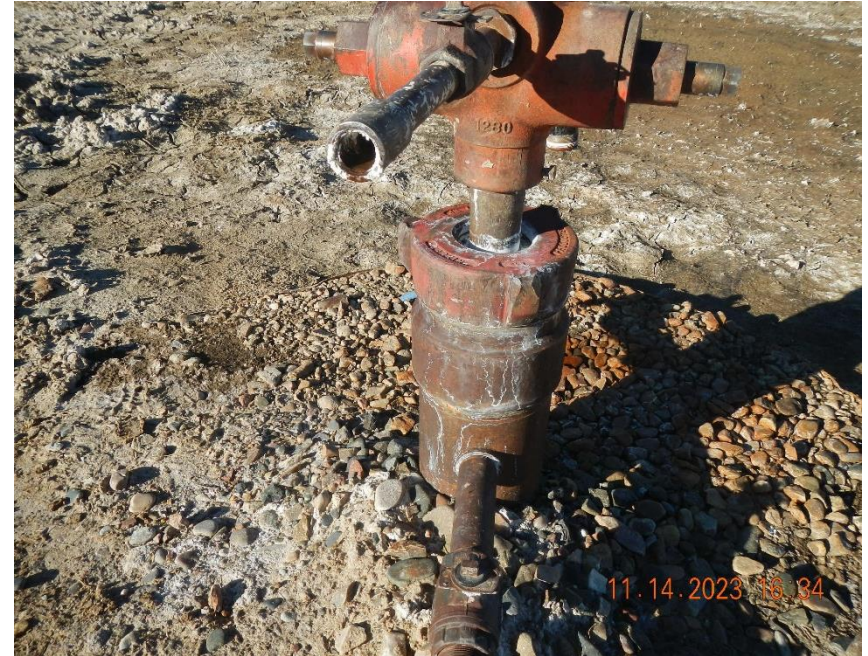
One inch valve is wet and stained.

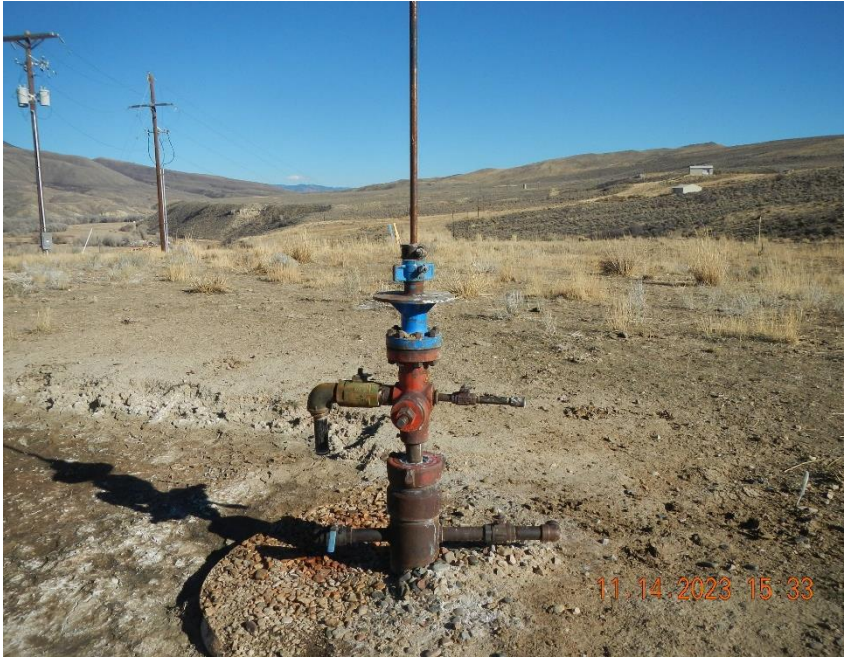
2 inch valve on the upper left of the well head dripped once every 10-15 seconds.

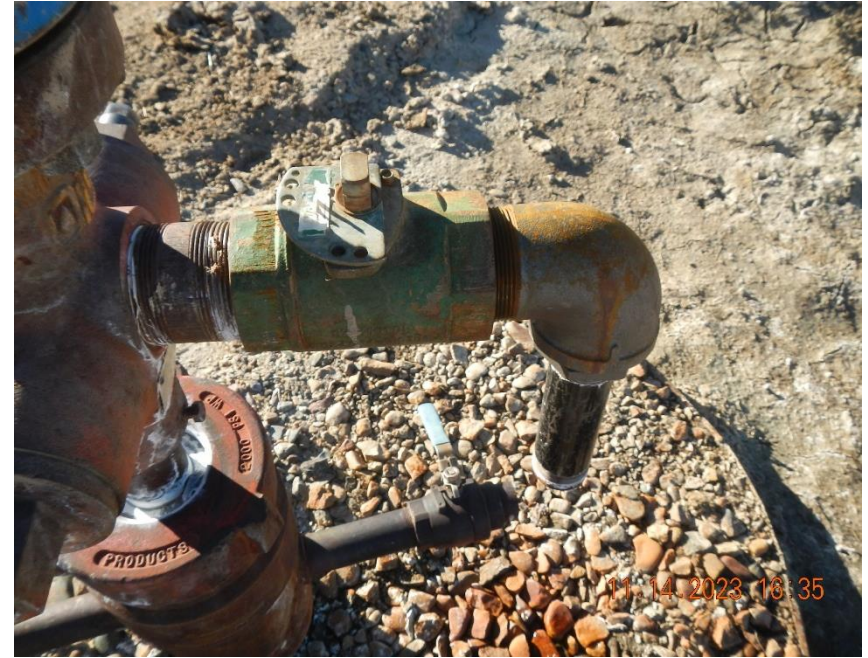
Drips from this valve could be seen once every 10-15 seconds.
