Inspection Photos
Location: Enterprise 16-1
Facility ID: 481042

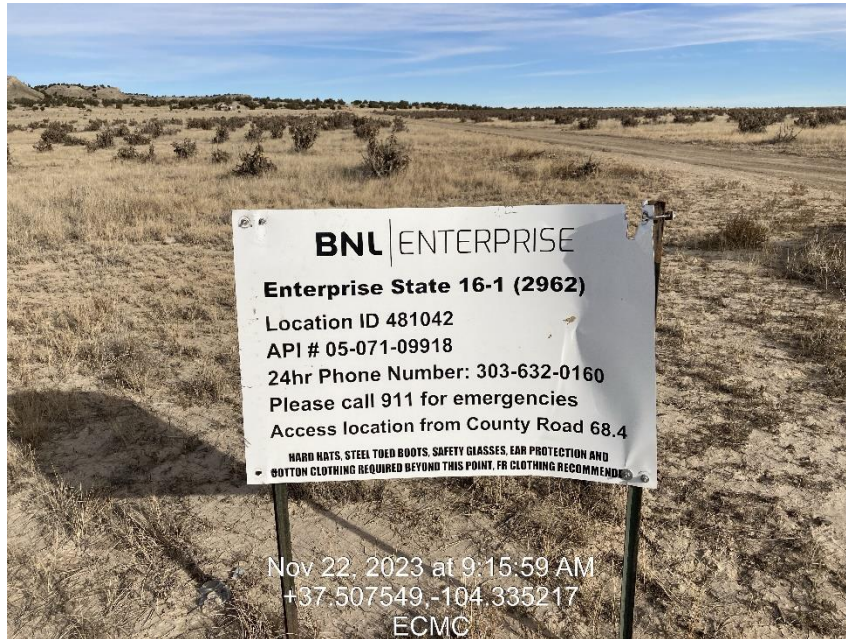
Photo 1 –Well Site Placard at access road

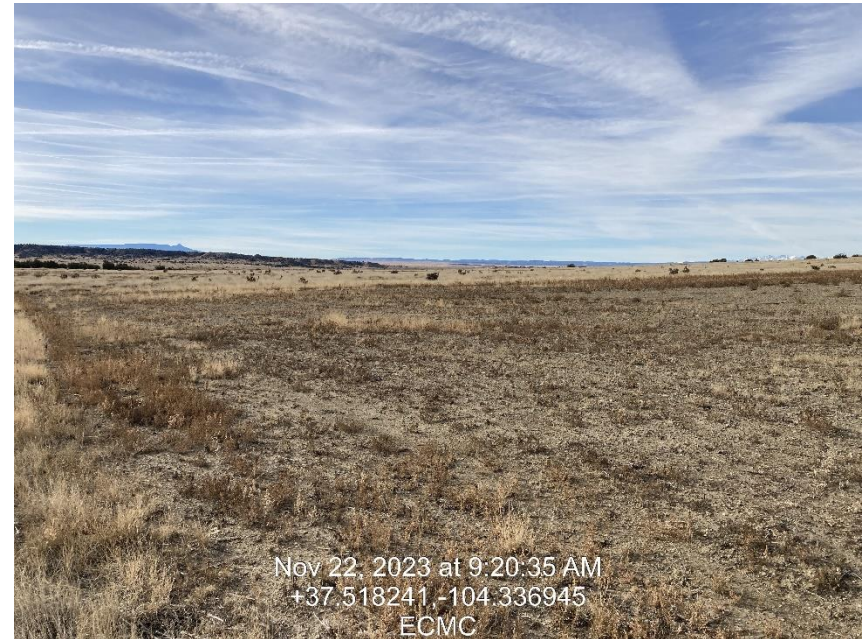
Photo 2 – Well location looking south

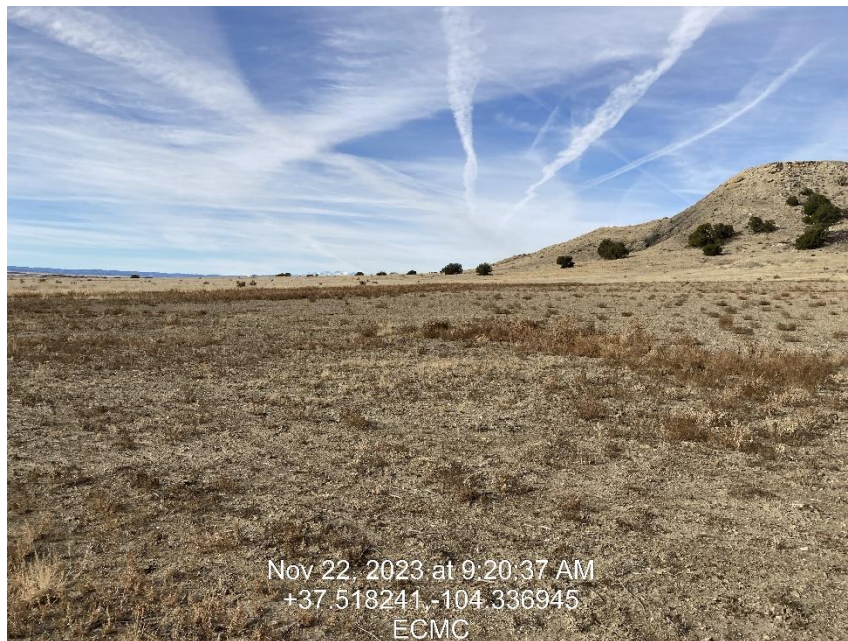
Photo 3 – Well location looking west

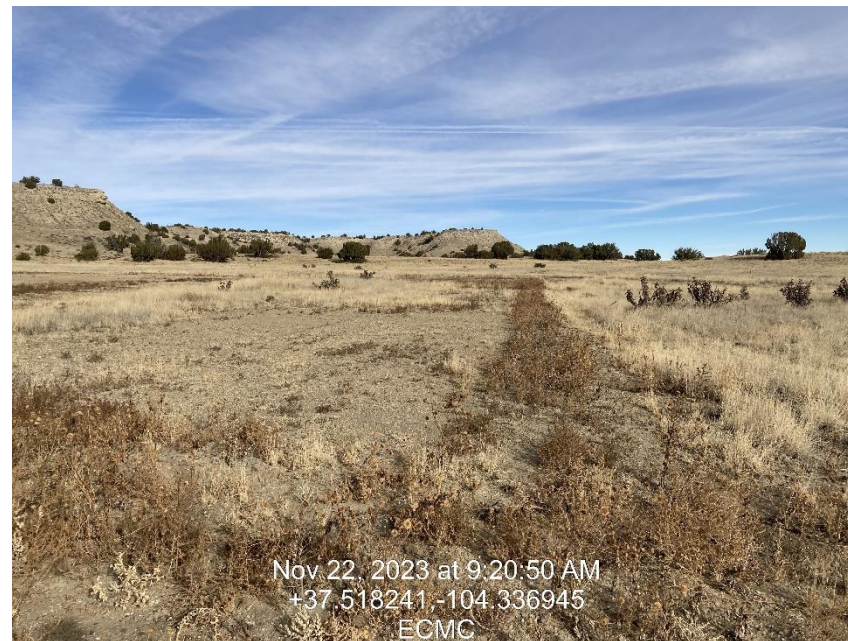
Photo 4 – Well location looking north/northwest

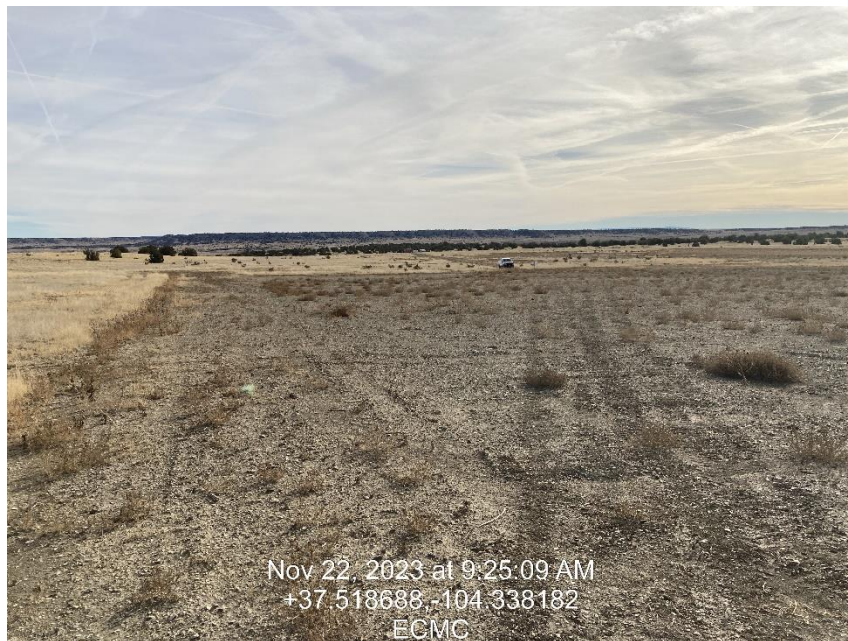
Photo 5 – Well location looking east

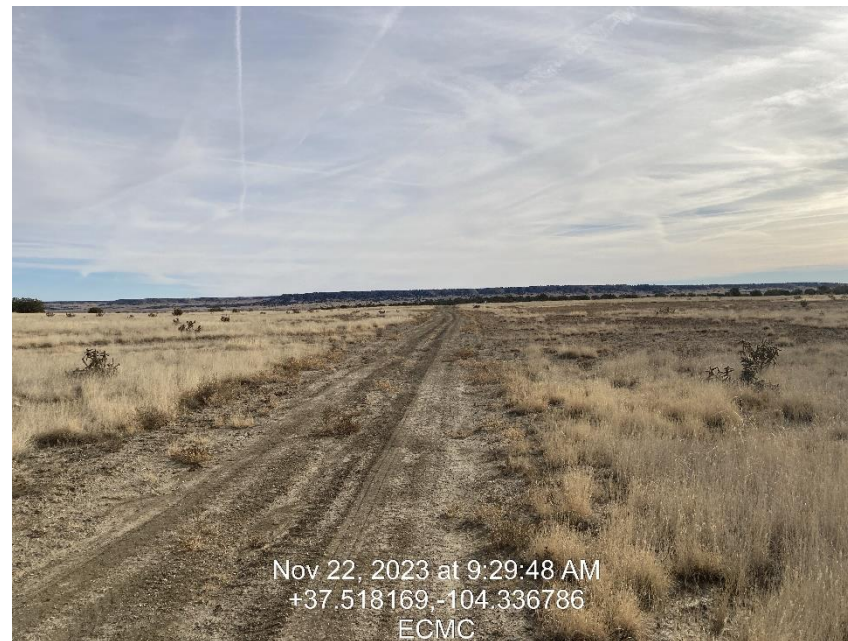
Photo 6 – Access road leaving location

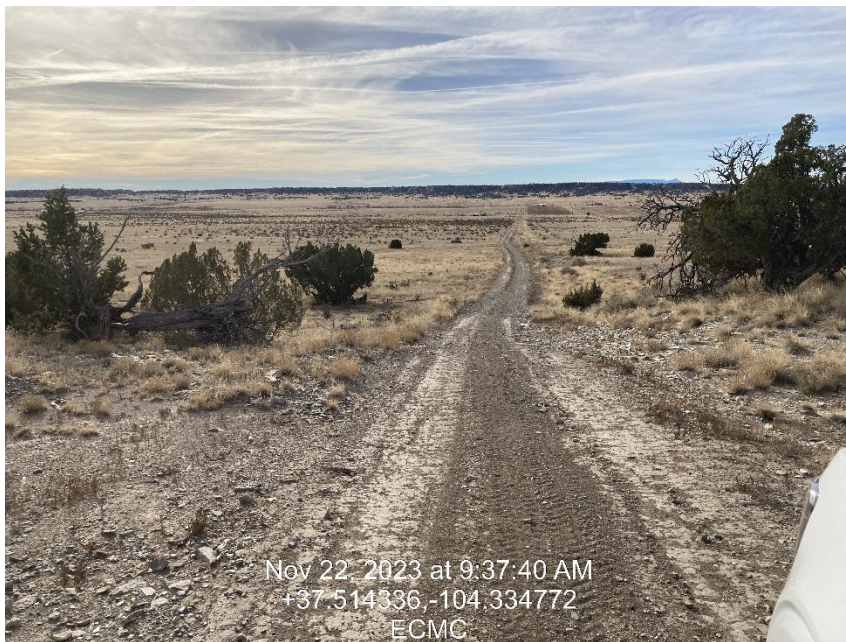
Photo 7 – Access road

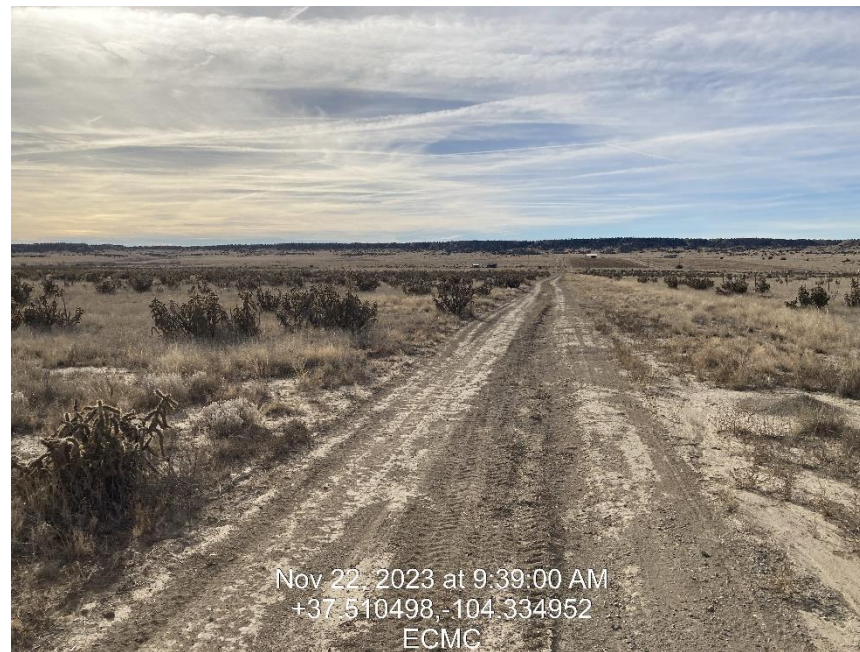
Photo 8 – Access road with riling and rutting
