# Interim Reclamation and Stormwater Inspection

Date: 11/27/2023

Operator: WESTERN OPERATING COMPANY - 95620

Location ID: 312292

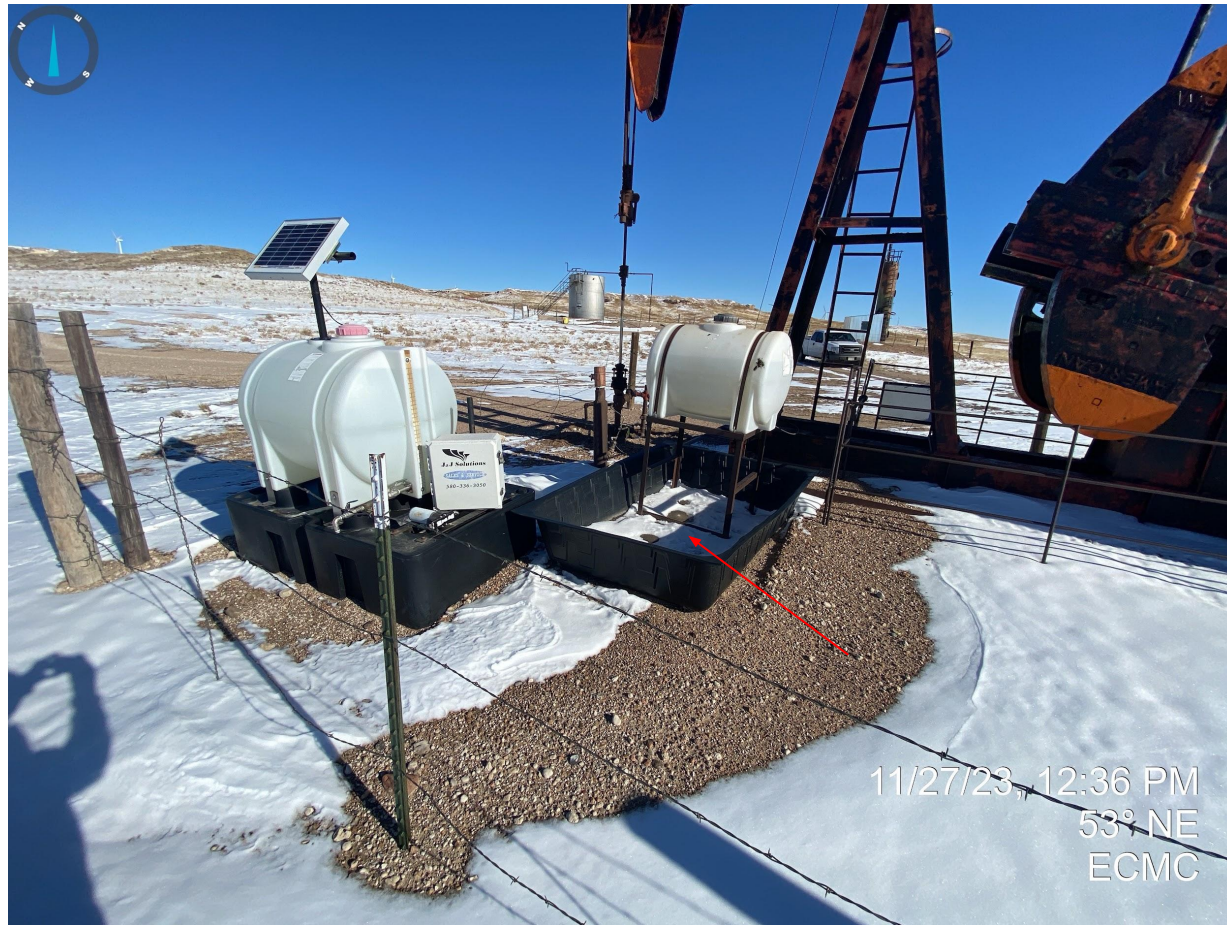
**Photo 1.** No wildlife exclusion device observed around secondary containment at day tank near the wellhead.

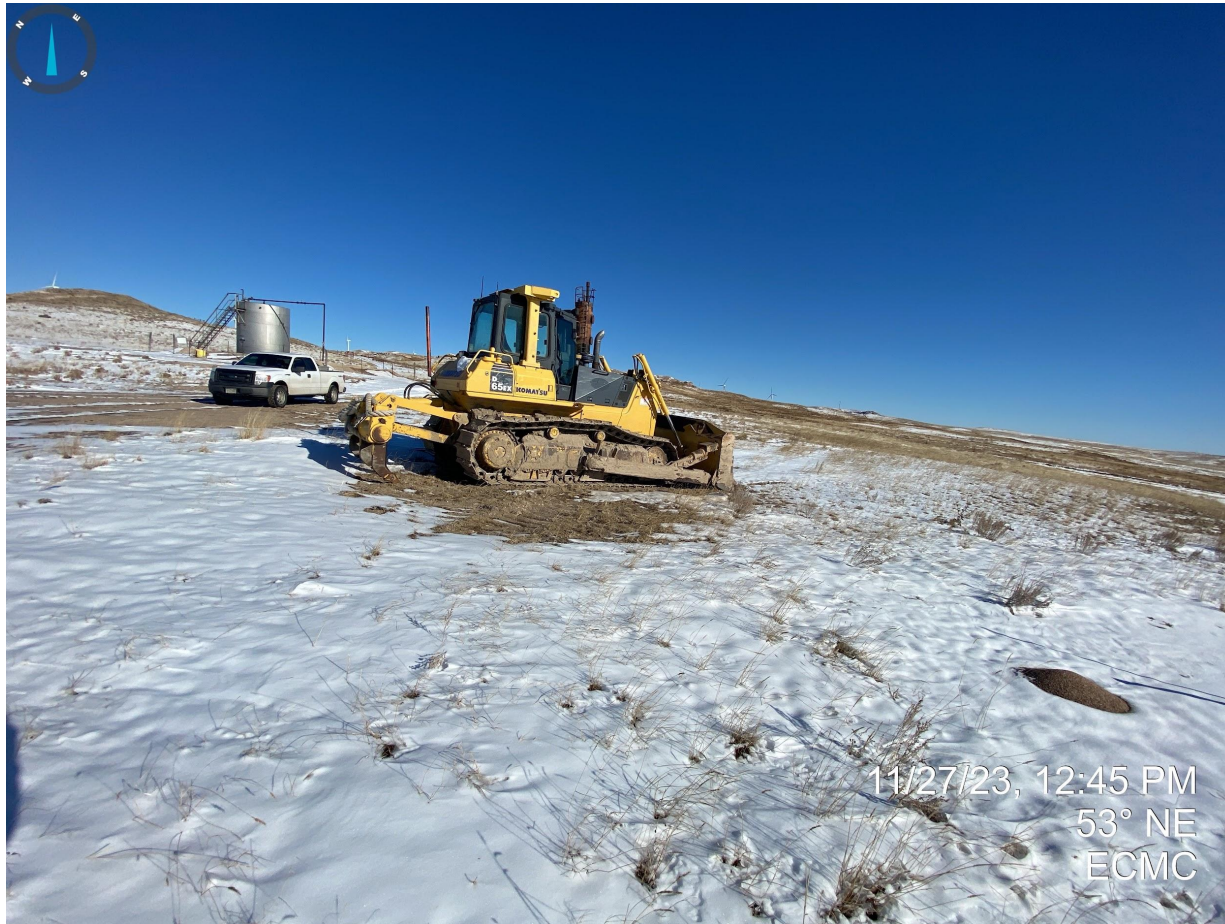
**Photo 2.** Bulldozer observed near the wellhead location. This equipment appears to have been stored on location since the previous inspection (doc no 708200627) on 10/16/2023. Locations are not to be used as equipment storage yards.

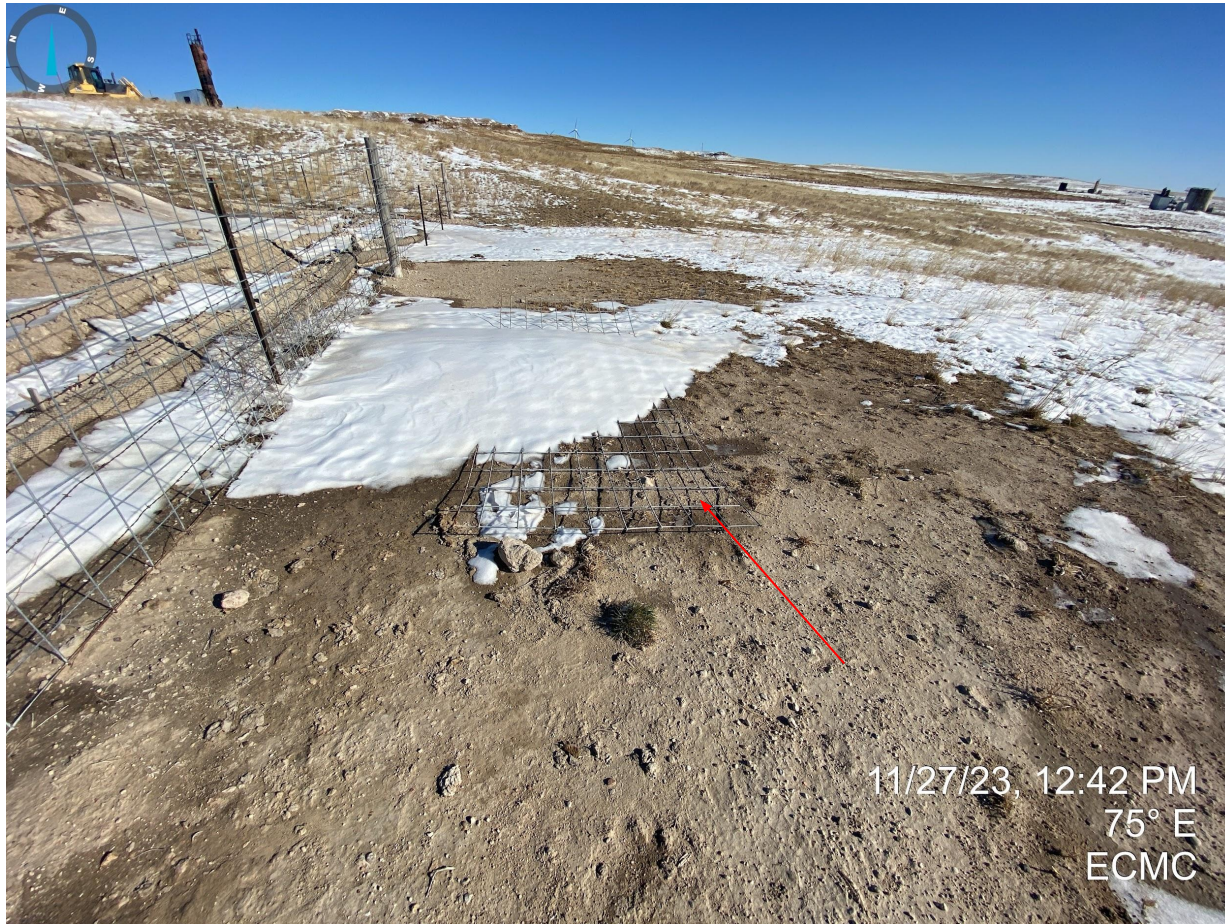
**Photo 3.** Cattle panel does not appear to be properly installed along with the other fencing; this is now considered unused equipment and either needs to be removed or reinstalled.

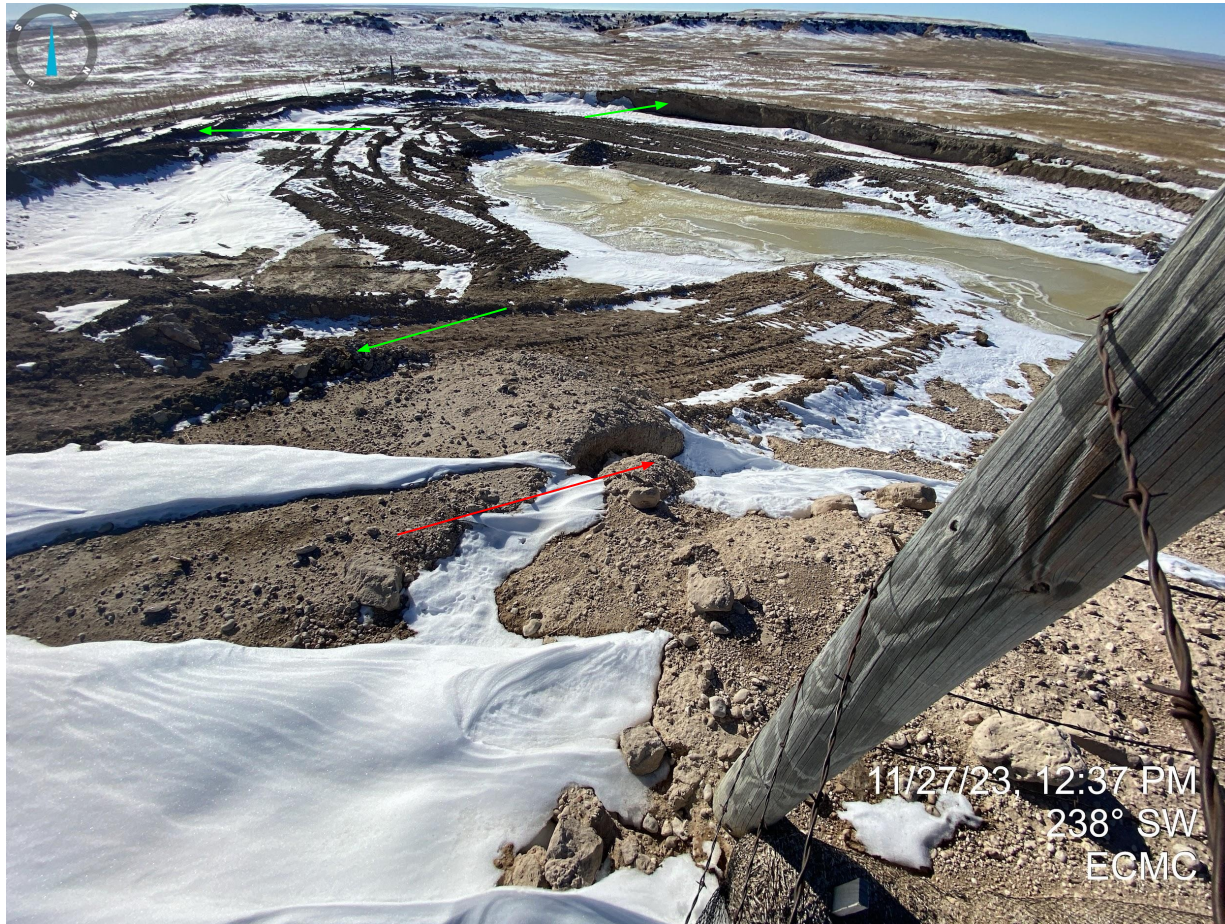
**Photo 4.** Taken from the eastern side of the pit. Photo illustrates erosion degradation (e.g. gullying with red arrow) that does not appear to have been repaired or stabilized, and no apparent stormwater control measures to prevent further erosion. Additionally, recent earthwork associated with soil sampling has left much of the pit with unstabilized/unconsolidated materials that can become a source of pollution itself (represented by green arrows).

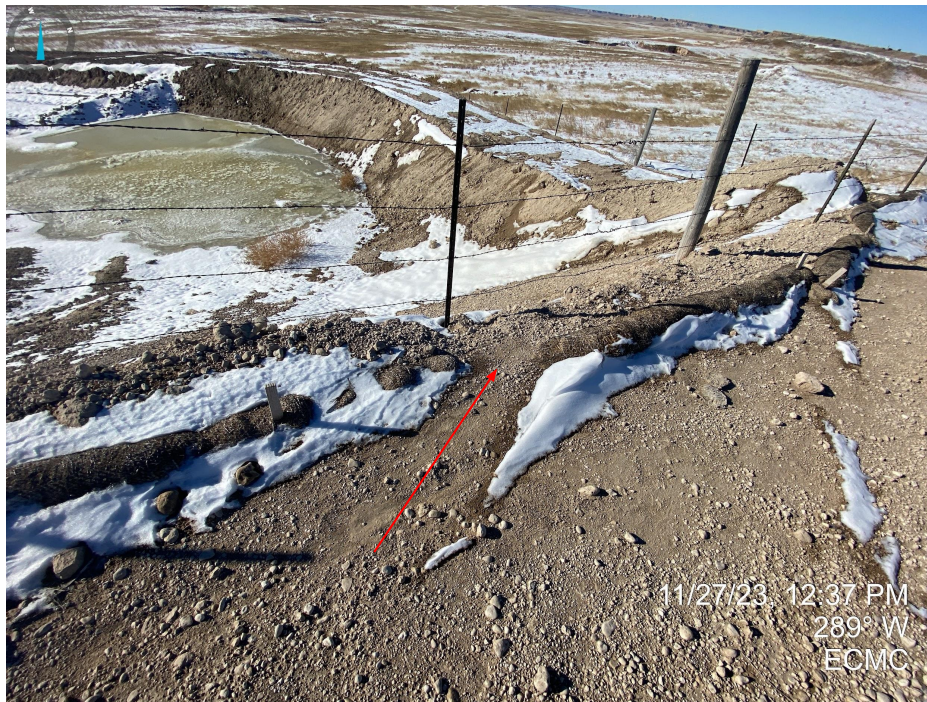
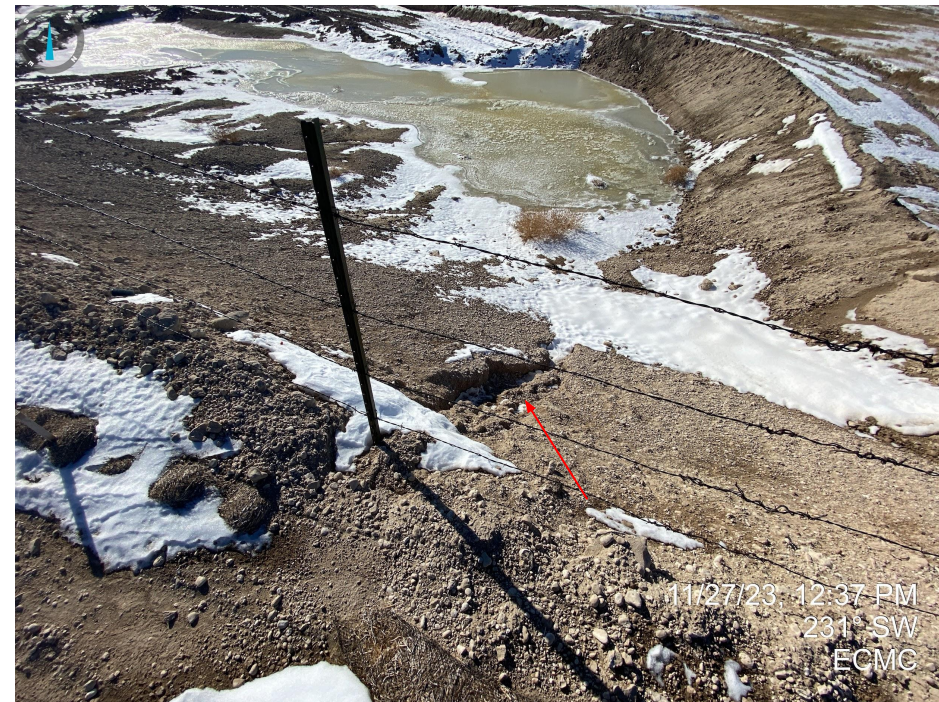
**Photos 5 & 6.** Stormwater control measures/BMPs remain insufficient along the eastern side of the pit; straw wattles are degraded and not properly installed, leading to erosion degradation (right photo). It is not apparent that any additional work has been done to repair and stabilize the soils.

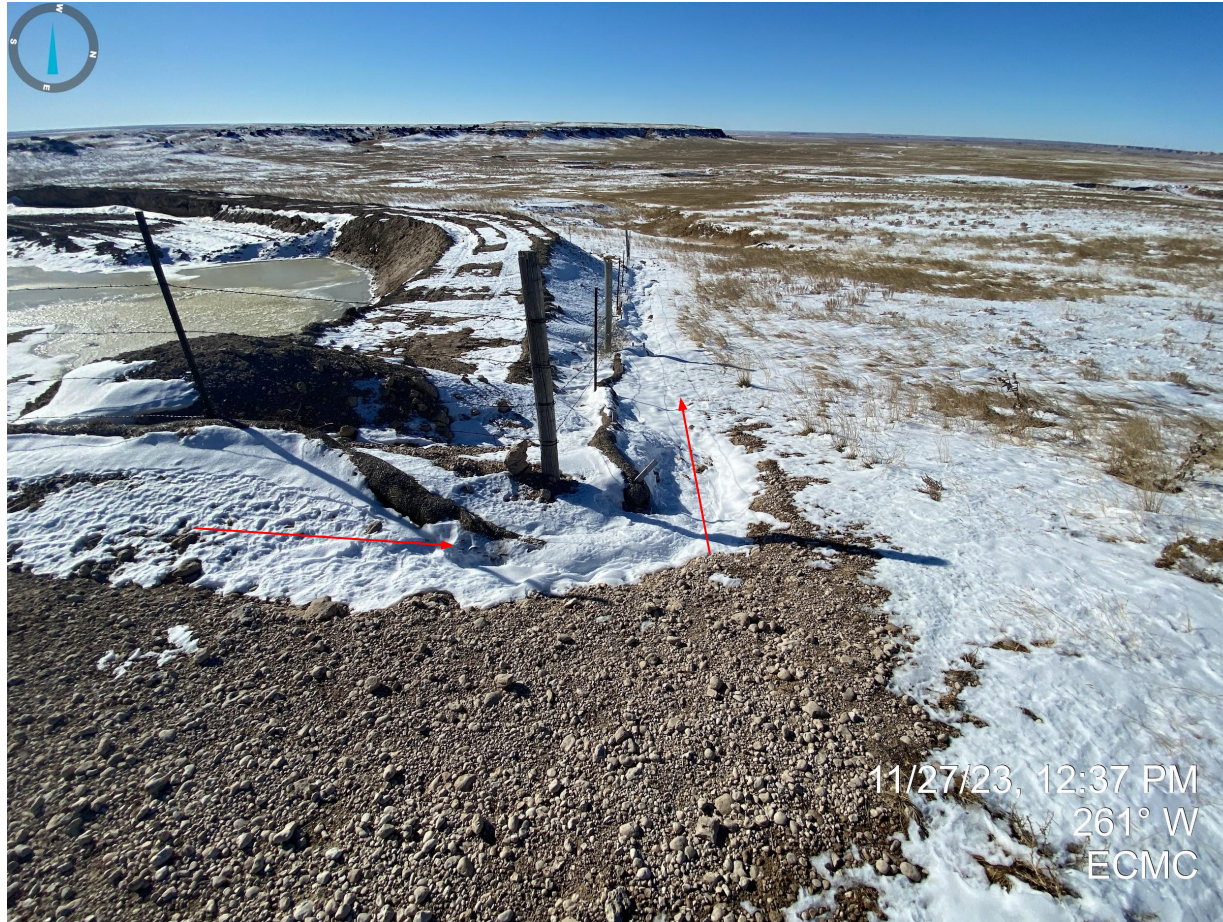
**Photo 7.** Taken from the northeastern portion of the pit. No apparent stormwater management work appears to have been performed since the previous inspection(s) to stabilize the eroded portions observed here.

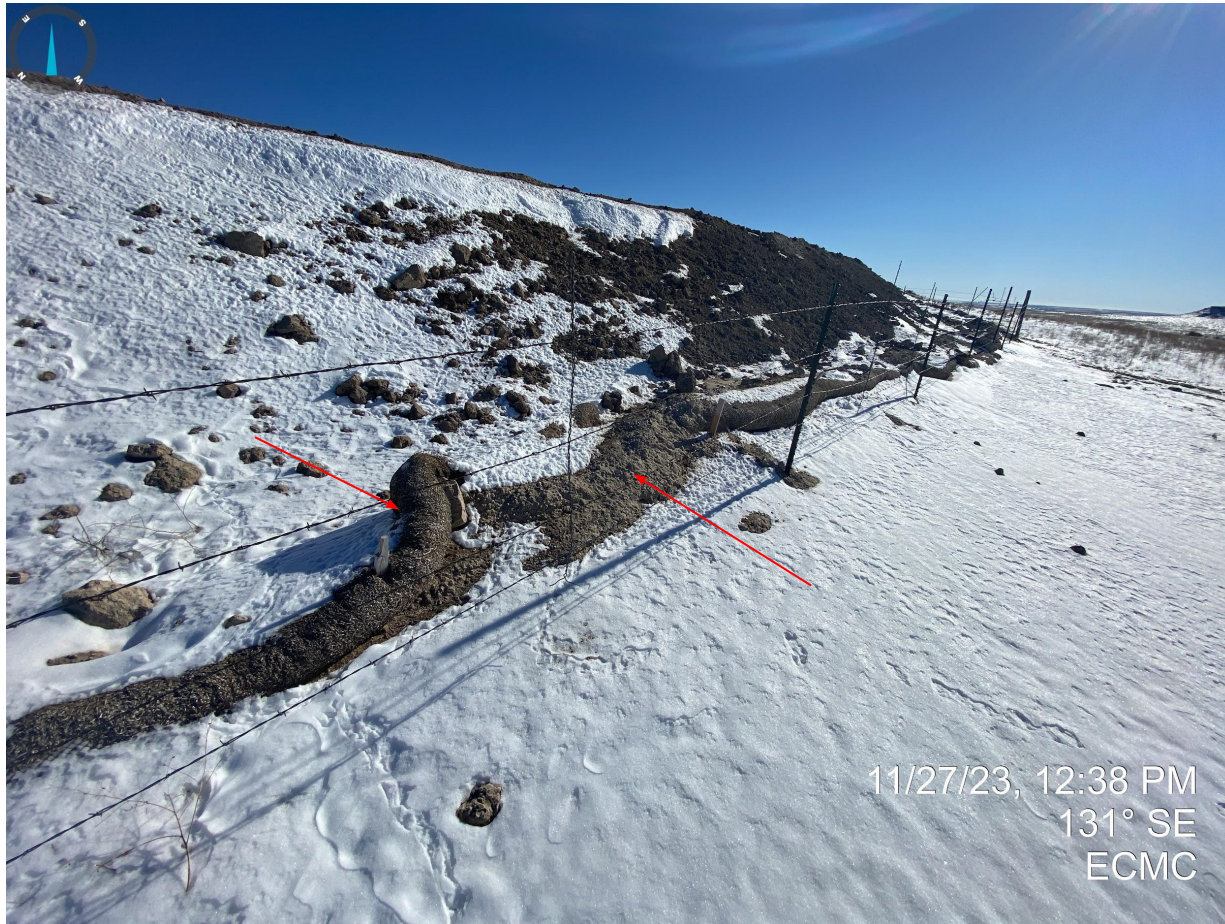
**Photo 8.** Taken from the western portion of the pit. Photo illustrates that straw wattles are inadequate as they are not installed properly and are degraded.

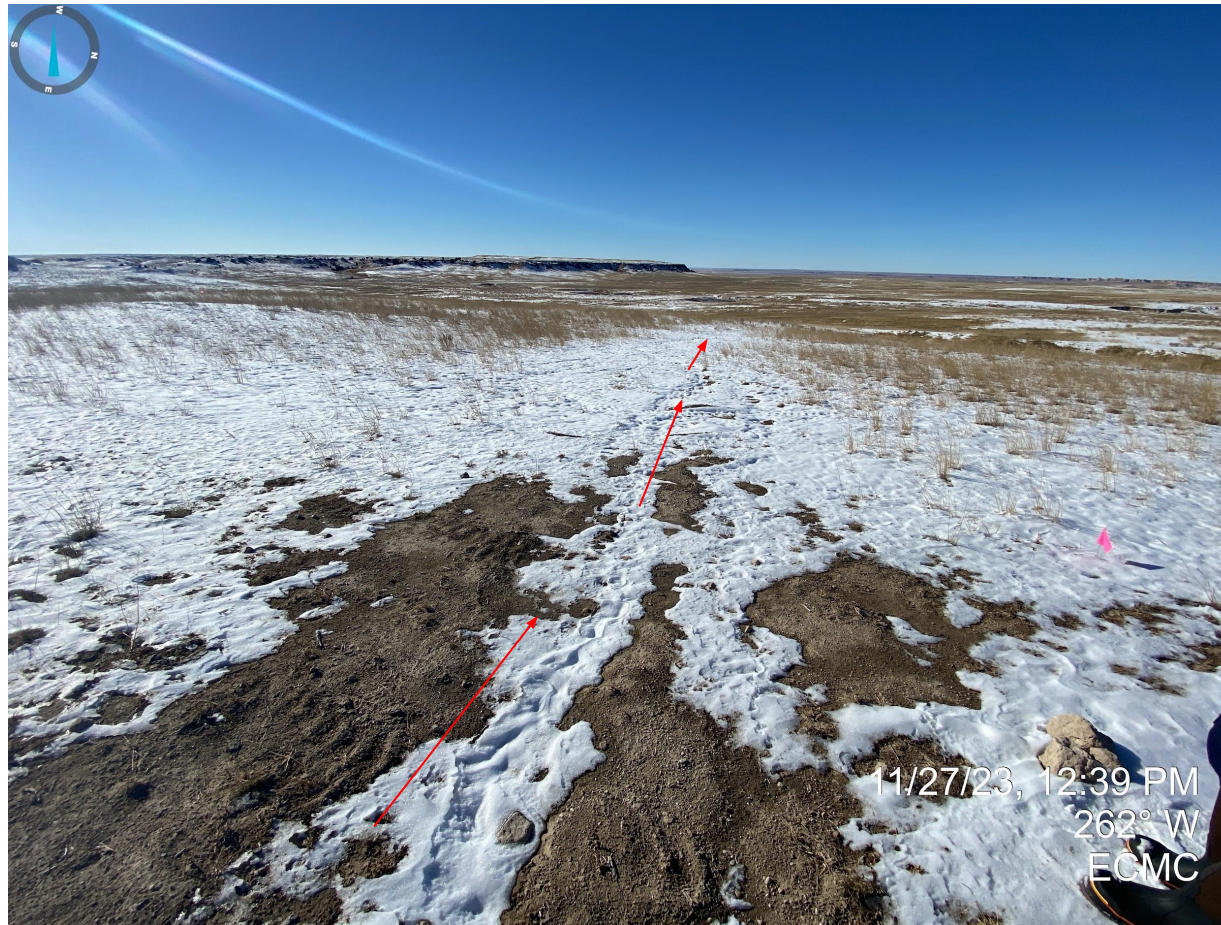
**Photo 9.** Taken from the western portion of the pit, facing west into the salt kill affected areas. Evidence of erosion degradation, previously documented, does not appear to have been repaired/stabilized with no evidence of control measures/BMPs observed that would prevent further erosion of the unstabilized/exposed soils.

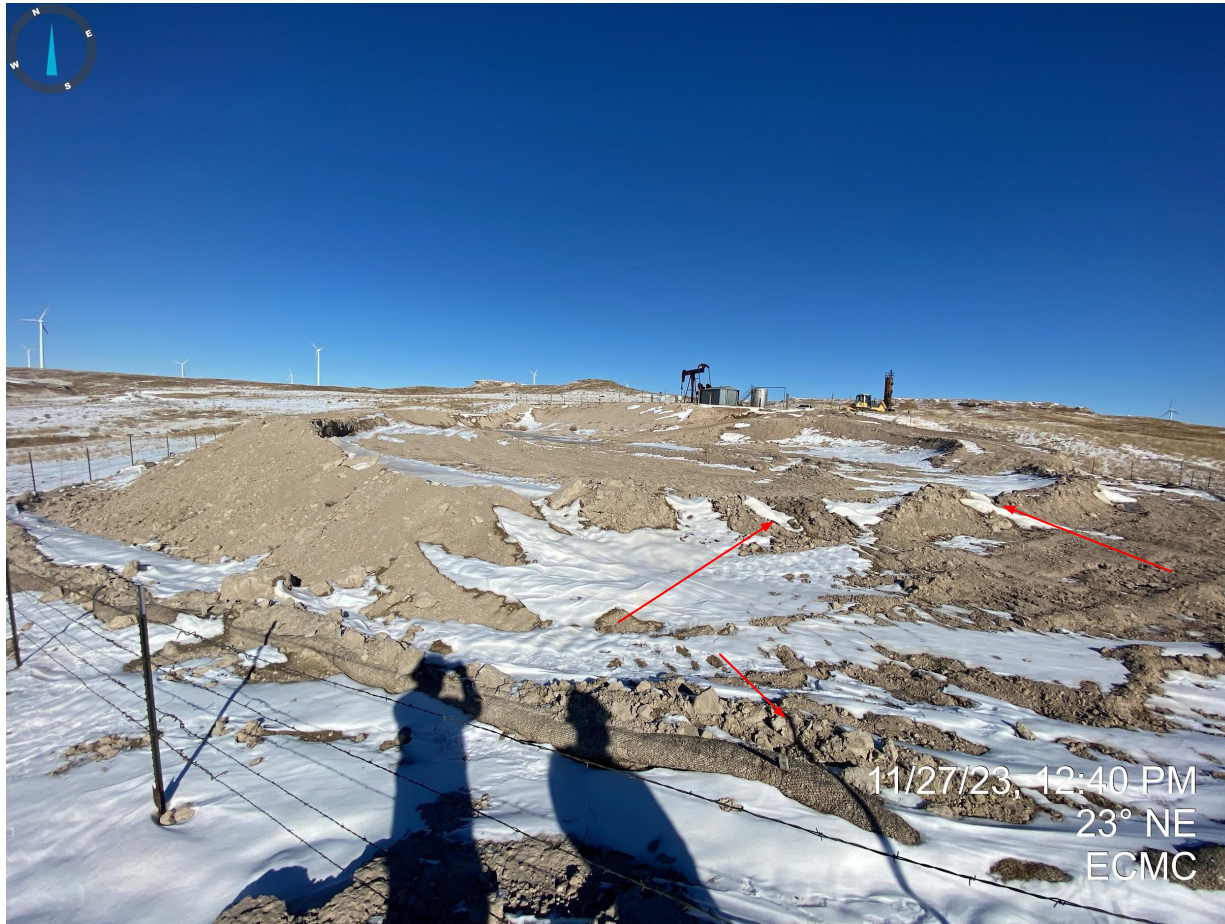
**Photo 10.** Taken from the southwestern corner of the pit. Photo illustrates unconsolidated soils/materials from dirt work within the pit.

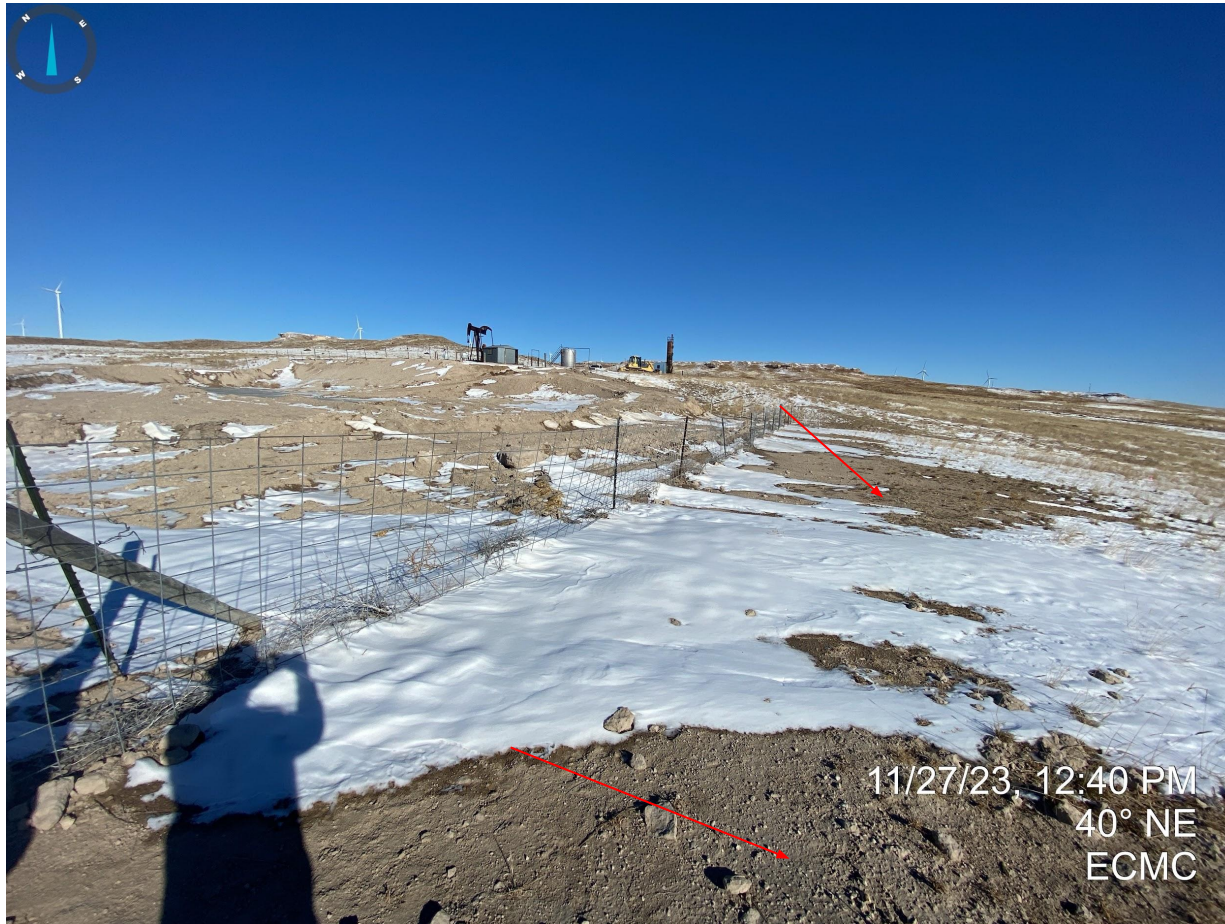
**Photo 11.** Exposed/bare soils south of the pit. No stormwater control measures or other stabilization BMPs of the exposed soils were observed during this inspection.

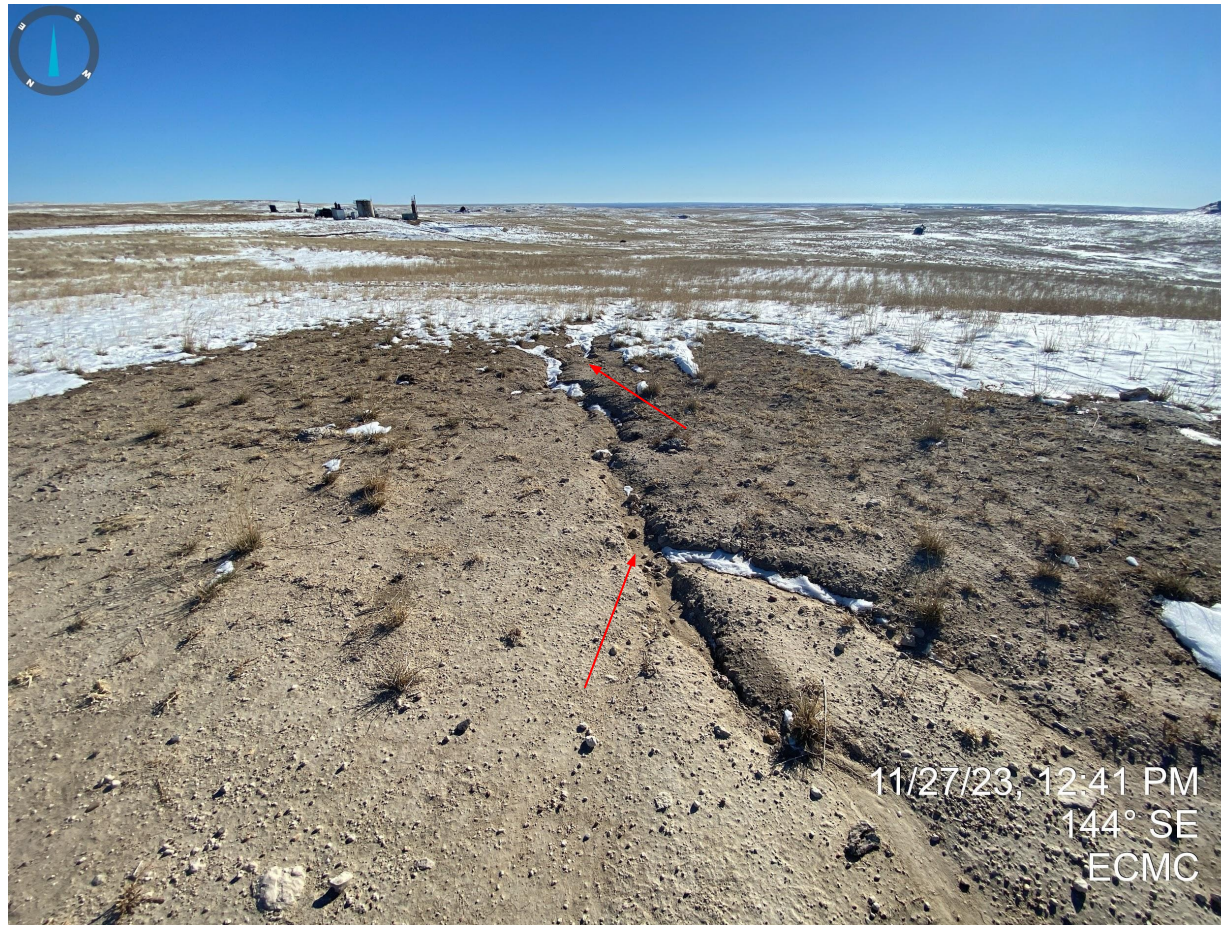
**Photo 13.** Taken south of the pit, looking southeast into the salt kill impacted areas. Evidence of erosion degradation, previously documented, does not appear to have been repaired/stabilized with no evidence of control measures/BMPs observed that would prevent further erosion of the unstabilized/exposed soils.

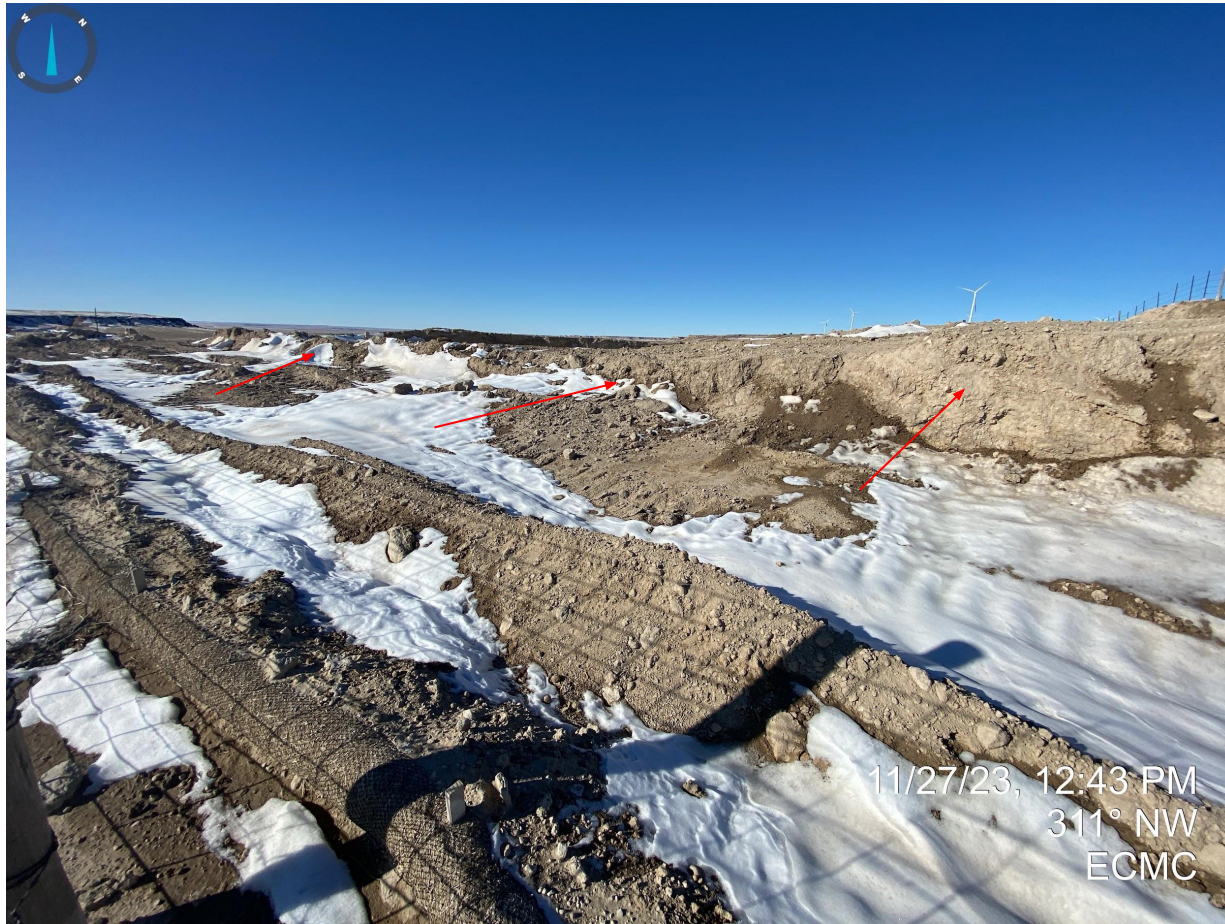
**Photo 14.** Taken near the southeast corner of the pit. Photo illustrates that pit walls are unconsolidated and not properly stabilized from the dirt work recently performed.

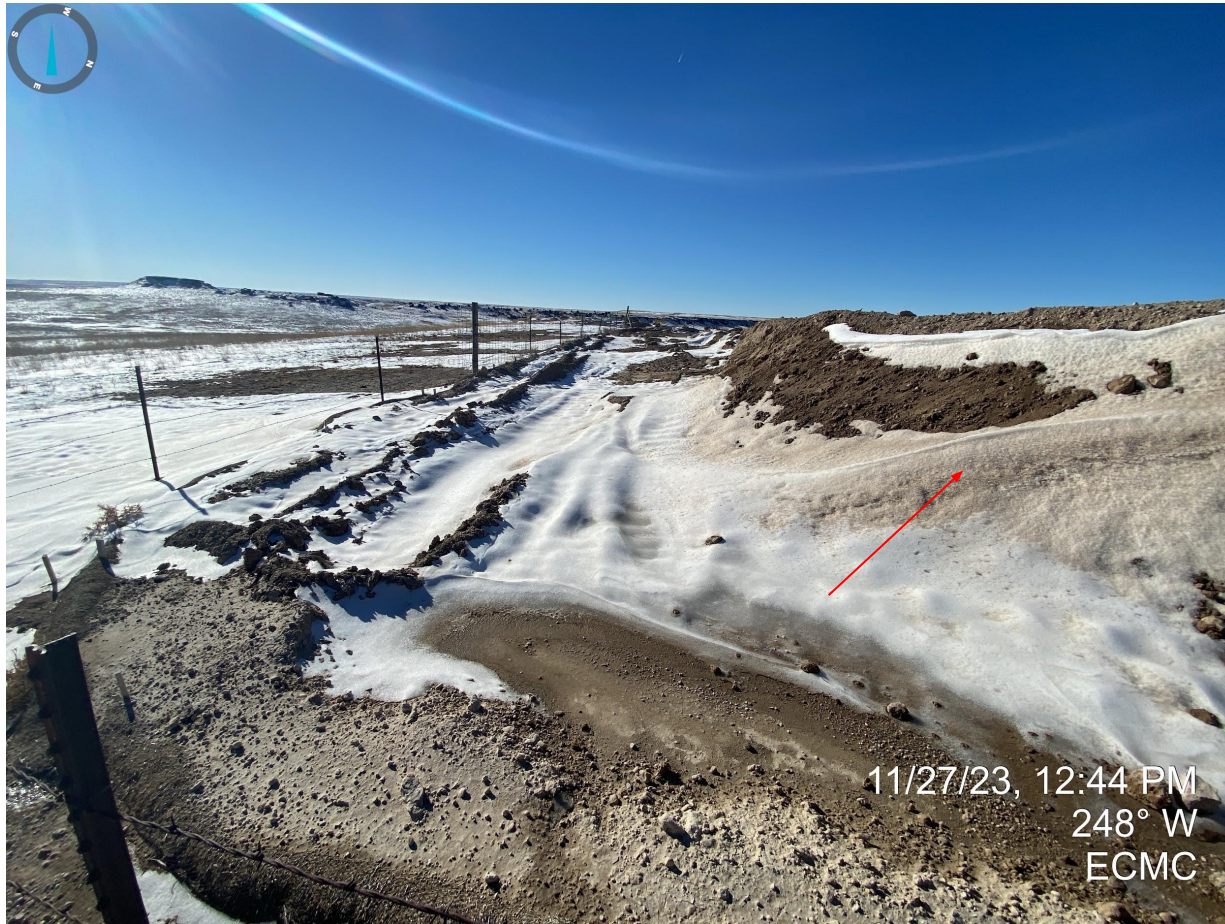
**Photo 15.** Continued from Photo 14. Red arrow illustrates dust on snow, indicative of wind erosion, from unconsolidated materials.

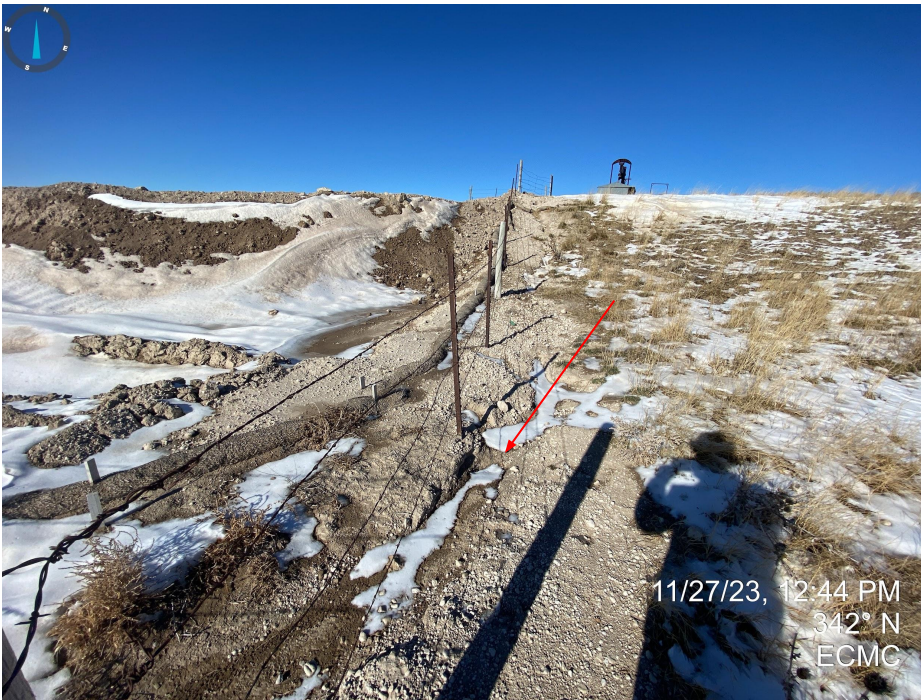
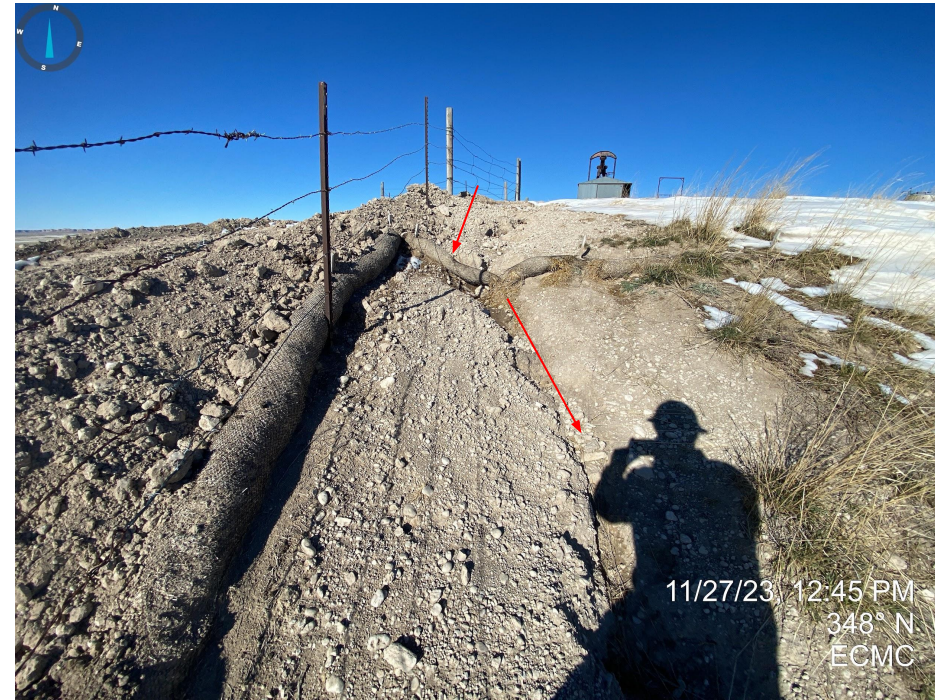
**Photos 16 & 17.** Taken from the eastern side of the pit. Photo illustrates that erosion degradation (e.g. rilling) does not appear to have been repaired or stabilized; stormwater control measures are inadequate as they are degraded.

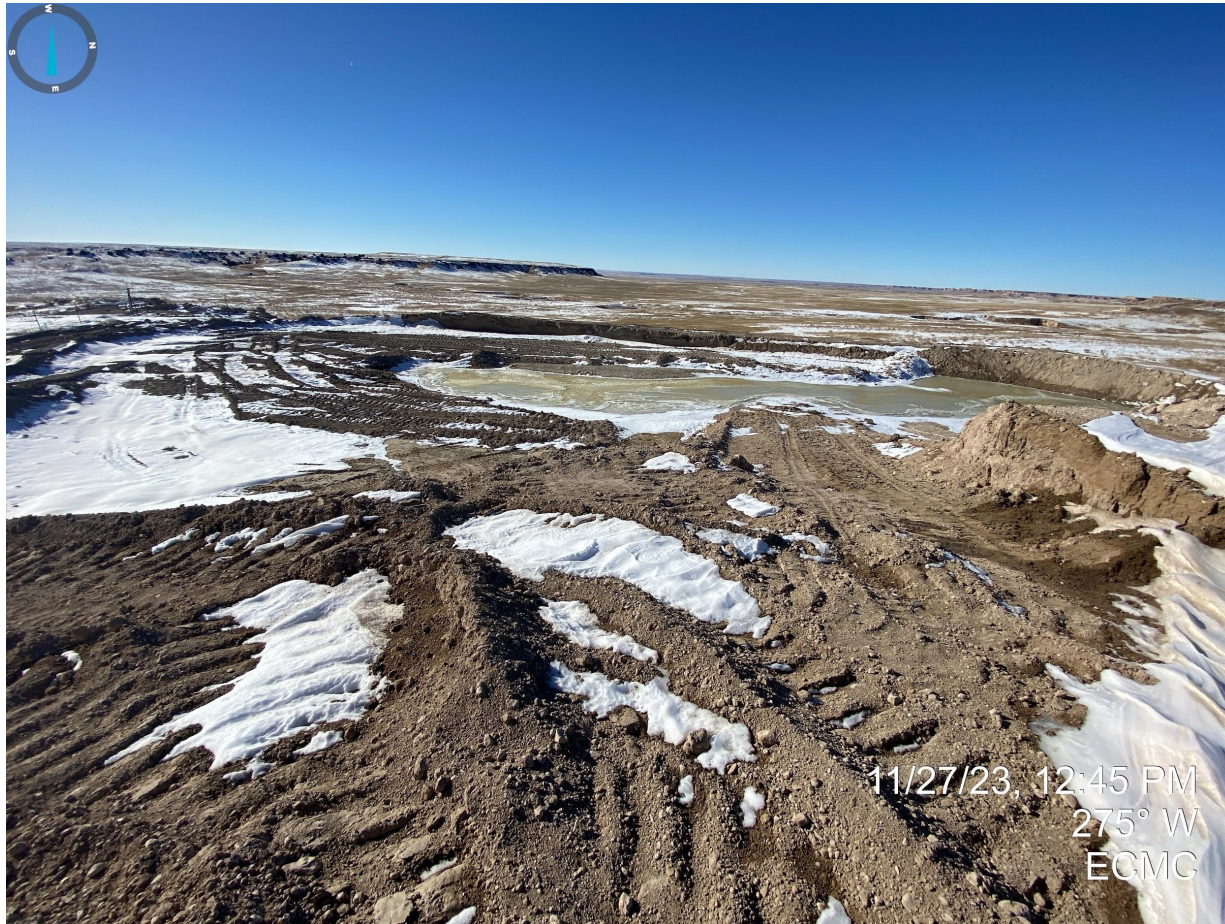
**Photo 18.** Unstabilized soil within the pit where dirt work recently occurred.

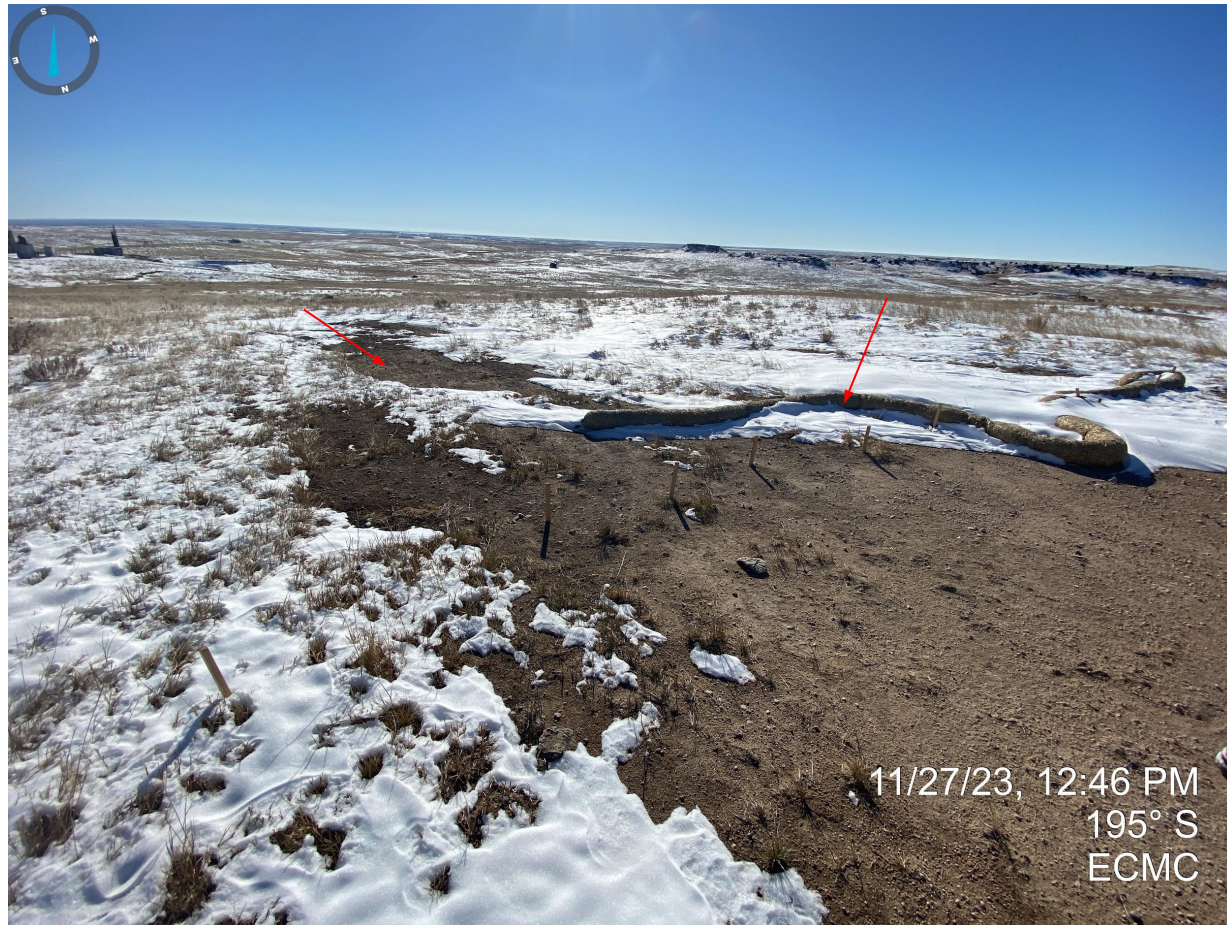
**Photo 19.** Taken near the vertical heater treater. Photo illustrates that straw wattles are not properly installed and bare/exposed soils are not properly stabilized.
