# Interim Reclamation and Stormwater Inspection

Date: 11/27/2023

Operator: WESTERN OPERATING COMPANY 95620

Location ID: 312229

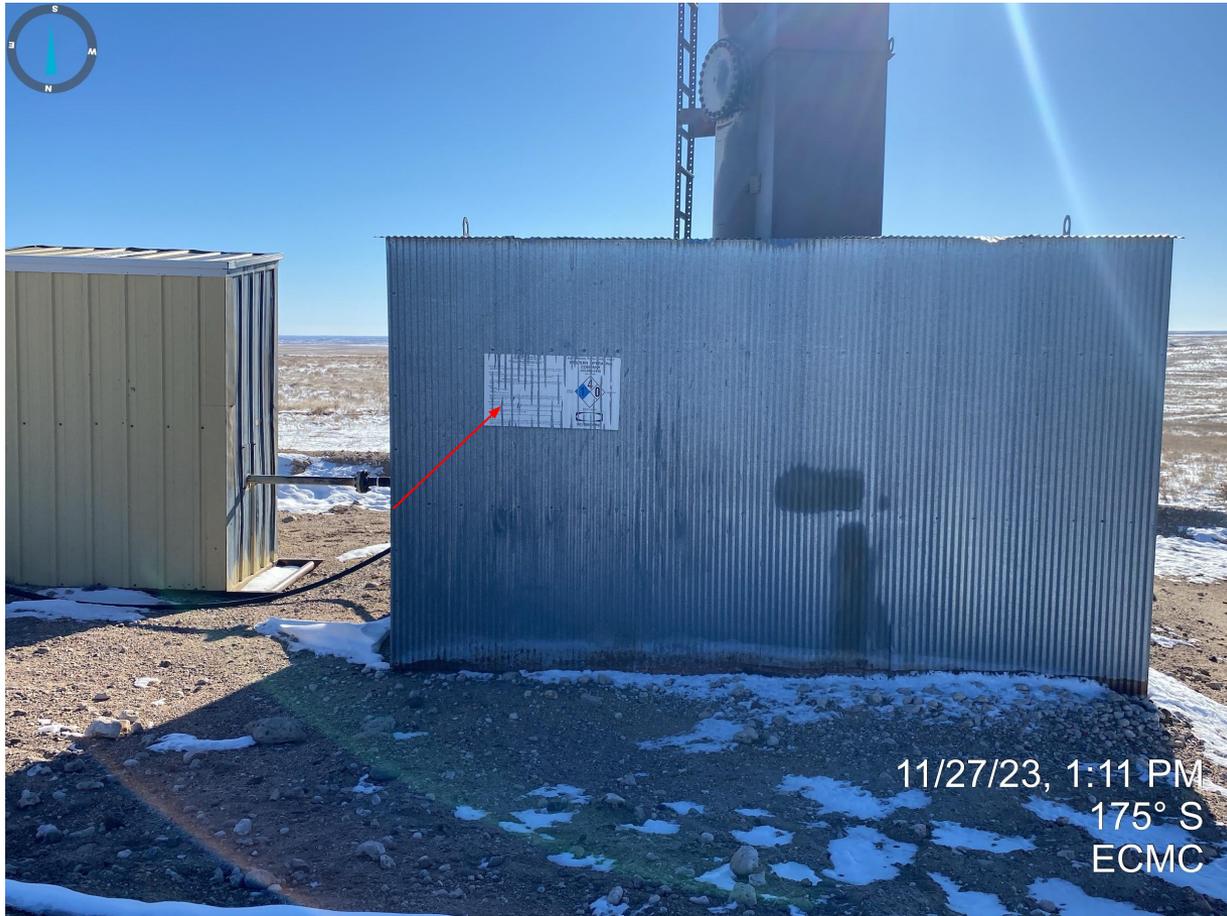
**Photo 1.** NFPA placard at separator shed is not legible (e.g. peeling, faded, cracked) and requires replacement.

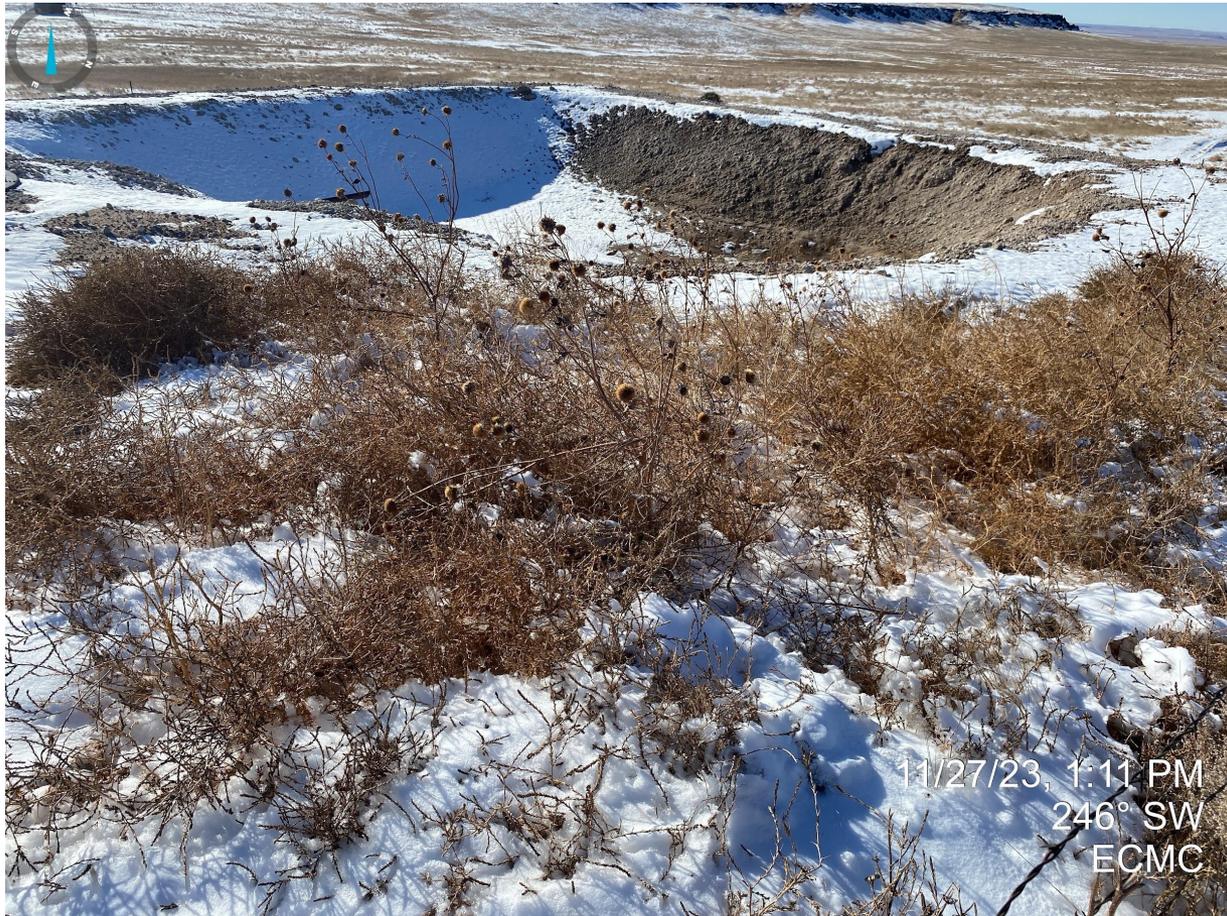
**Photo 2.** Weedy debris observed on the northeastern portion of the pit.

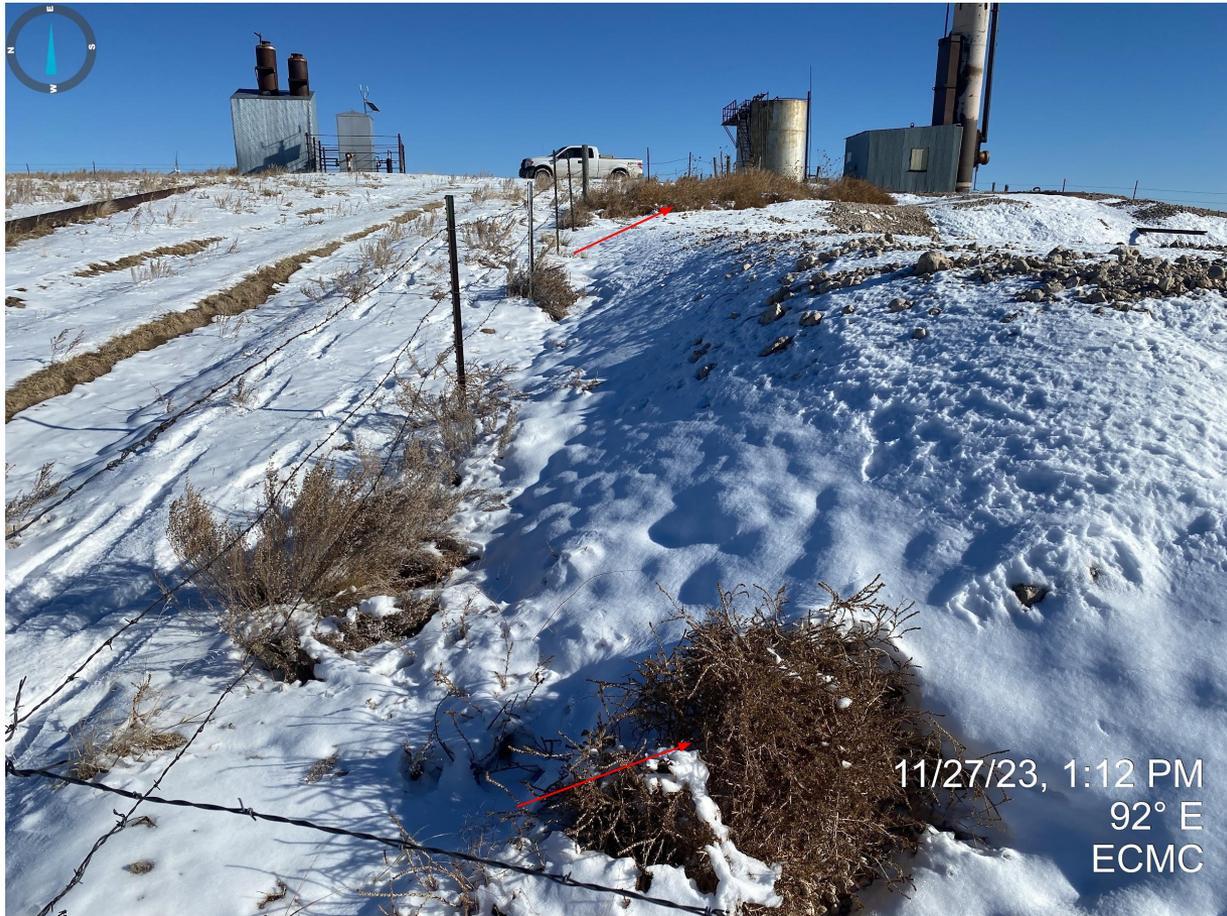
**Photo 3.** Continued from Photo 2. Weedy debris observed on the northwest corner of the pit.

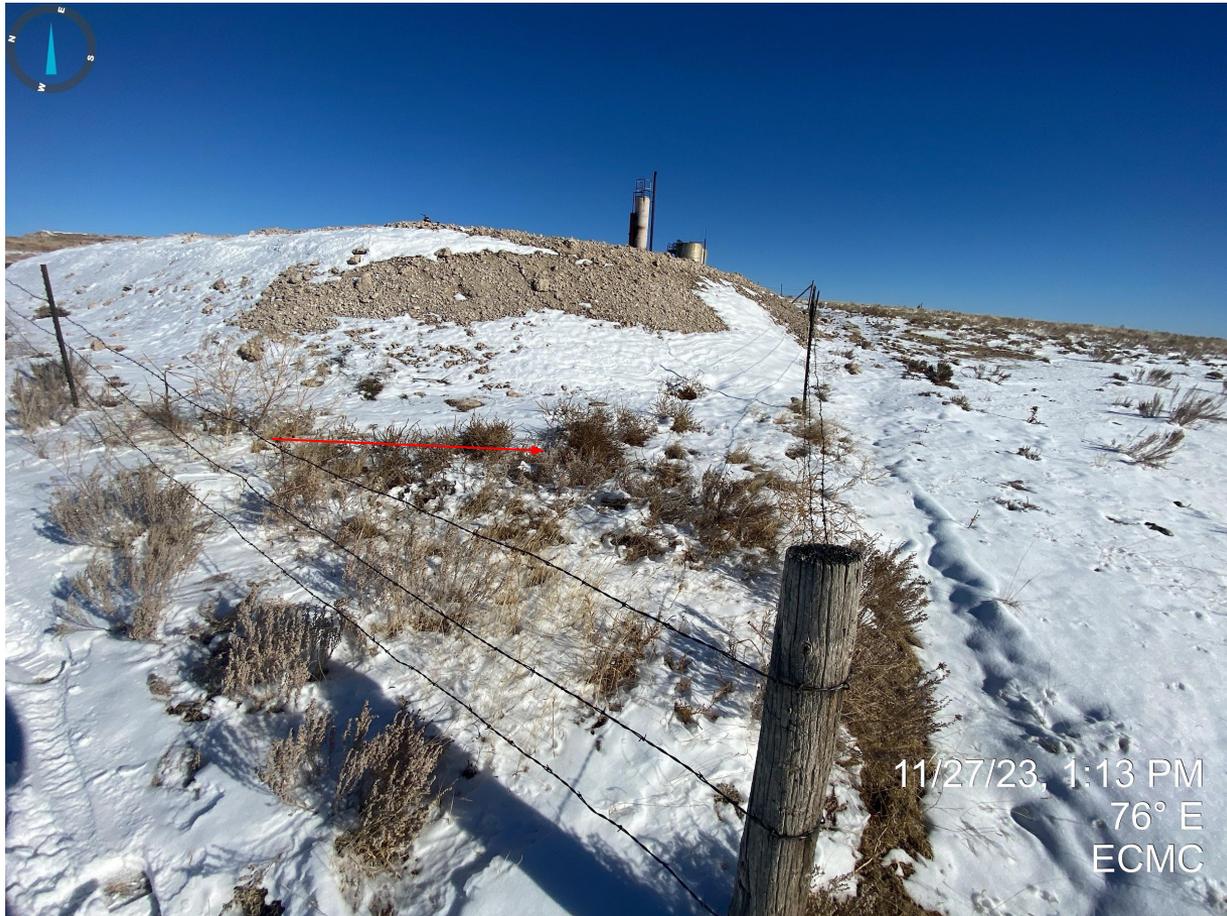
**Photo 4.** Continued from Photo 2. Weedy debris observed on the southwest corner of the pit.

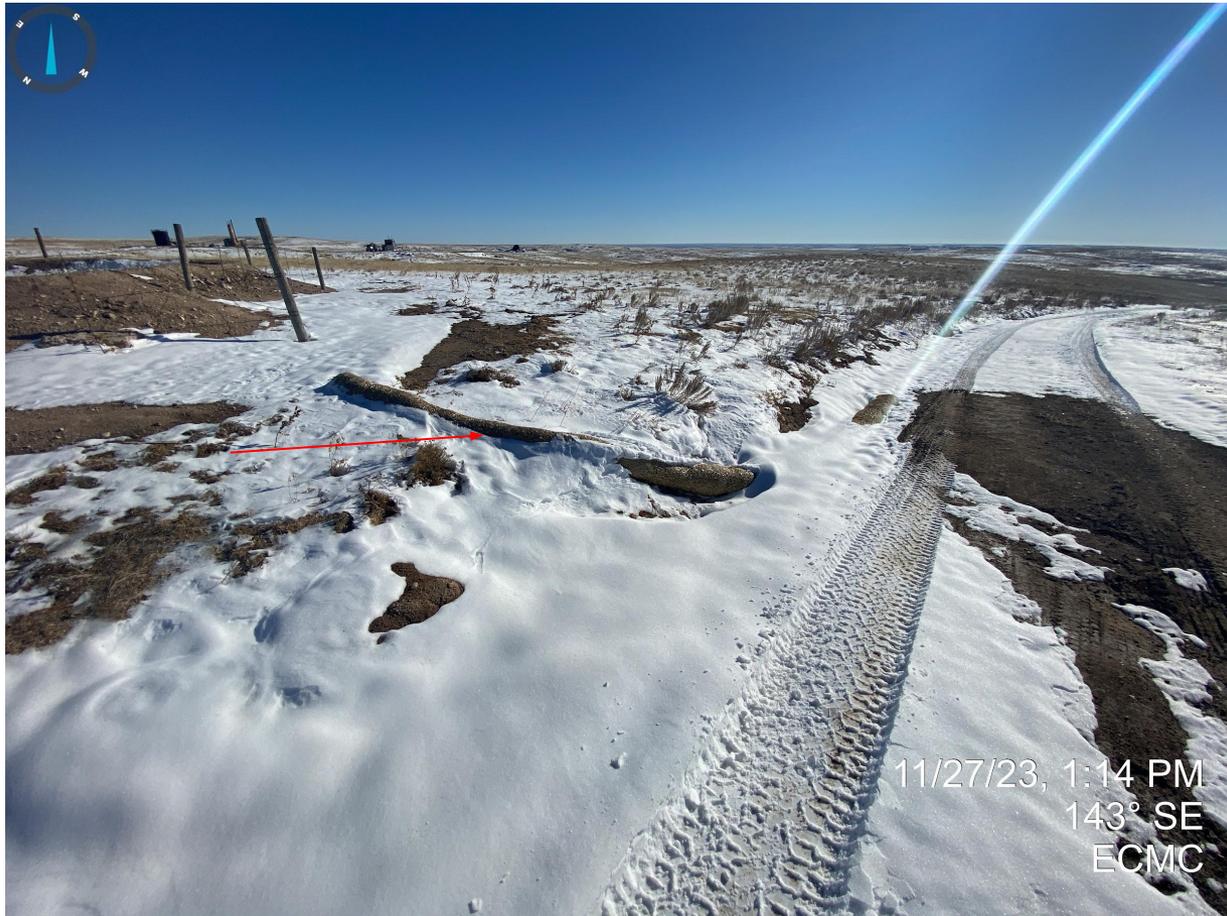
**Photo 5.** Taken from the western portion of the tank battery, photo illustrates stormwater control measure (straw wattle) that is not properly installed and is beginning to blow into the access road.

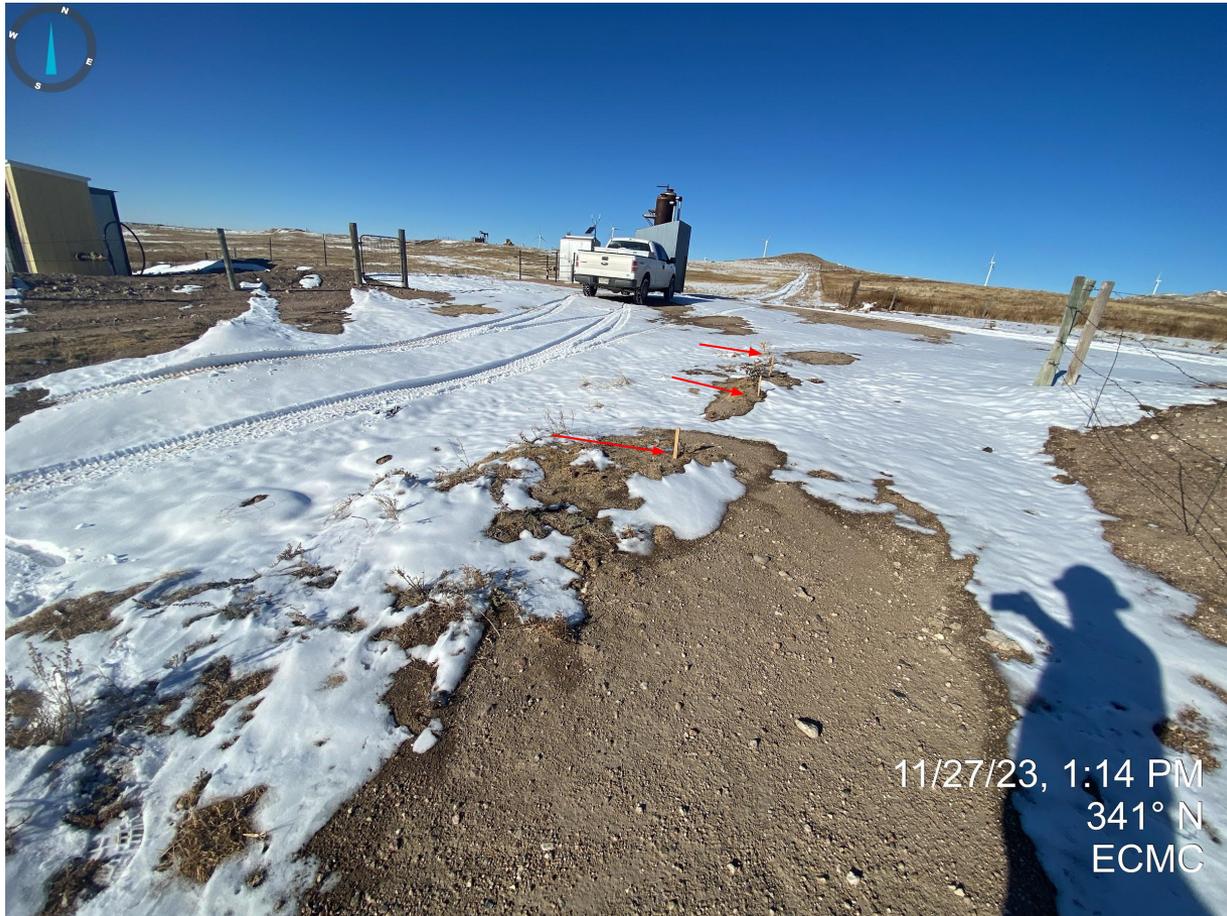
**Photo 6.** Continued from Photo 5. Photo illustrates stakes leftover from improperly installed straw wattle.

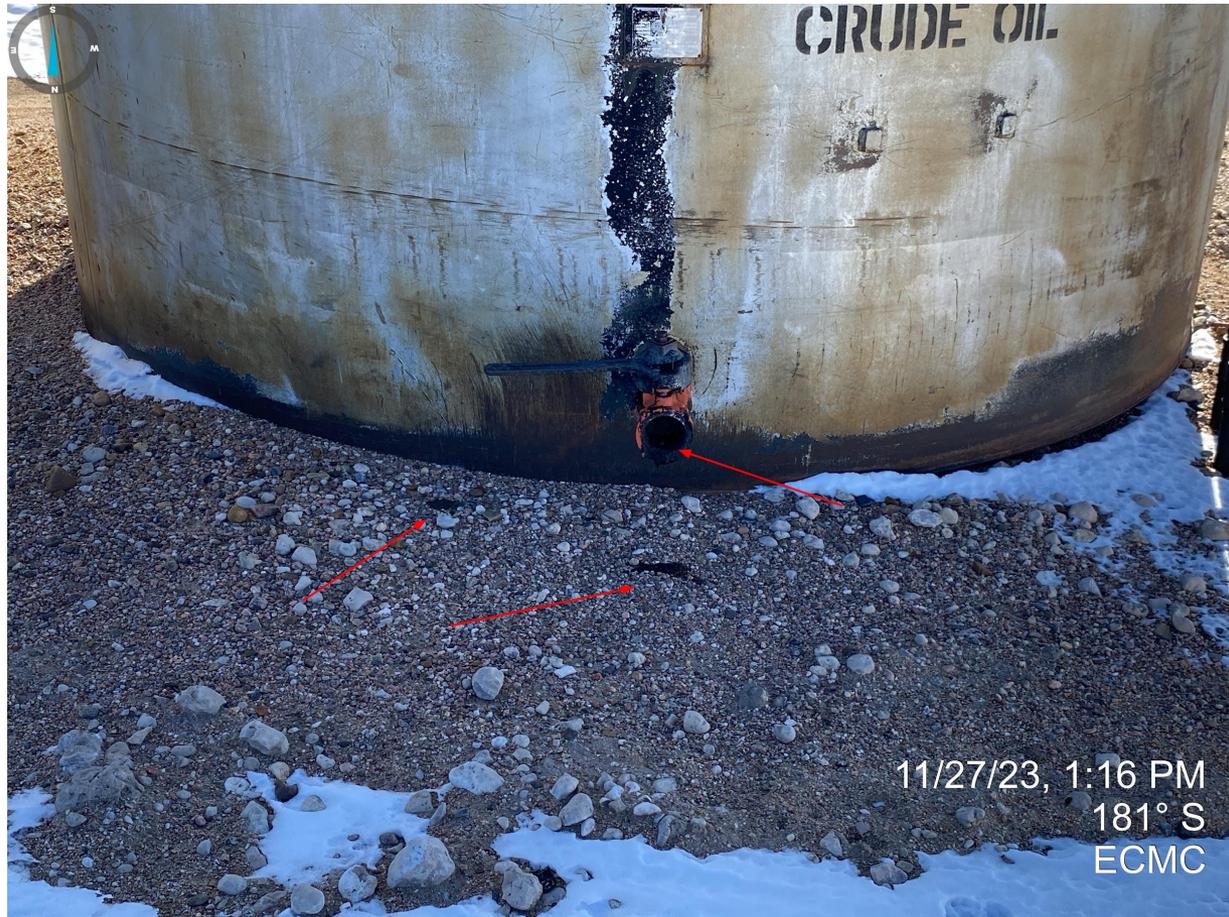
**Photo 7.** Stained soil observed near valve at AST within the tank battery.

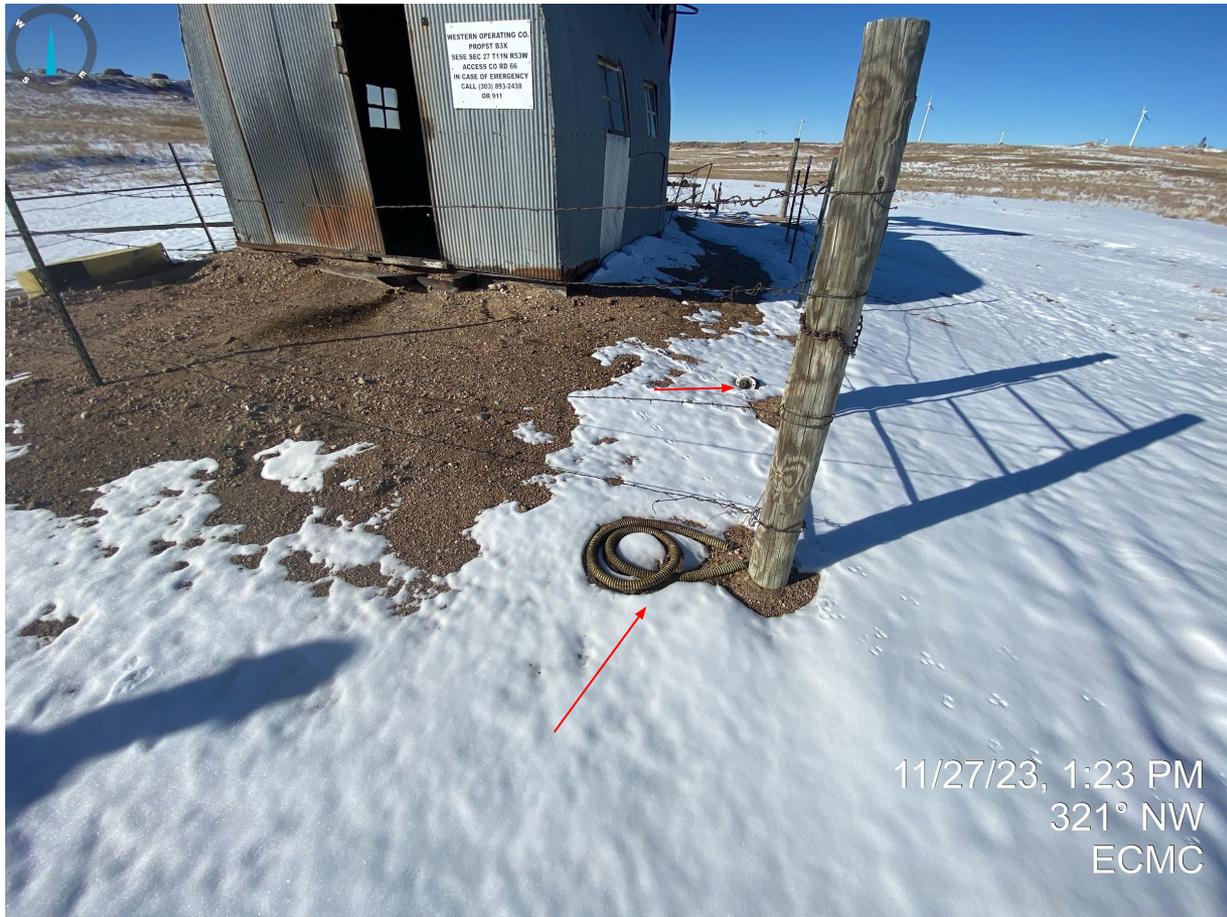
**Photo 8.** Unused equipment near pumpjack/wellhead; hose and fittings pictured.

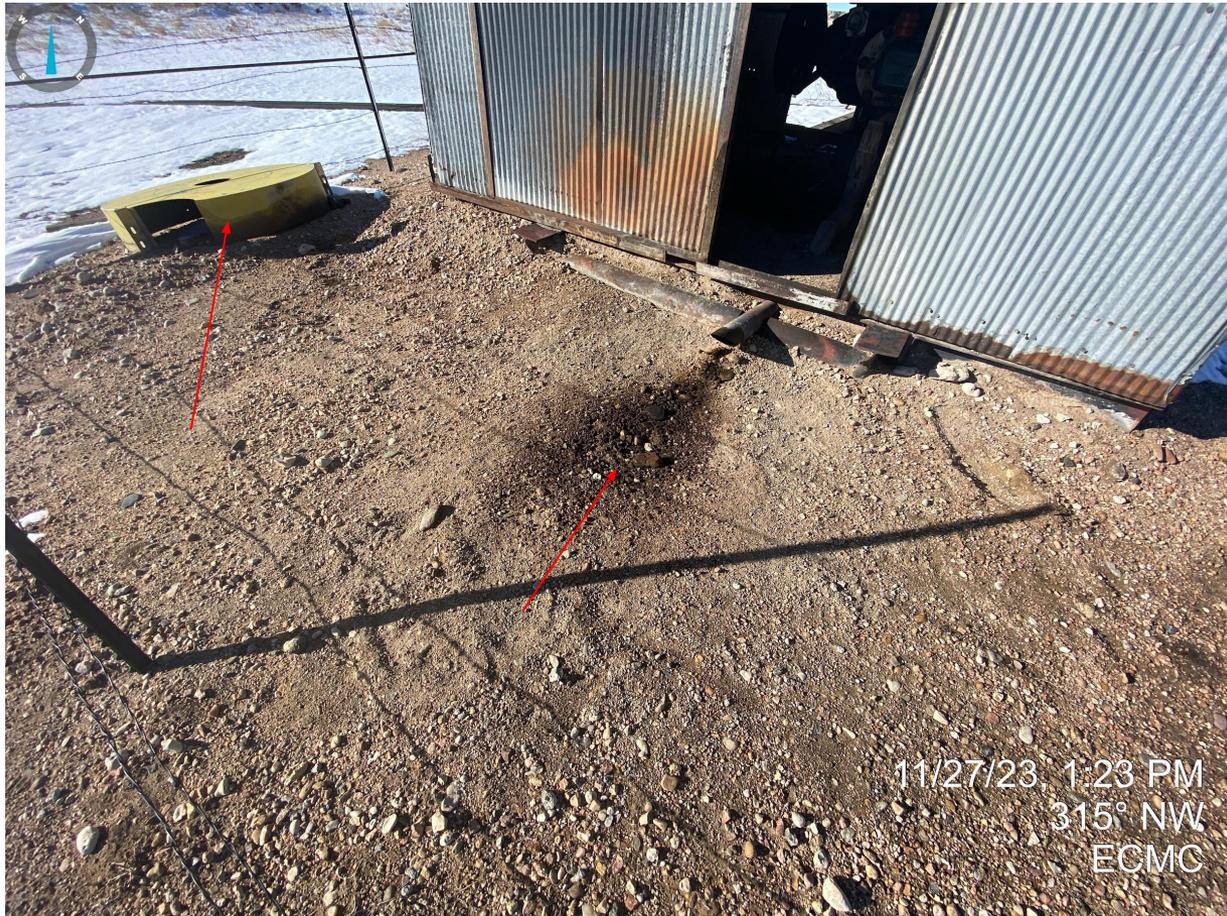
**Photo 9.** Unused equipment and stained soil near pumpjack.

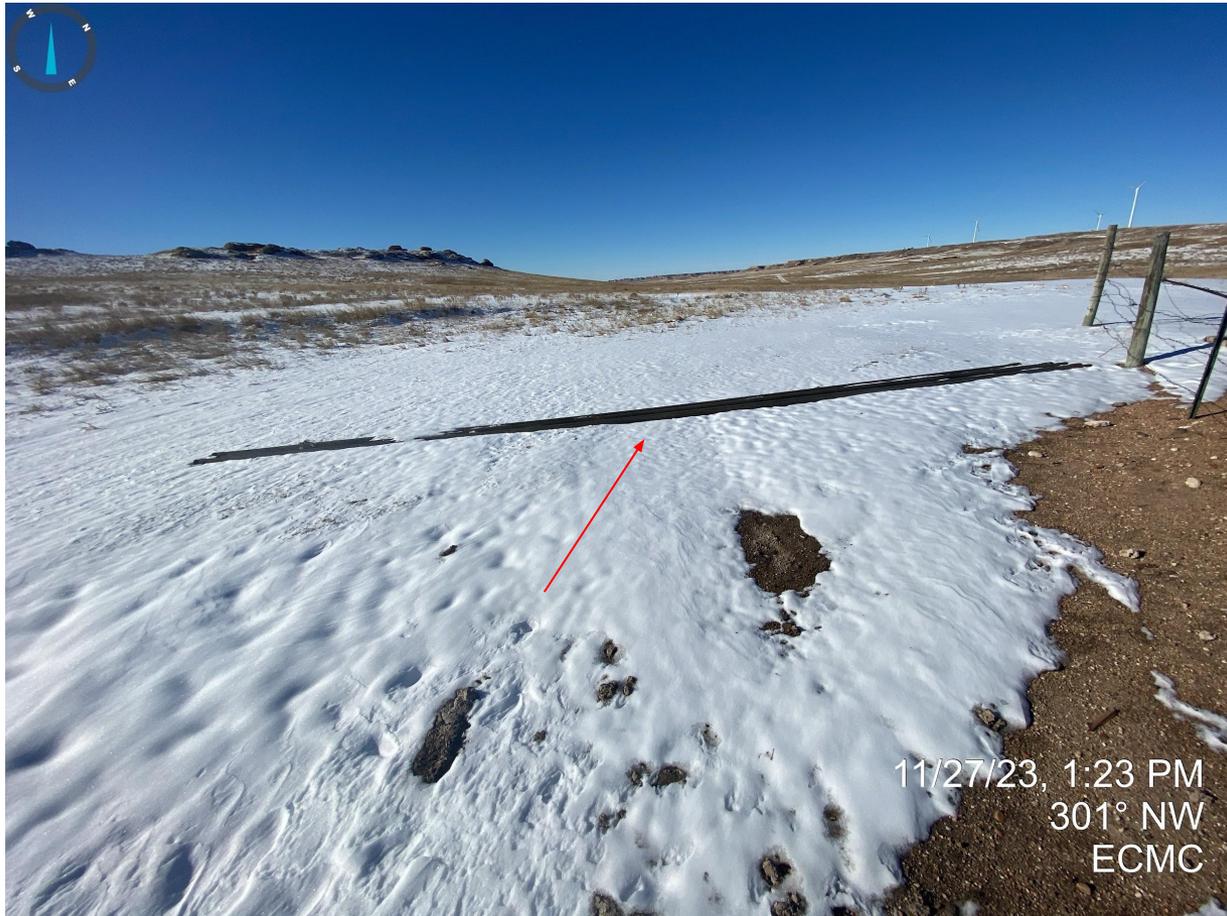
**Photo 10.** Unused equipment (pipe) near pump jack.

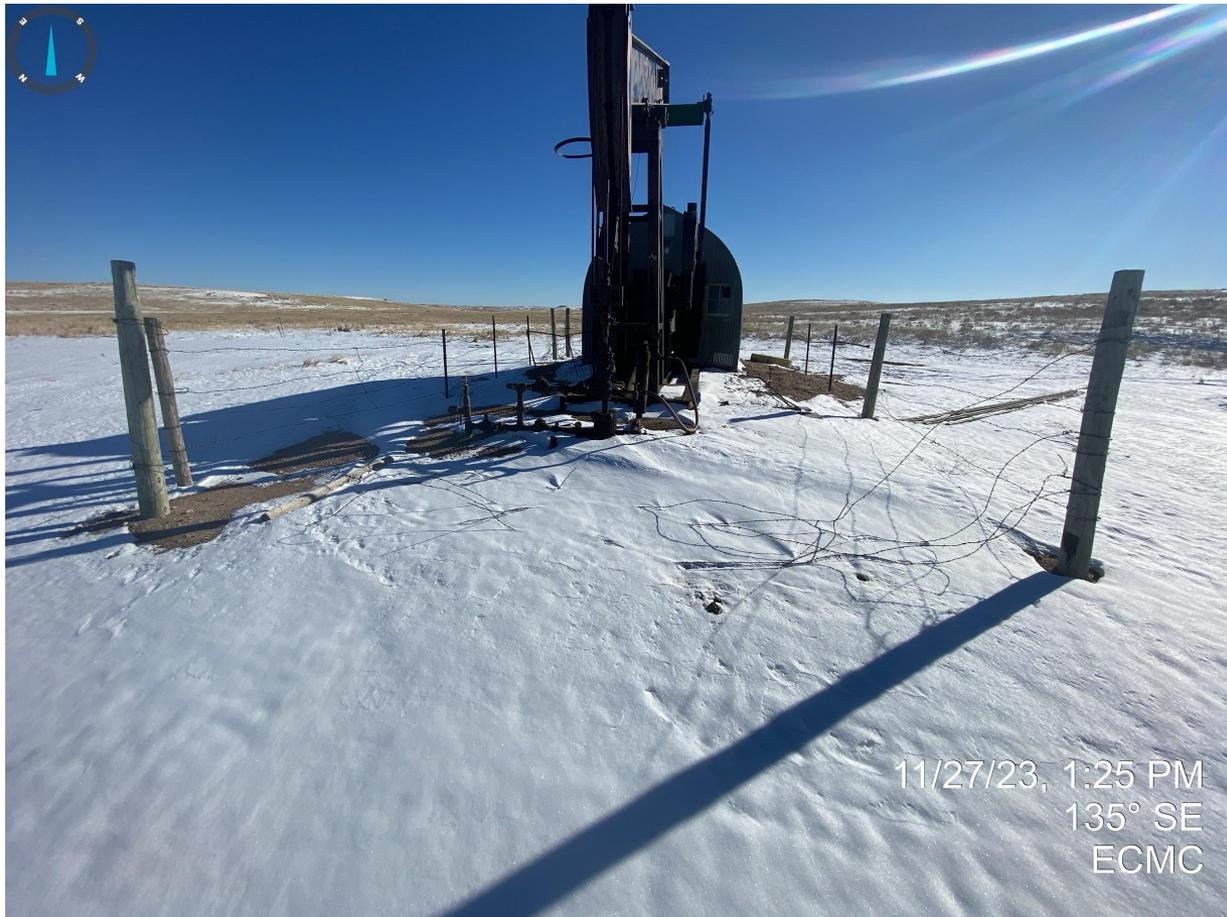
**Photo 11.** Open/downed stretch gate at pumpjack. Staff closed the gate during this inspection; the Operator shall ensure that all fences and gates are in good working order and closed in order to exclude livestock from equipment.

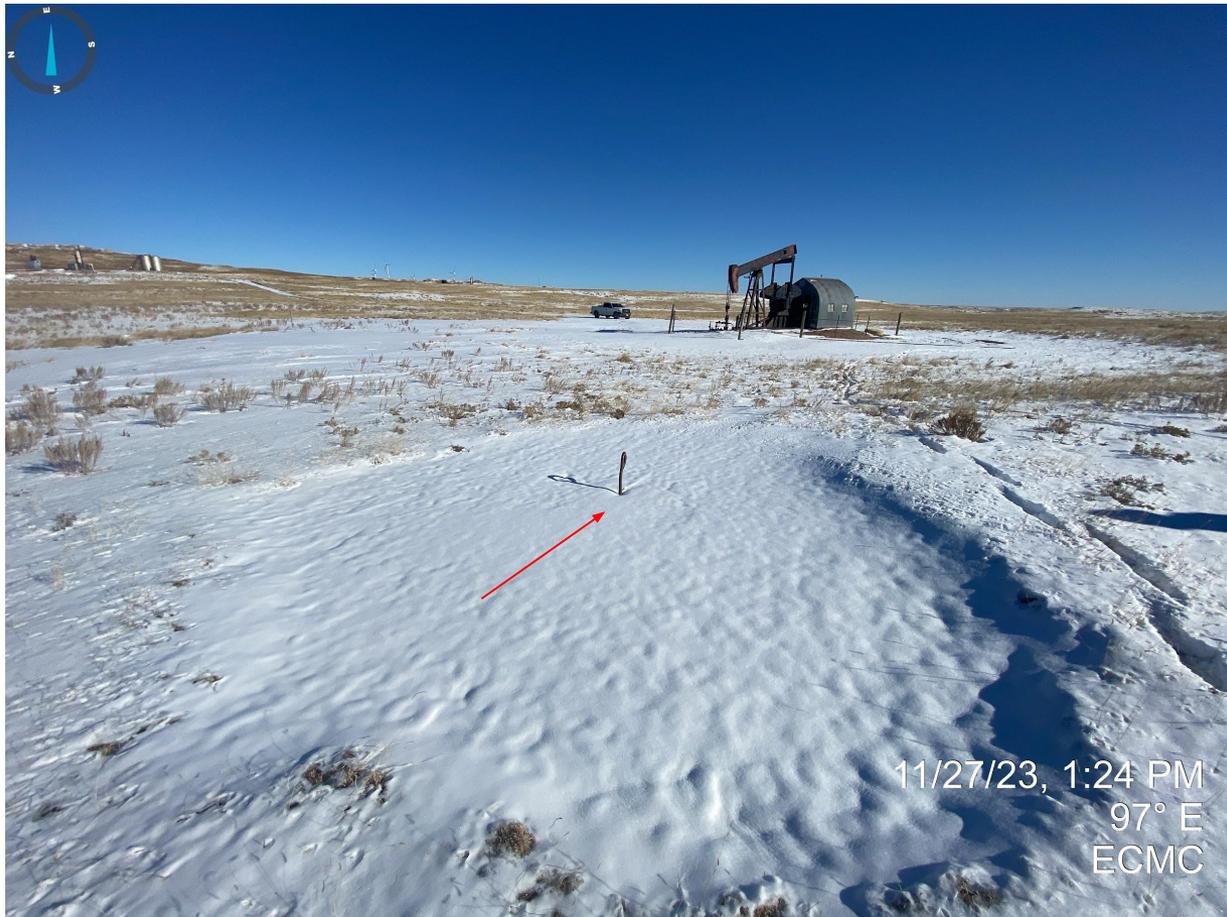
**Photo 12.** Northwest guyline anchor is not properly marked.
