Interim Reclamation and Stormwater Inspection

Date: 11/27/2023

Operator: WESTERN OPERATING COMPANY - 95620

Location ID: 312291

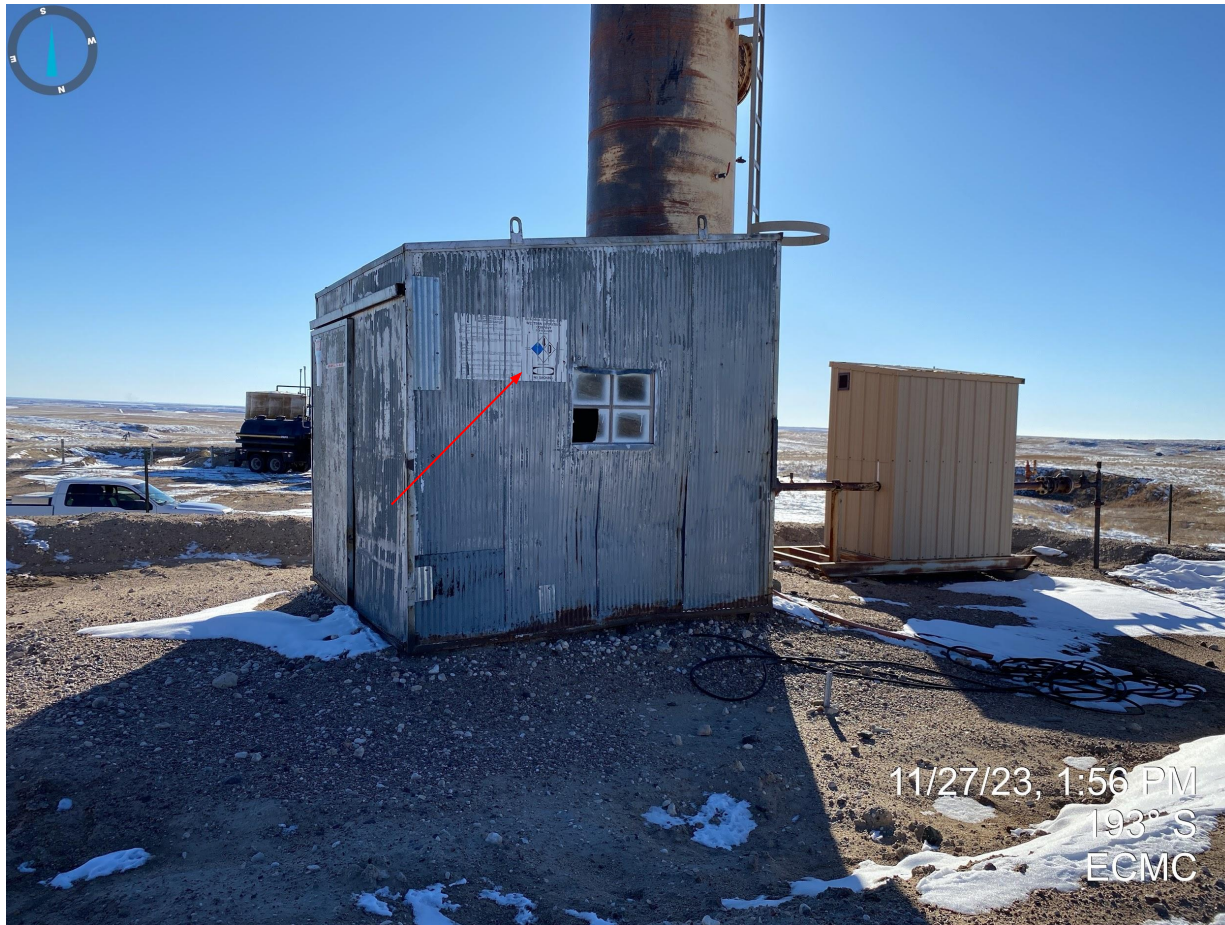
Photo 1. Sign and NFPA placard at vertical heater treater are not legible (e.g. peeling, faded, cracked).

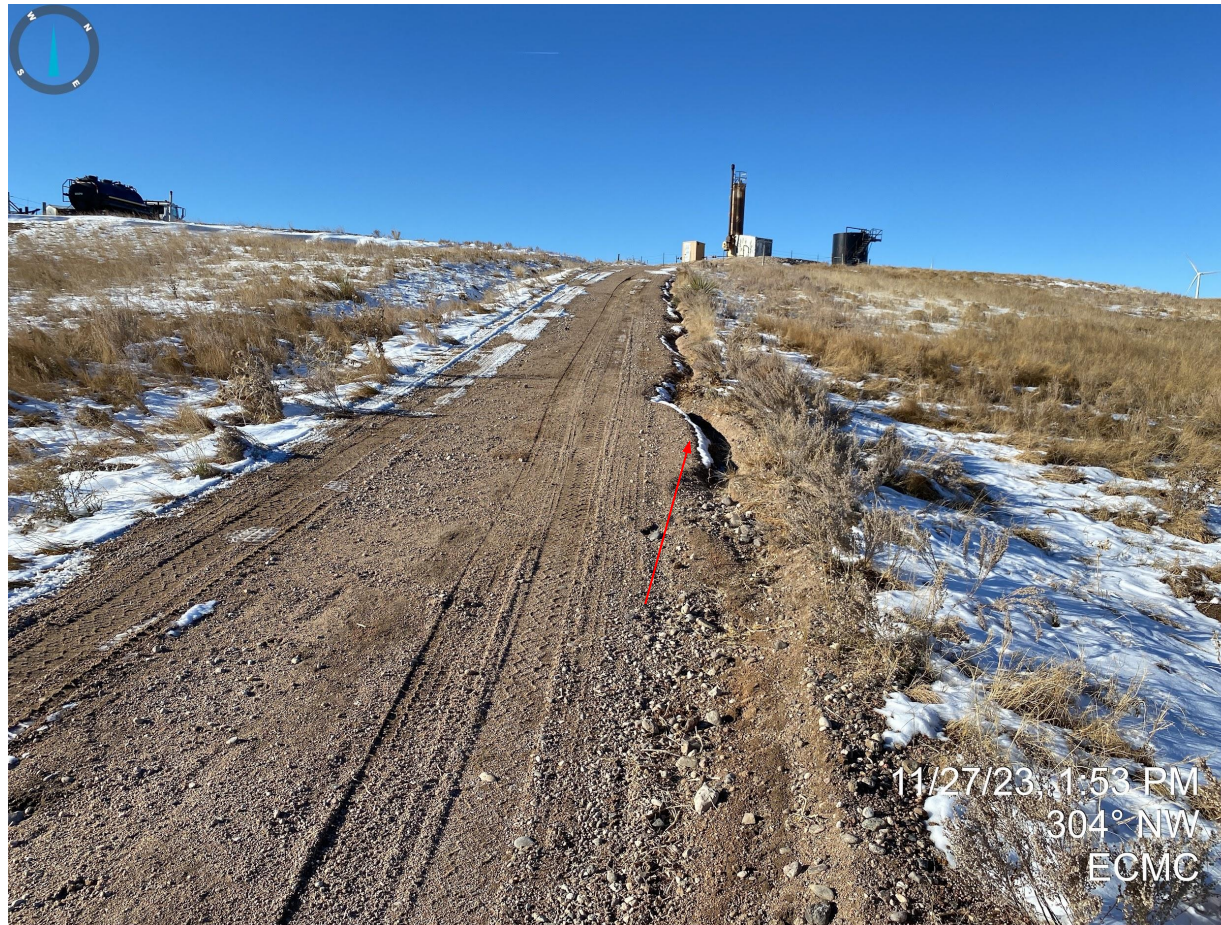
Photo 2. Taken from the access road east of the pit. Evidence of erosion degradation, previously documented, does not appear to have been repaired/stabilized with no evidence of control measures/BMPs observed that would prevent further erosion of the access road.

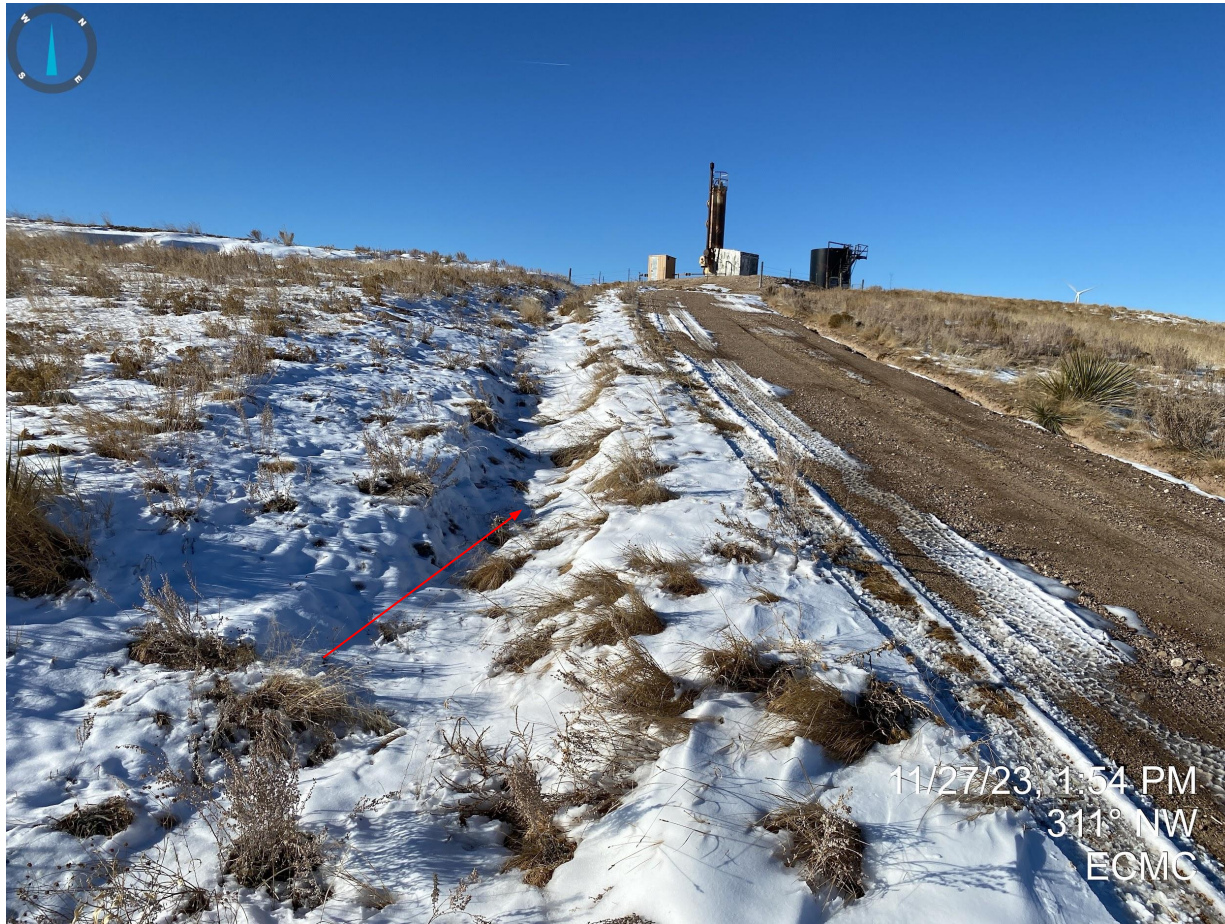
Photo 3. Continued from Photo 2; opposite side of the access road. See comments in previous Photo.

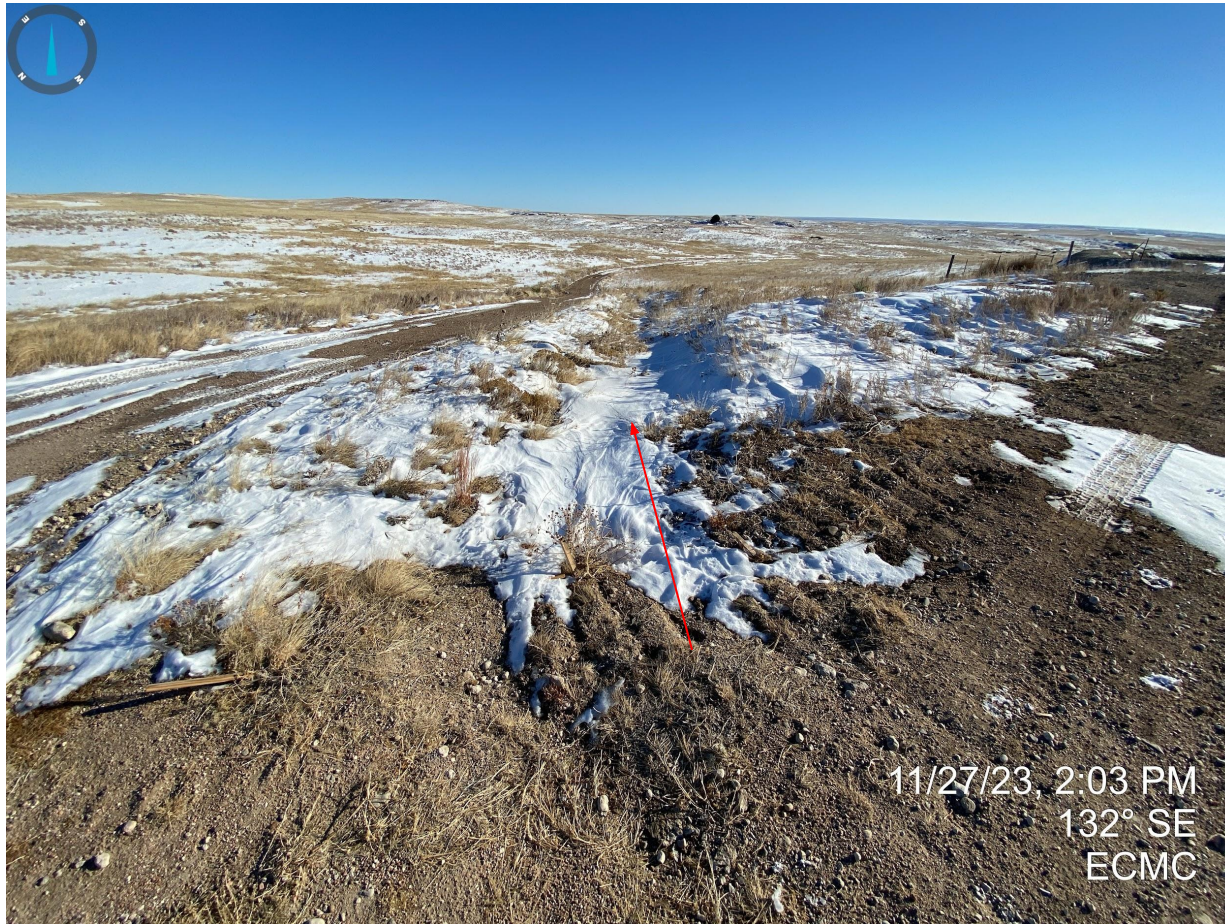
Photo 4. Taken from the location, facing southeast along the access road. See comments in Photos 2.

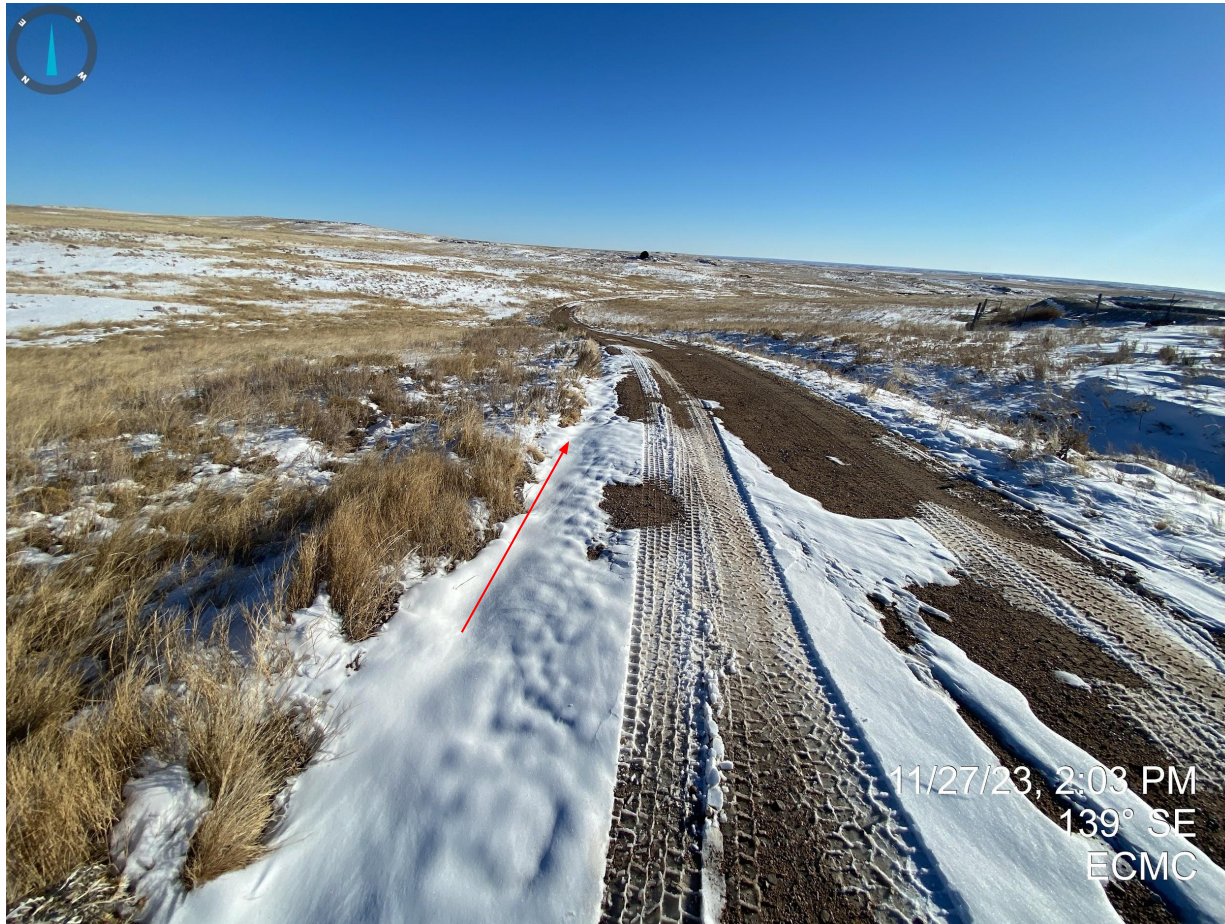
Photo 5. Taken from the location, facing southeast along the access road. See comments in Photos 2.

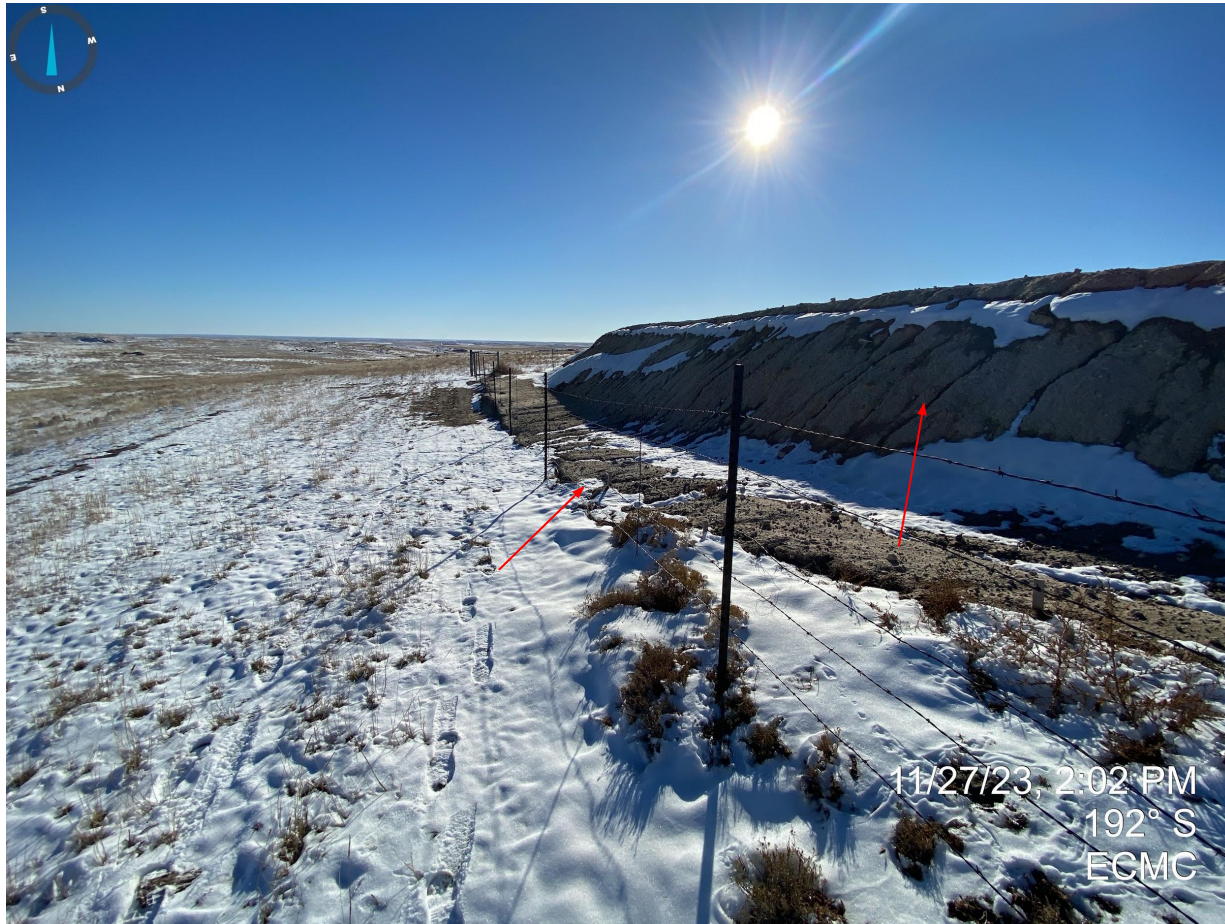
Photo 6. Taken from the eastern portion of the pit. Photo illustrates erosion degradation on the pit walls and inadequate stormwater control measures around the base, or perimeter, of the pit.

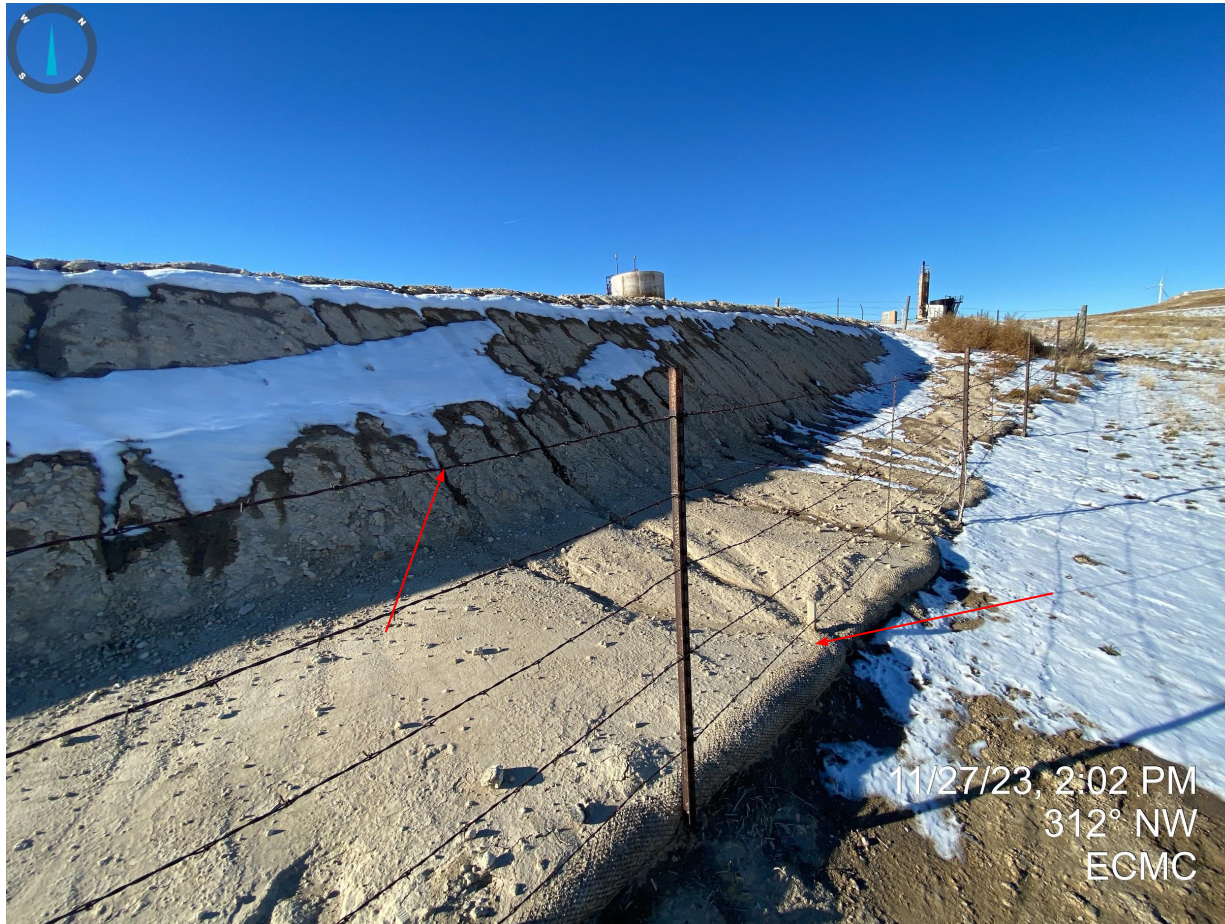
Photo 7. Continued from Photo 6, east side of the pit. Stormwater control measures (e.g. straw wattles) are inadequate as they're filled with sediment and beginning to degrade. Also pictured, erosion degradation on pit walls.

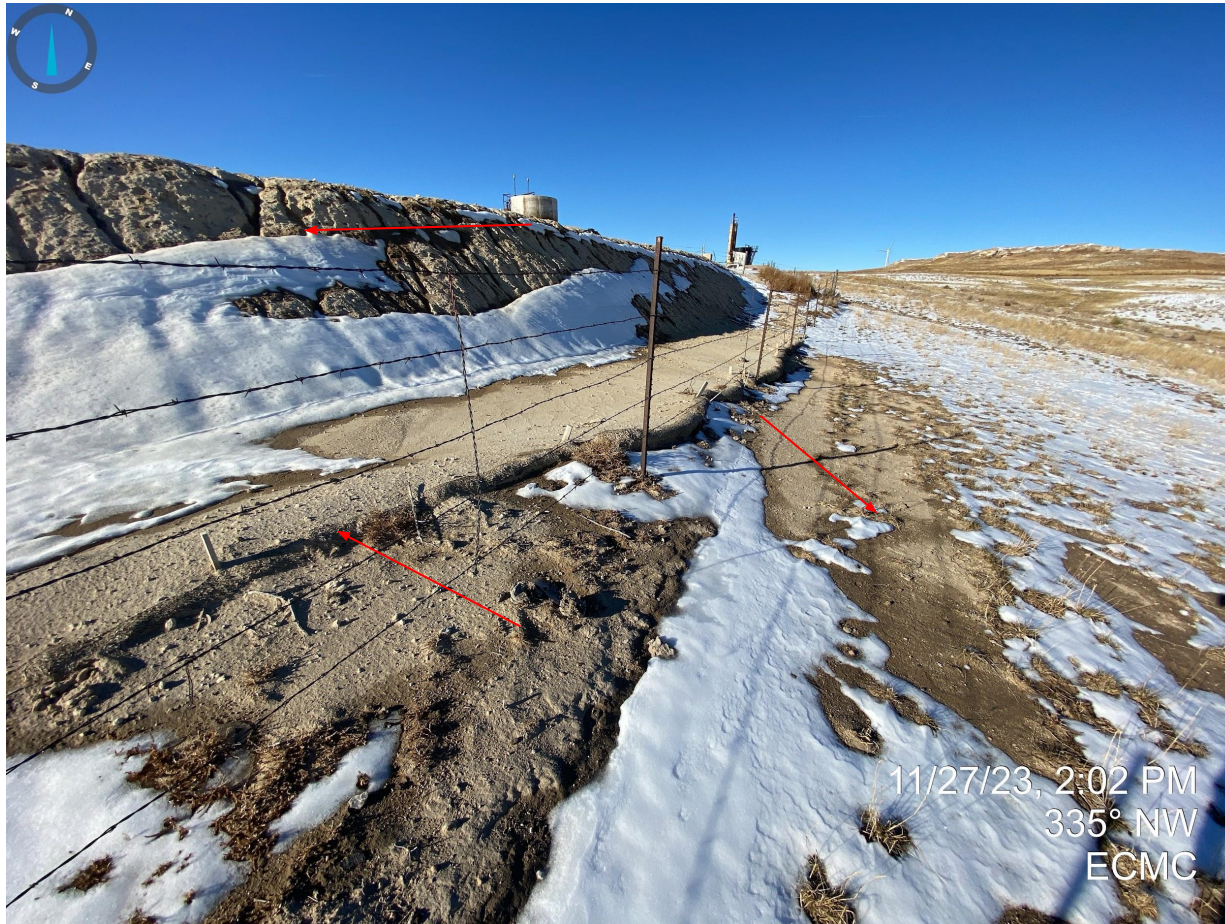
Photo 8. Taken near the southwest corner of the pit; see comments in Photo 7.

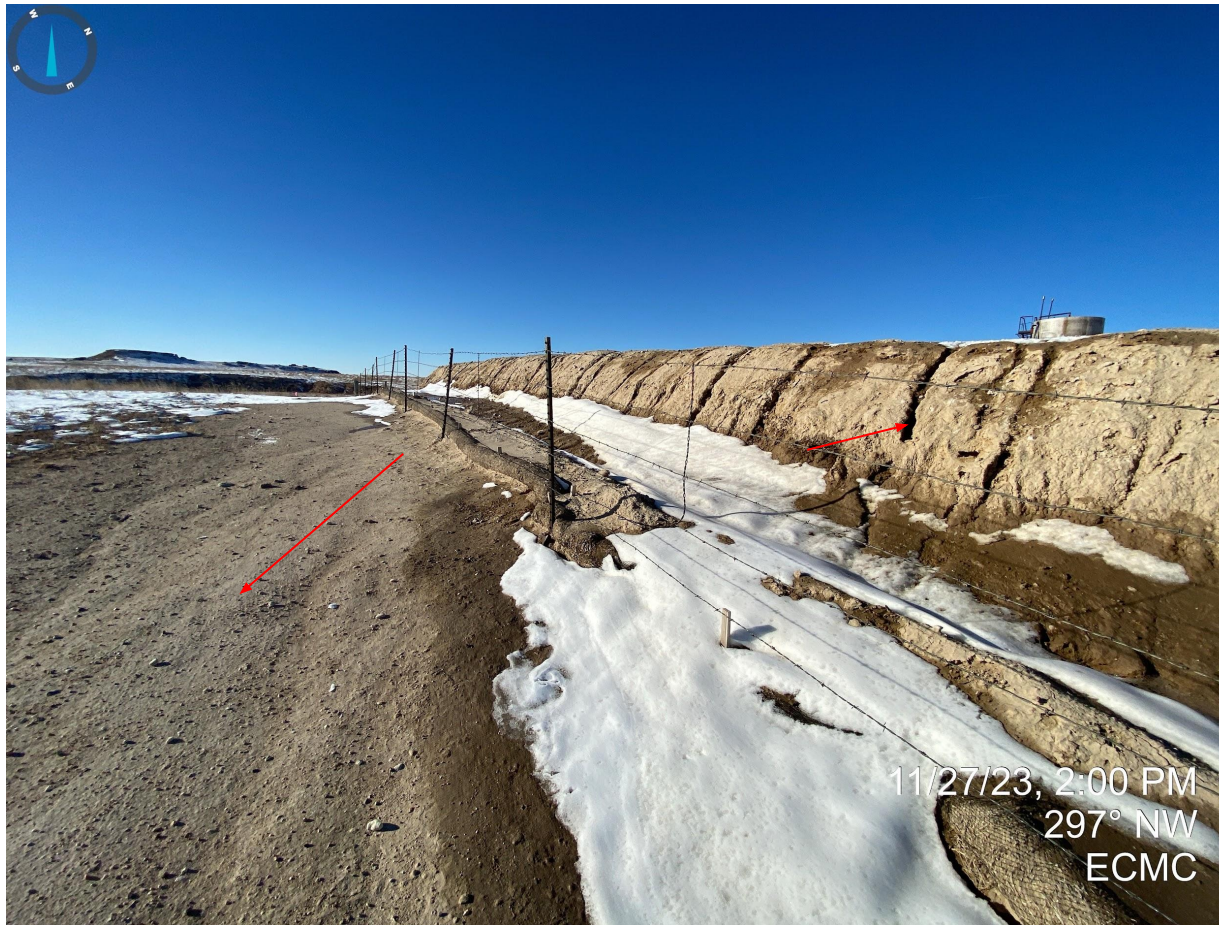
Photo 9. Taken near the southern portion of the location/pit. Exposed and bare soils south of the pit. No stormwater control measures or other stabilization BMPs of the exposed soils were observed during this inspection. Also pictured, erosion (e.g. rilling) occurring on the pit walls.

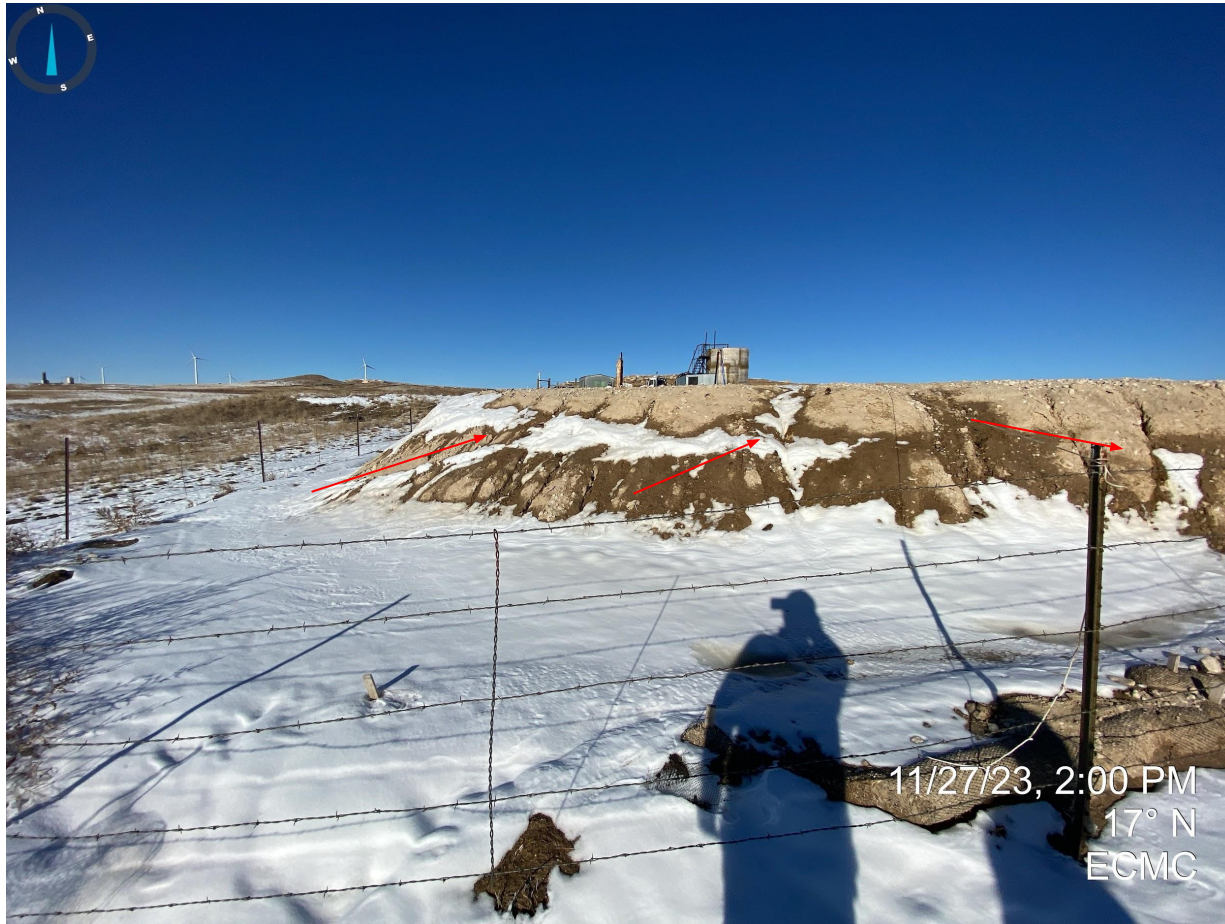
Photo 10. Rill erosion degradation occurring on the southwest portion of the pit walls.

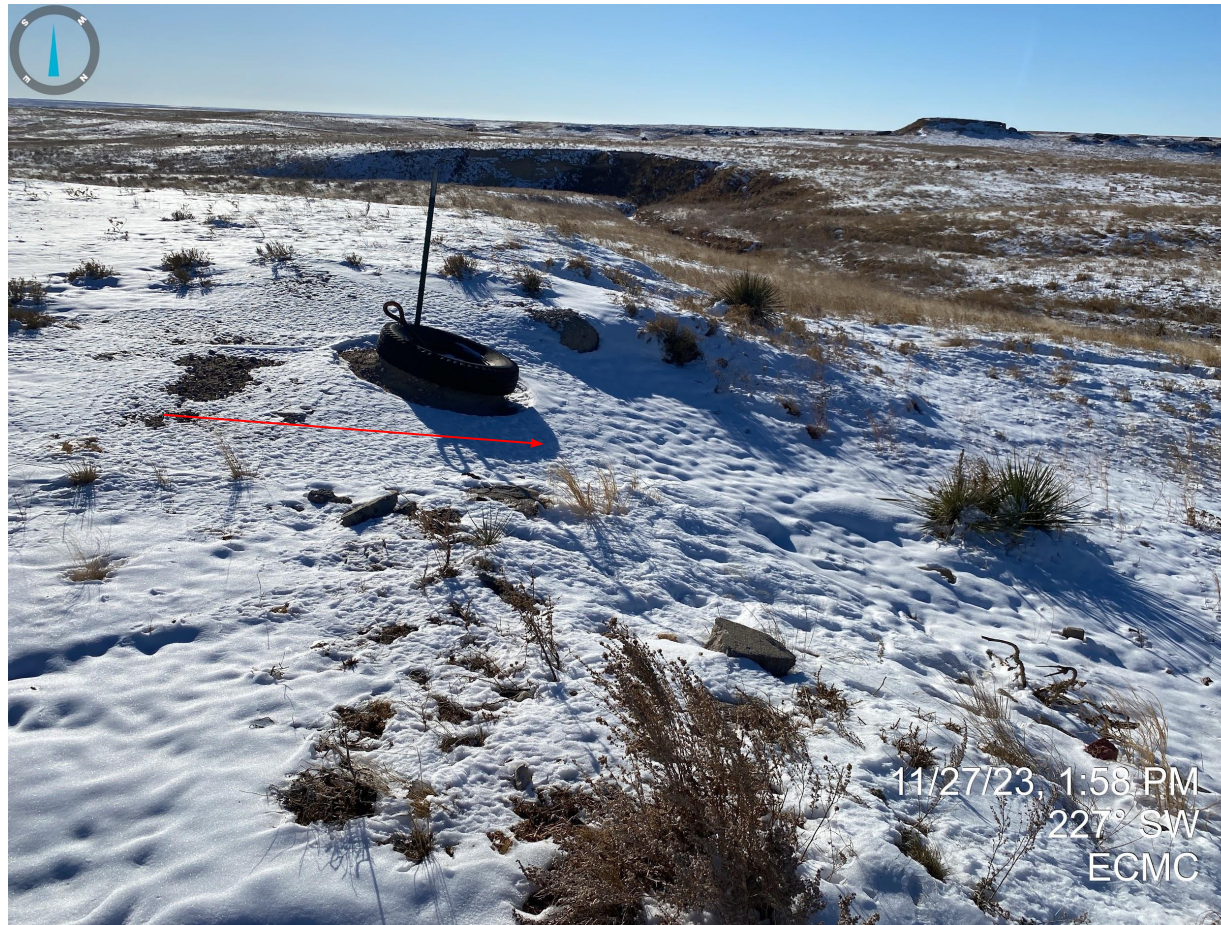
Photo 11. Areas northwest of the pit experiencing erosion degradation were previously documented and it does not appear any stormwater controls measures have been implemented and the unstabilized soils have not been repaired.

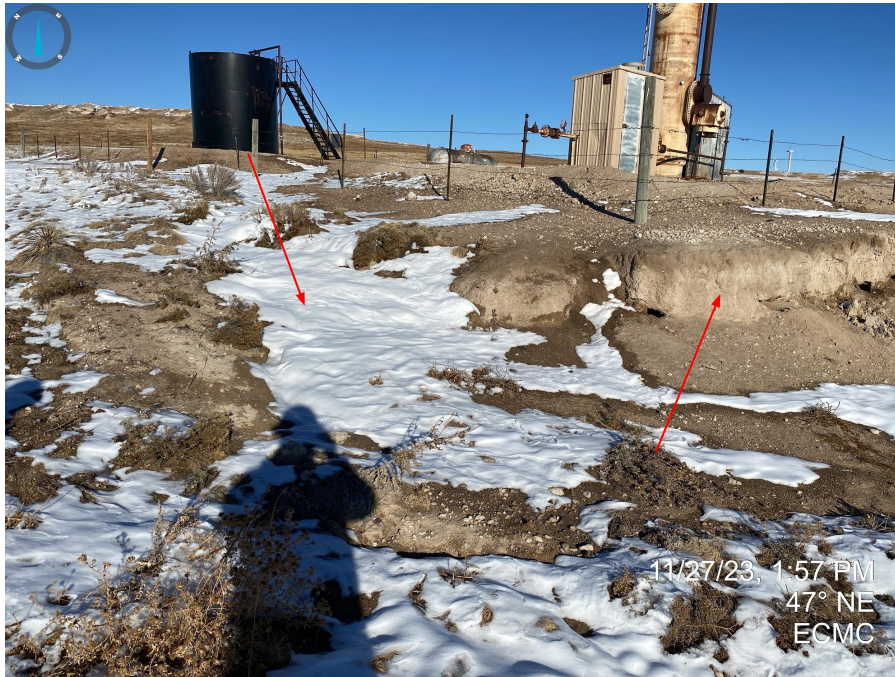
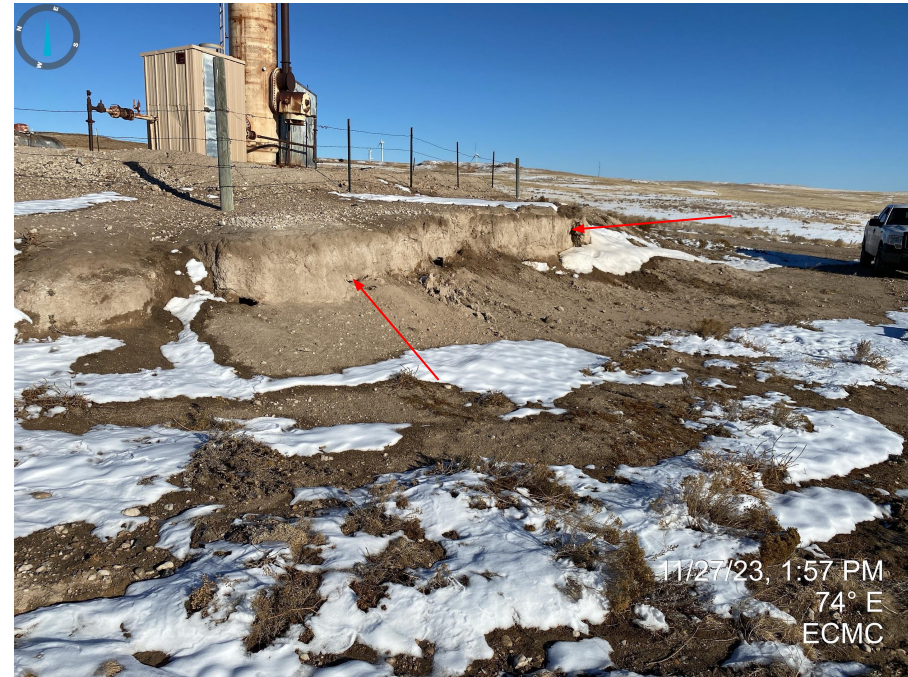
Photos 12 & 13. Taken near the vertical heater treater. Erosion degradation previously documented does not appear to have been repaired, and there is no evidence that stormwater control measures have been implemented to protect the unstabilized soils.
