# Final Reclamation and Stormwater Inspection

Operator: MAGPIE OPERATING INC - 52530

Location ID: 312143

Logan County, CO

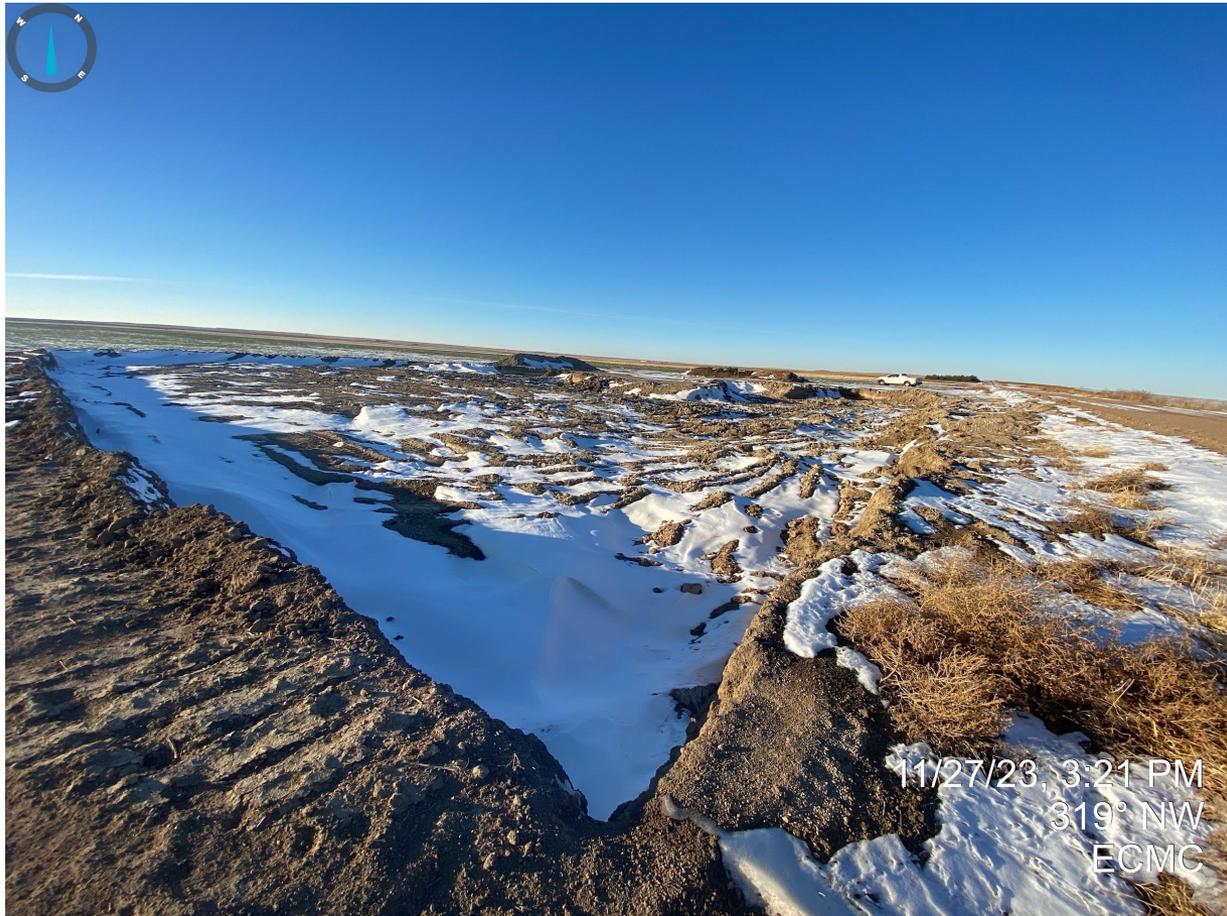
**Photo 1.** Taken from the southeast corner of the excavated pit. No exclusion fencing observed around the perimeter at the time of inspection.

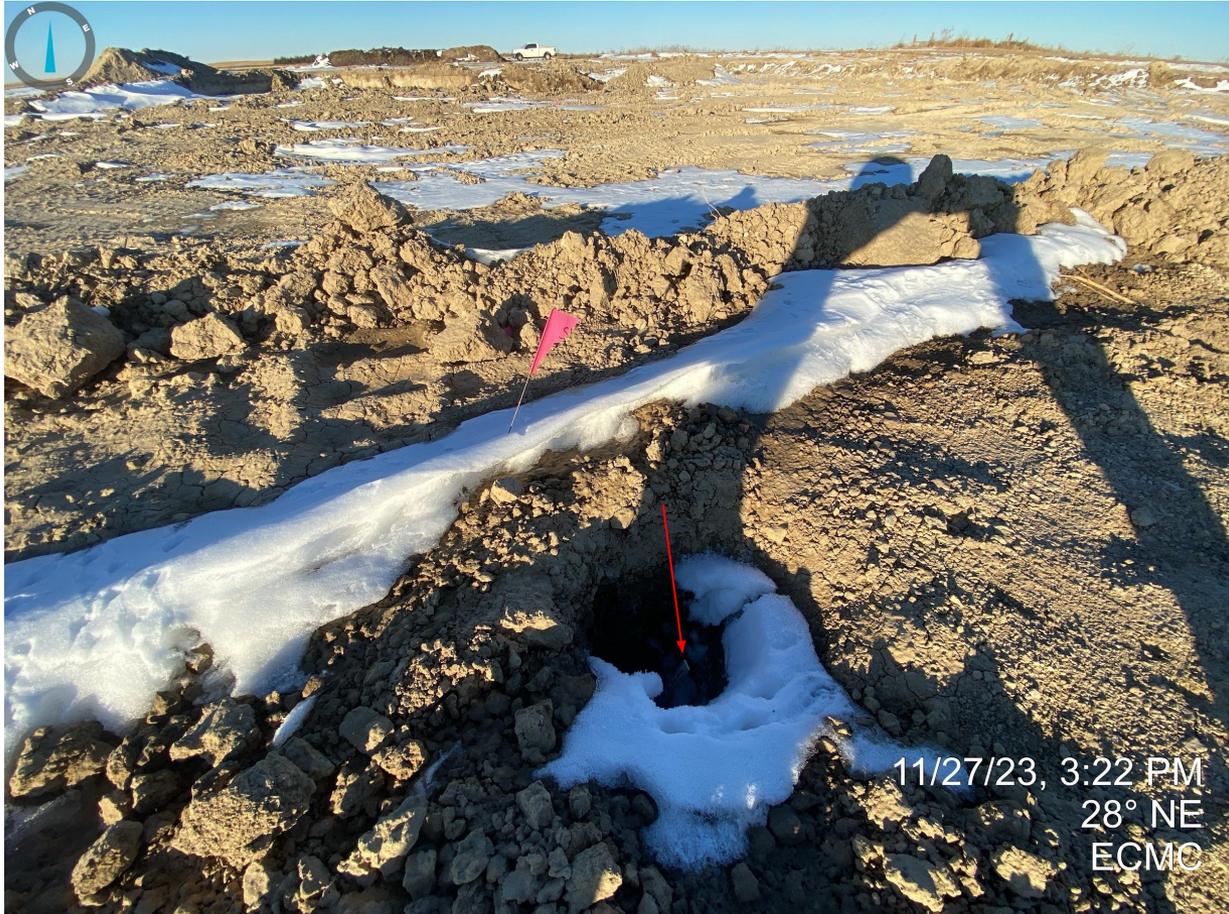
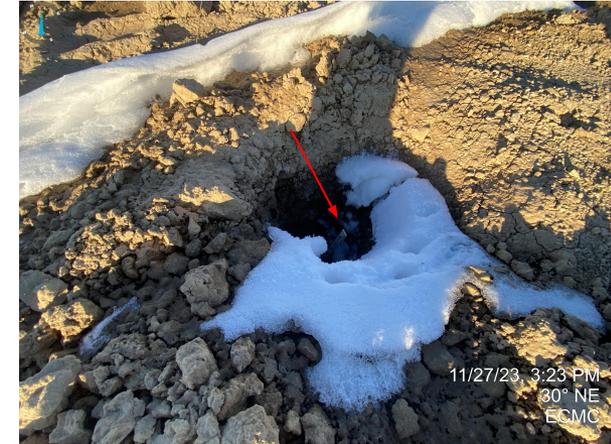
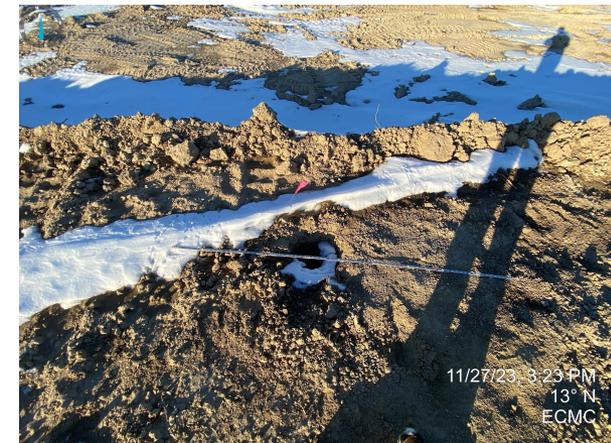
**Photo 2.** Taken from the southern portion of the excavated pit. Photos illustrate one example of a soil boring that is approximately 12" wide by at least 6' deep. These open excavations require immediate backfill to ensure safe operations on location.

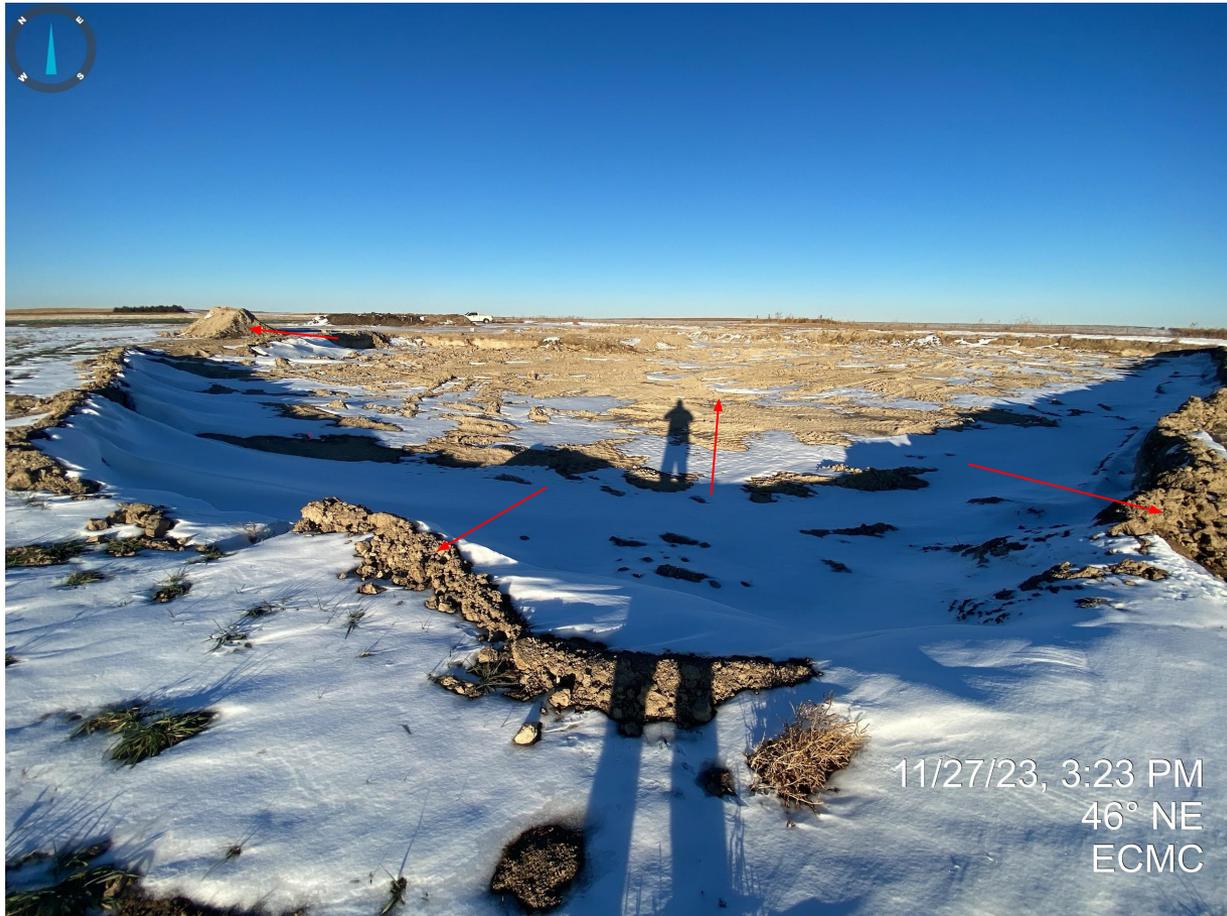
**Photo 3.** Taken from the southwestern corner of the excavated pit. Stockpiled and exposed soils are not protected from wind and water erosion as they are unconsolidated and not properly stabilized in their current state.

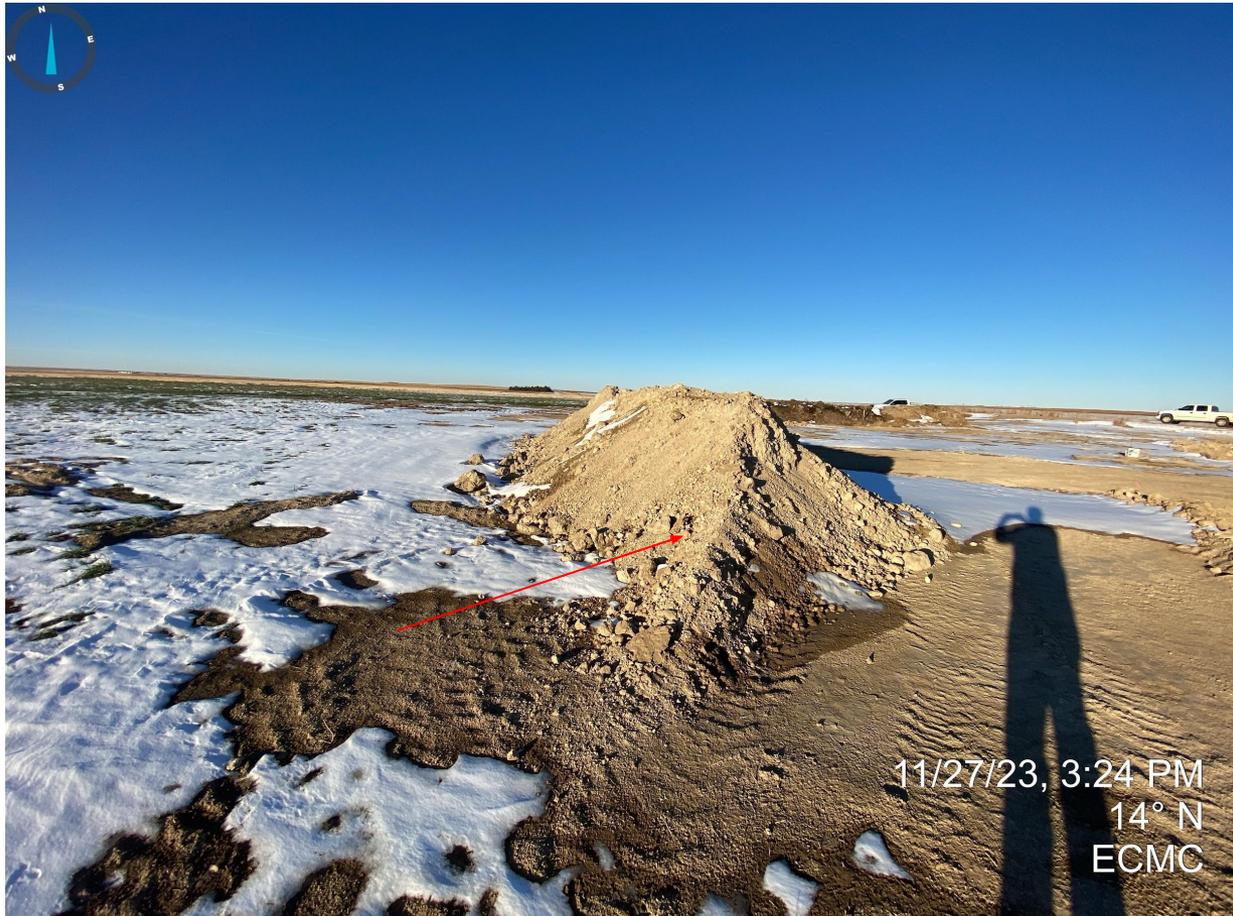
**Photo 4.** Taken near the northwest corner of the pit. See comments in Photo 3.

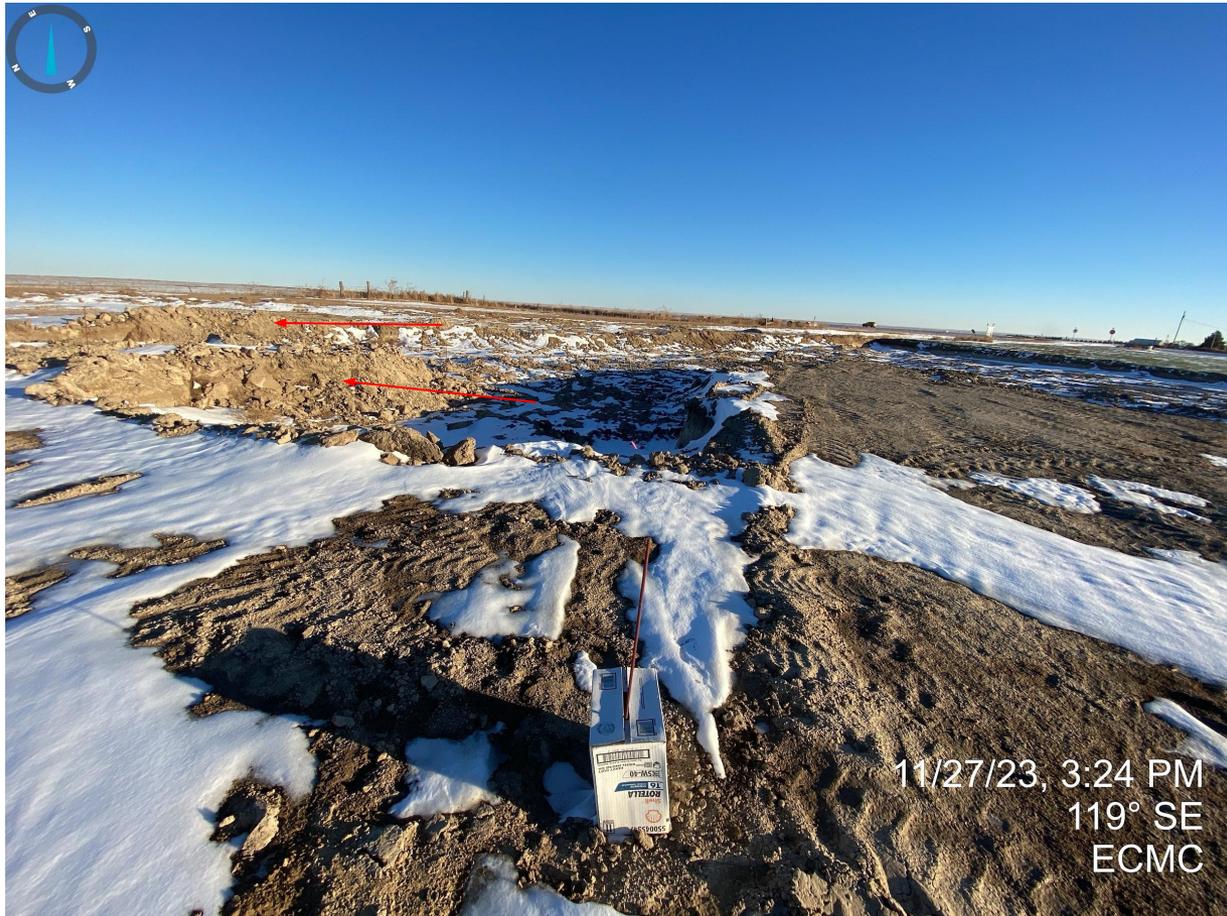
**Photo 5.** Taken near the northern/center portion of the pit. See comments in Photo 3.

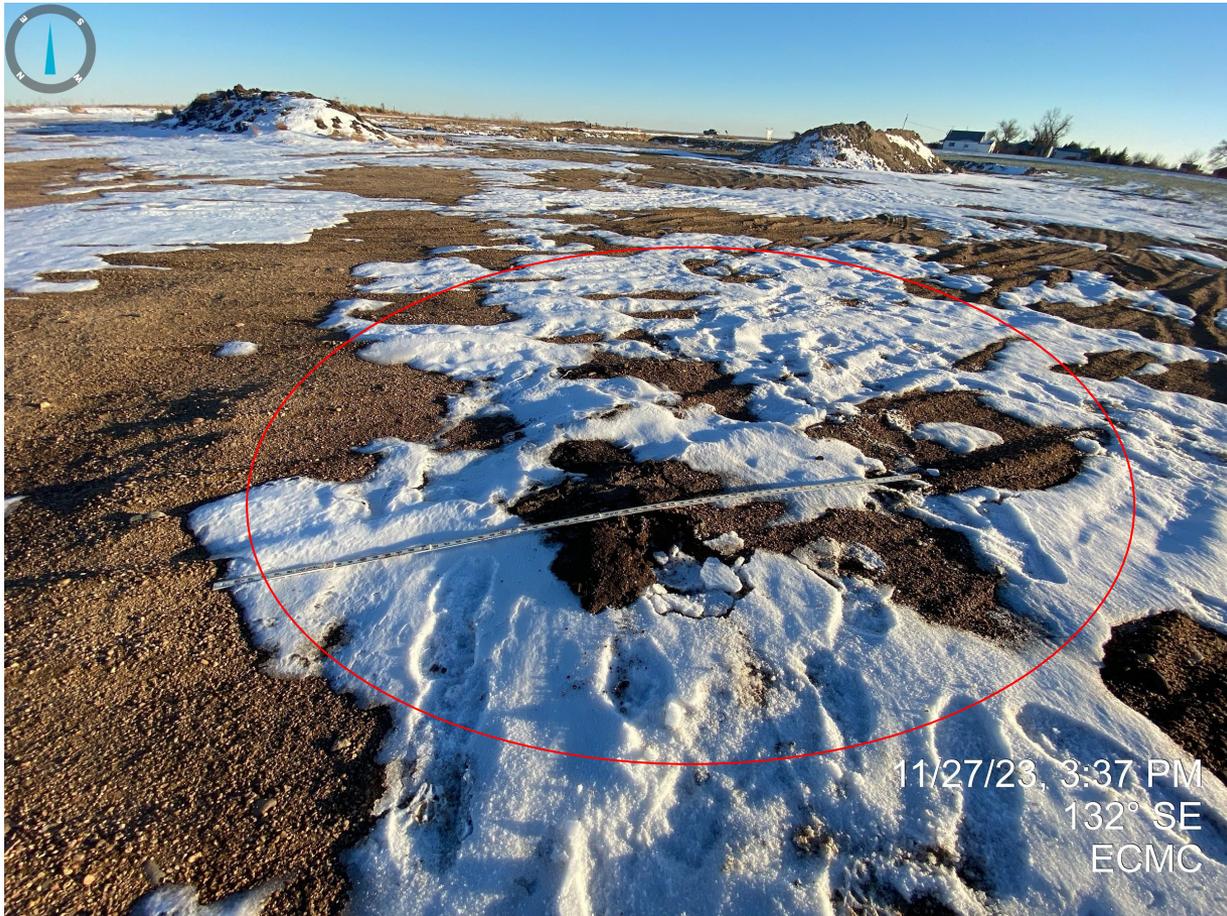
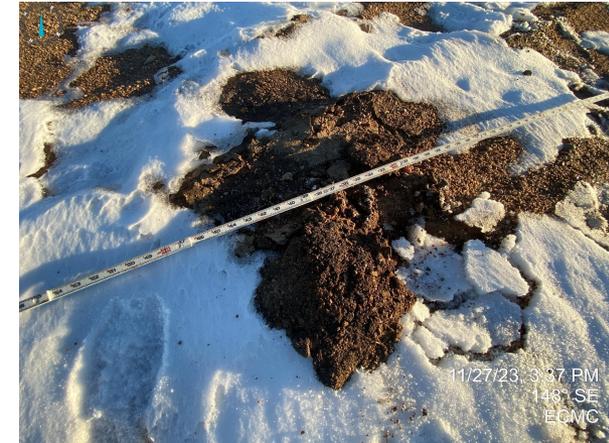
**Photo 6.** Stained soil observed on the northwestern portion of the former production areas; it is apparent the stained soil has not been removed and properly disposed of since previously documented. This stained soil is not associated with the manure pile pictured in the background.

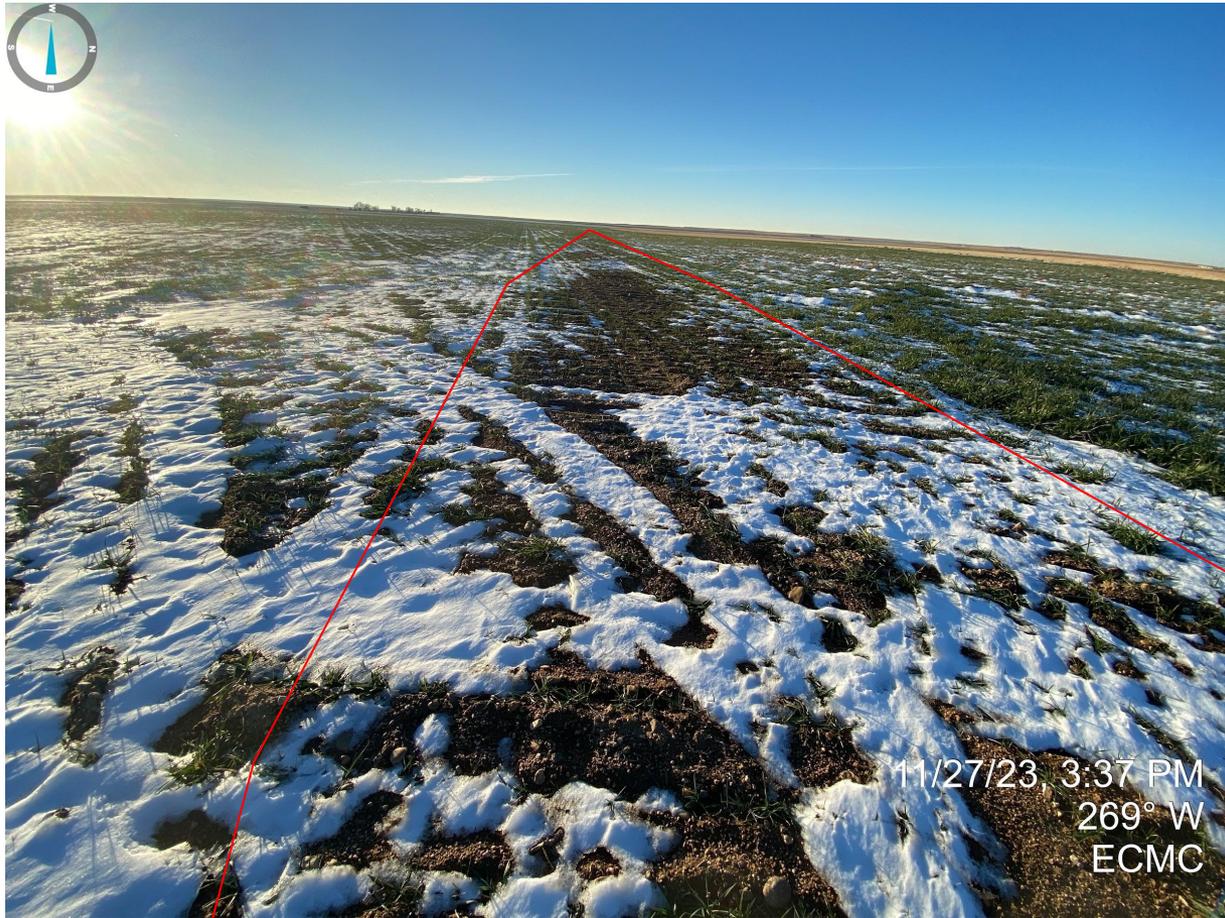
**Photo 7.** Taken from the northwest corner of the former production areas, where the well access road starts. It is apparent that no reclamation work has been conducted since the previous inspections. Gravel/road base material remain on location and requires removal to comply with Rule 1004.

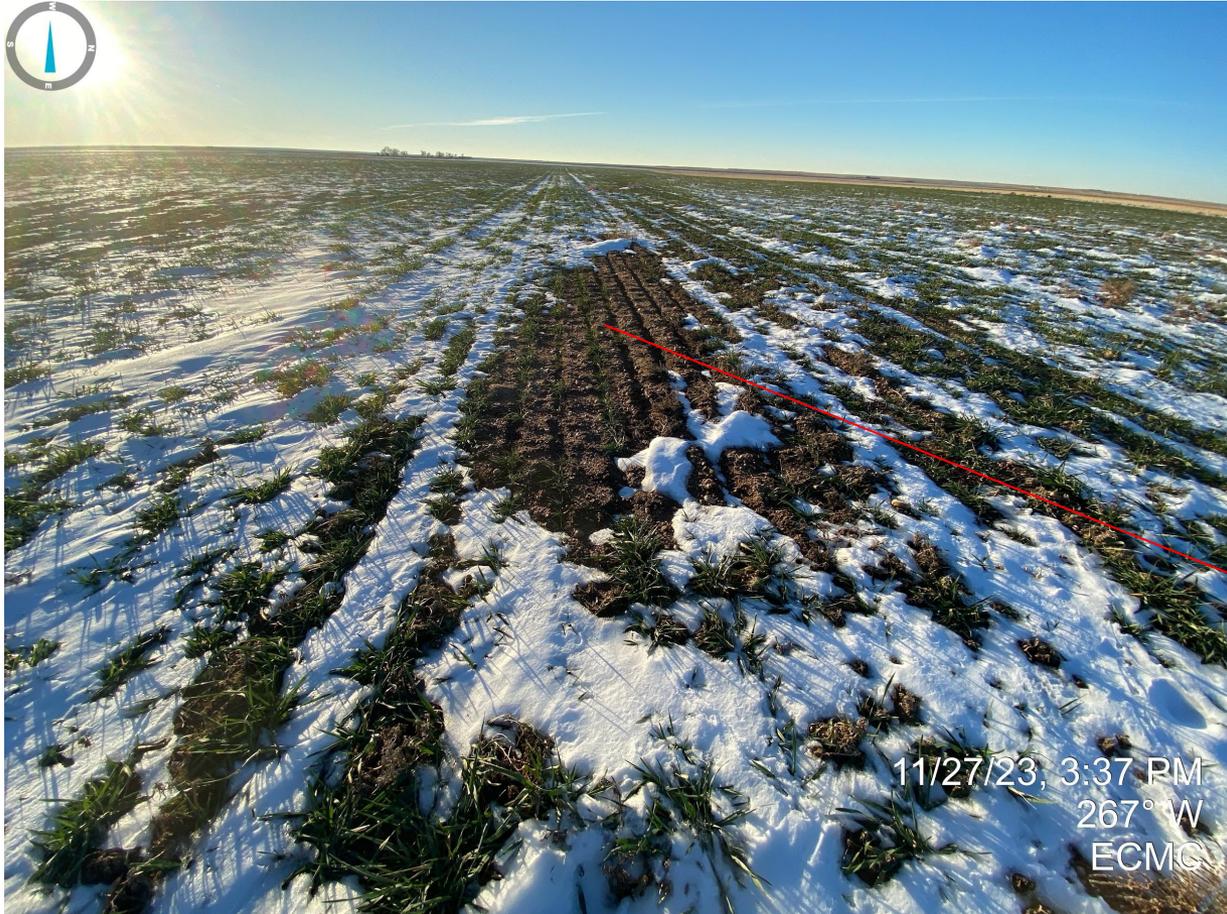
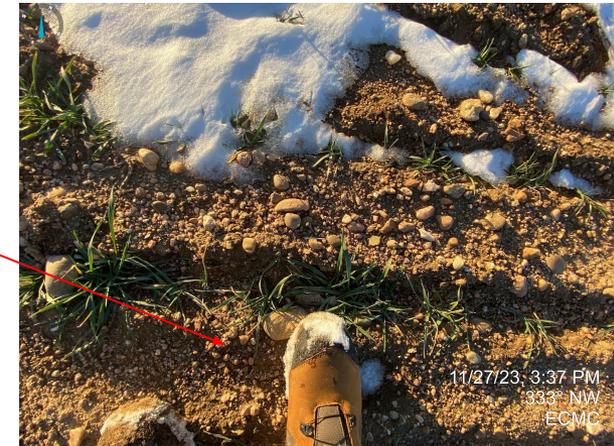
**Photo 8.** Taken midway between the former production areas and well location. See comments in Photo 7.

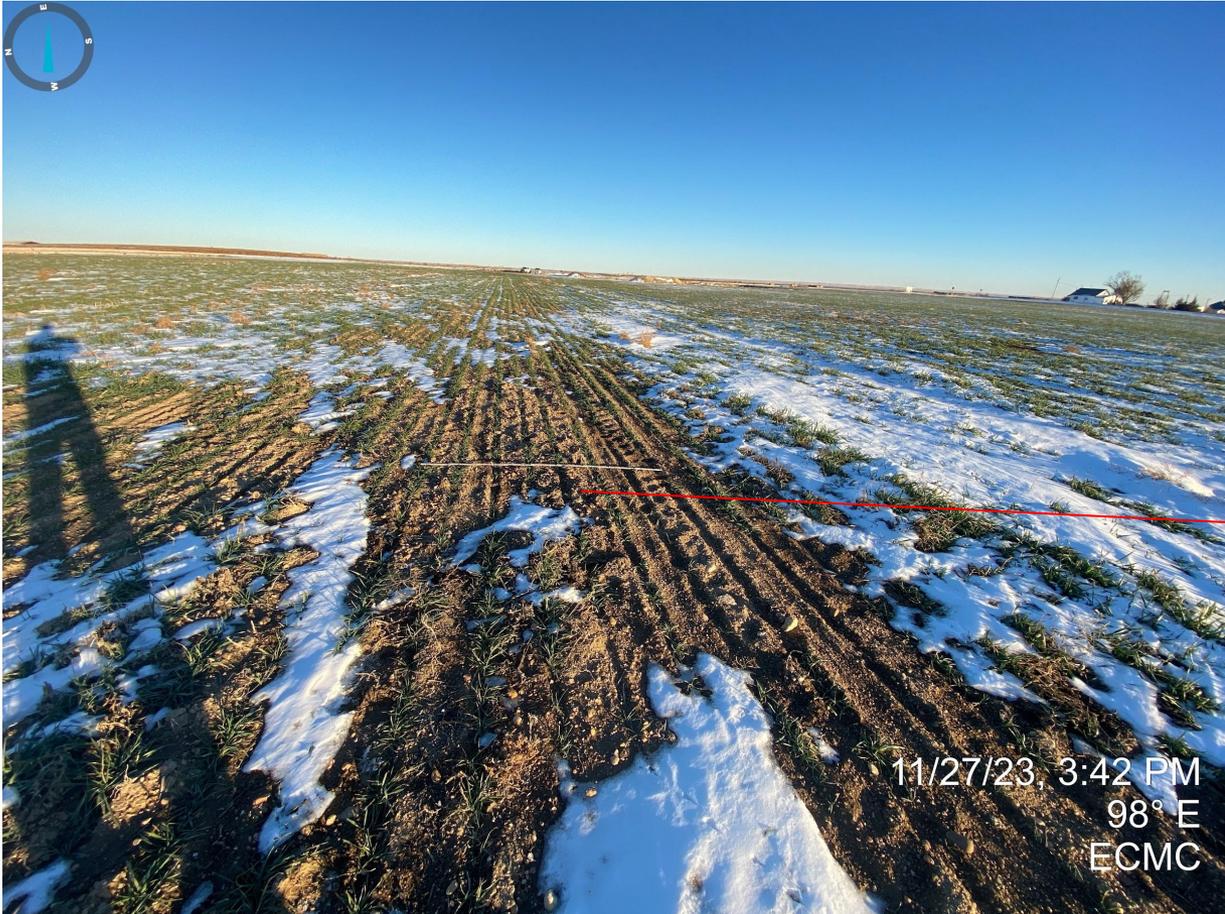
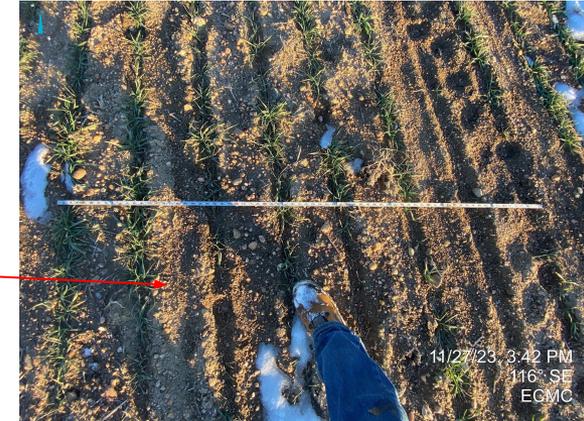
**Photo 9.** Taken from the former well location. It is apparent that no reclamation work has been conducted since the previous inspections. Gravel/road base material remain on location and requires removal to comply with Rule 1004.

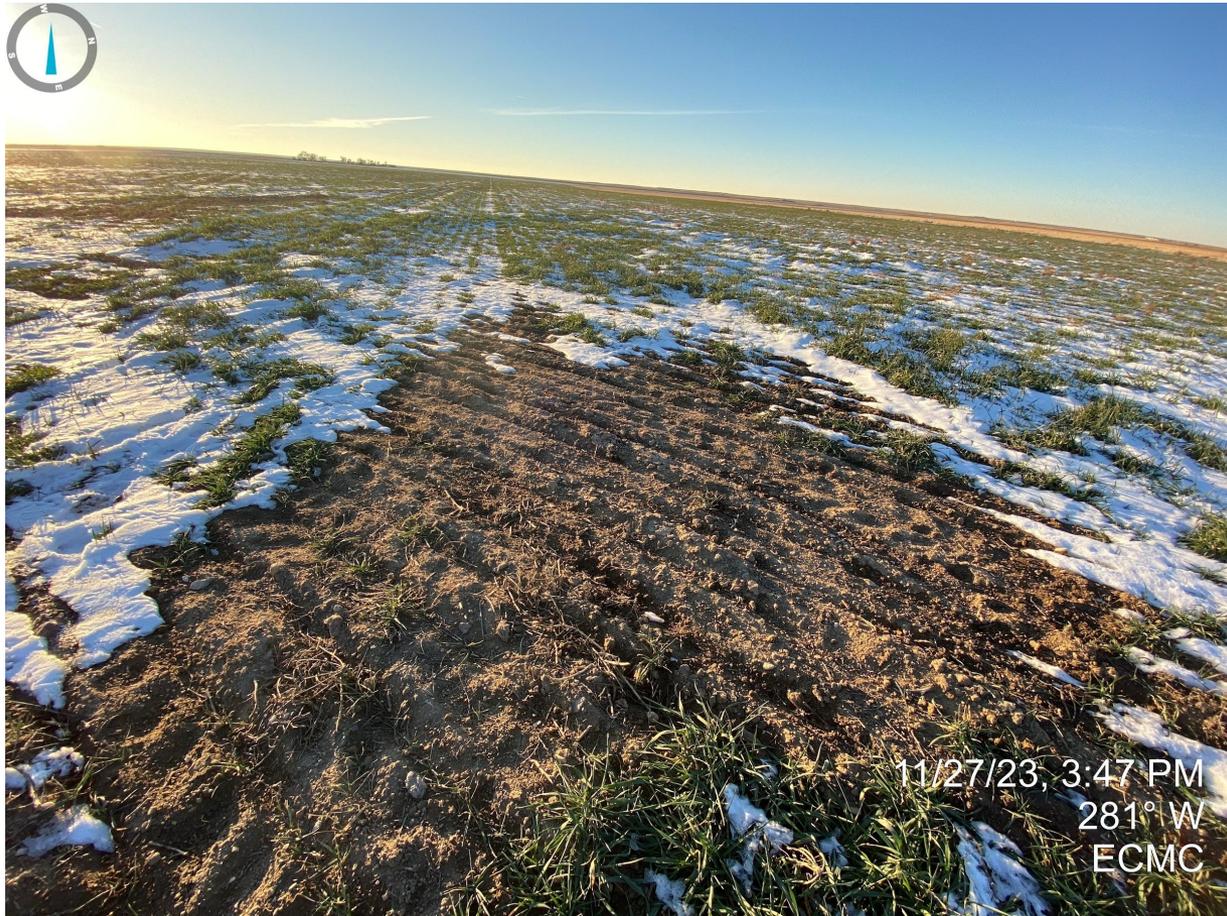
**Photo 10.** Facing west at the former well location; see comments in Photo 9.

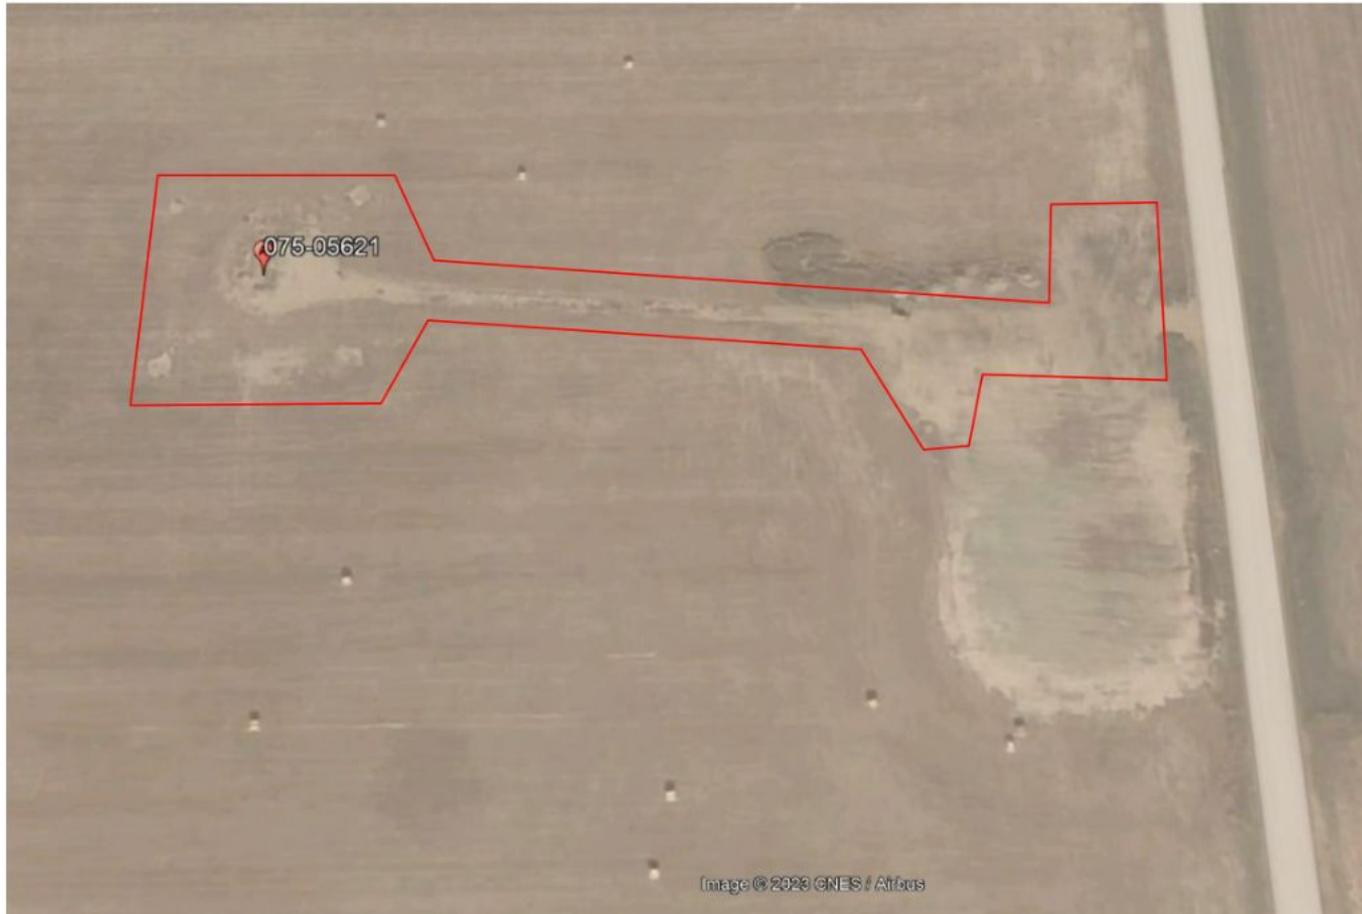
**Photo 11.** Google Earth aerial imagery (circa 10/2020) illustrating red outline of former access road, well location, and production area disturbances that will require final reclamation activities ASAP. Active remediation should not preclude the commencement of final reclamation activities on the above identified areas. Final reclamation should have been completed by 07/22/2019, per 1004 Rules.
