# Interim Reclamation and Stormwater Inspection

Operator: Bonanza Creek ENergy Operating  
Company LLC. - 8960

Location ID: 466974

Inspection Photos  
Location Name: Antelope C-33  
Location ID: 466974

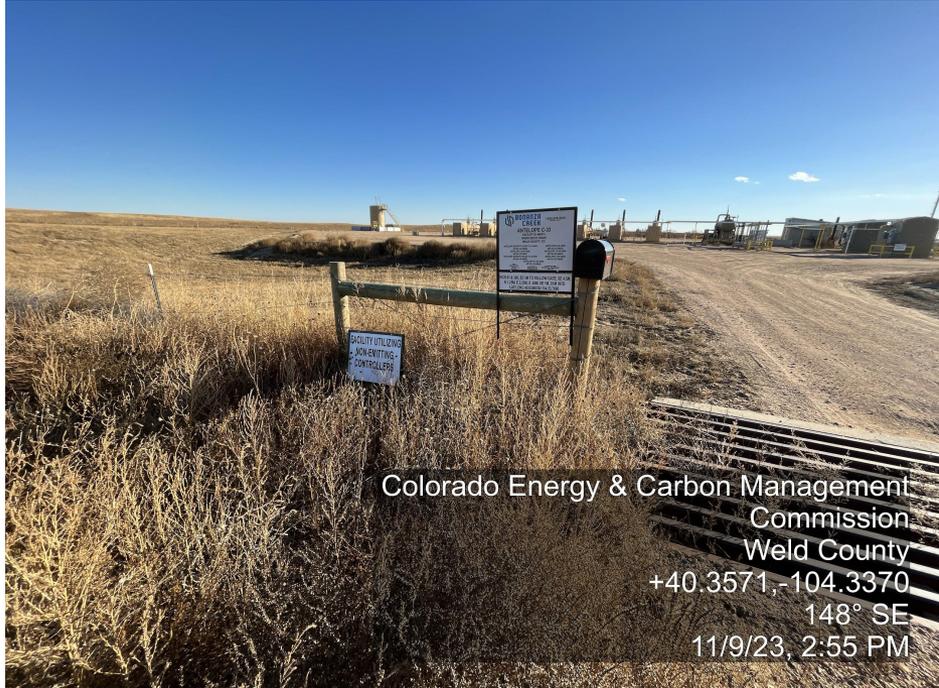
**Photo 1.** The photo was taken at the entrance to the location of the location sign facing Southeast.

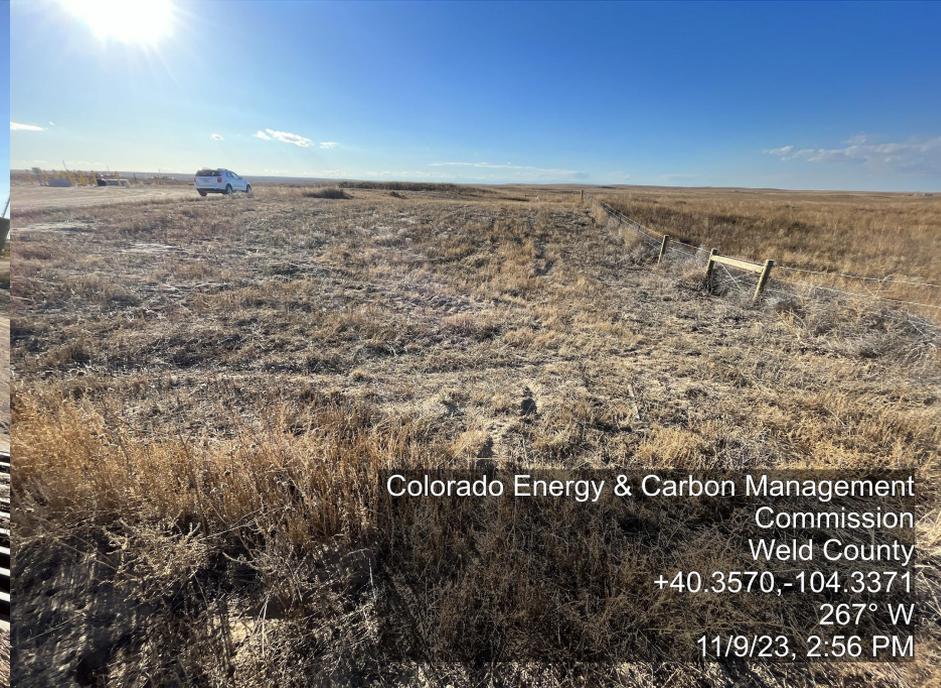
**Photo 2.** The photo was taken at the well location facing West. The photo illustrates the interim areas have been mowed and there are evidence of perennials as well undesirable weeds.

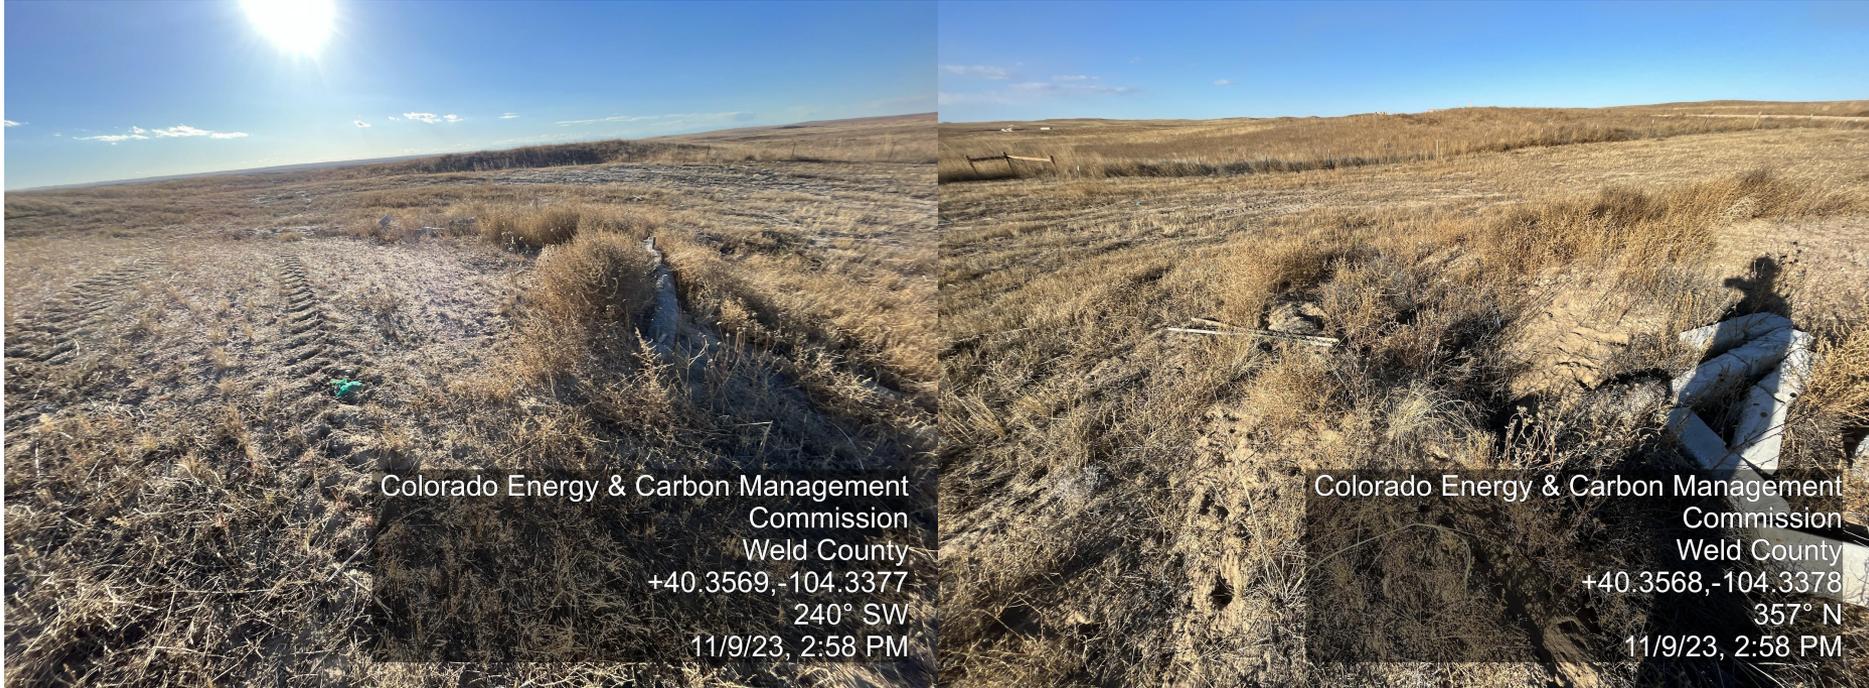
**Photo 3.** The photo was taken at the well location facing Southwest. The photo illustrates debris including straw wattle, concrete blocks and stakes as well as some accumulation of undesirable vegetation.

**Photo 4.** The photo was taken at the well location facing North. Refer to the comment for photo 3.

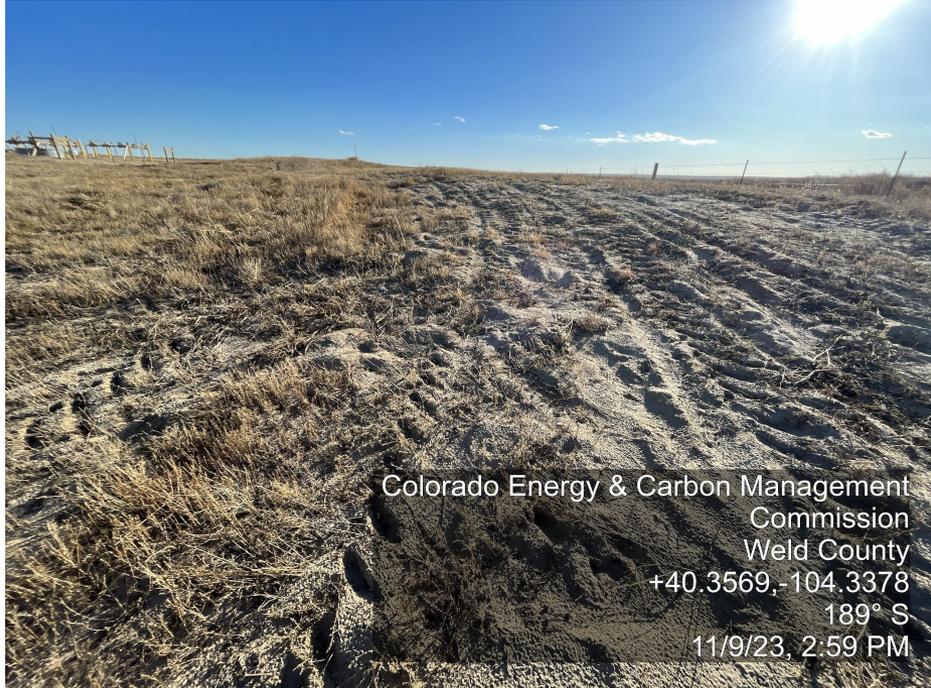
**Photo 5.** The photo was taken at the well location facing South. The photo illustrates areas of bare soil being torn up by wheel tracking in the interim areas.

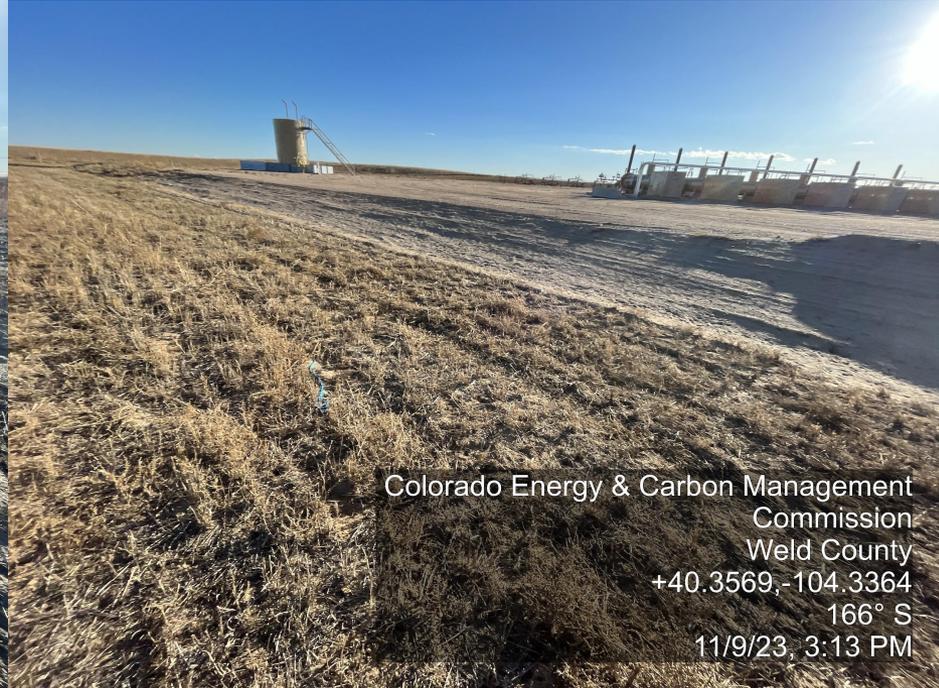
**Photo 6.** The photo was taken at the well location facing South. The photo illustrates the slope off the active pad is unprotected from erosion by vegetation or BMP's.

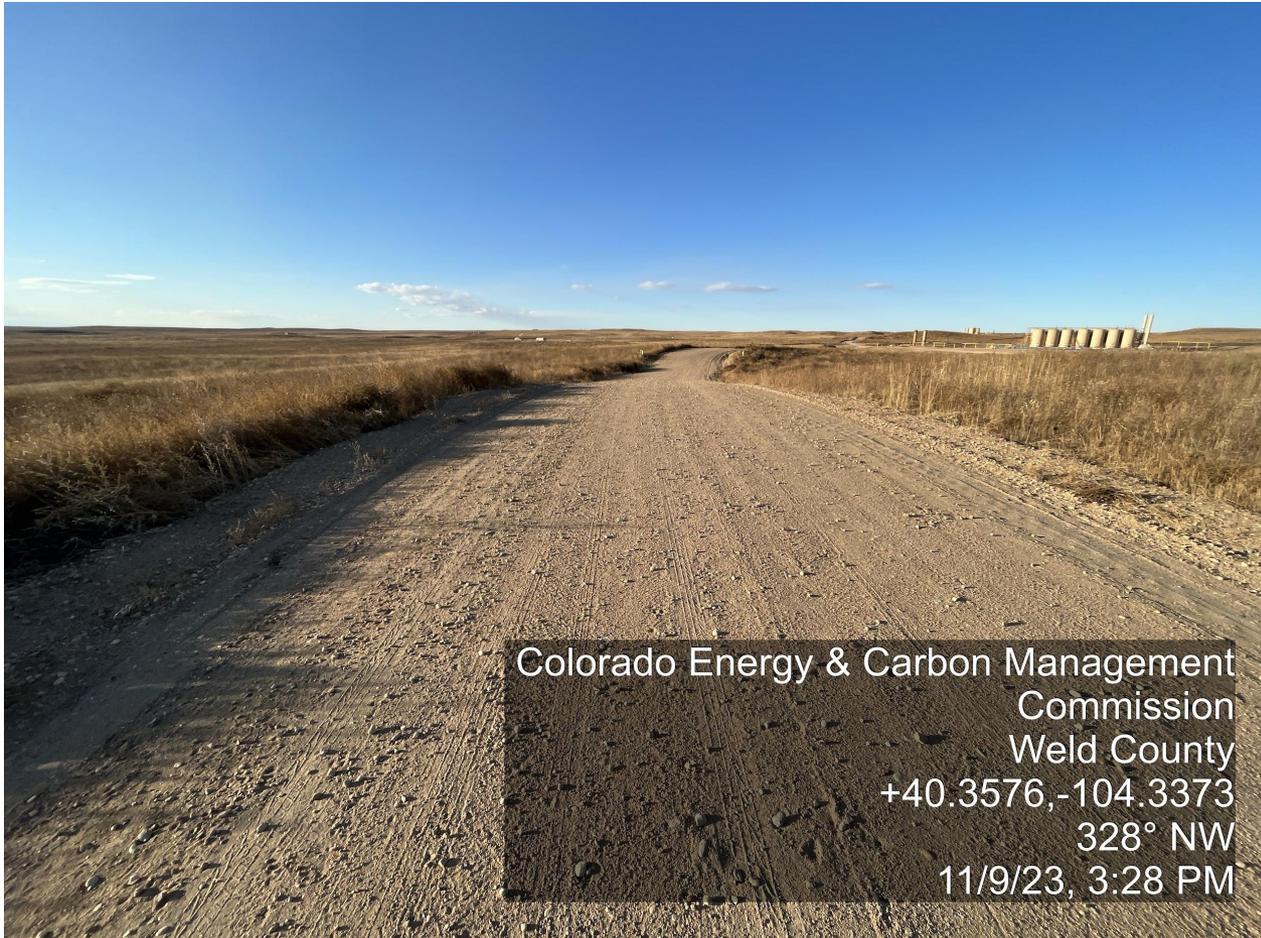
**Photo 7.** The photo was taken at the entrance to the well location facing Northwest of the access road.
