Final Reclamation Inspection

Operator: Hilcorp Energy Company- 10133

Location ID: 333494

Inspection Photos
Location Name: Argenta 34-10 32-2, 32-2A
Location ID: 333494

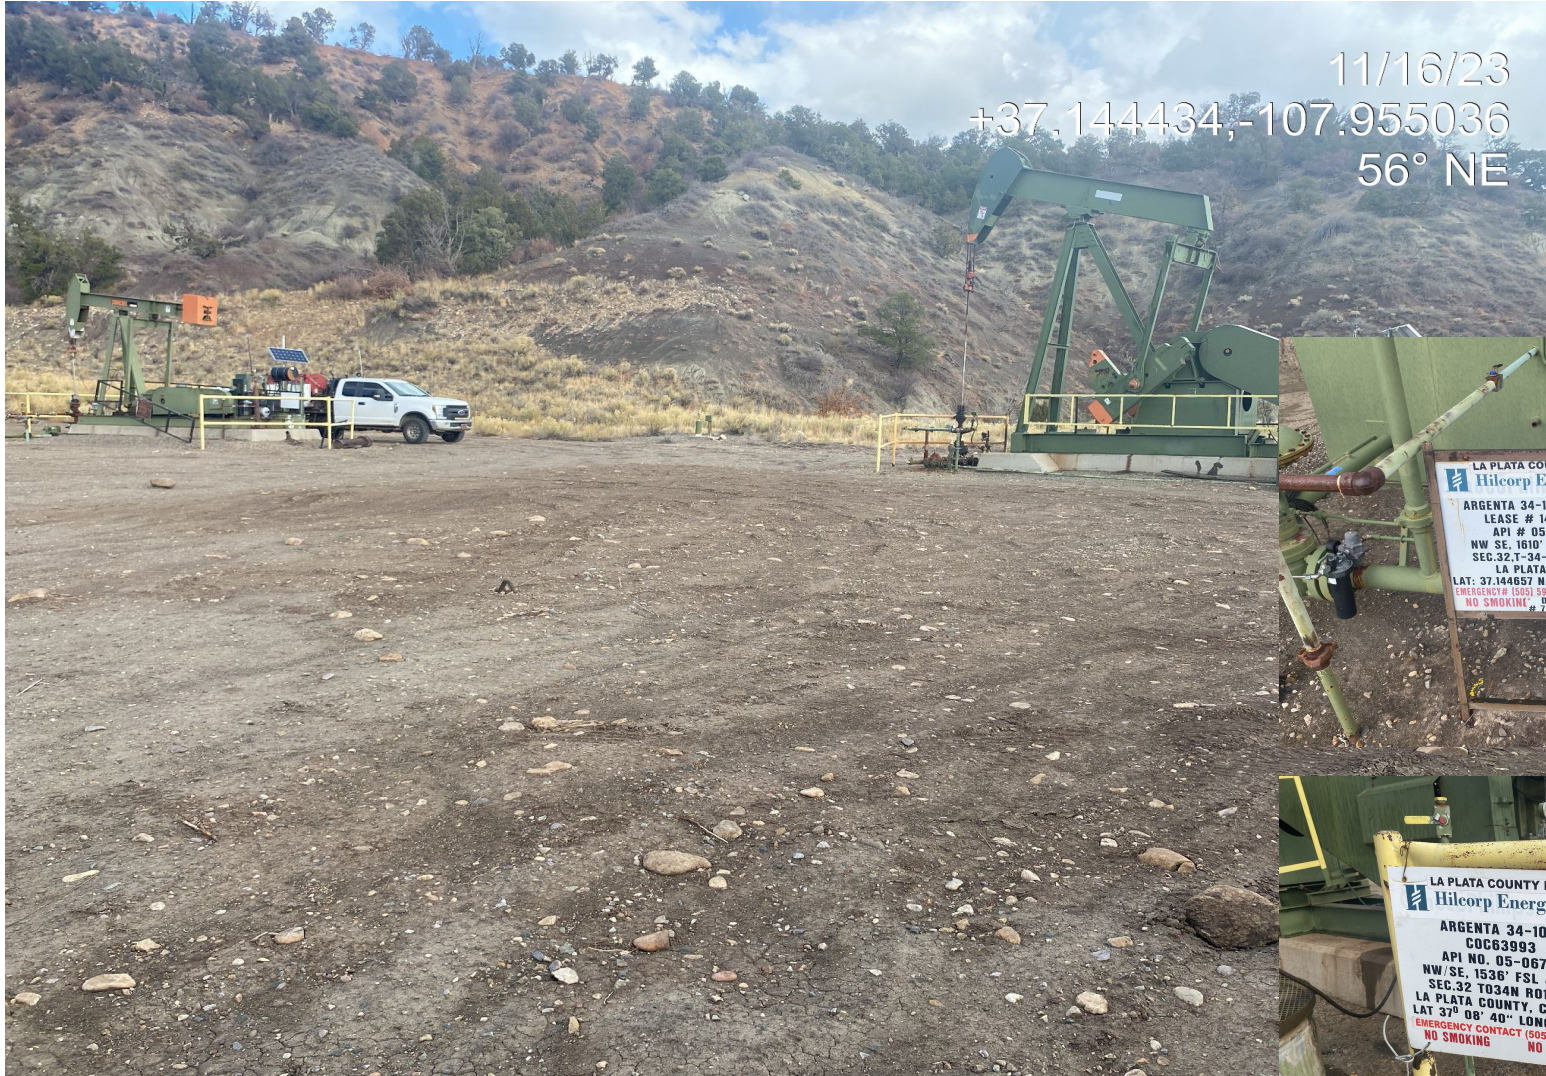
Photo 1. View of the project area taken from the entrance facing center.

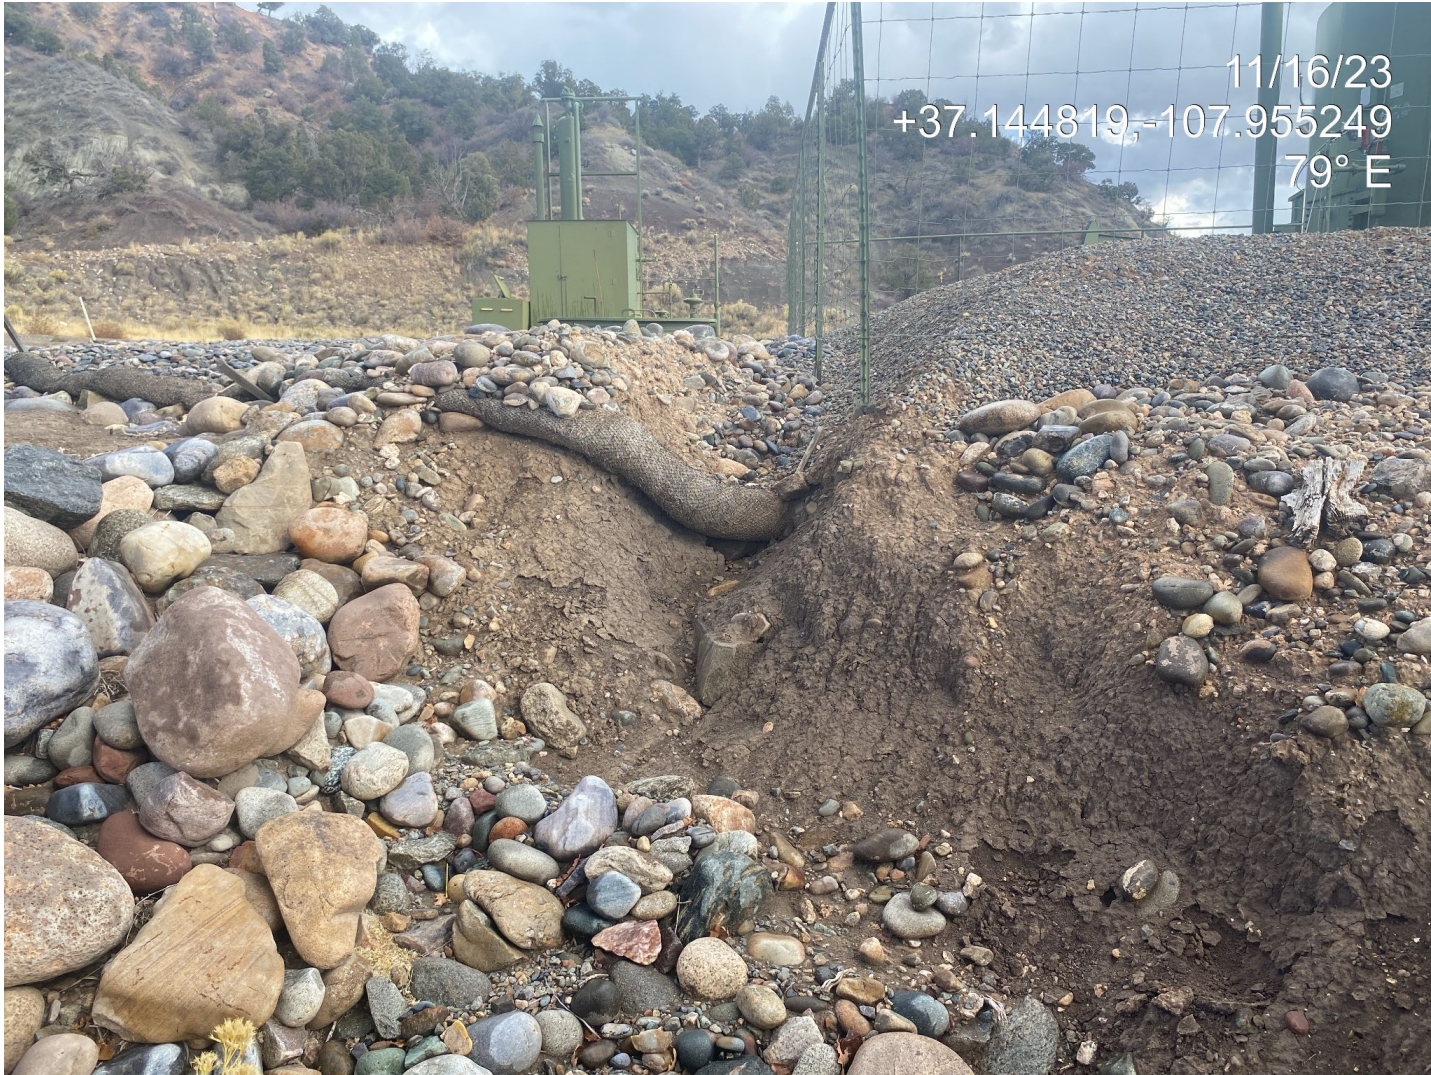
Photo 2. View of failing stormwater BMPs and forming gully erosion observed on the western fill slope/interim area of the disturbance.

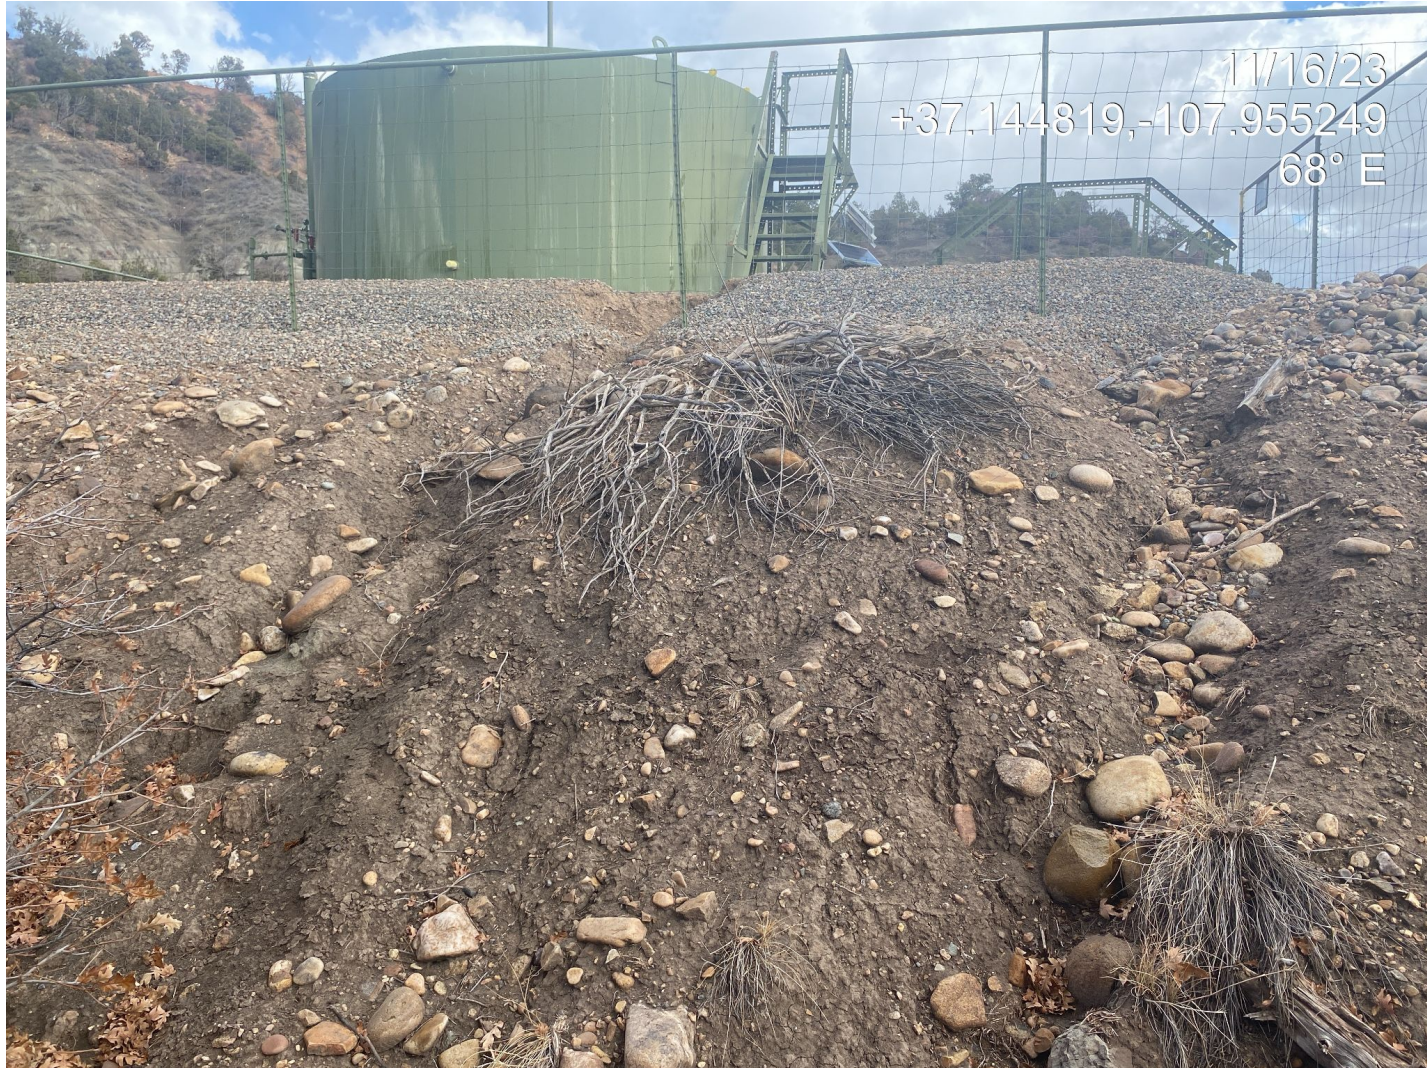
Photo 3. View of additional rill erosion forming on the western fill slope of the disturbance.

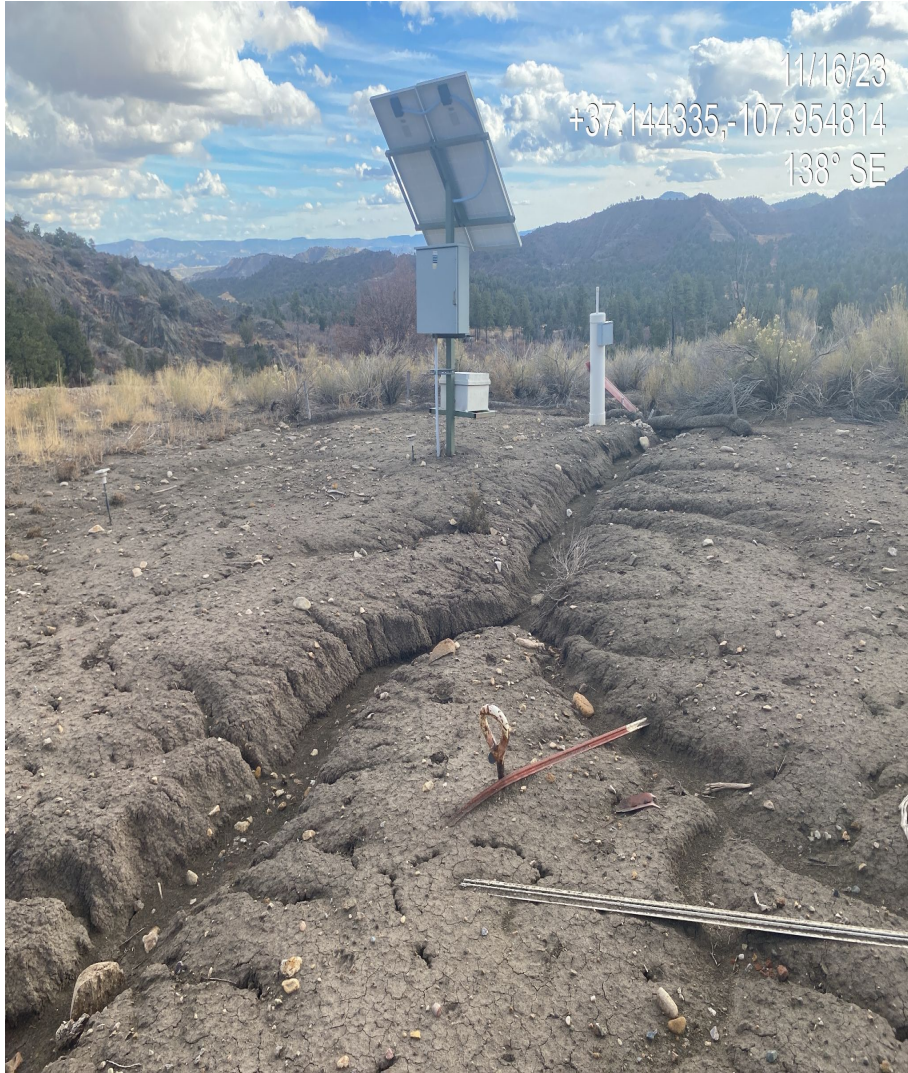
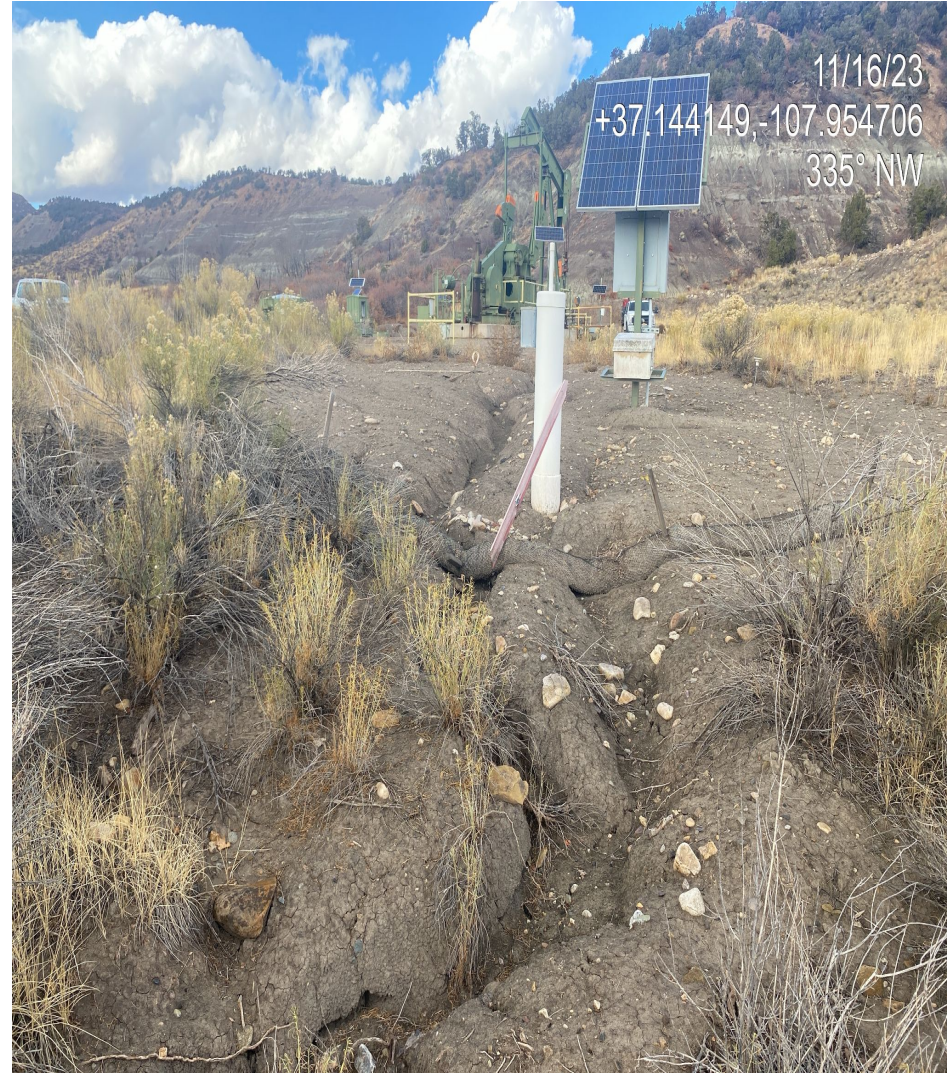
Photo 4. View of rill erosion and failing stormwater BMPs observed in the southern interim area of the disturbance.

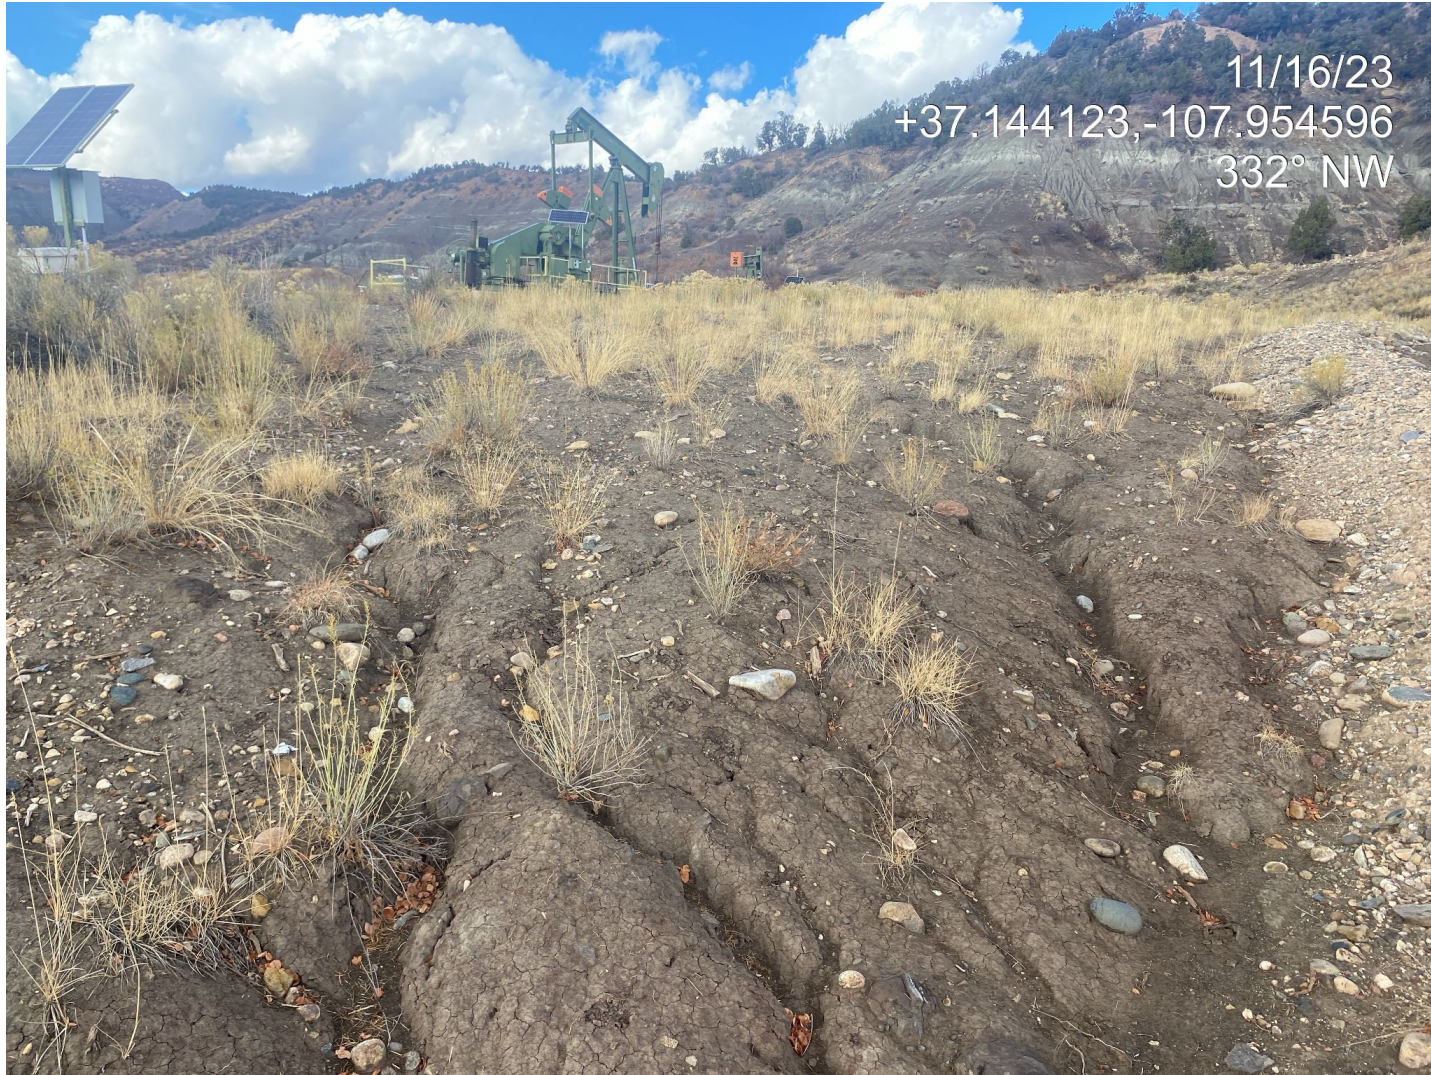
Photo 5. Additional rill erosion forming downslope of failing stormwater BMPs in the southern interim reclamation area.
