Final Reclamation Inspection

Operator: Hilcorp Energy Company- 10133

Location ID: 325510

Inspection Photos
Location Name: Davis Gas Unit 1
Location ID: 325510

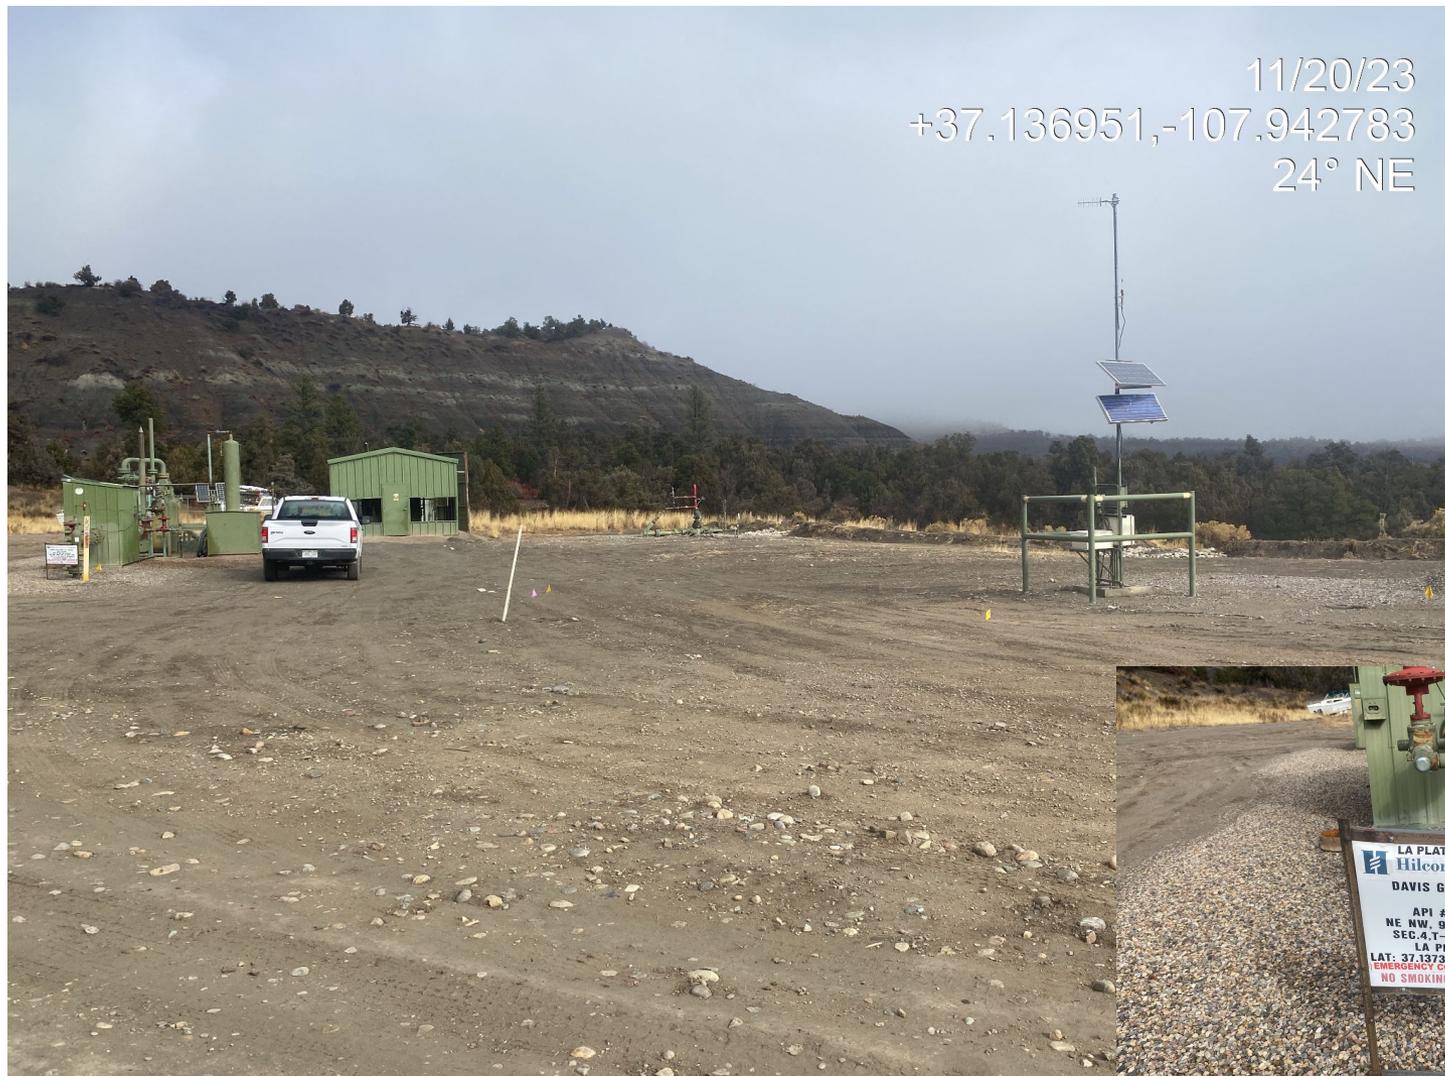
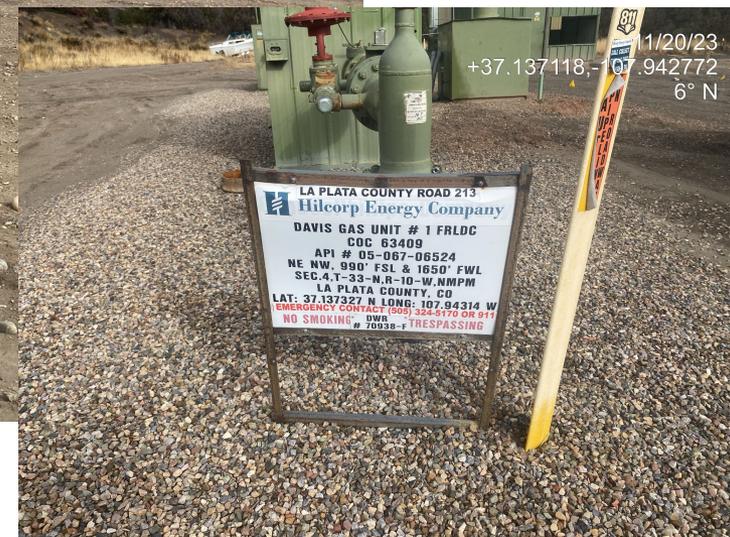
Photo 1. View of the project area taken from the entrance facing center.

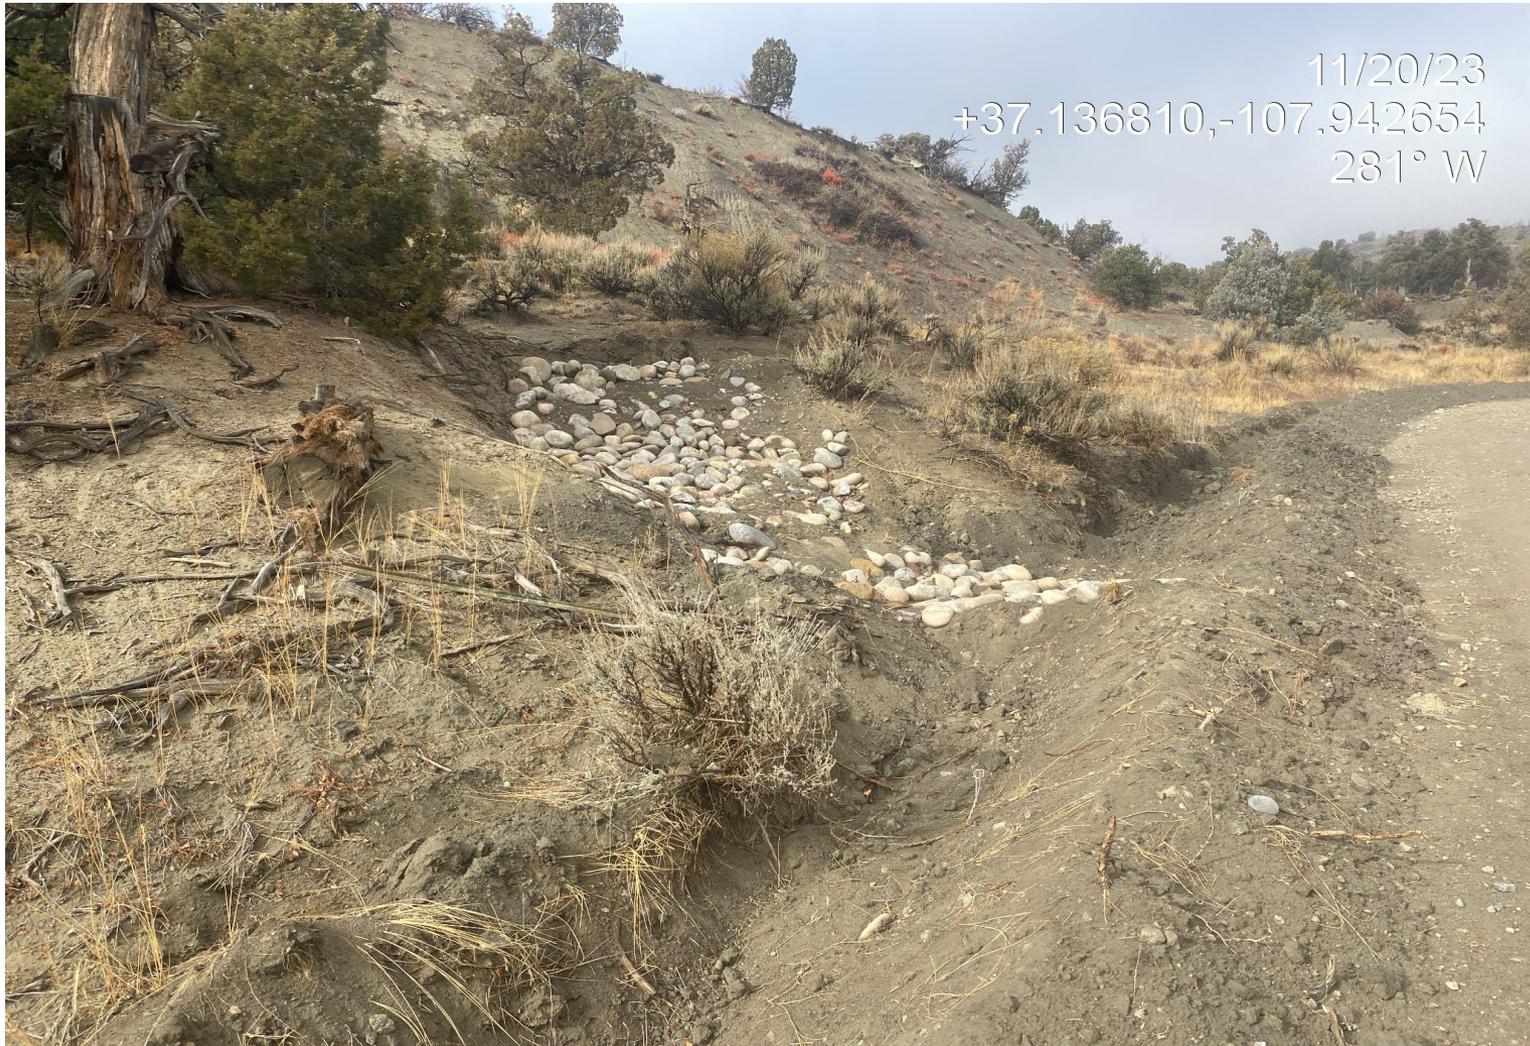
Photo 2. View of stormwater BMPs installed in the western interim reclamation area by the access road.

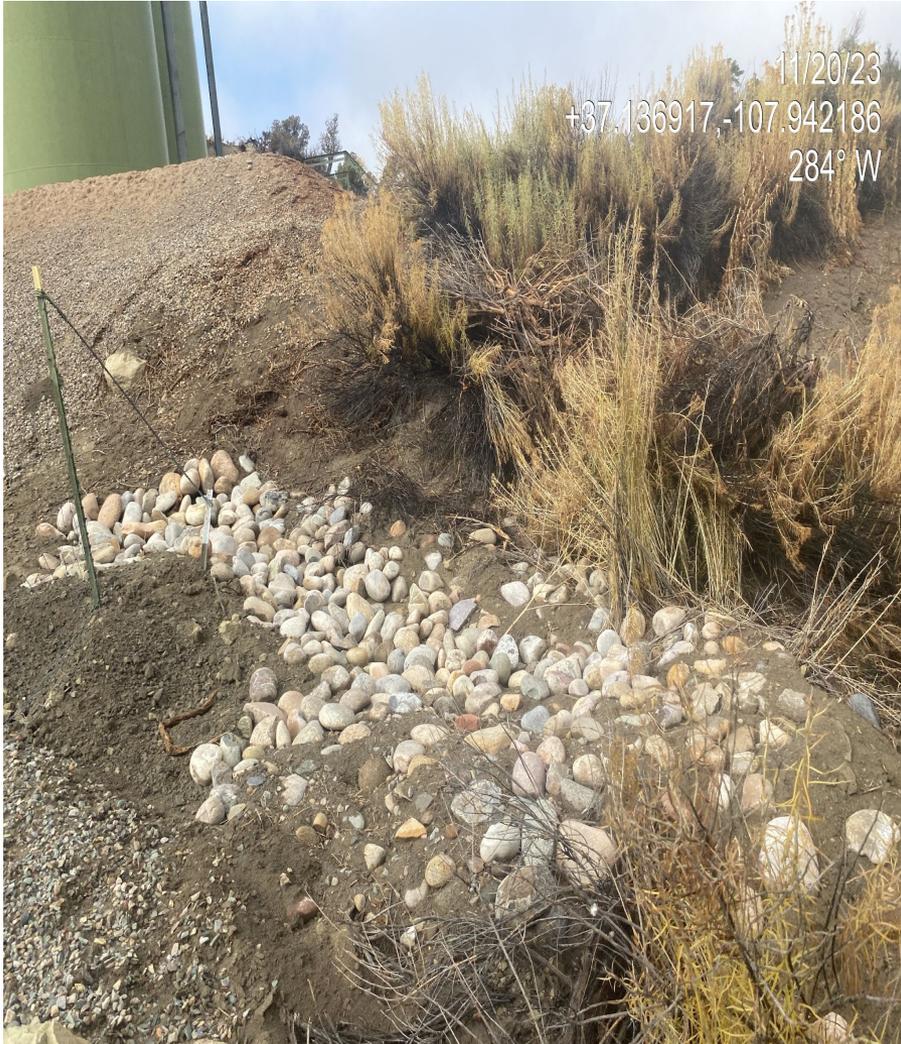
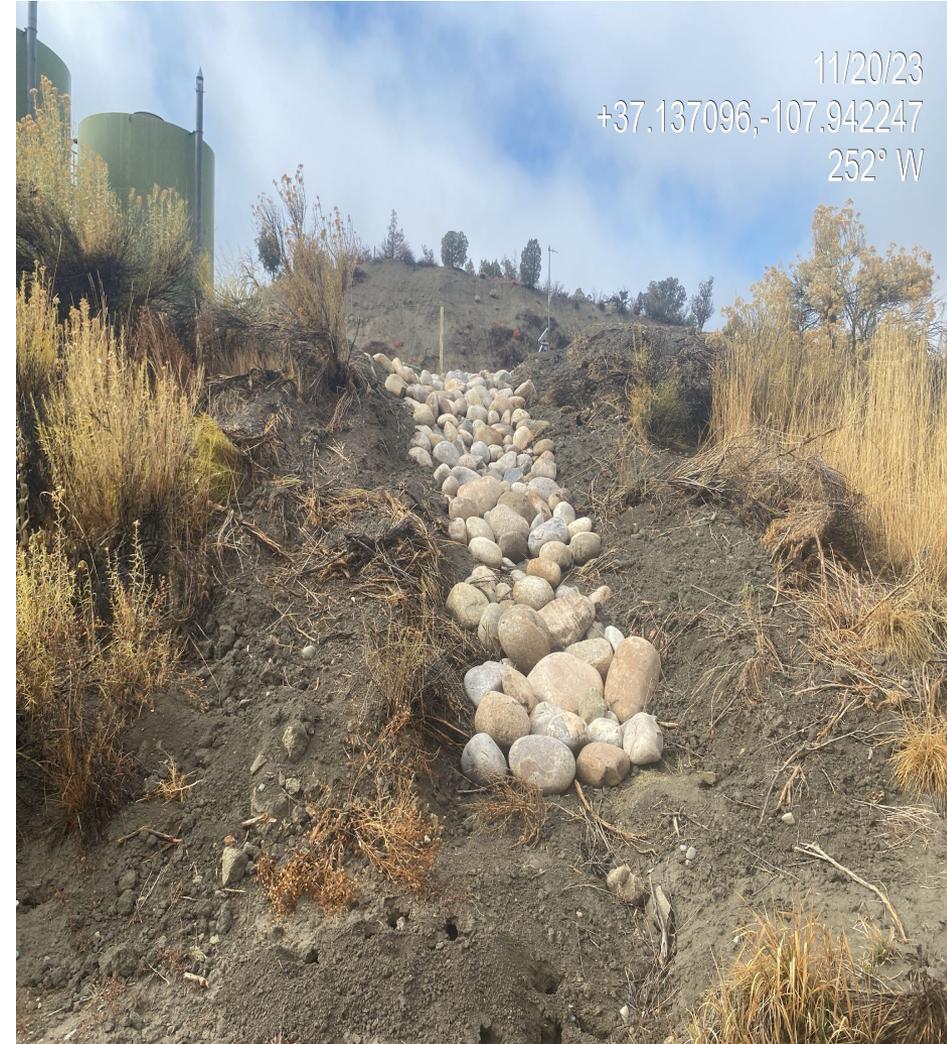
Photo 3. View of stormwater BMPs installed in the eastern interim reclamation area.

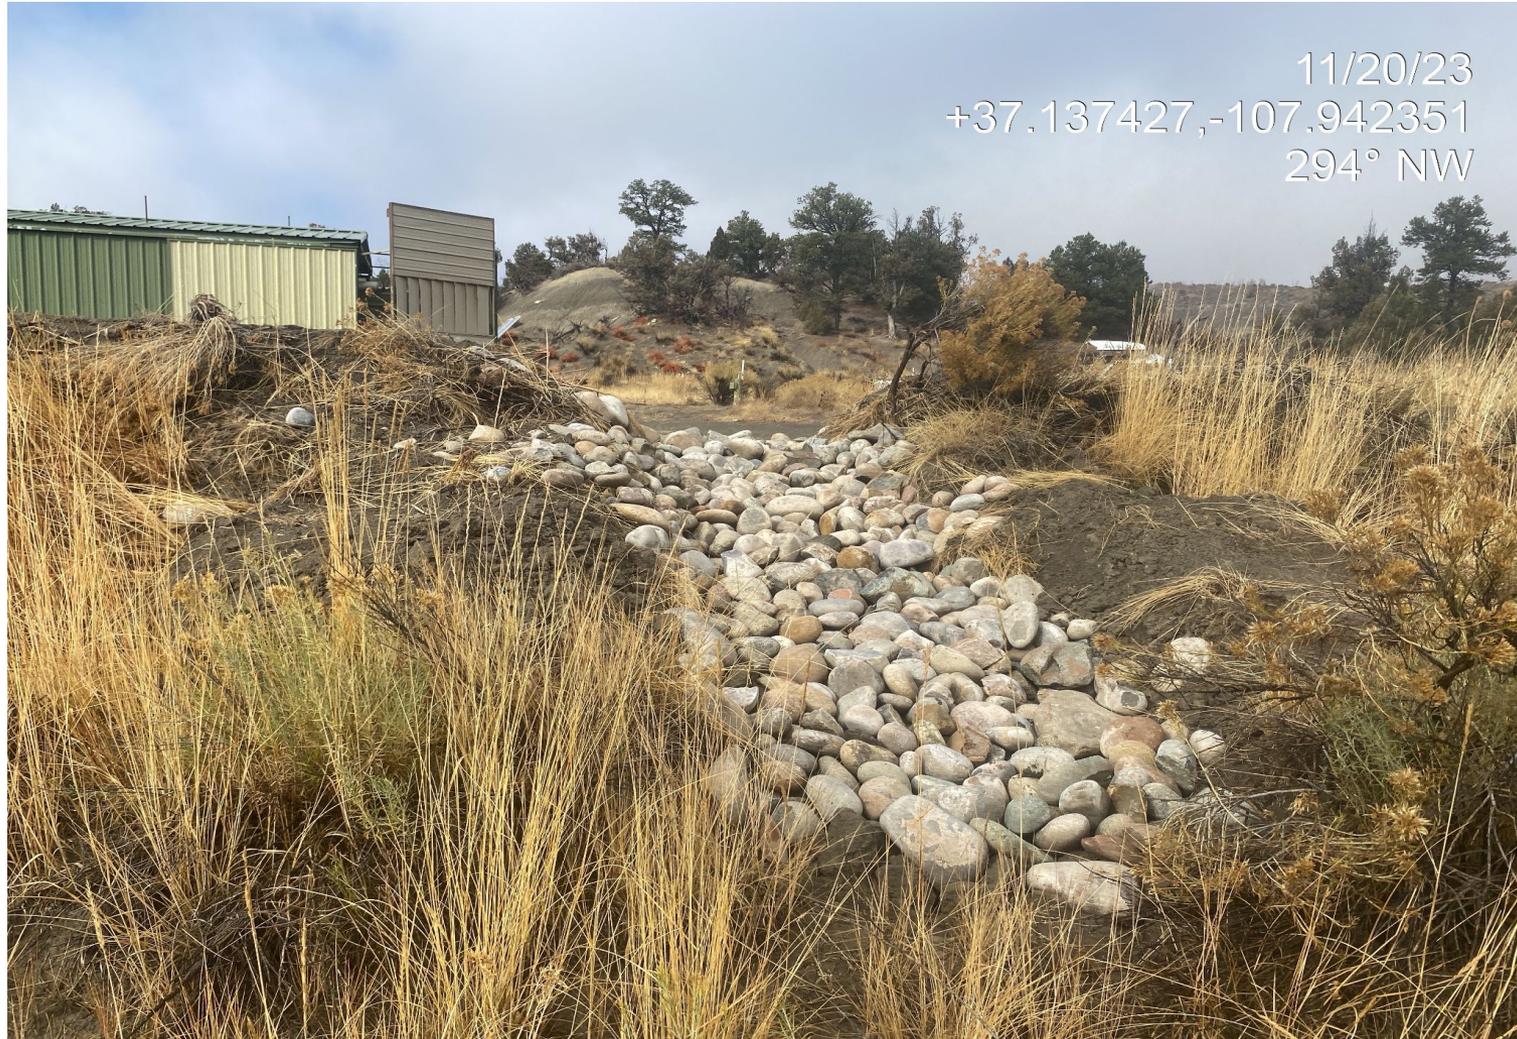
Photo 4. Installed BMPs observed around the location are not per good engineering practice, operator has used round river stone rather than large angular rock. Round rock may increase erosion and scouring in these areas.
