Inspection Photos

API: 061-06296

Operator: STRACHAN EXPLORATION INC

Inspection Date: 11/29/2023

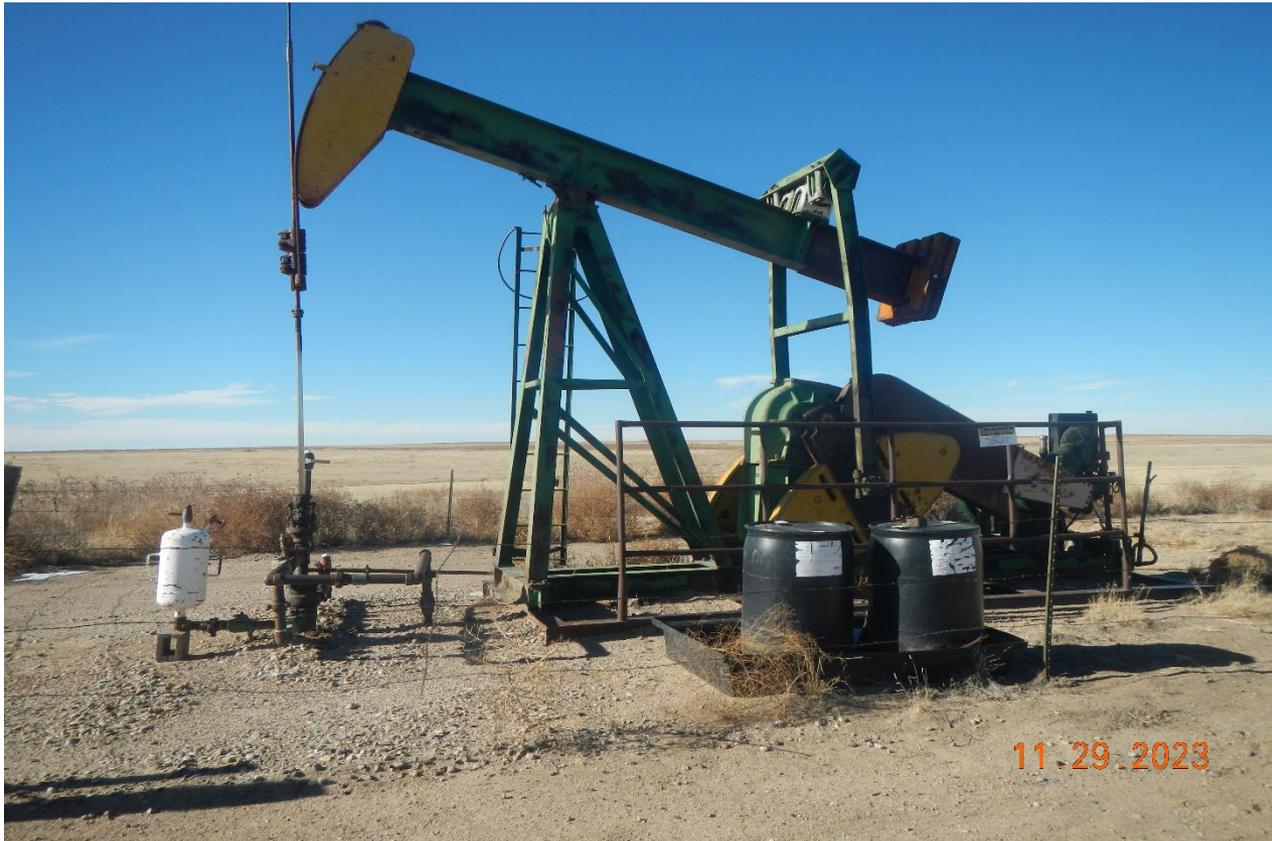
Photo 1. Facing toward the wellsite.

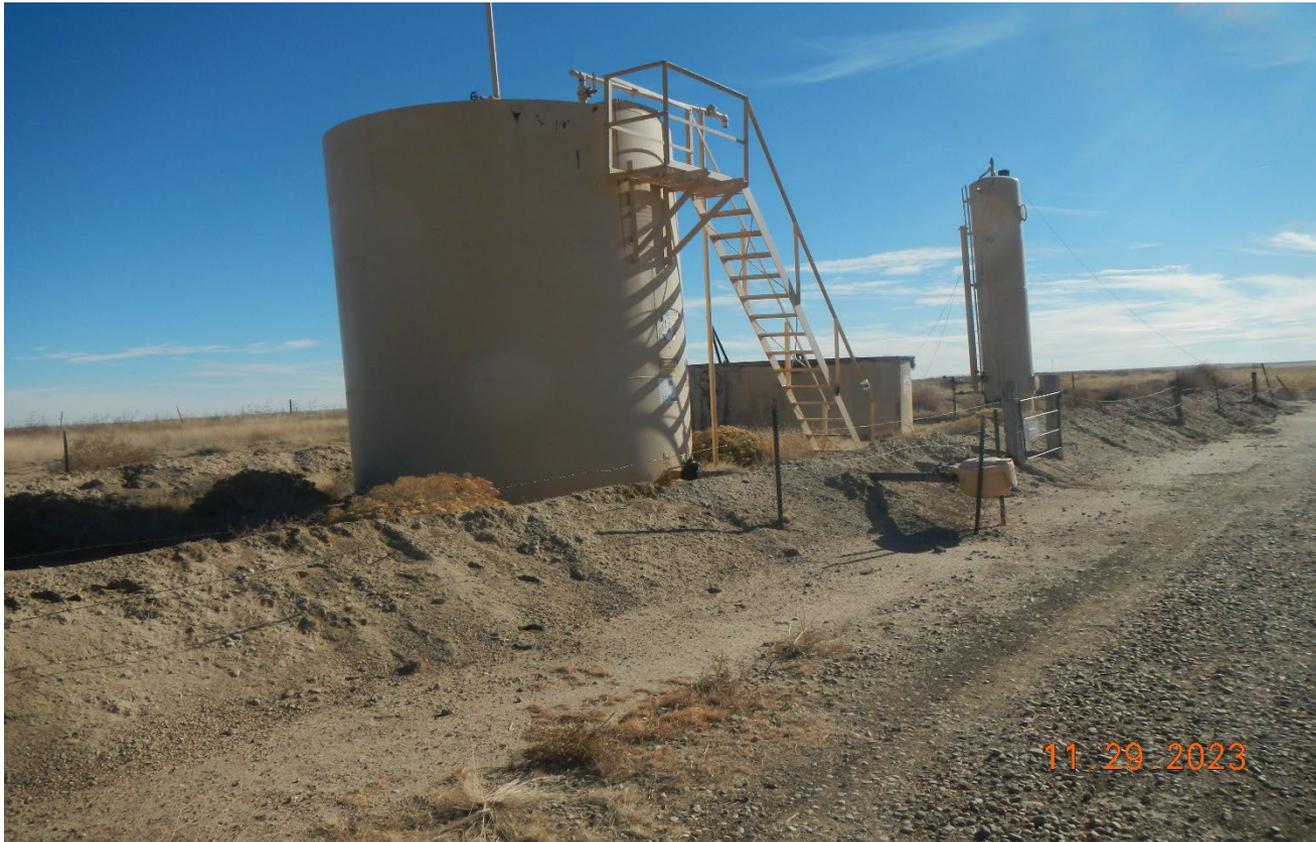
Photo 2. Facing northeast toward the tank battery.

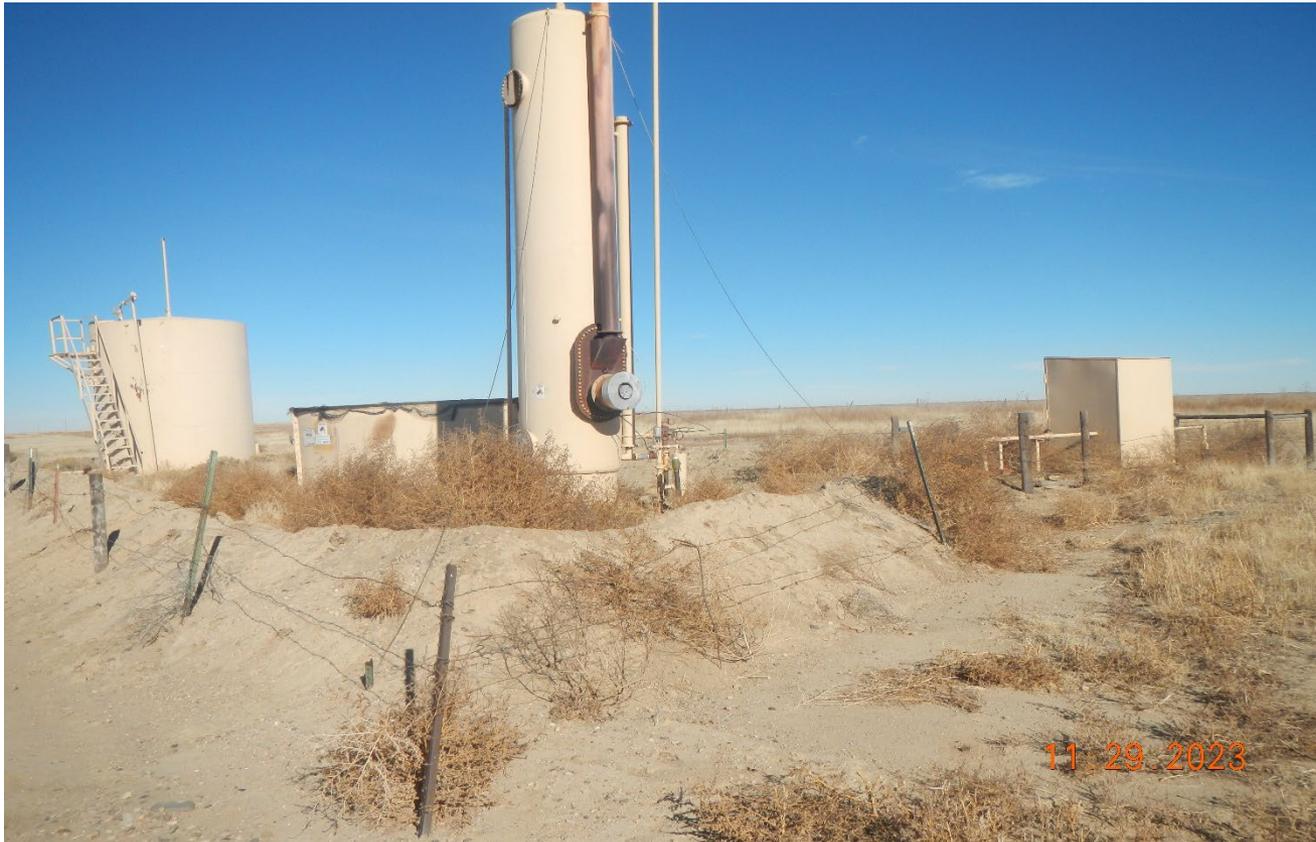
Photo 3. The fence around the tank battery is inadequate to prevent livestock entry and is not maintained. Previous corrective action was not completed.

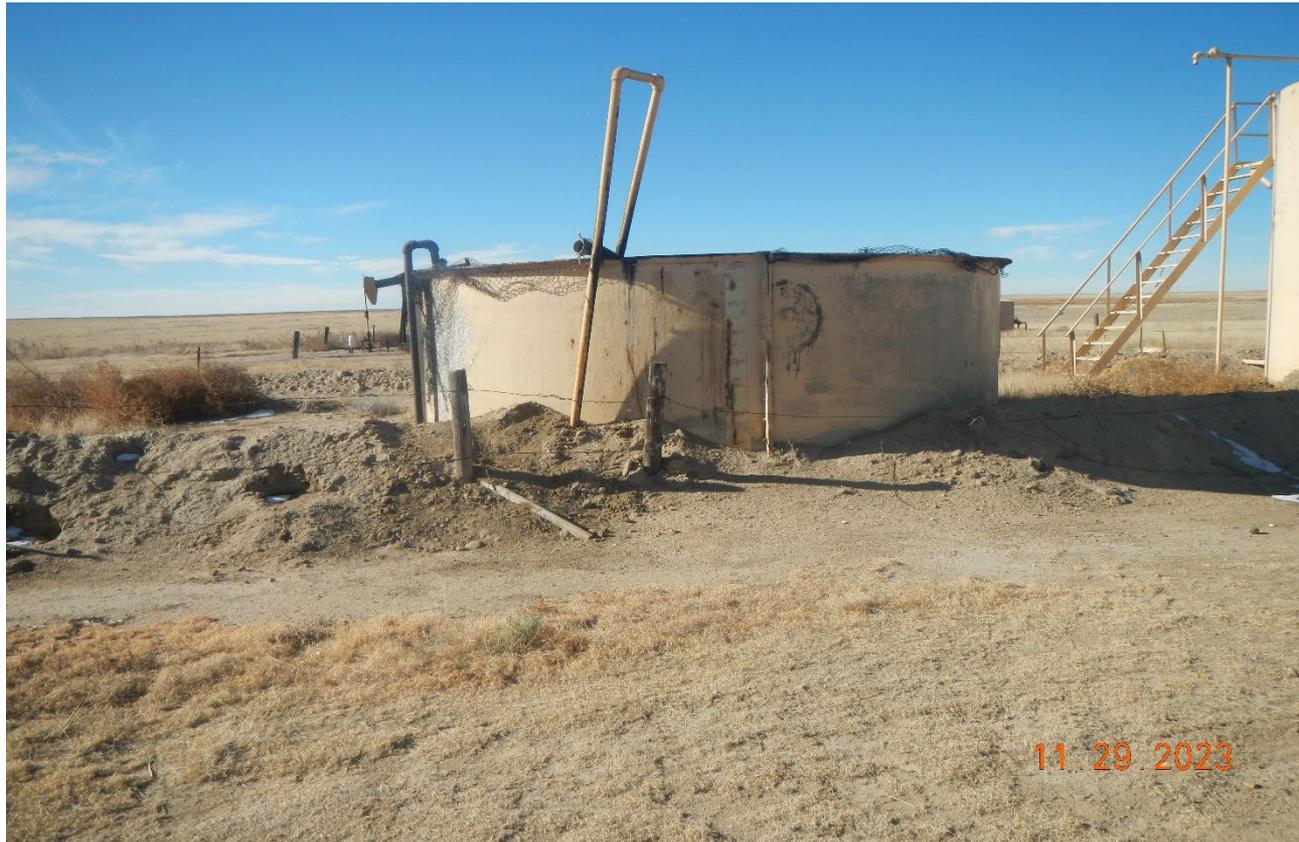
Photo 4. The berm is inadequate to contain a spill as it is piled up against the tank and would spill over the berm along this side. Previous corrective action was not completed.
