Inspection Photos

API: 061-06368

Operator: STRACHAN EXPLORATION INC

Inspection Date: 11/29/2023

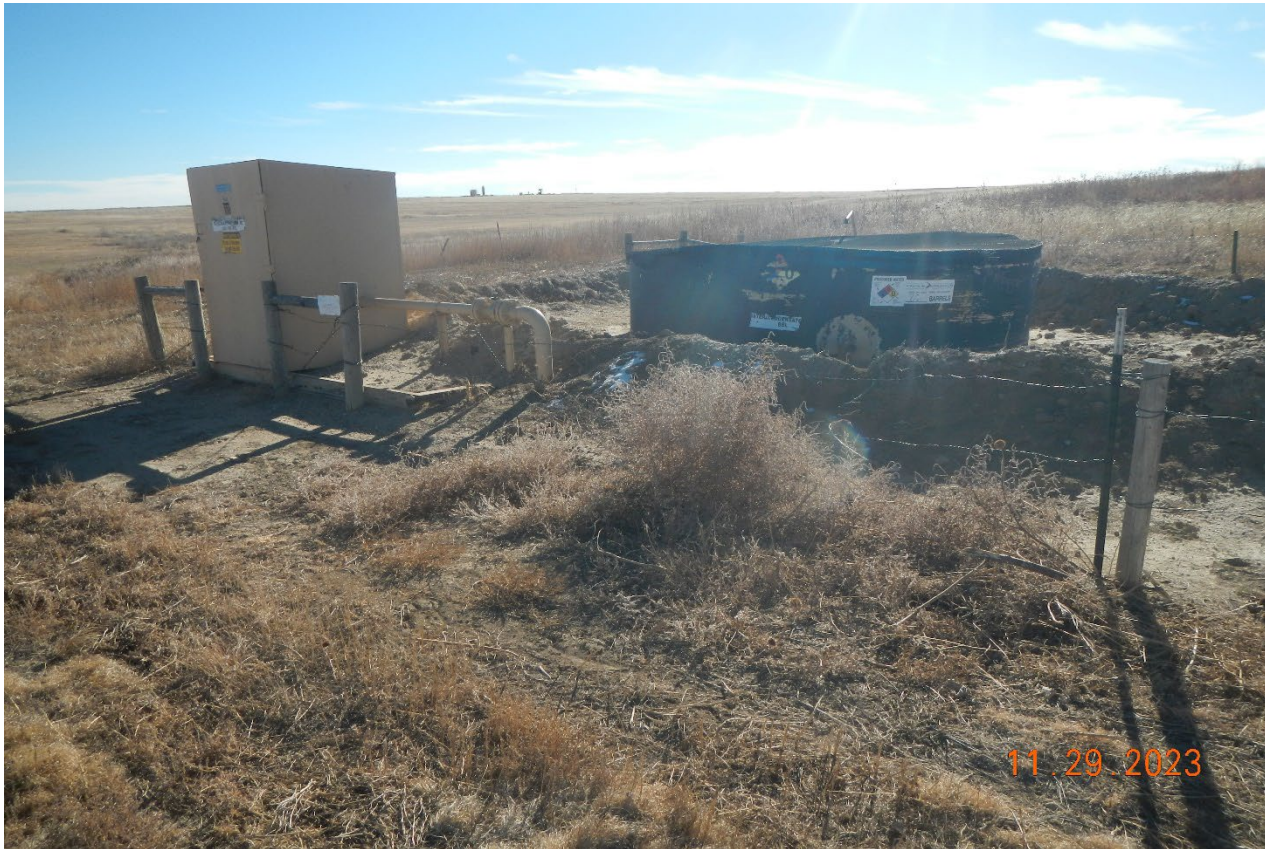
Photo 1. Facing toward the offsite meter run and open top condensate tank located about 2000' east of the wellsite.

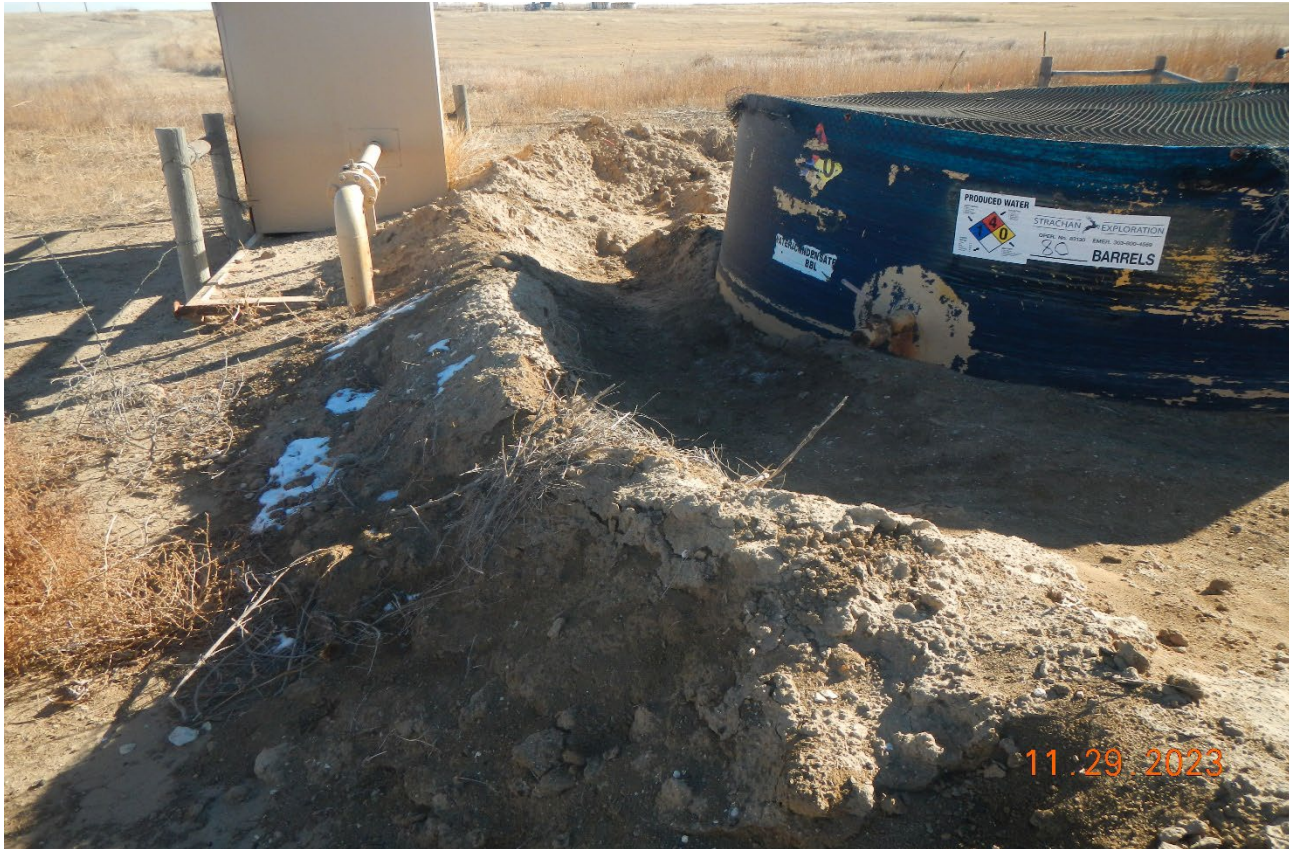
Photo 2. The berm around the tank has been built up however soils were not compacted to be impermeable.

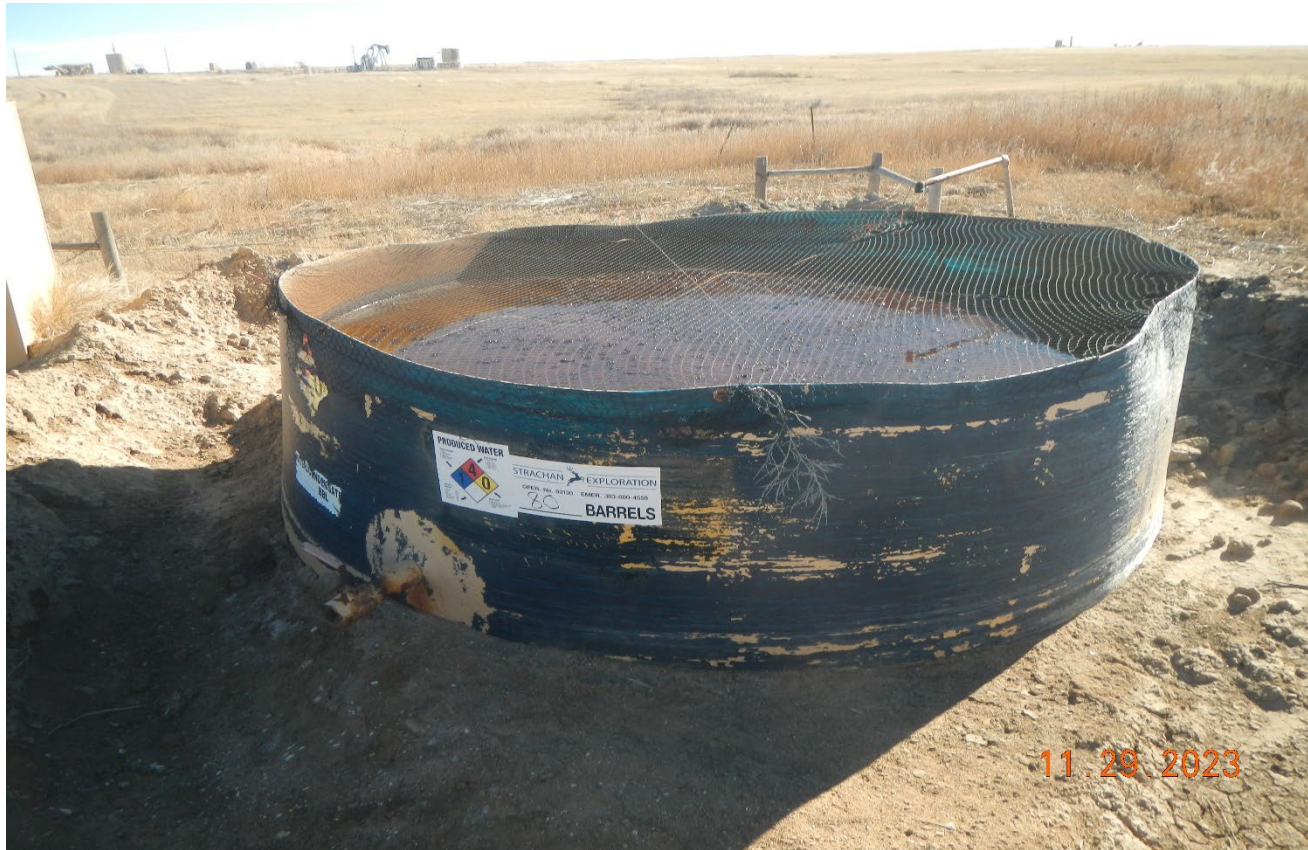
Photo 3. The netting on the open top tank is torn and needs repair. Previous corrective action was not completed.

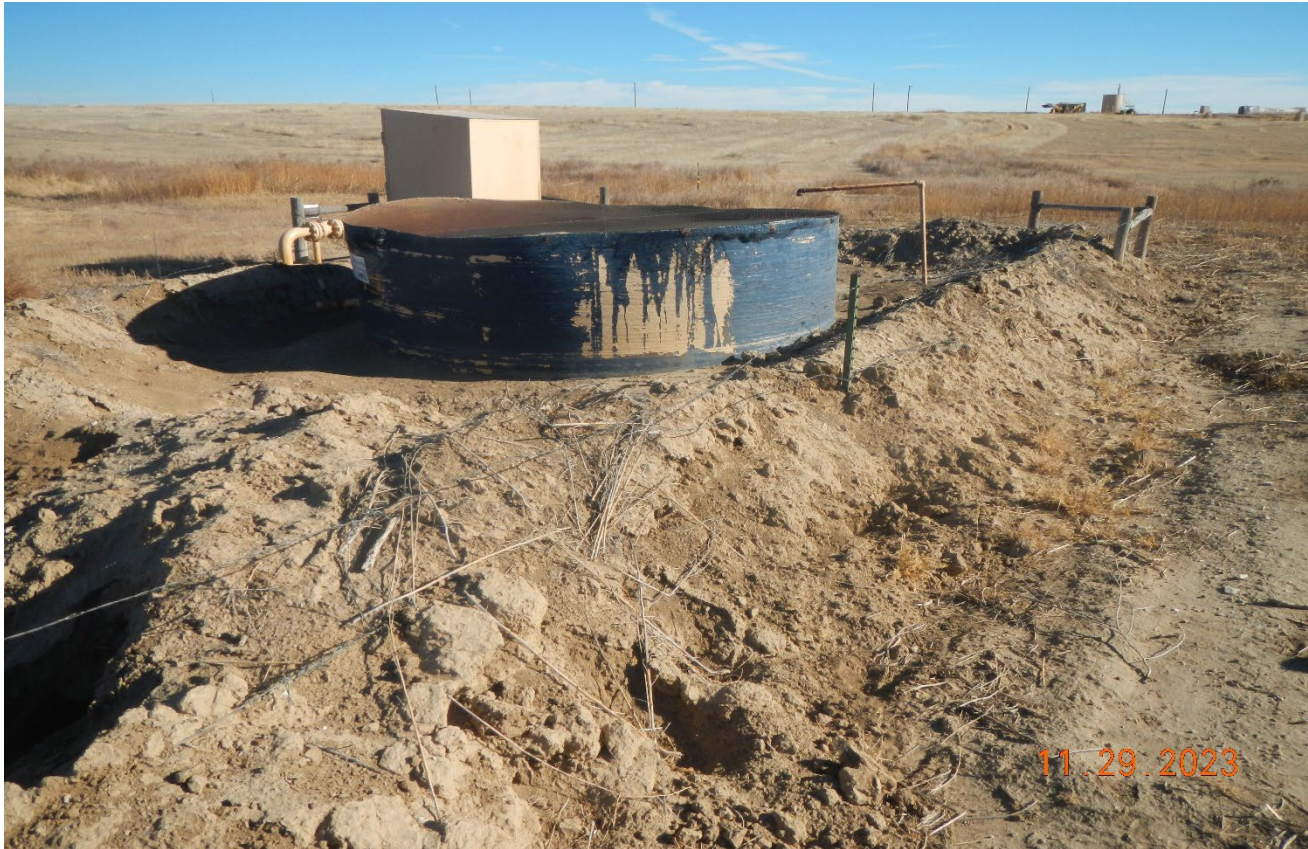
Photo 4. The fence around the open top tank is inadequate to prevent livestock entry and is not maintained. Previous corrective action was not completed.

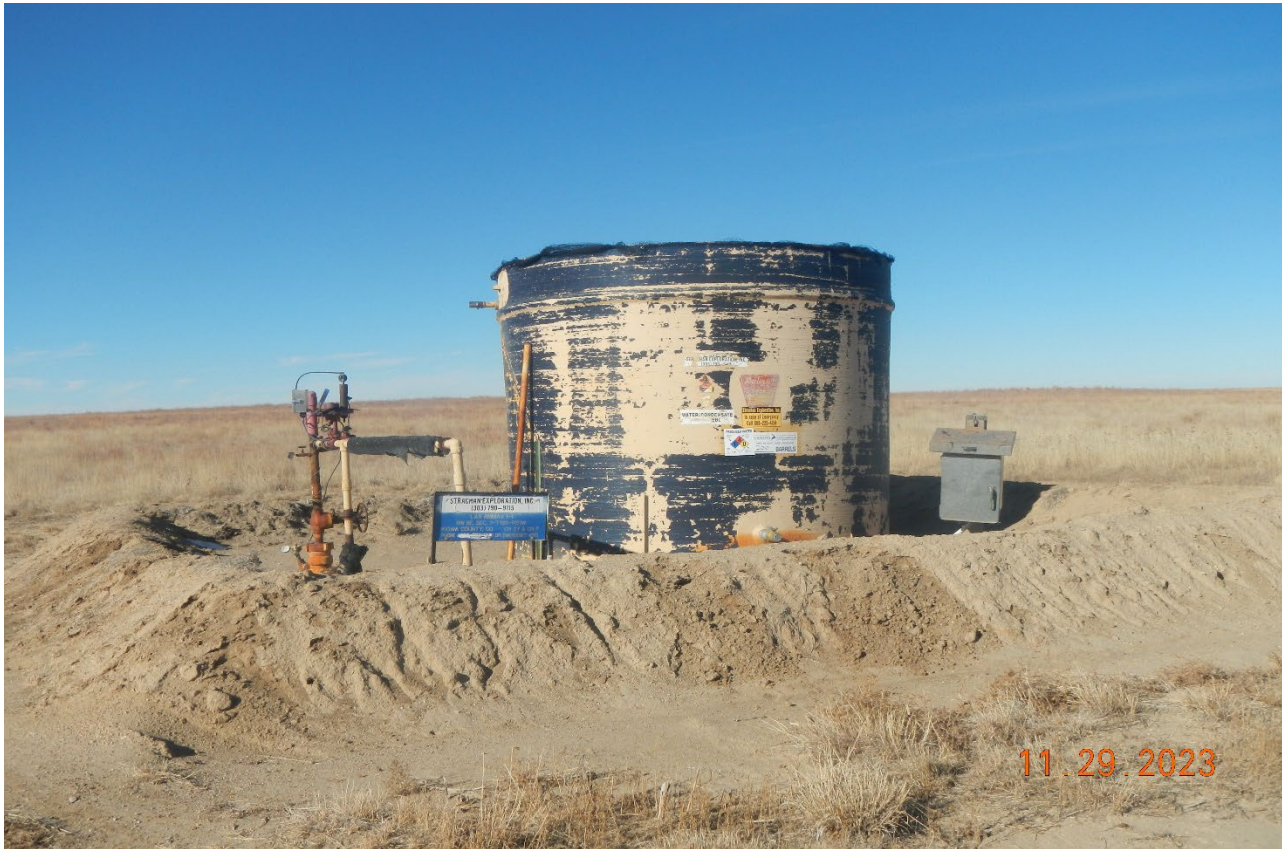
Photo 6. Facing toward the wellsite. The labeling on the tank is faded and peeled off. The berm around the tank has been built up however soils were not compacted to be impermeable.
