Inspection Photos
Location Name: CAERUS PICEANCE LLC D13W Pad
Location ID: 334676

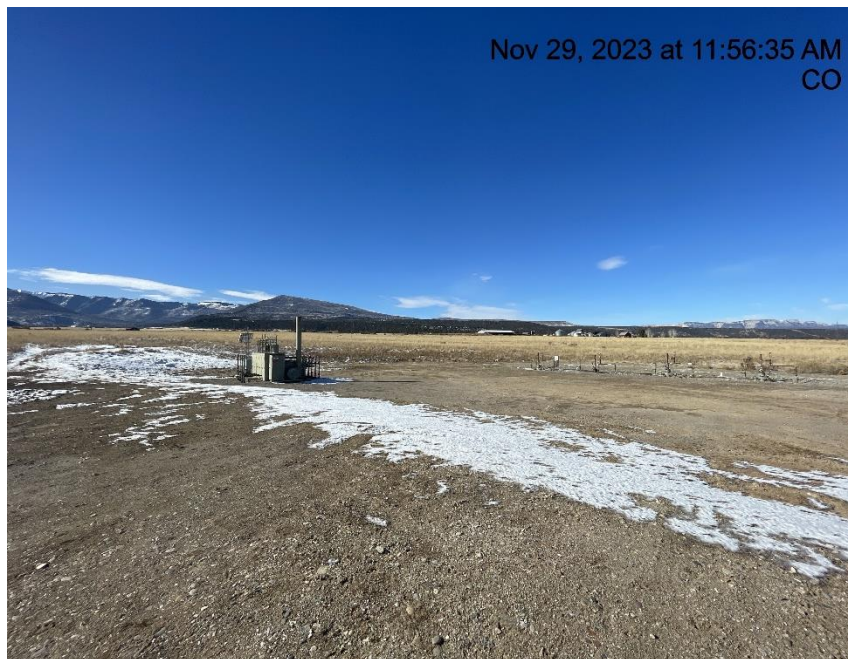
Photo # 7833 From entrance to location

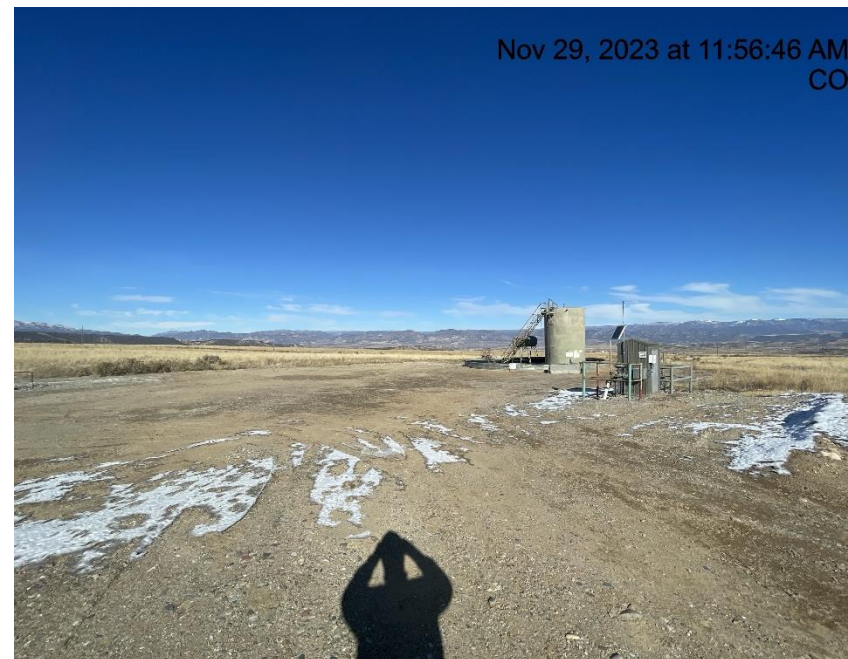
Photo # 7834 From entrance to location

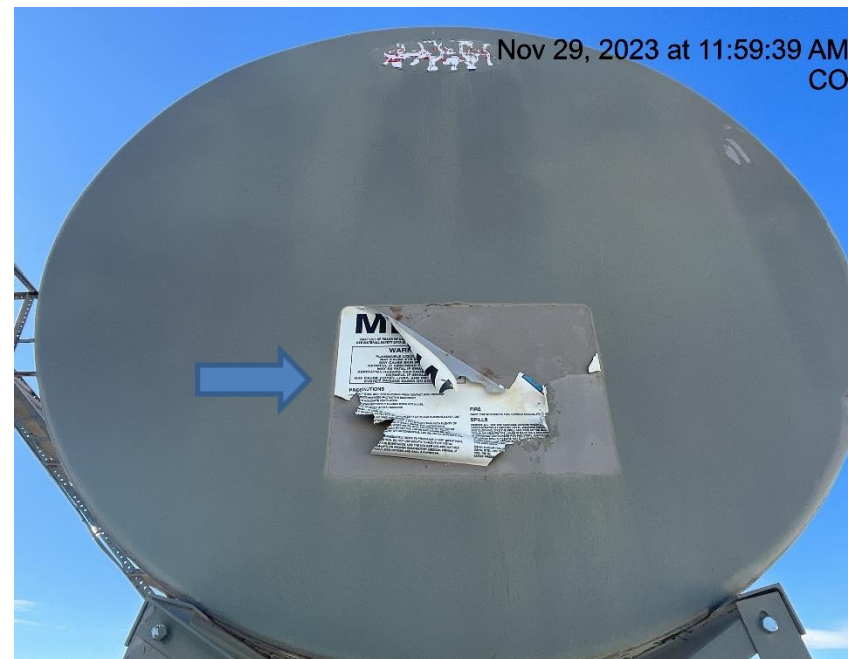
Photo # 7840 Tank label damaged & illegible

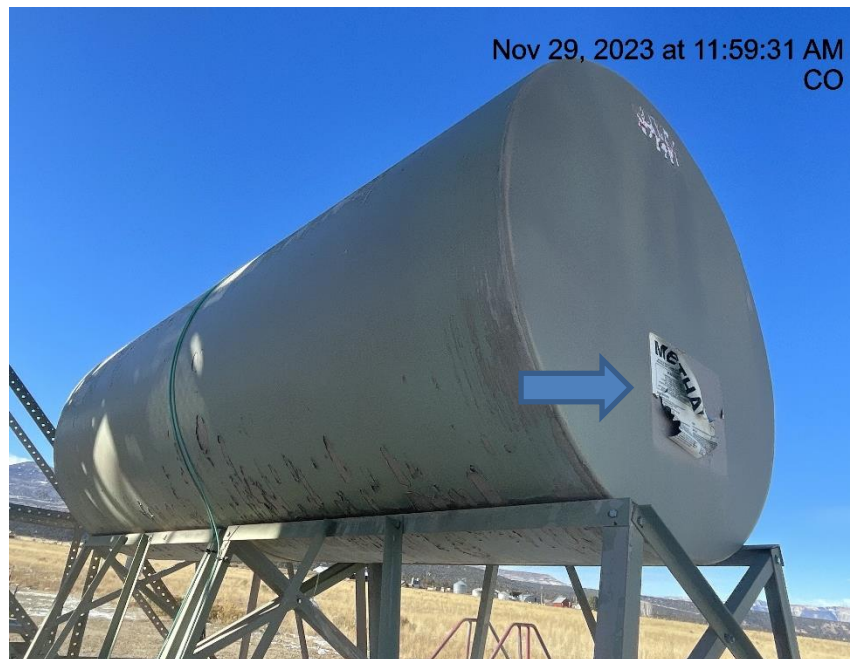
Photo # 7841 Tank label damaged & illegible

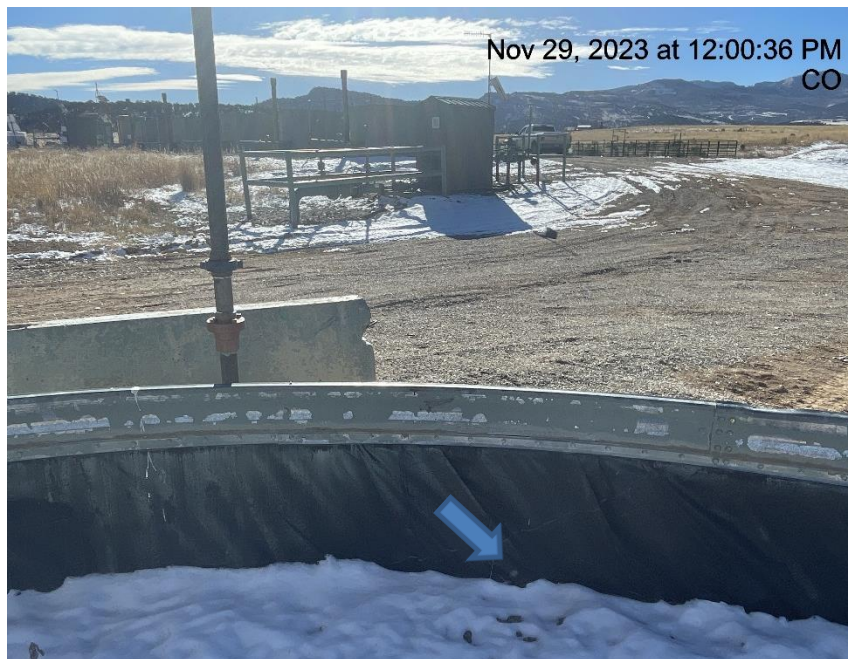
Photo # 7843 Hole in liner/liner needs maintenance

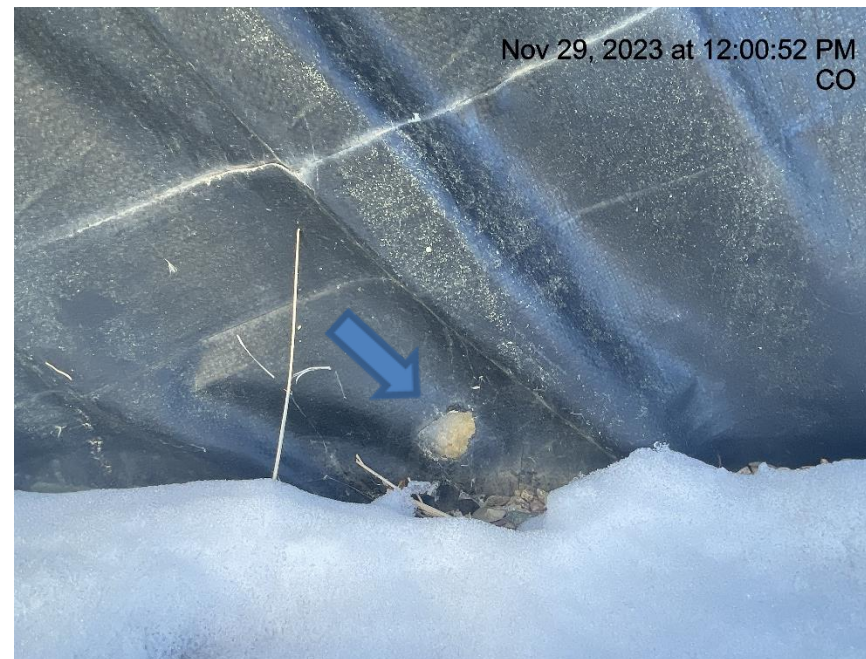
Photo # 7844 Hole in liner/liner needs maintenance
