# Inspection Photos

Loc: 472353

Operator: MCCOY PETROLEUM CORPORATION

Inspection Date: 11/29/2023

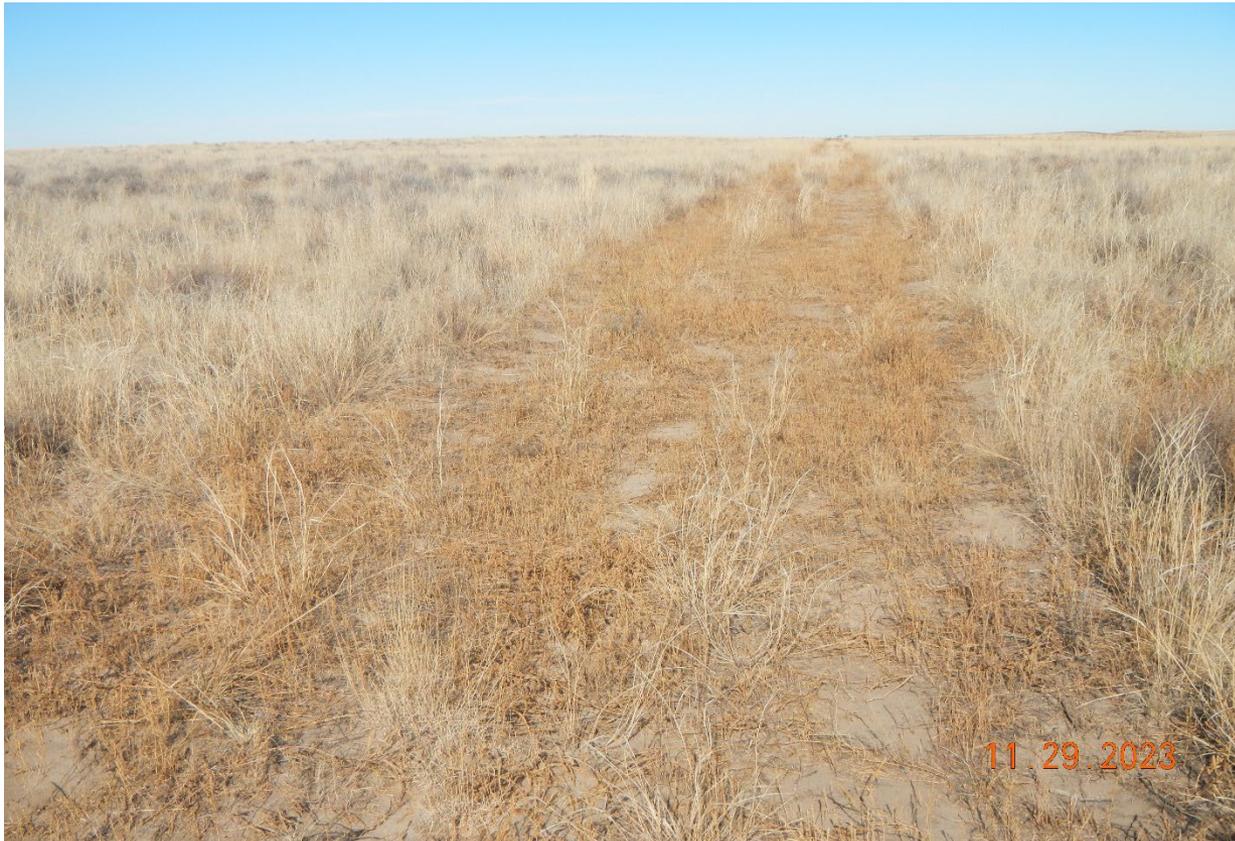
**Photo 1.** Facing north along the access road. There are areas of the road where perennial vegetation has not established. This area of the road consists mostly of undesirable weeds.

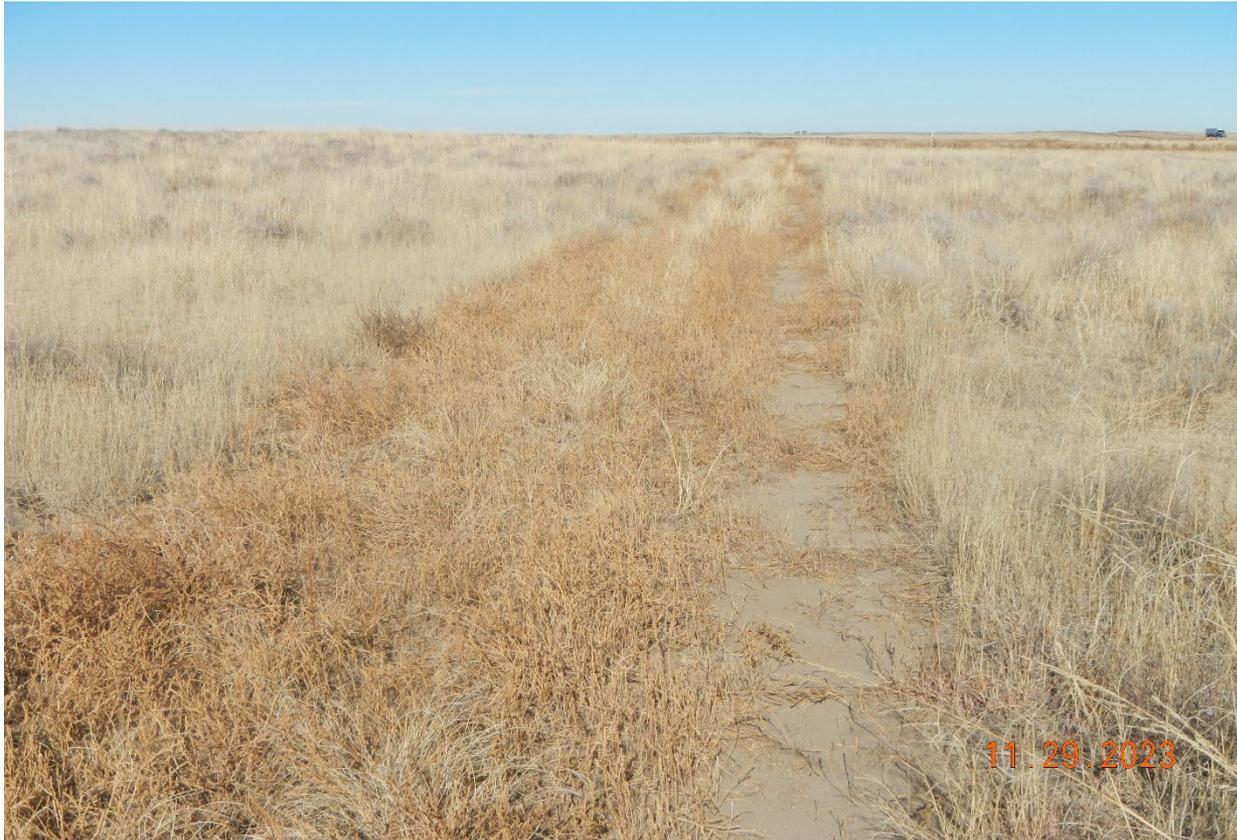
**Photo 2.** Facing north further along the access road. There are areas of the road where perennial vegetation has not established. This area of the road consists mostly of undesirable weeds.

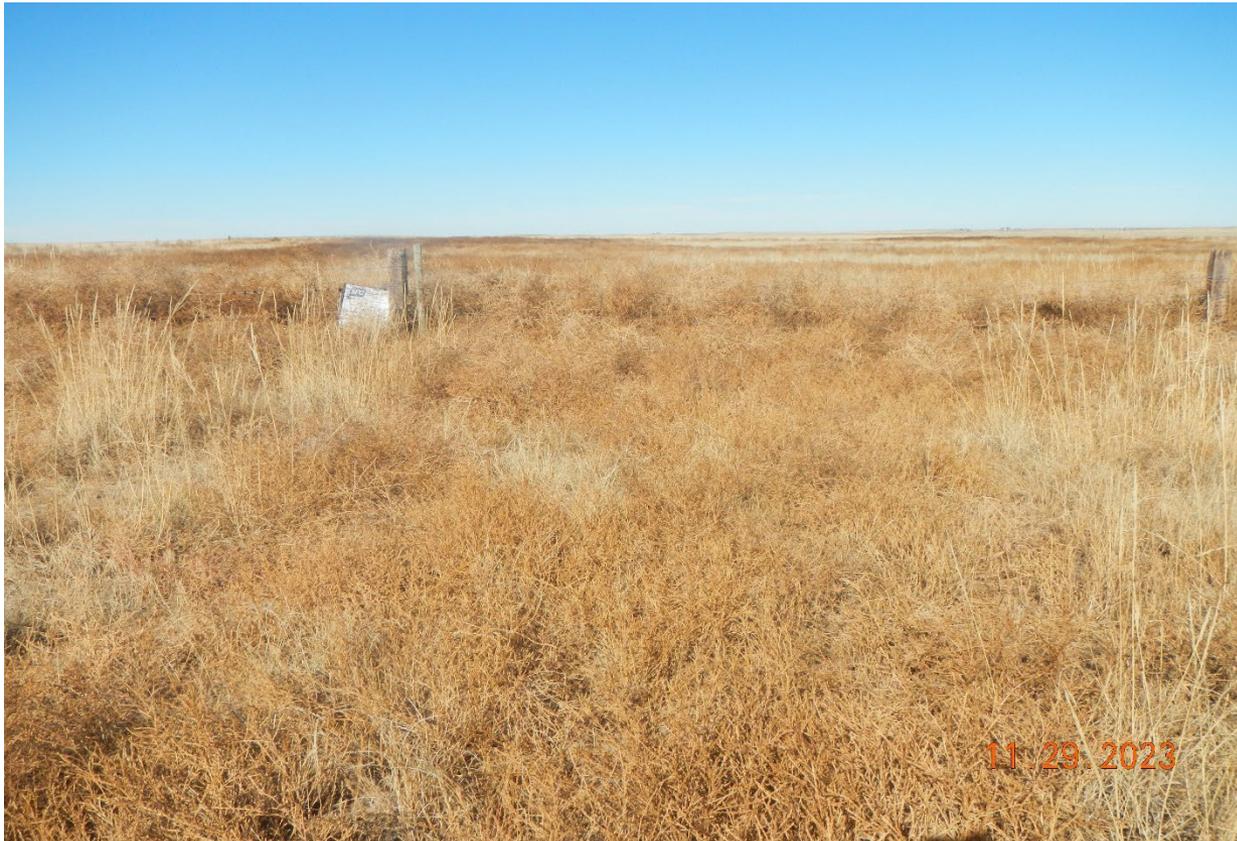
**Photo 3.** Facing north toward the fenced location.

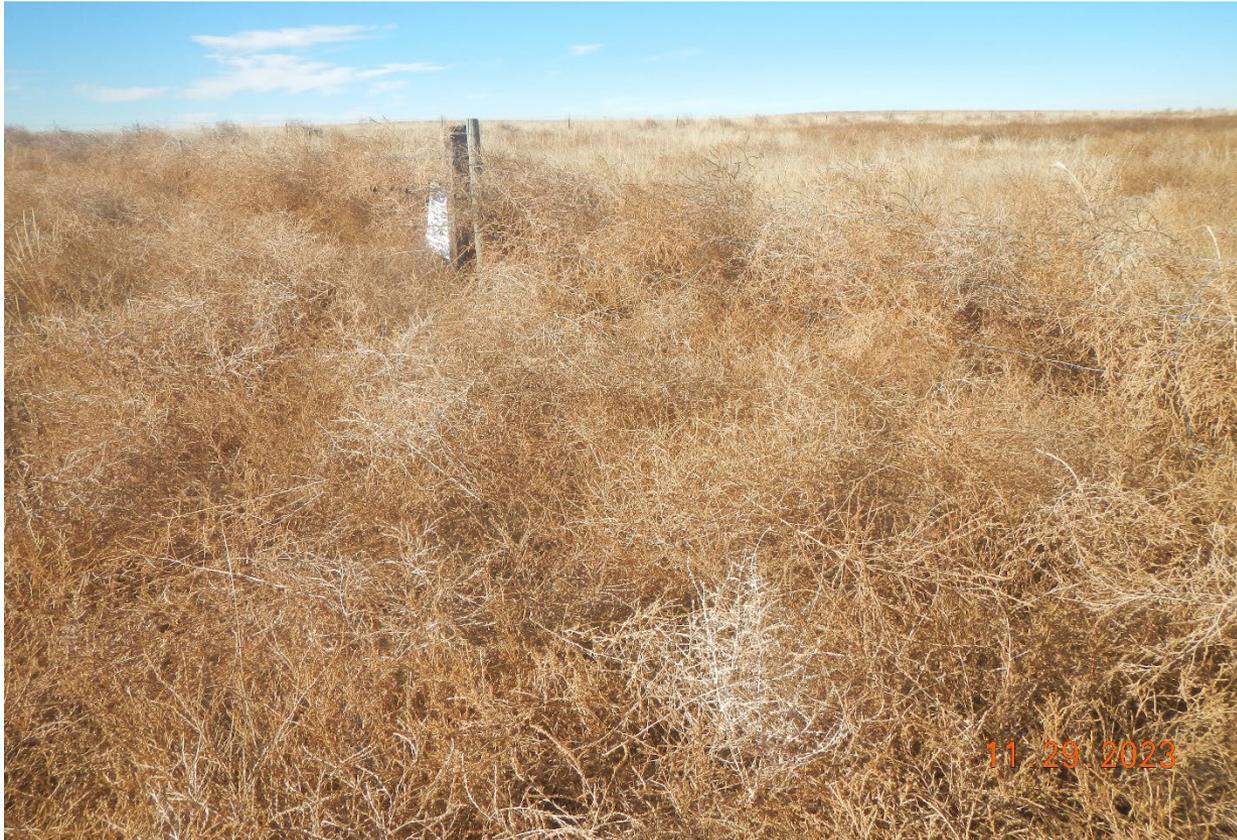
**Photo 4.** Facing northwest toward the fenced location. There are undesirable weed debris caught in the perimeter fence which will need to be removed.

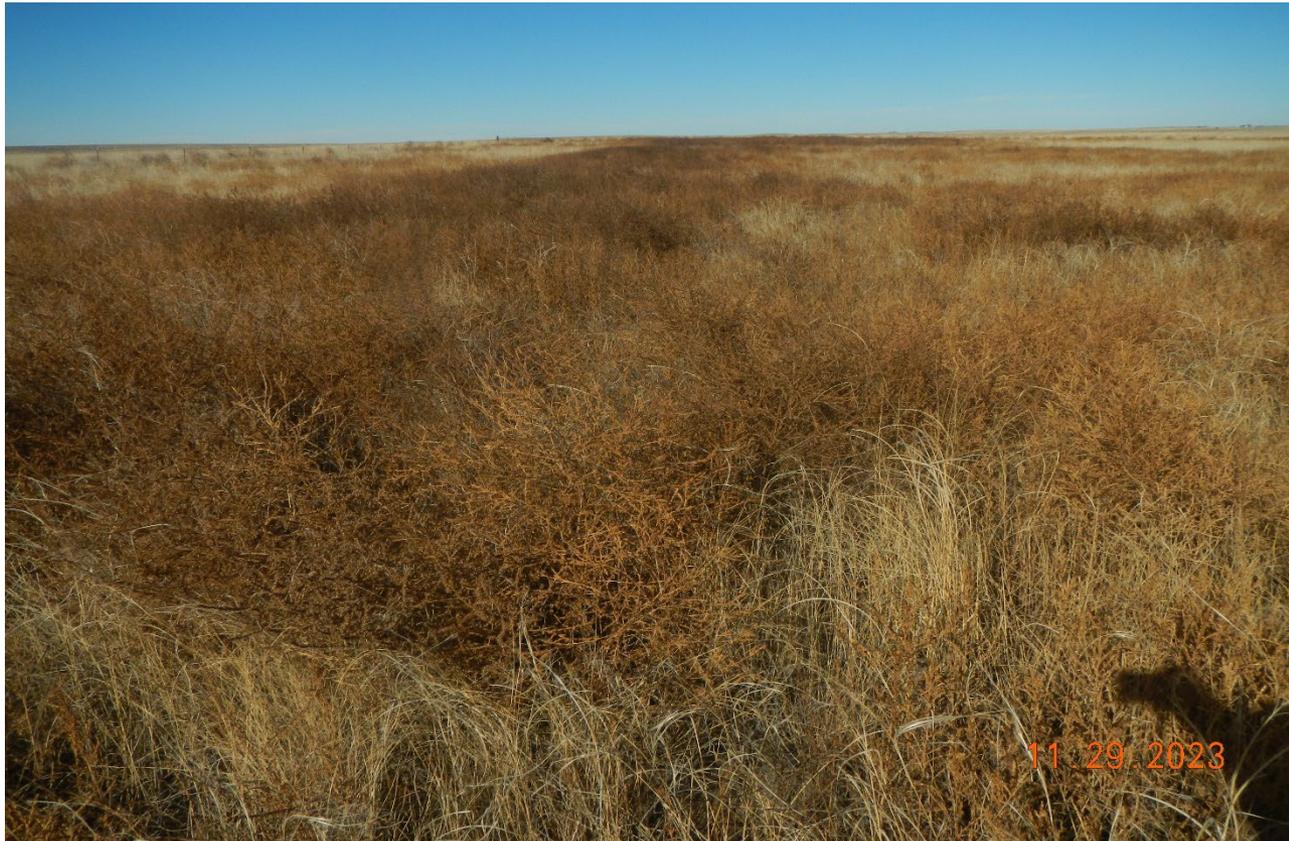
**Photo 5.** Southwest side of the location facing north. The brown vegetation is undesirable weeds of Russian thistle which will need to be controlled.

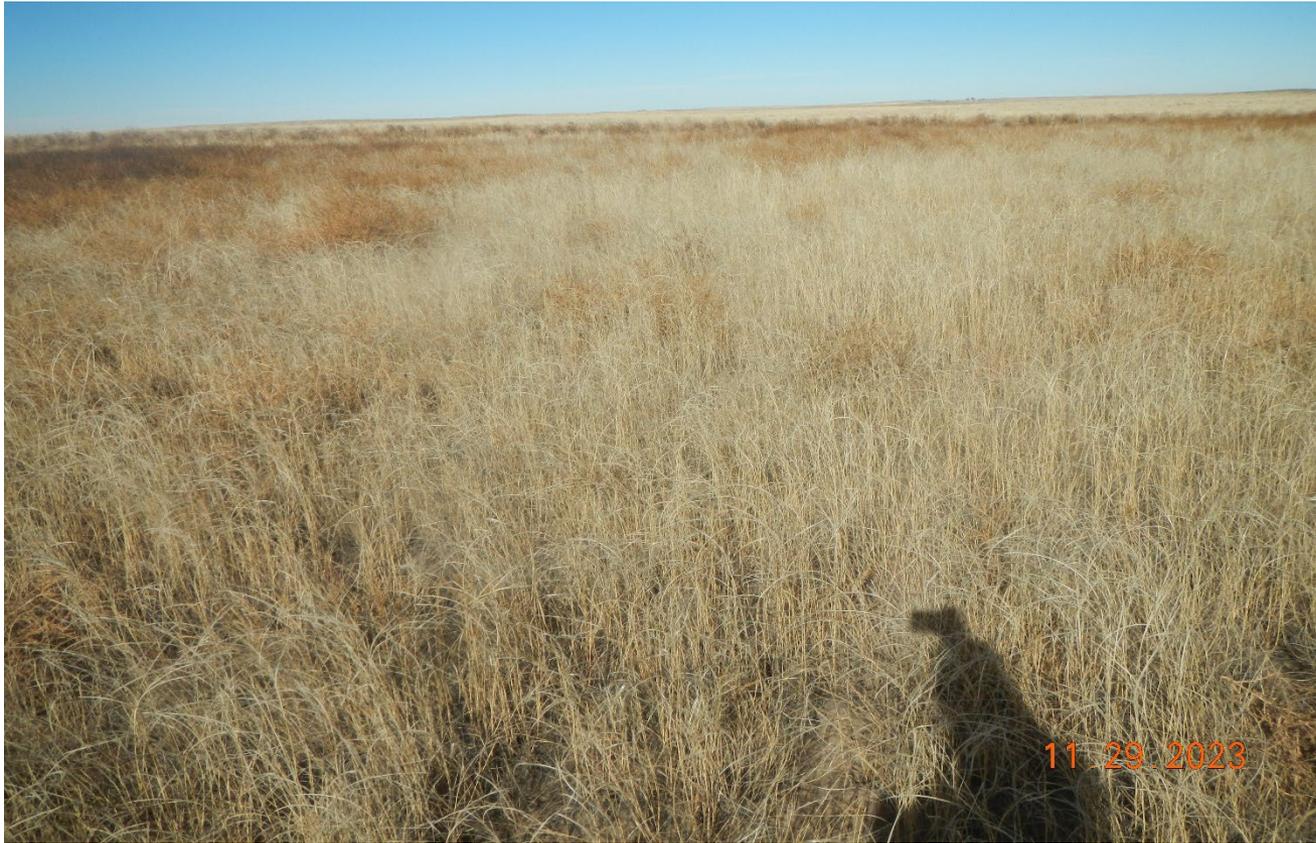
**Photo 6.** Center of the location facing north. The lighter color vegetation is desirable grasses of Sand drop seed, Blue grama among other species.

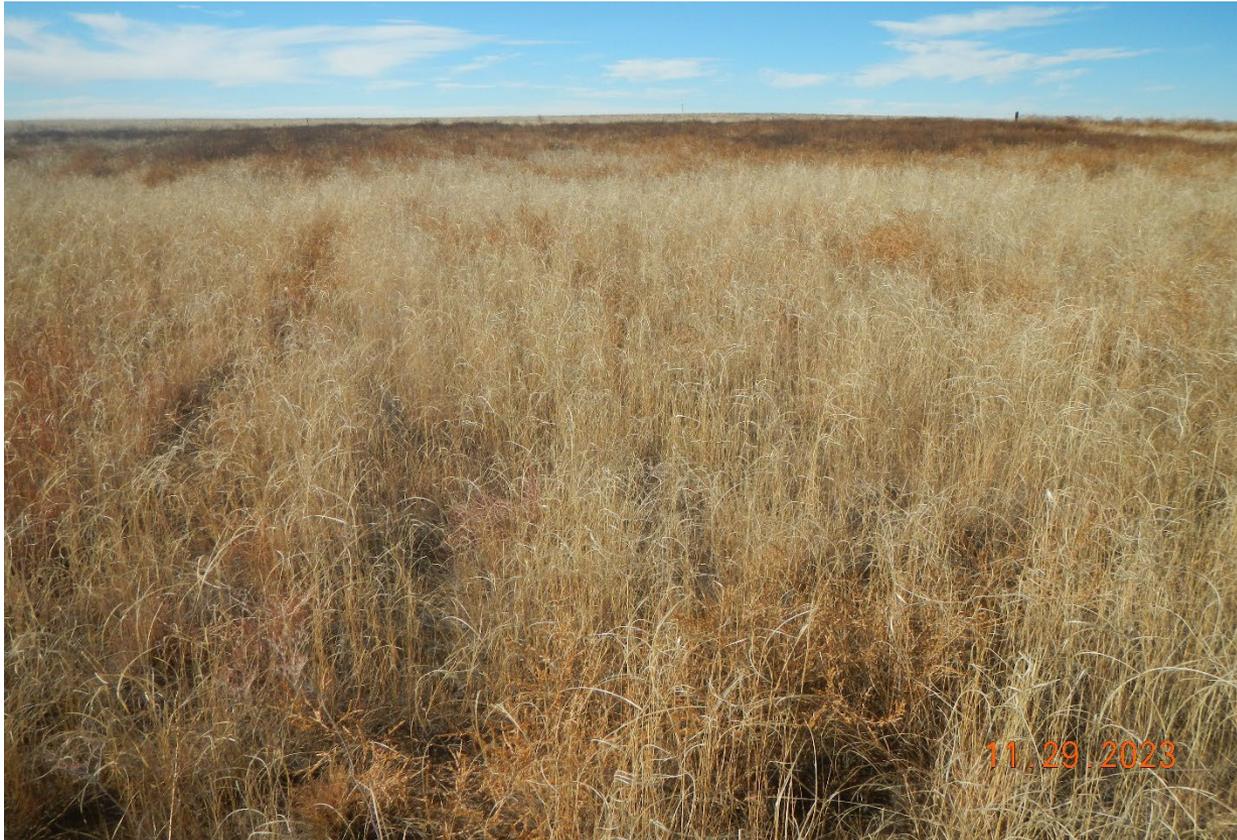
**Photo 7.** Center of the location facing west. The light colored vegetation is desirable grass but the darker vegetation further out is undesirable weeds.

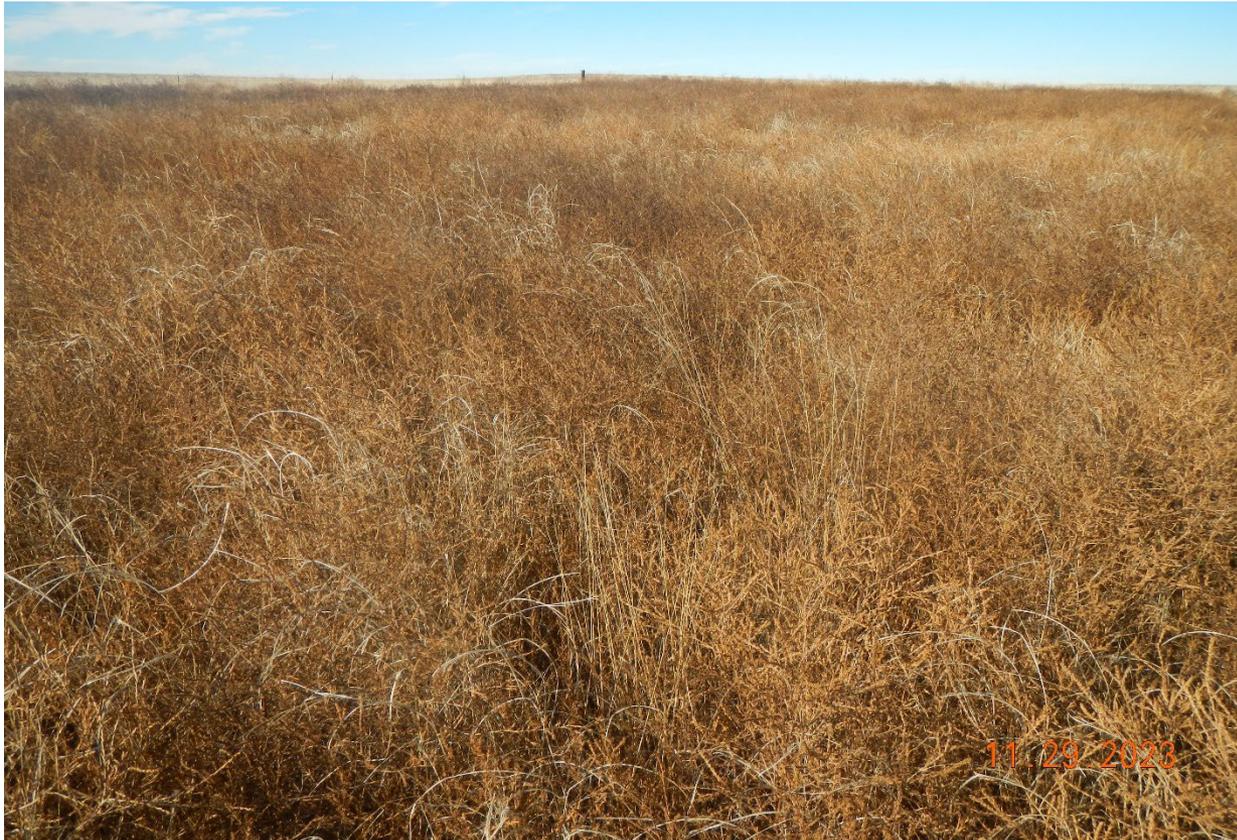
**Photo 8.** Facing toward the northwest portion of the location. The brown vegetation is undesirable weeds of Russian thistle.

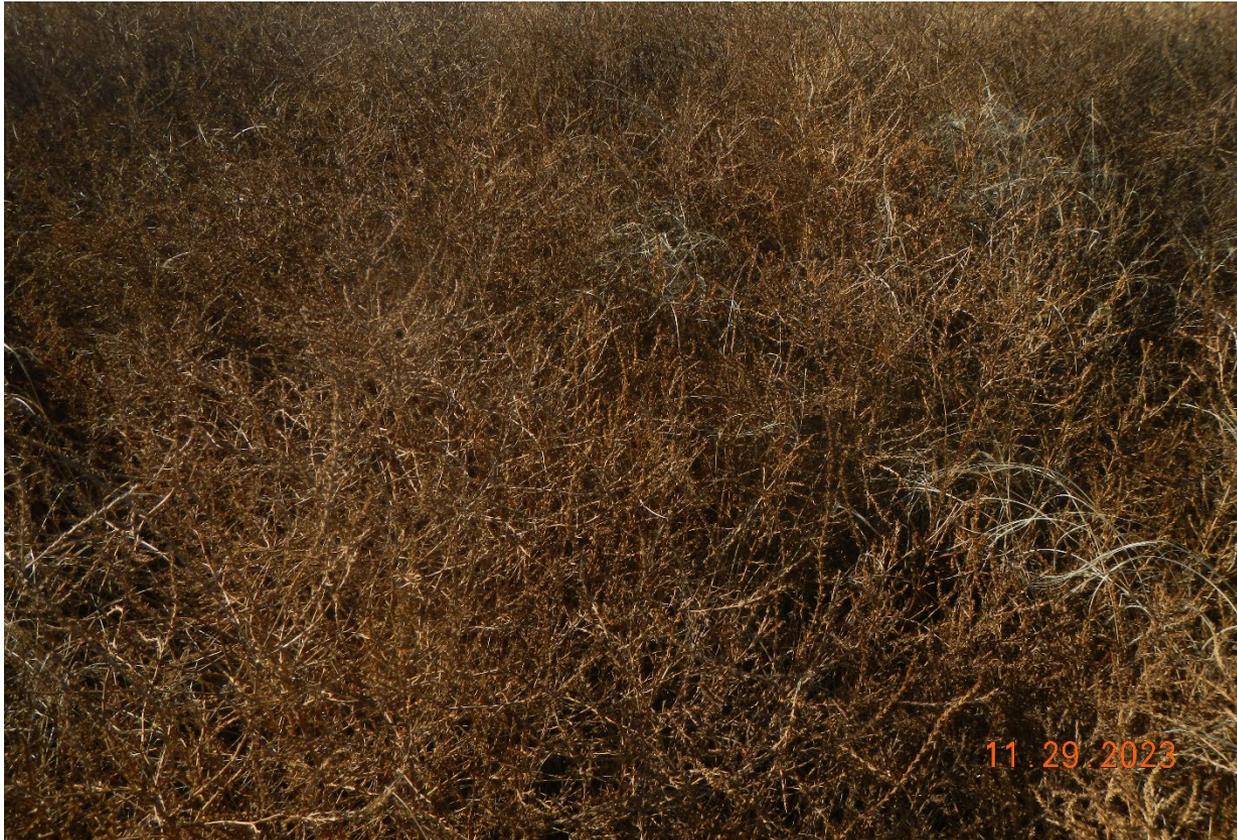
**Photo 9.** View of ground cover at areas of the location consisting of undesirable weeds of mostly Russian thistle.

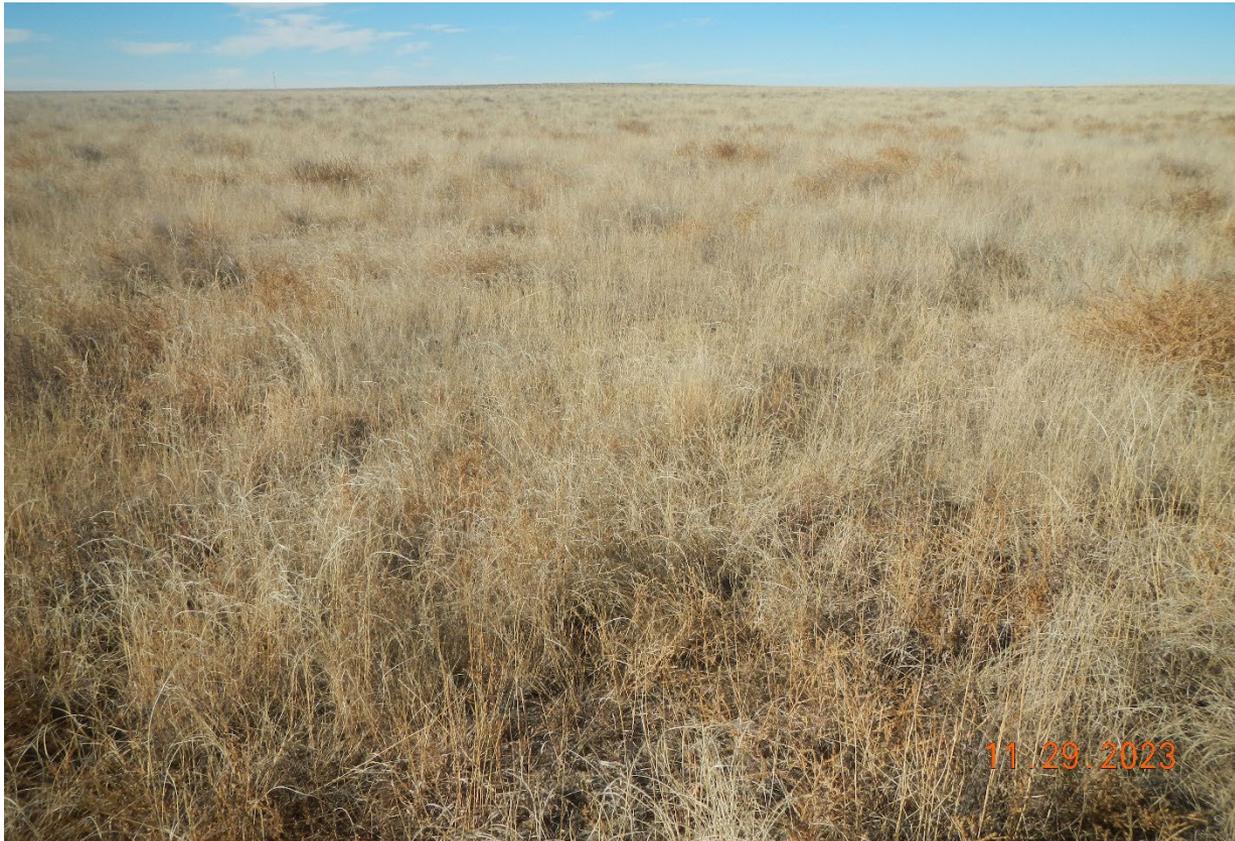
**Photo 10.** Facing west toward the surrounding undisturbed reference area which consists of native Blue grama, Sand dropseed, vegetation.
