Interim Reclamation and Stormwater Inspection

Date: 11/28/23

Operator: PDC Energy Inc. - 69175

Inspection Photos
 Location Name: Sanford 21-29 Pad
 Location ID: 329853

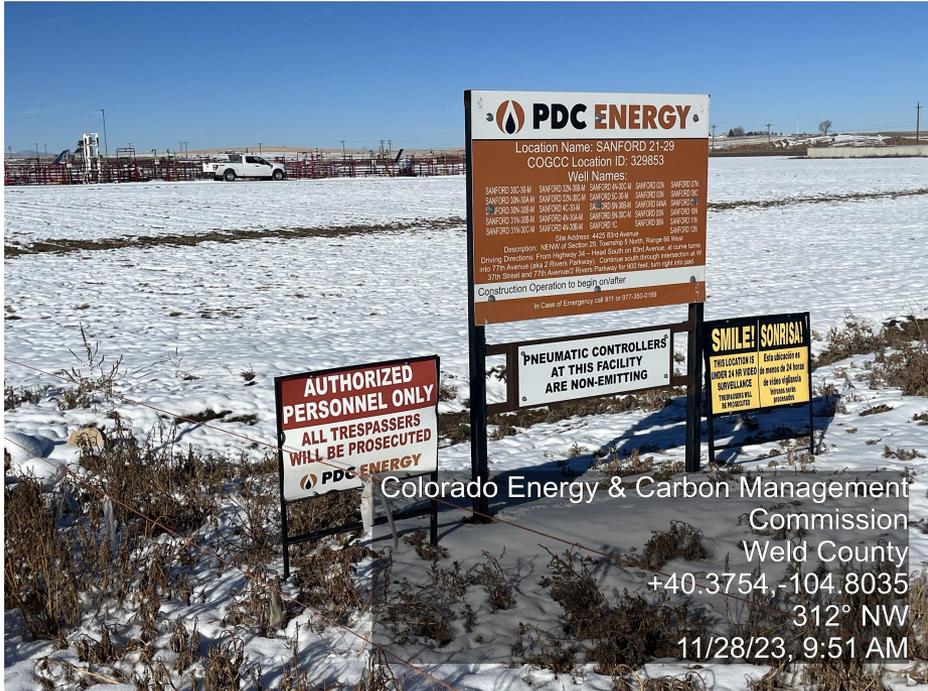
Photo 1. The photo was taken at the entrance to the location facing Northwest. The photo illustrates the operator signage.

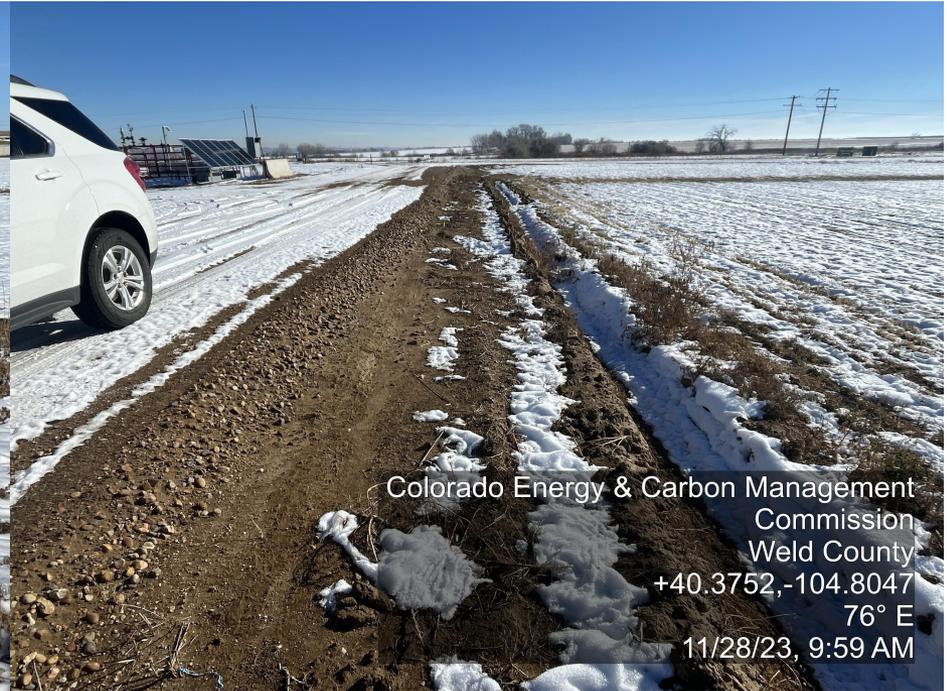
Photo 2. The photo was taken from the well location facing East. The photo illustrates the tertiary stormwater ditch surrounding the well location.

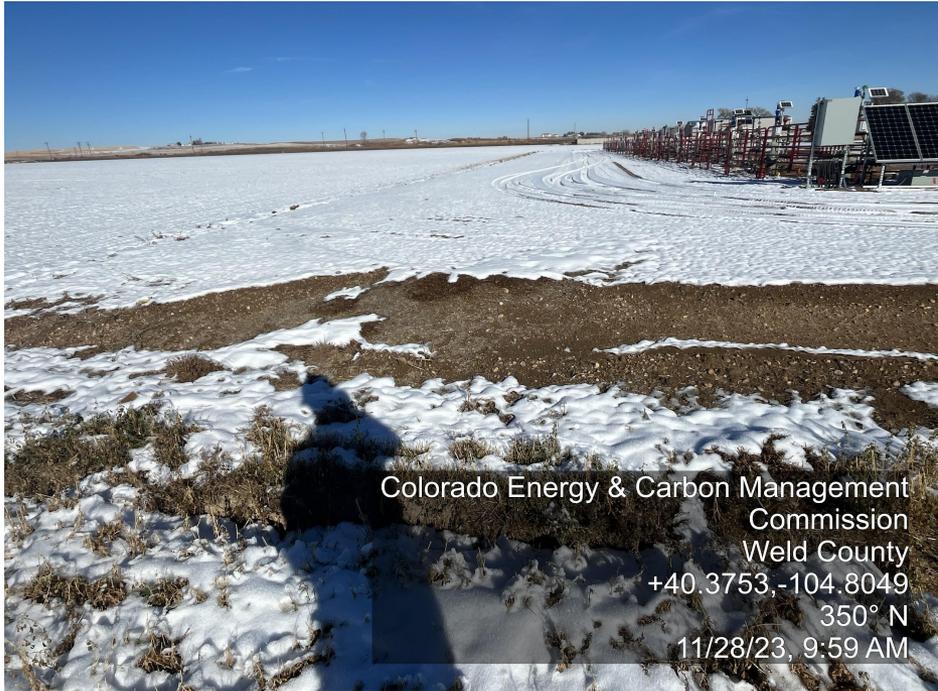
Photo 3. The photo was taken from the well location facing North. The photo illustrates the western string of producing wells.

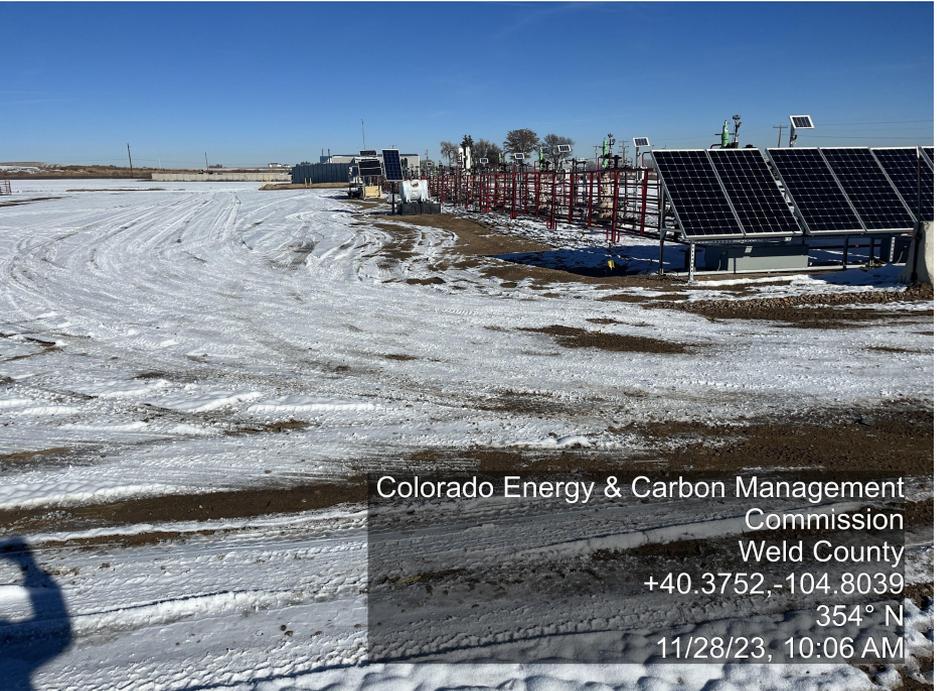
Photo 4. The photo was taken from the well location facing North. The photo illustrates the eastern string of producing wells.

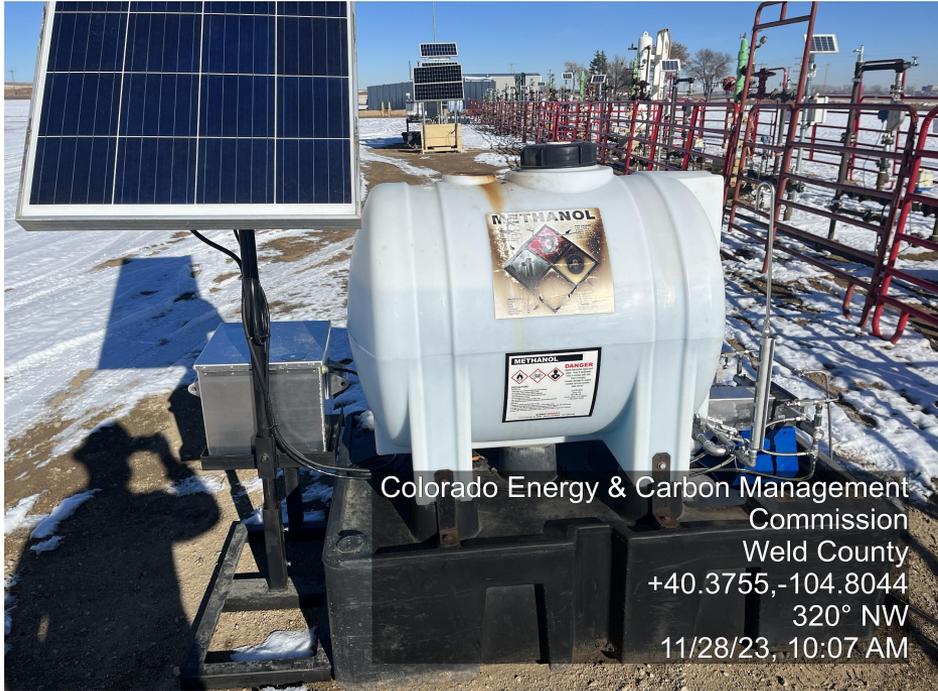
Photo 5. The photo was taken from the well location facing Northwest. The photo illustrates the tank signage needs replacing.

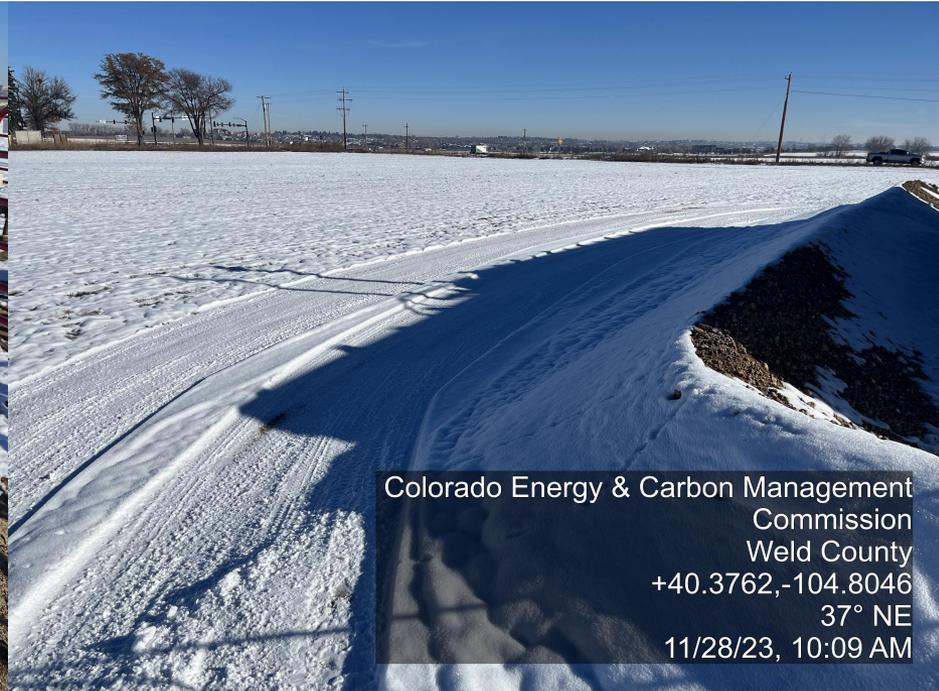
Photo 6. The photo was taken from the North end of the location facing Northeast. The photo illustrates a path being driven

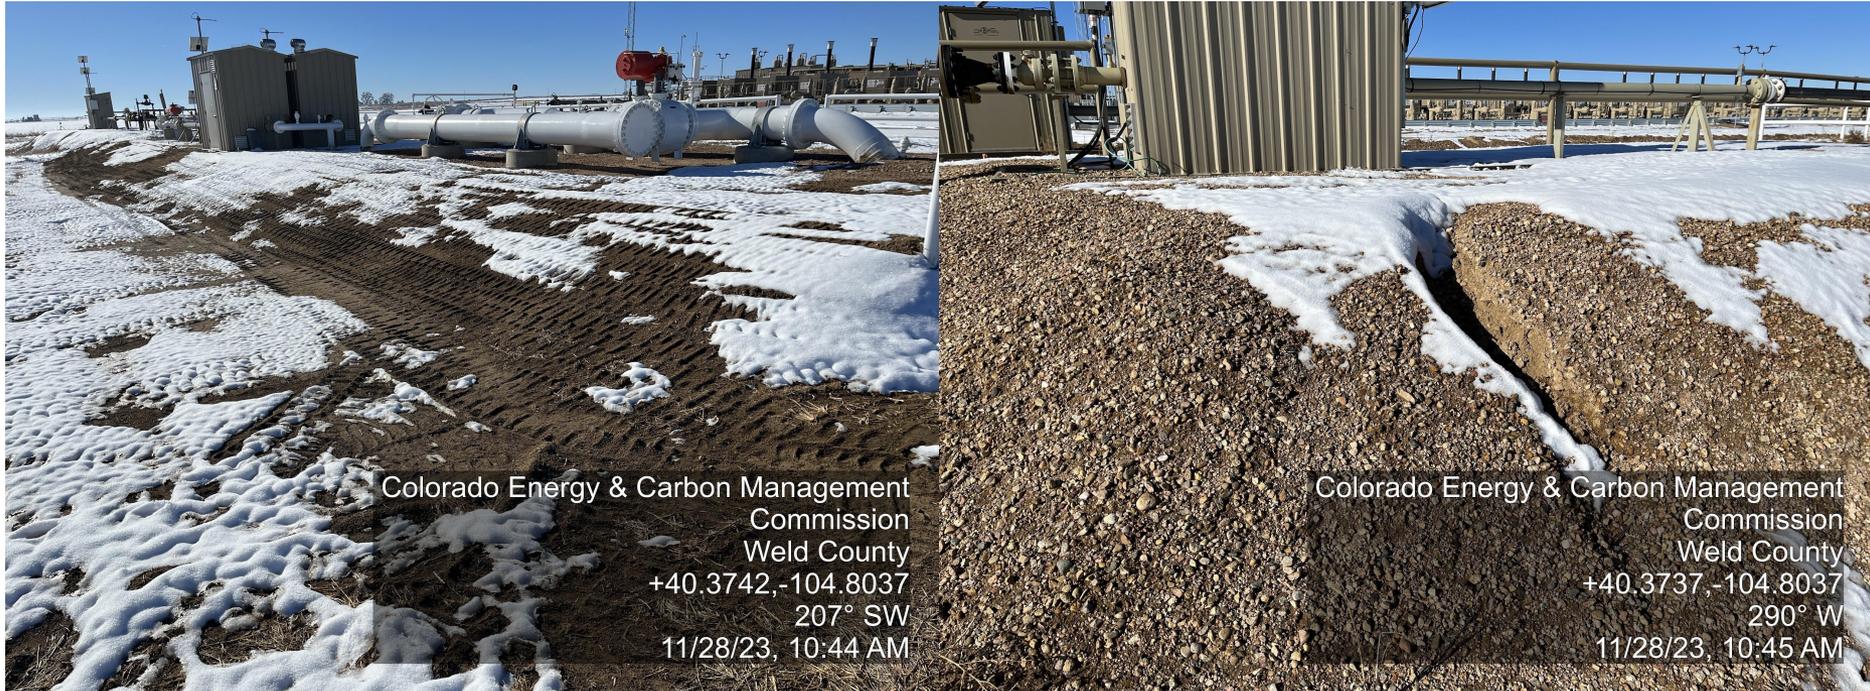
Photo 7. The photo was taken from the production facility facing Southwest. The photo illustrates improperly tracked slope.

Photo 8. The photo was taken from the production facility facing West. The photo illustrates runoff has creating erosion issues on the production pad.

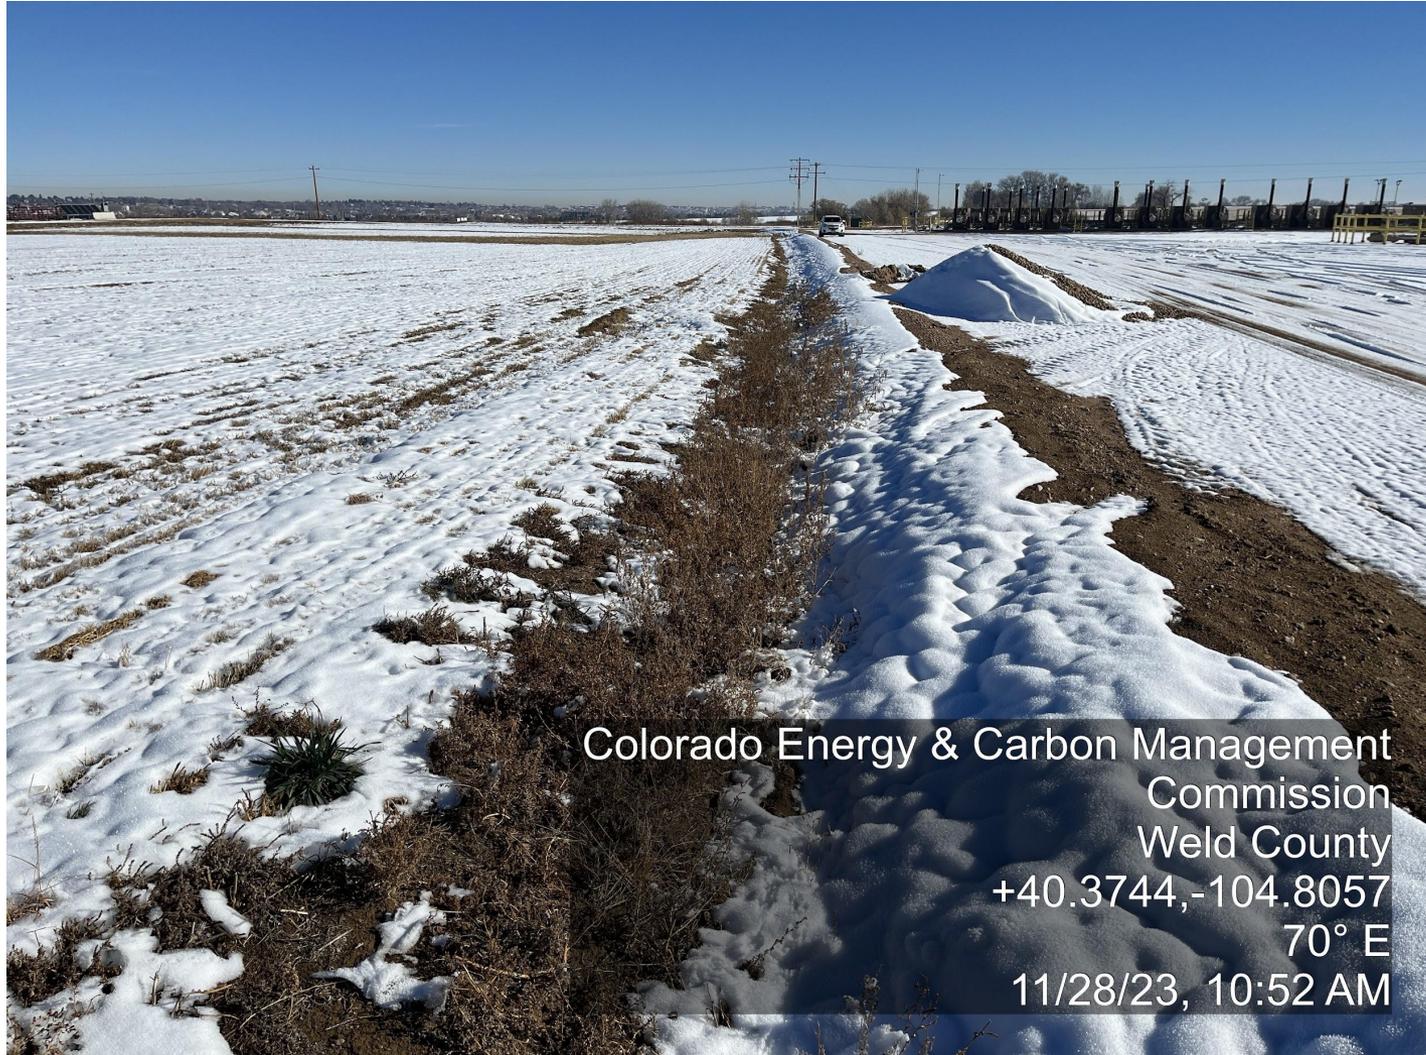
Photo 9. The photo was taken from the production facility facing East. The photo illustrates tumbleweeds growing in the ditch.
