Inspection Photos

Operator: TEP ROCKY MOUNTAIN LLC #96850
/ NONSUCH NATURAL GAS INC #10163

Location ID: 322524 (TEP), 453726 (Nonsuch)

Inspection Doc: 696205436

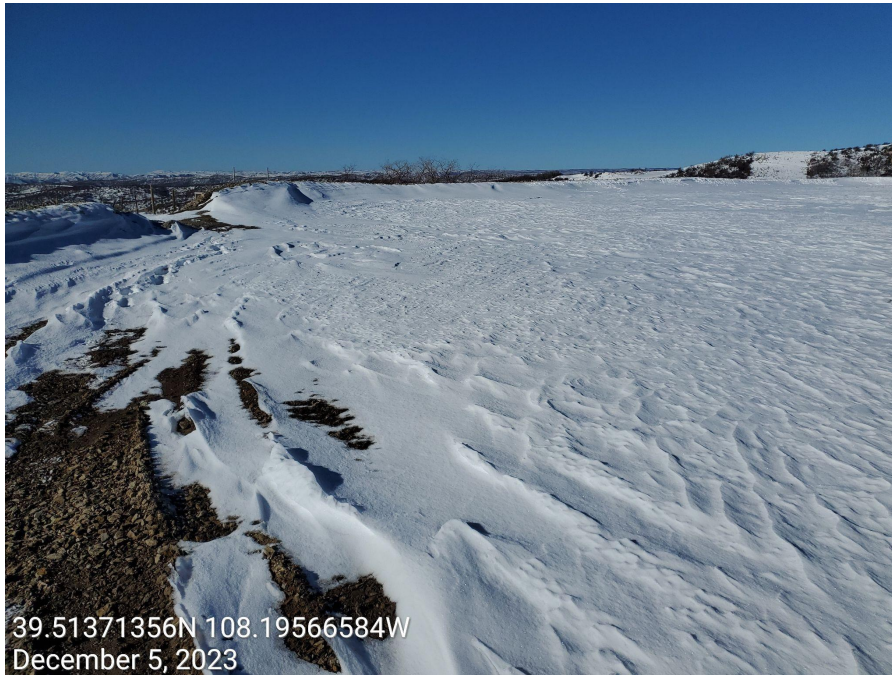
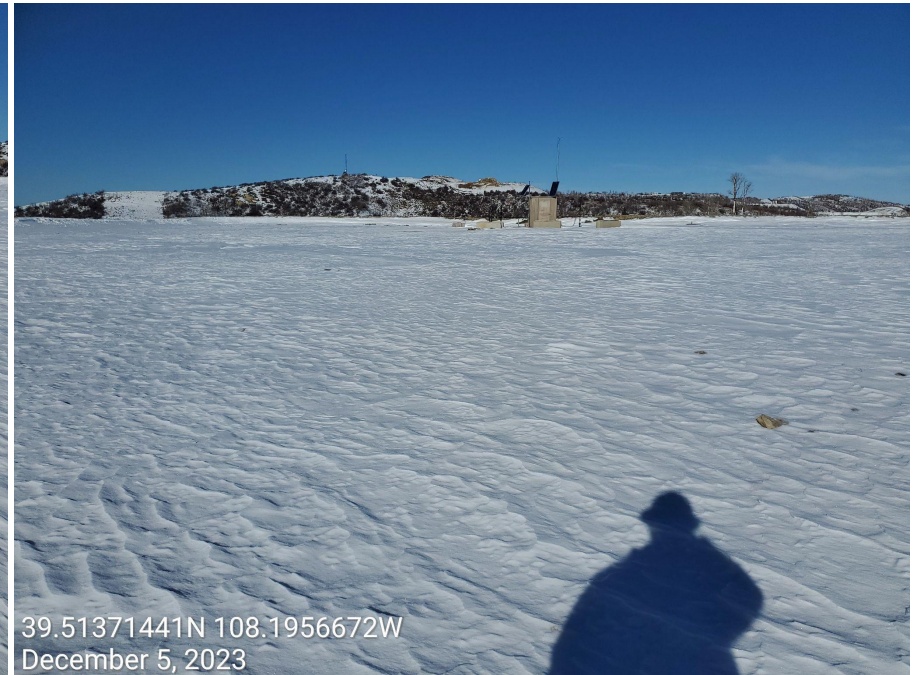
Photo 1: Photos 1-2 taken from the east end of the Location. Photos provide an overview from south, southwest, northwest to north.

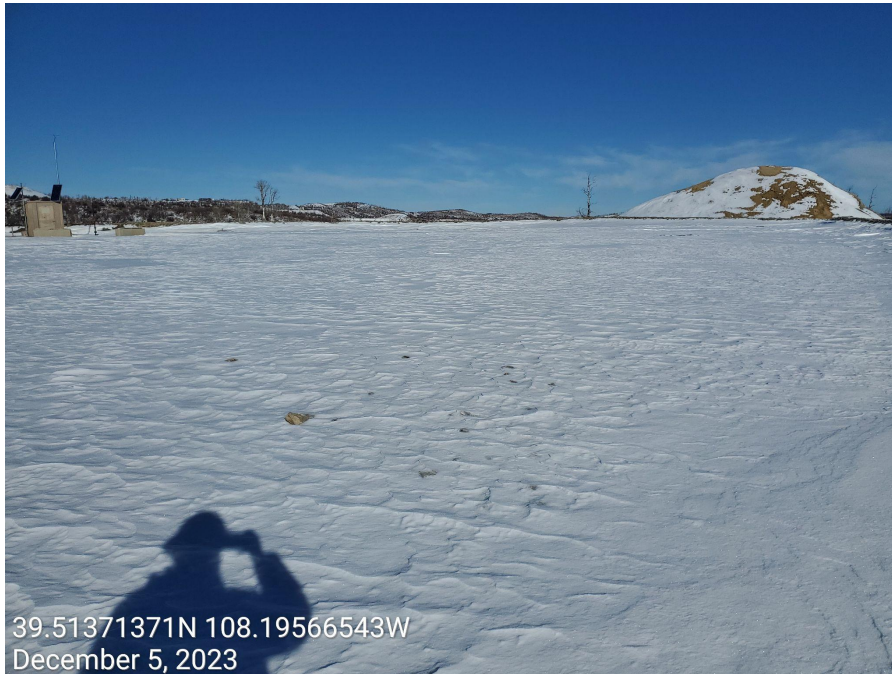
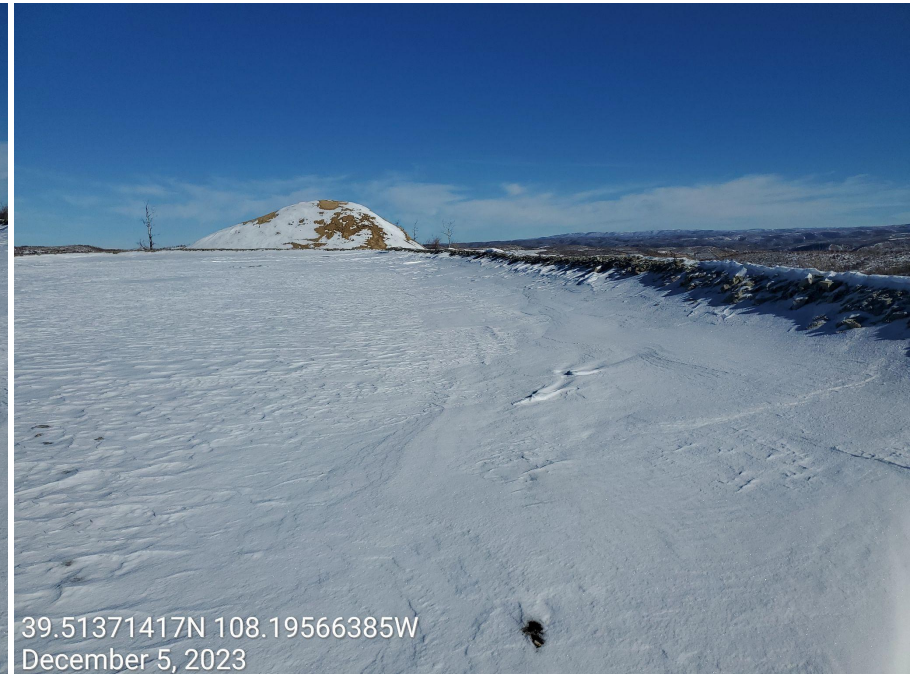
Photo 2: See comments under photo 1.

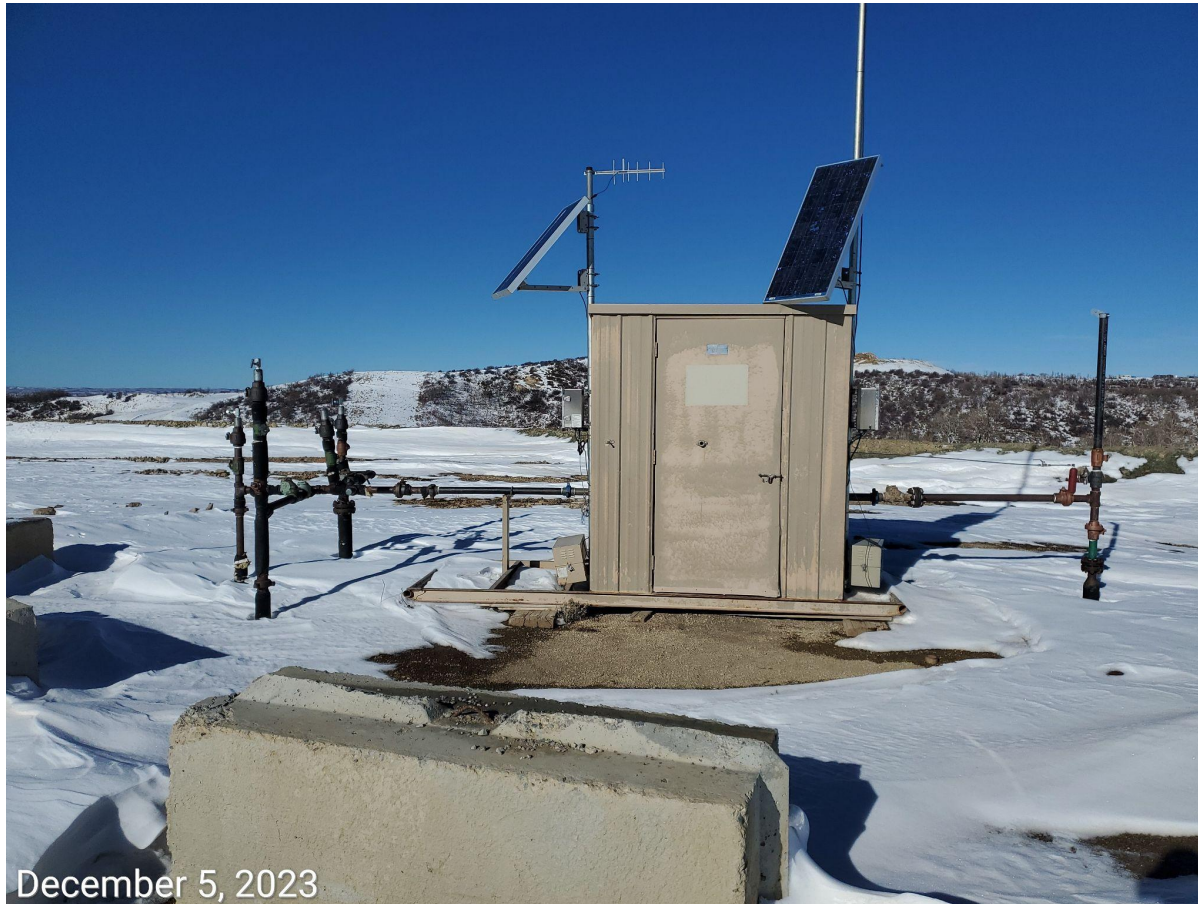
Photo 3: Equipment from Nonsuch's Tank Battery facility remains on the Location.

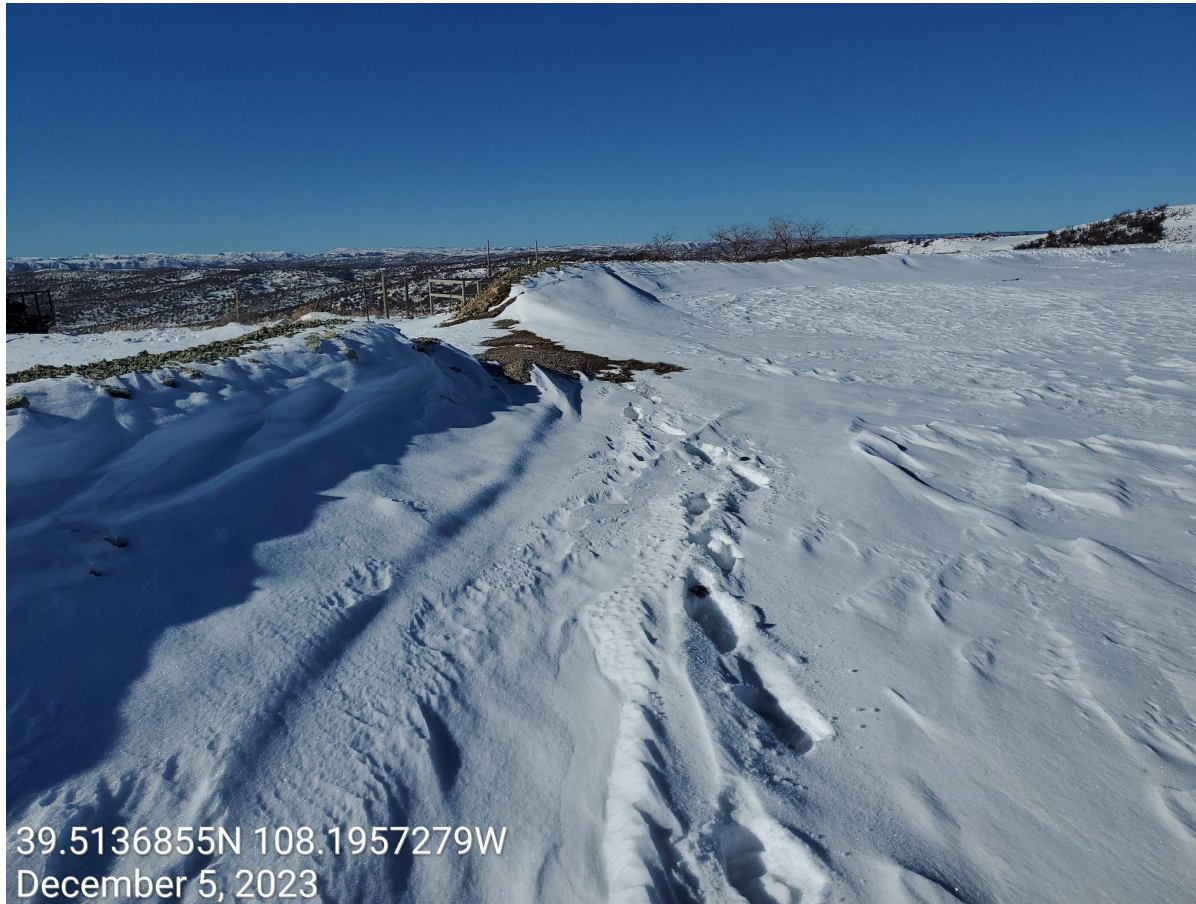
Photo 4: Additional contour work appears to have been conducted at the Location entrance.

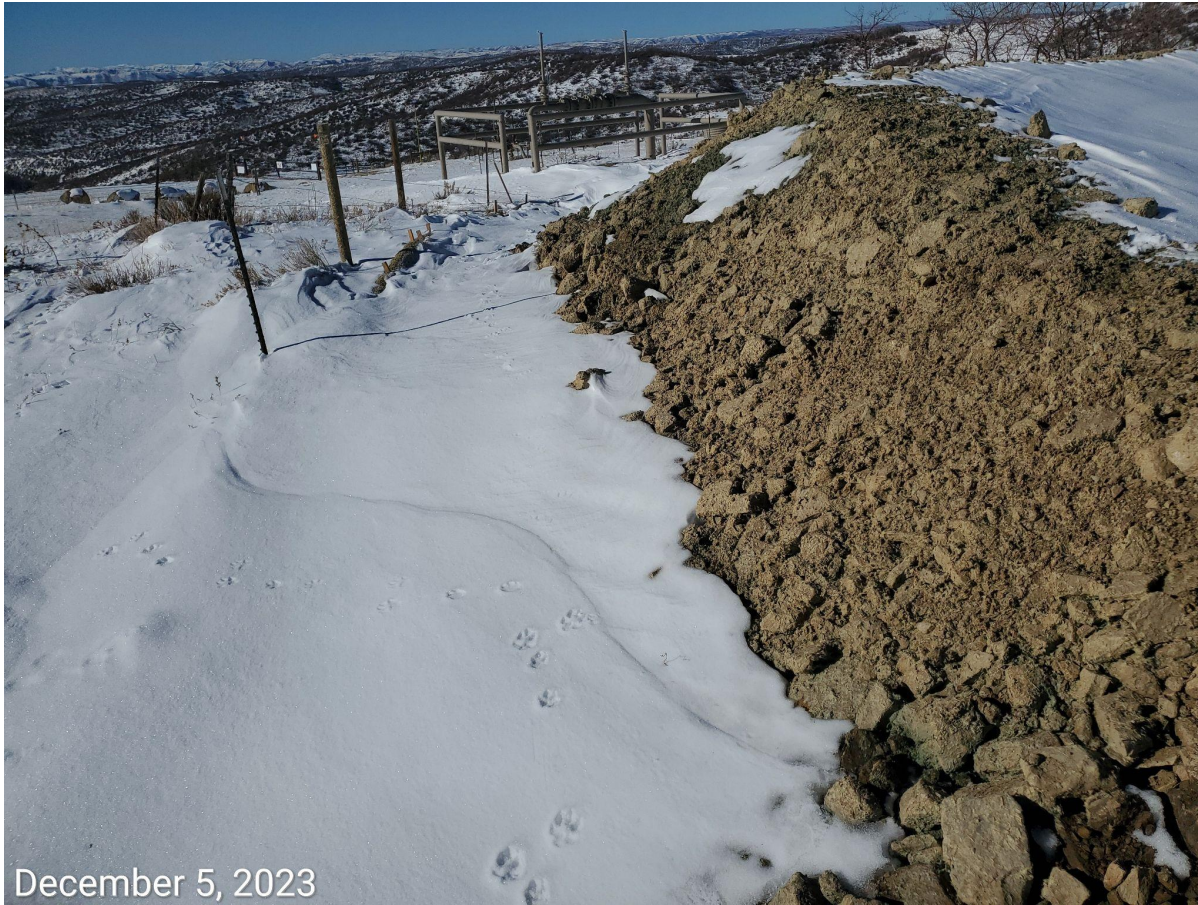
Photo 5: Hydromulch applied to slopes.

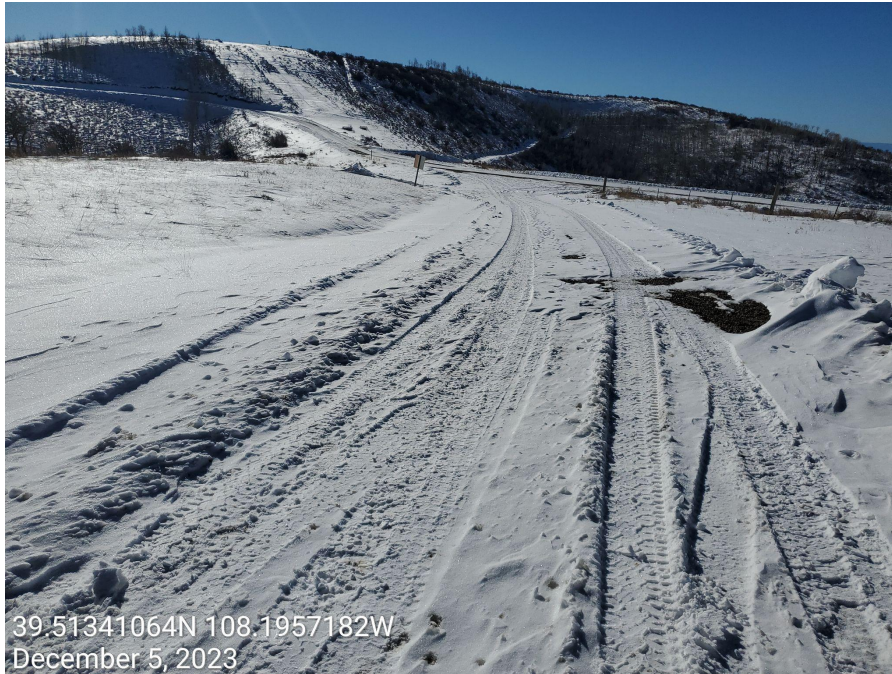
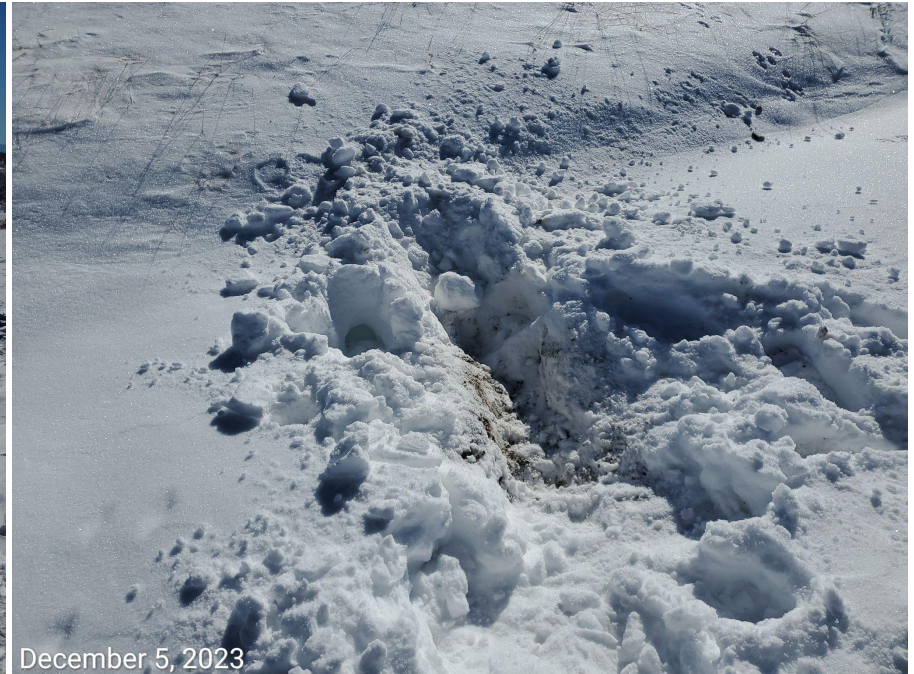
Photo 6: Photos taken from along the access road. Photo right example showing erosion degradation (rill/gully erosion) along the access road documented in prior inspections remains apparent and have not been addressed.
