Inspection Photos

Location Name: CAERUS PICEANCE LLC, NPR/K10-596

Location ID: 335676

Date: 12/4/2023

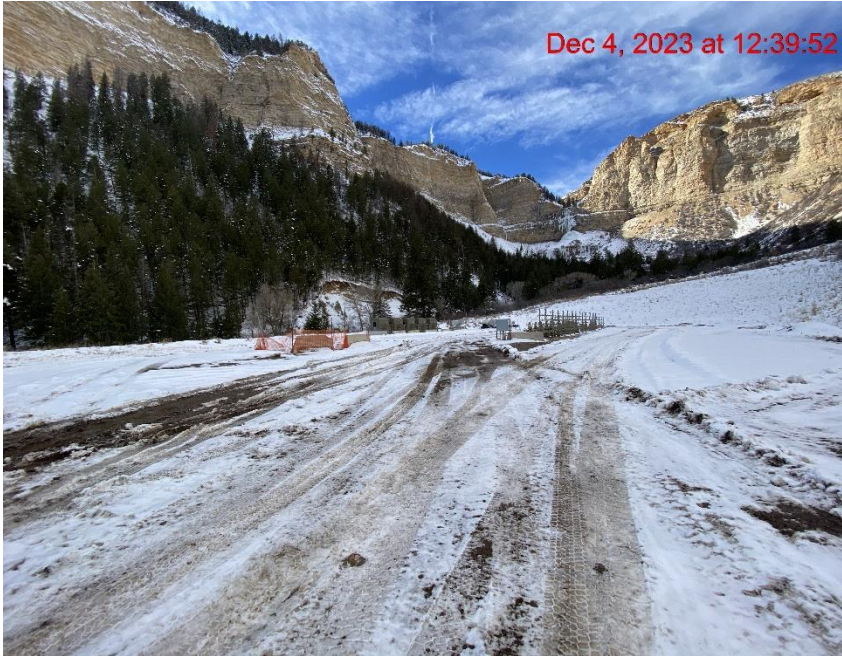
Location Entrance – Photo #07824

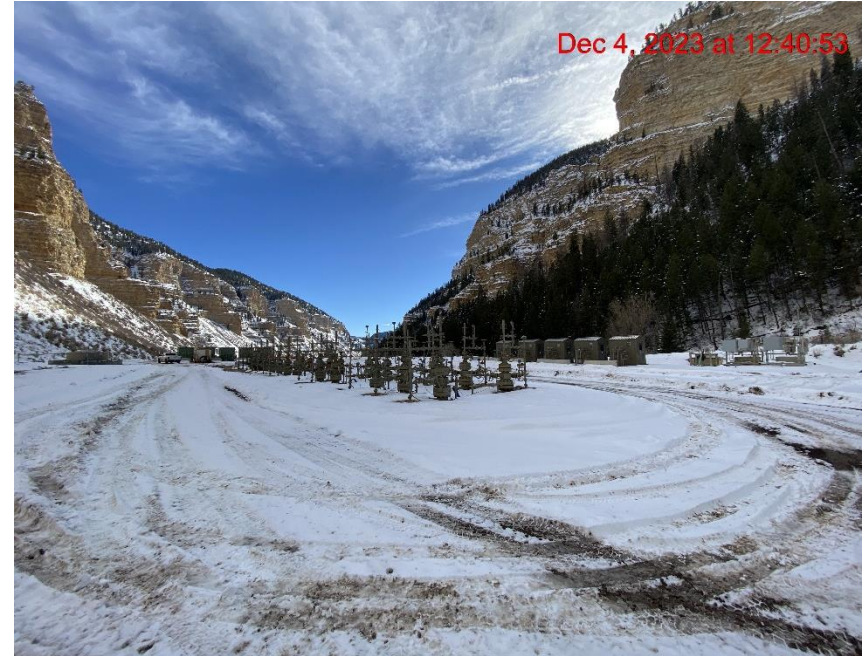
West End of Location – Photo #07825

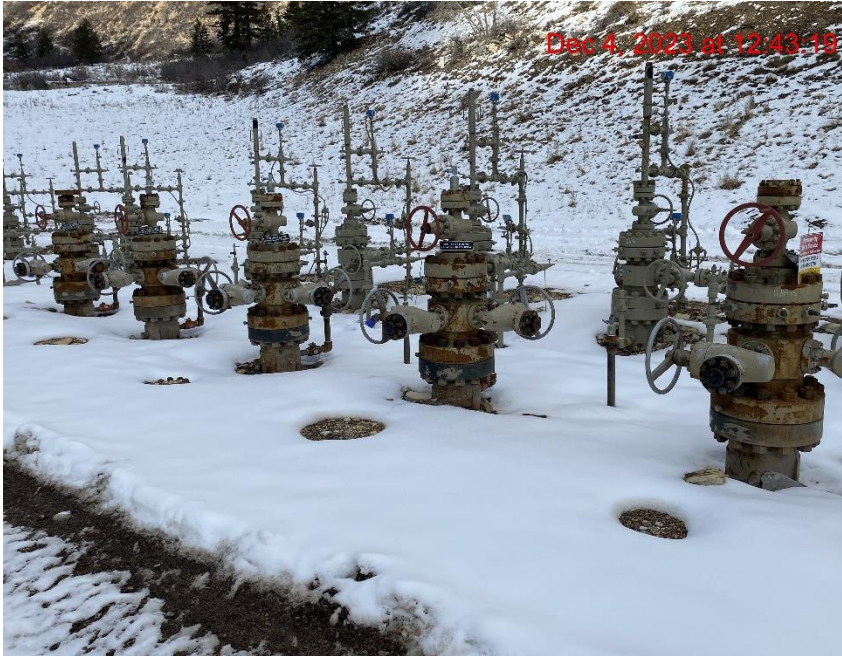
Wellheads – Photo #07828

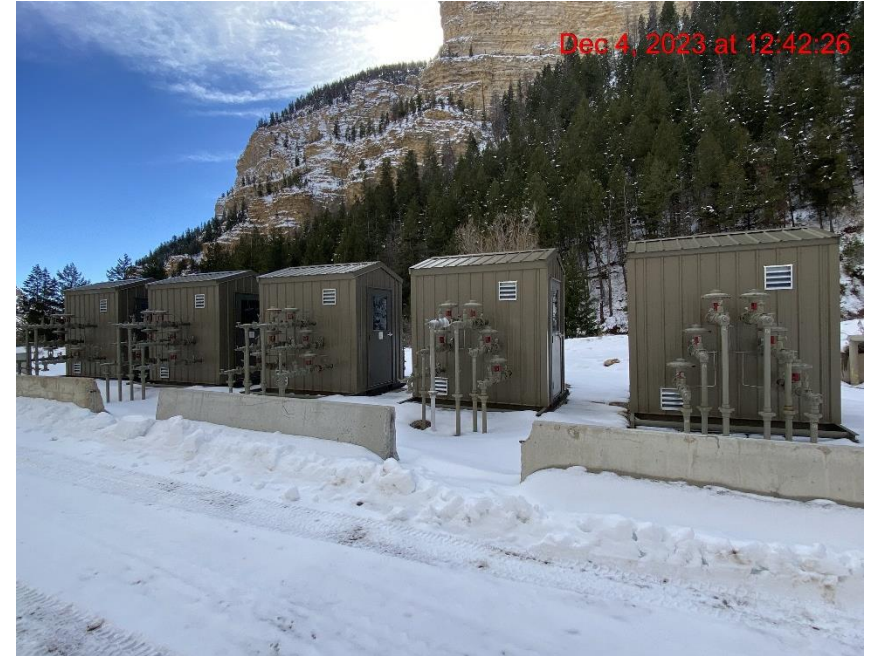
Gas Meters – Photo #07827

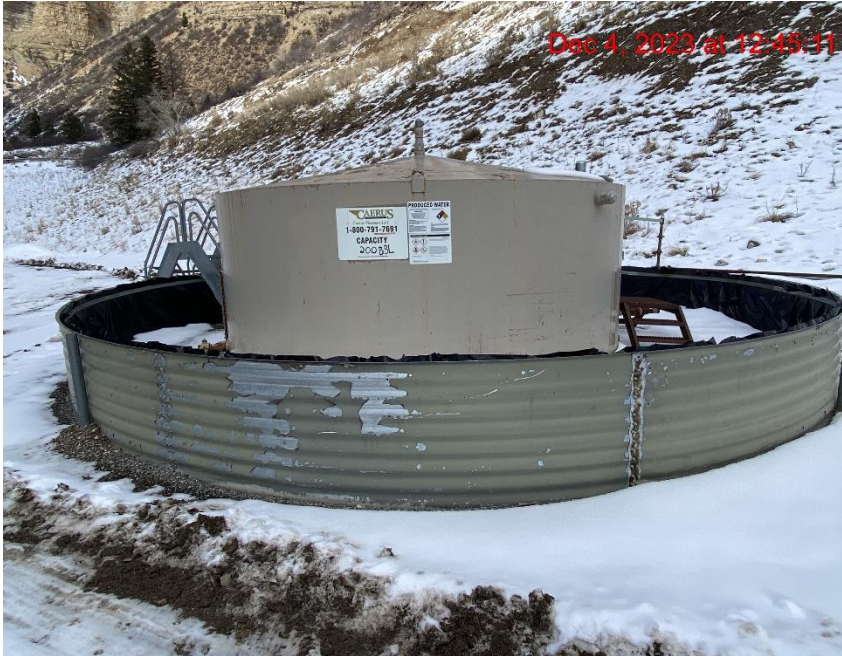
Tank Battery – Photo #07831

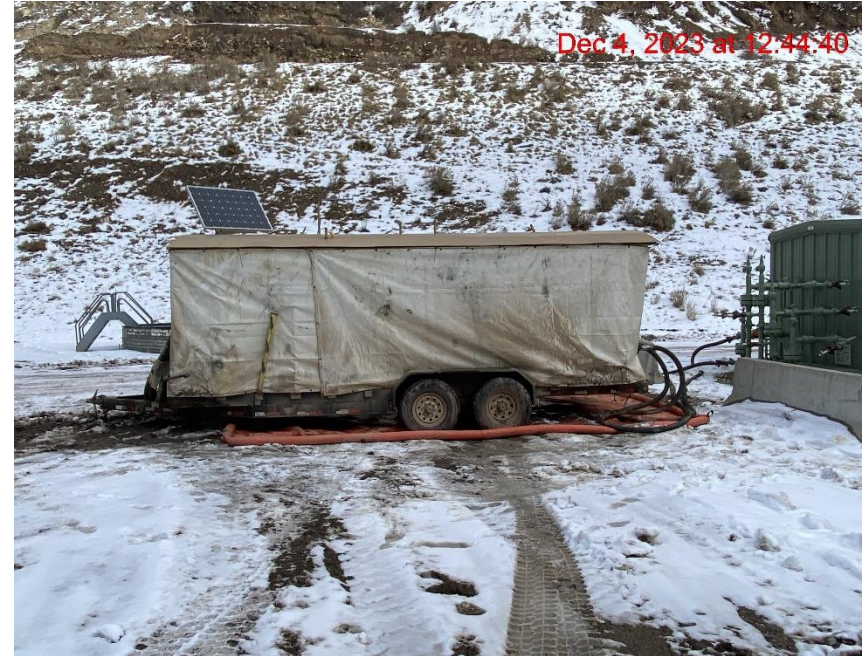
Mobile Separator – Photo #07830

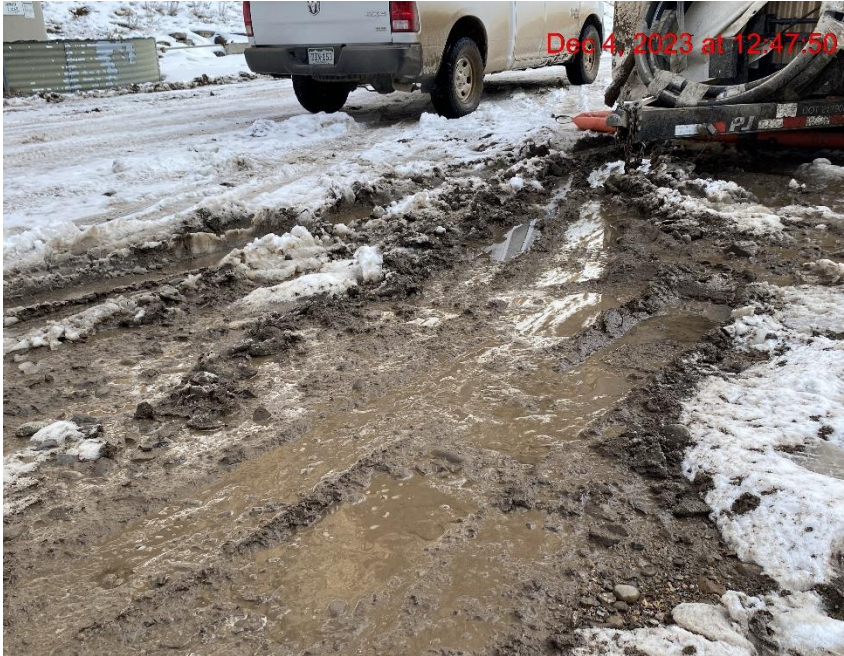
Lack of Stabilization – Photo #07834

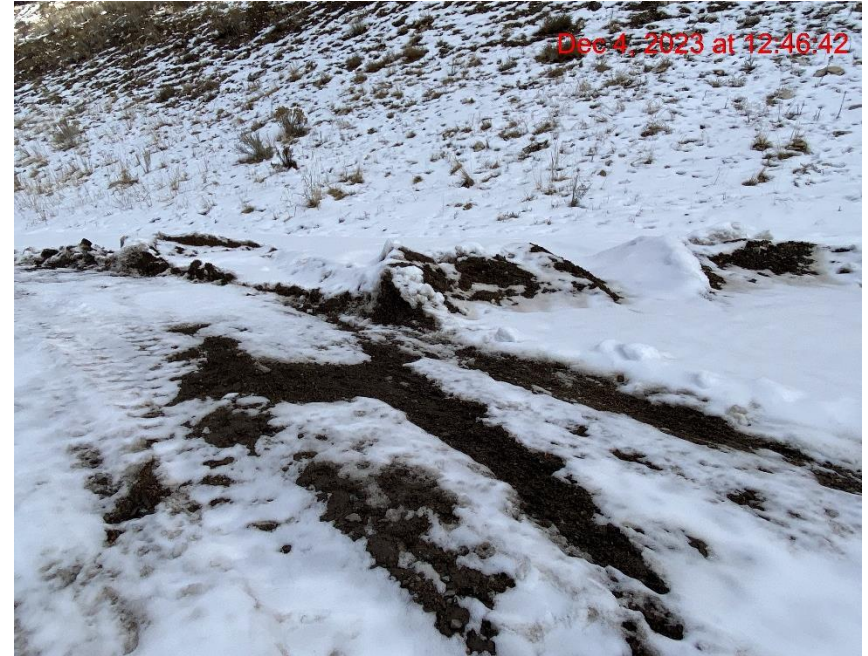
Lack of Stabilization/Sediment Transport of Sediment – Photo #07833

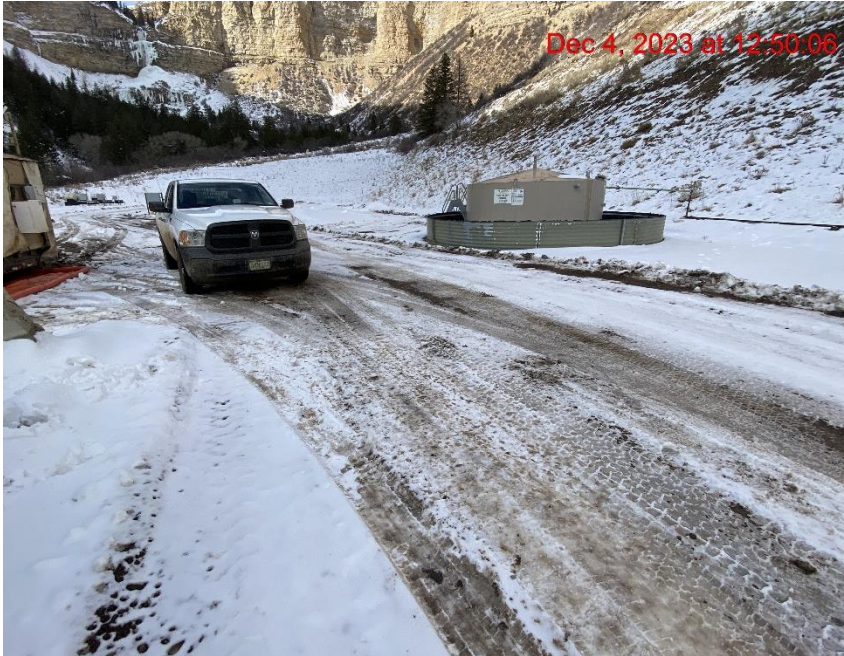
Insufficient Vehicle Tracking BMPs at Location Entrance/Exit
– Photo #07835
