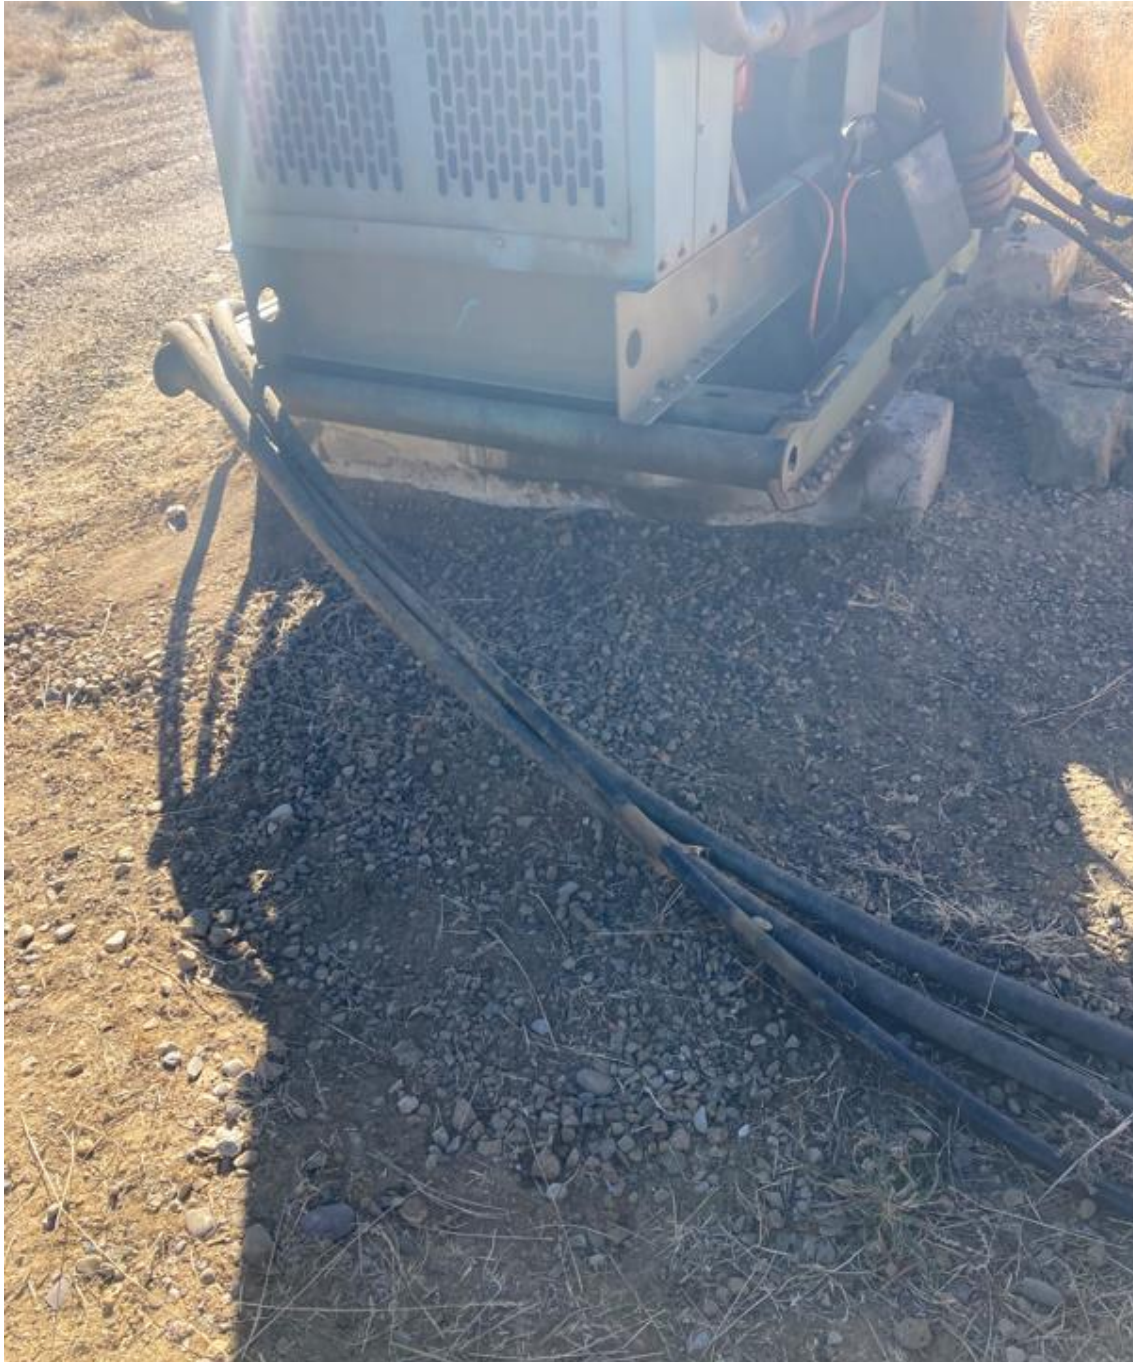
PHOTO 1: THE OILY FLUIDS HAVE BEEN REMOVED FROM THE ENGINE SKID AND MAINTENANCE HAS BEEN CONDUCTED ON ALL EQUIPMENT. THE IMPACTED SOIL HAS BEEN REMOVED AND REPLACED WITH FRESH GRAVEL MATERIAL. THE SELF INSPECTION PROCESS HAS BEEN REVIEWED.
