# Inspection Photos

Loc: 308613

Operator: OGRIS OPERATING LLC

Inspection Date: 12/5/2023

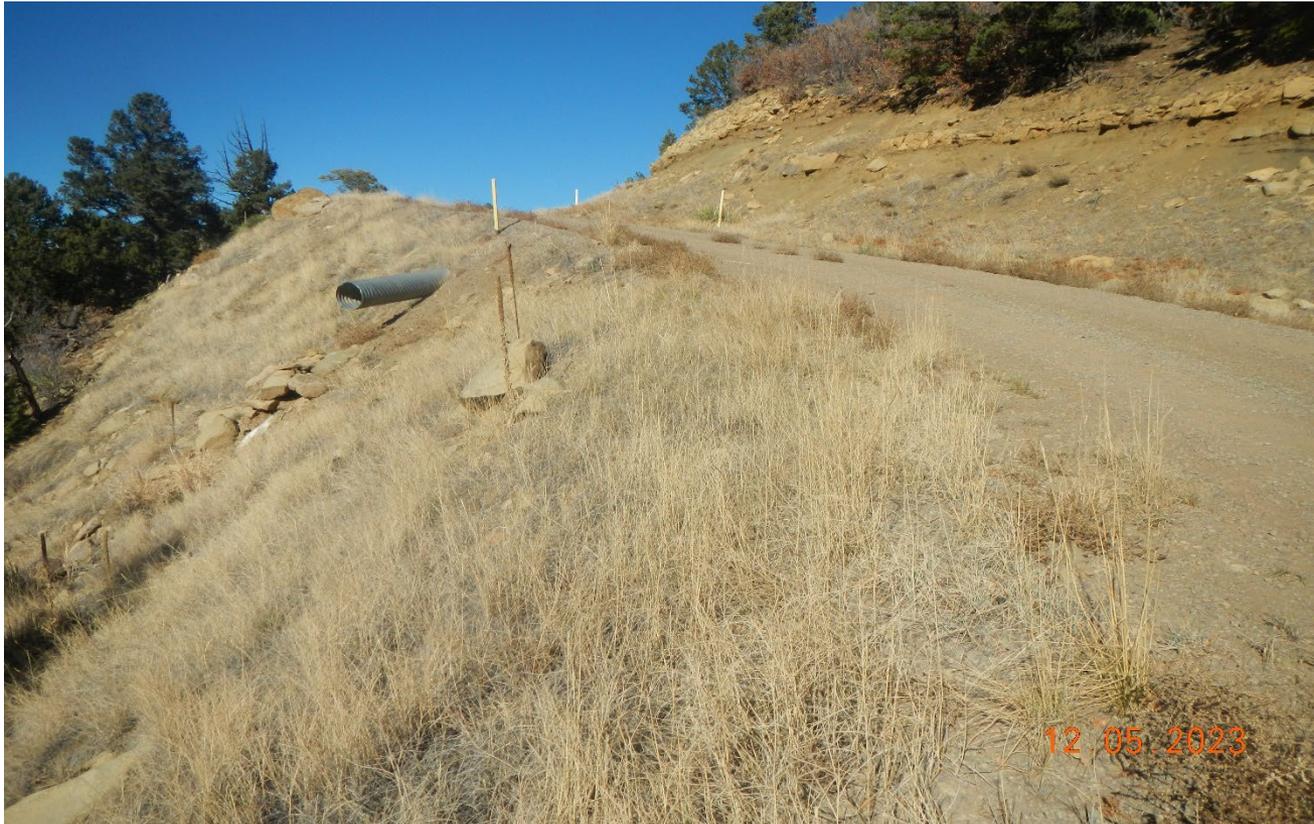
**Photo 1.** Facing northwest along the access road which is stabilized with vegetation and gravel. Culvert outlet protection is installed at the culvert outlet.

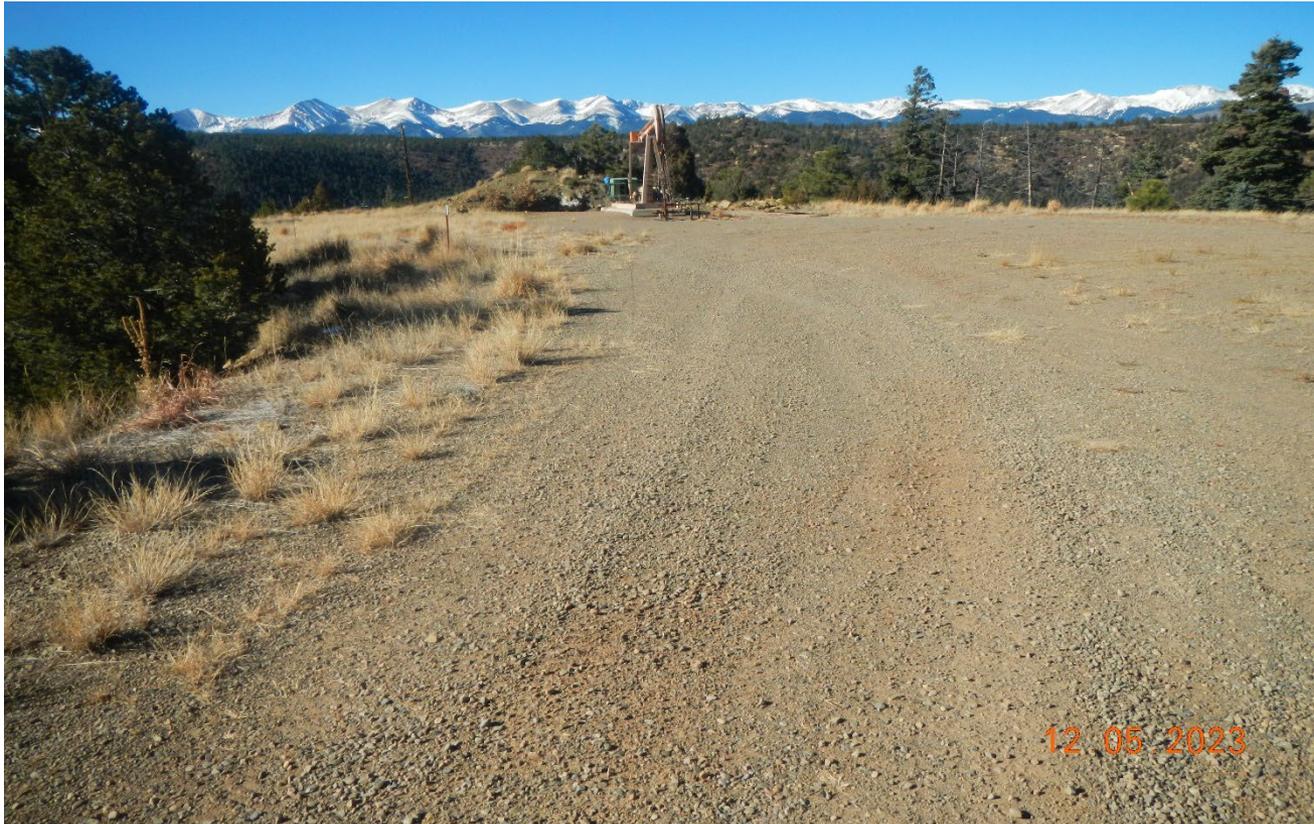
**Photo 2.** Facing west toward the wellsite.

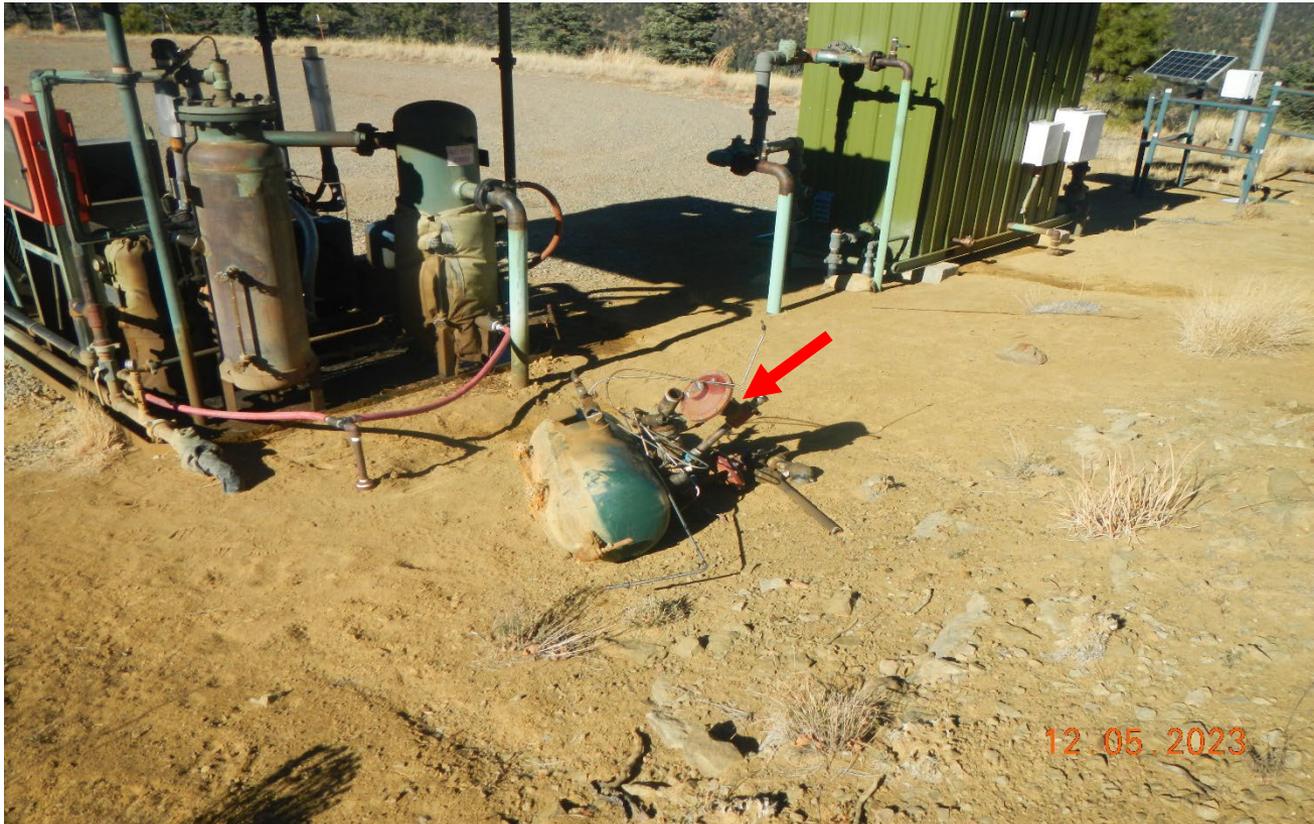
**Photo 3.** There are some parts laying on the back side of the engine that should be removed.

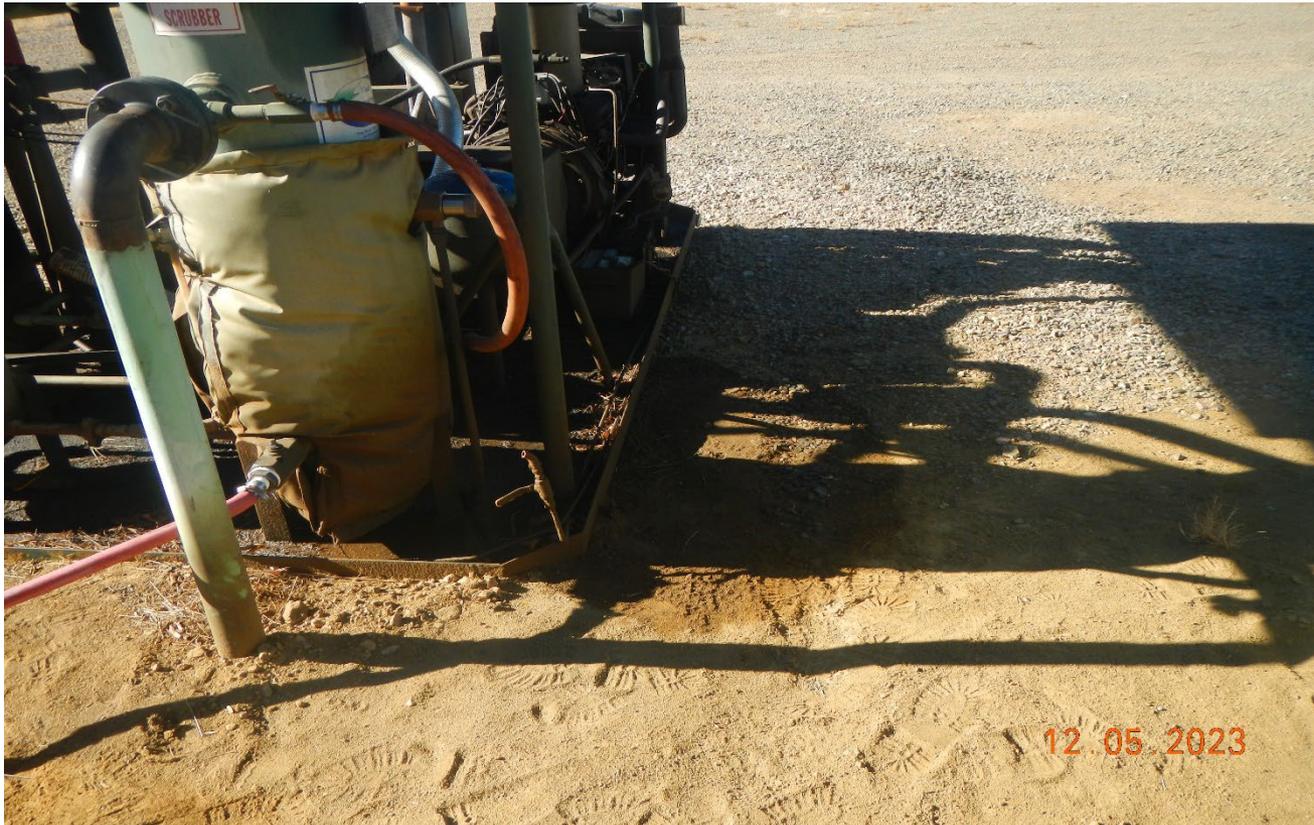
**Photo 4.** There is stained soil next to the engine skid that will need to be cleaned up.
