Interim Reclamation and Stormwater Inspection

Operator: NOBLE ENERGY INC - 100322

Location ID: 421834

Inspection Photos
Location Name: Igo Creek 09-13H
Location ID: 421834

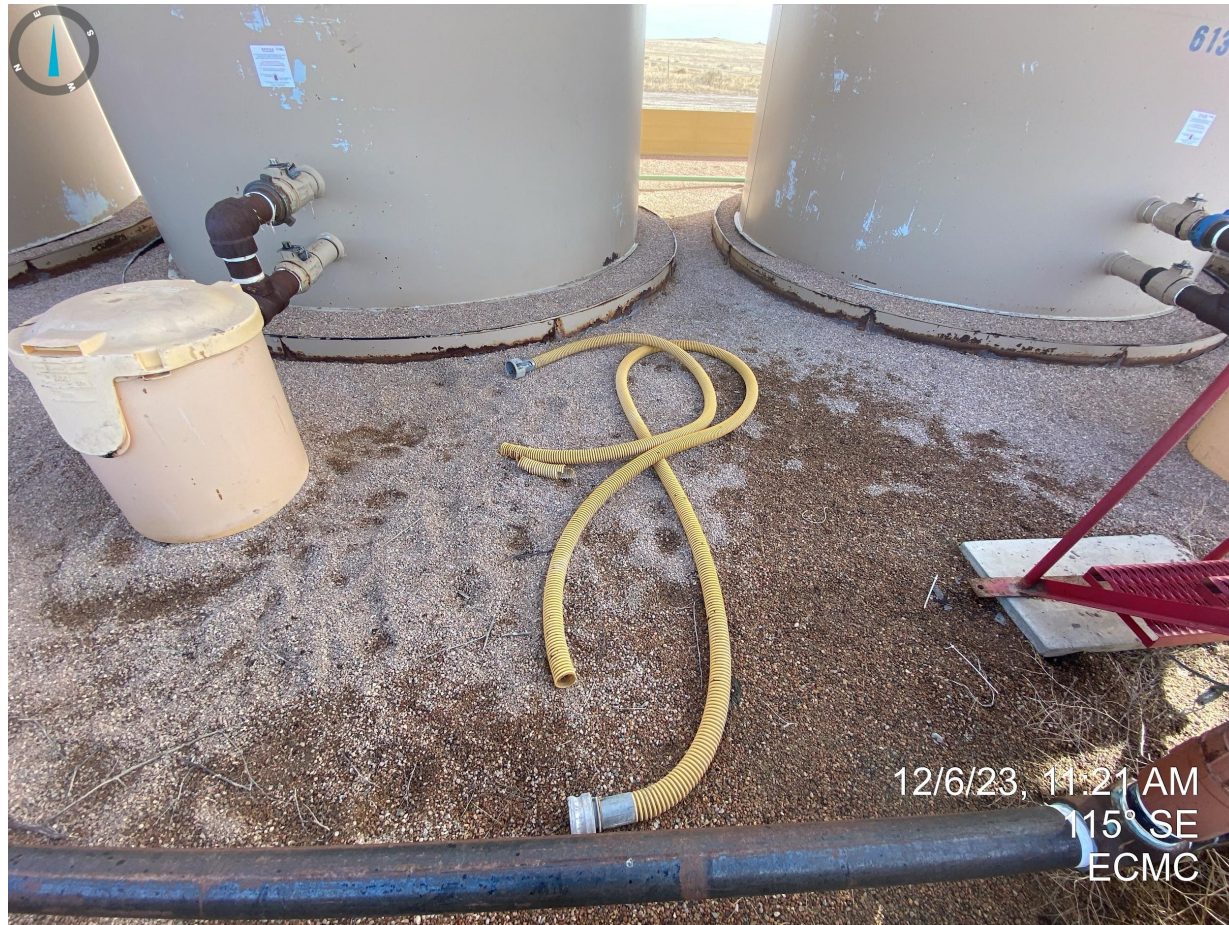
Photo 1. Broken load out line/hose observed within tank battery secondary containment.

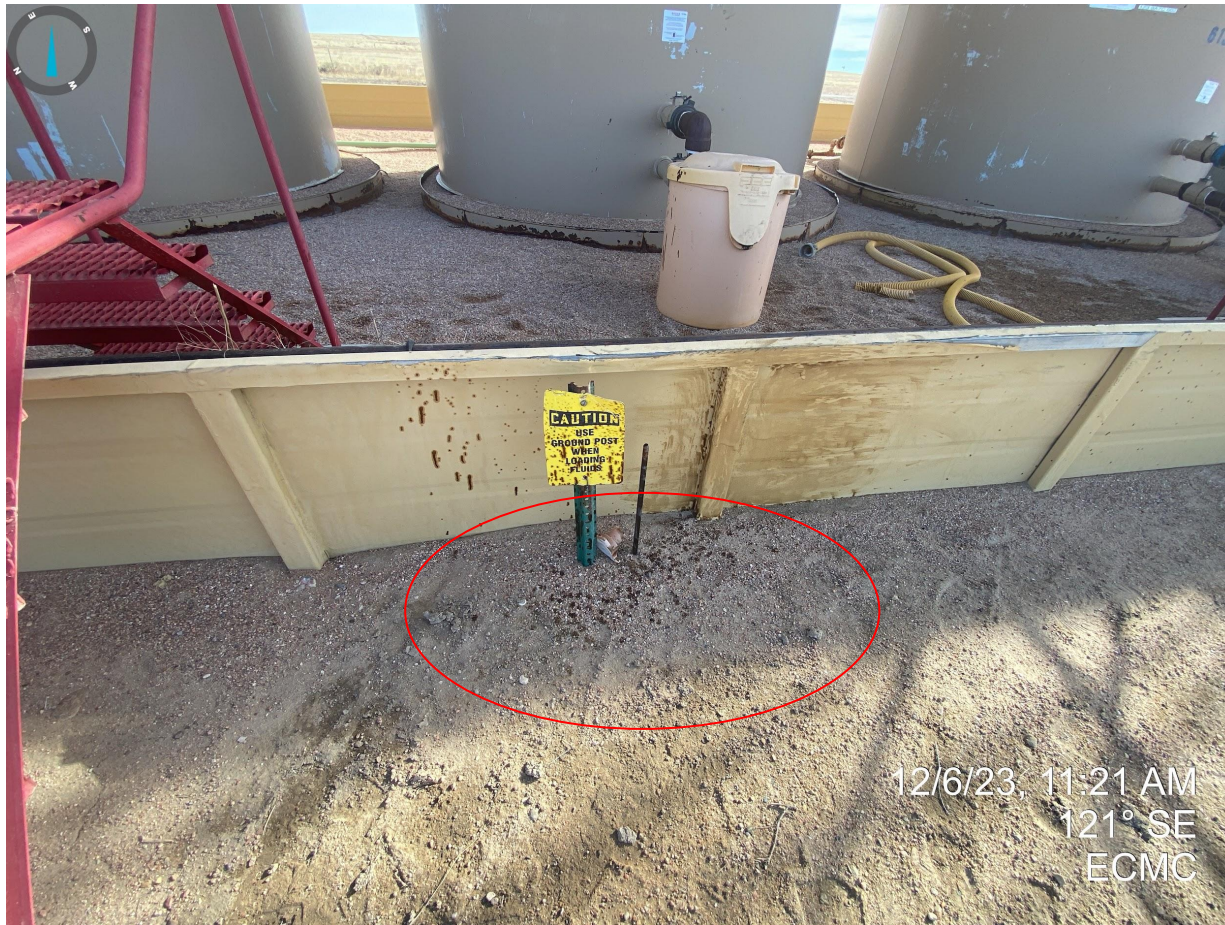
Photo 2. Stained soil observed near secondary containment.

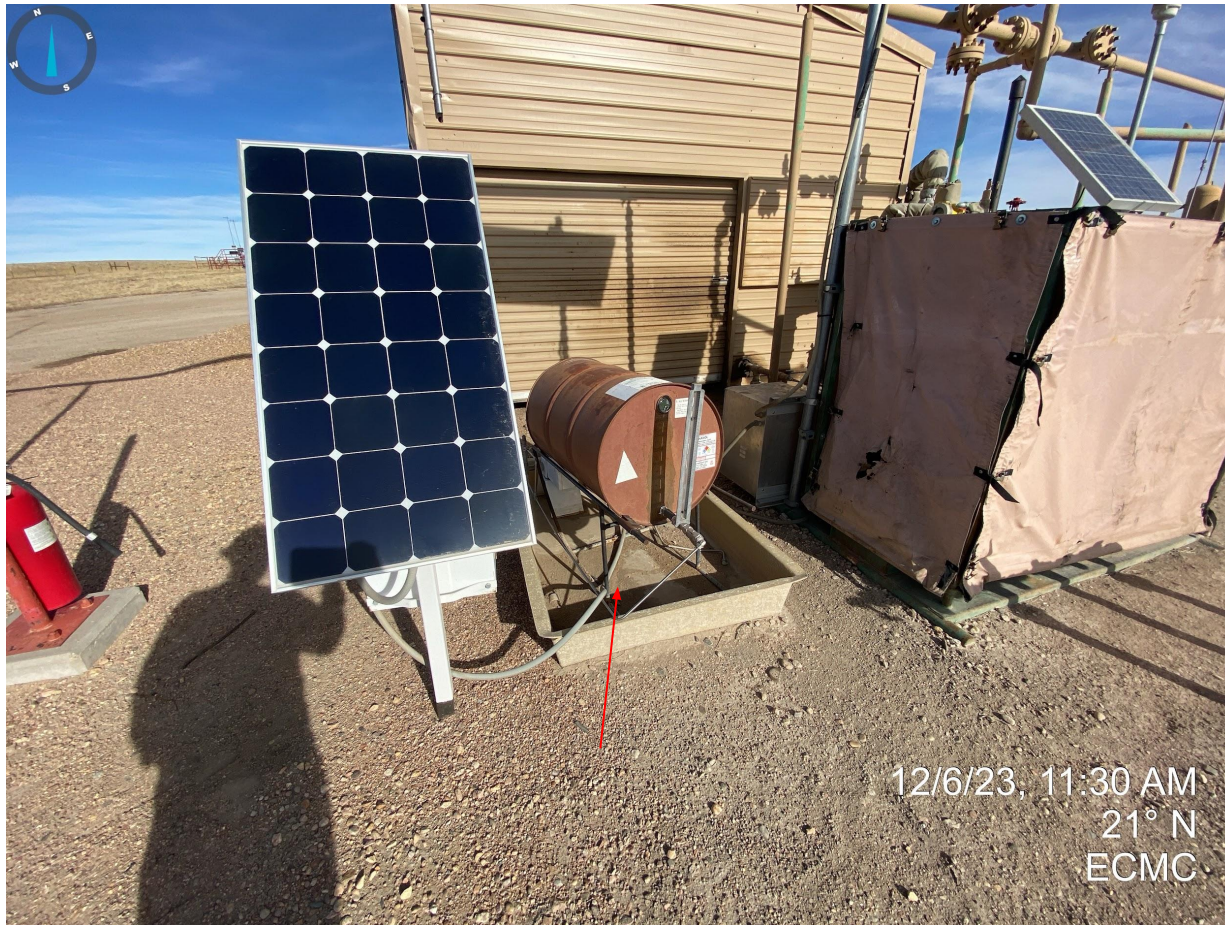
Photo 3. No wildlife exclusion device (e.g. netting) observed around secondary containment at methanol tank.

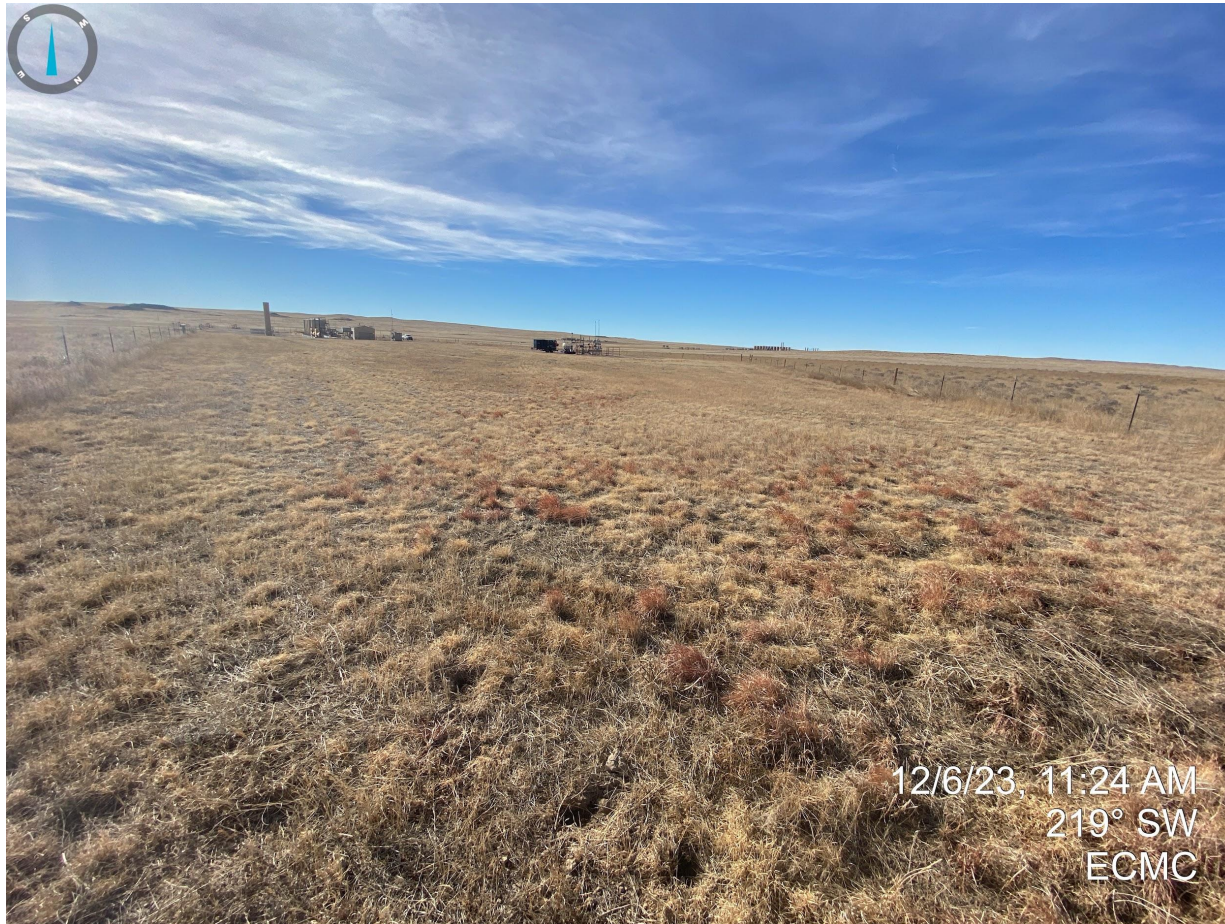
Photo 4. Northern portion of the location, within the interim areas. Appears interim reclamation activities have been performed to reduce disturbance areas only needed for production operations. Vegetation throughout the interim areas is progressing towards Rule 1003 standards and will need to be re-inspected during the next growing season to verify vegetative compliance; therefore, the location will remain IN-PROCESS. Operator shall continue to monitor and manage this site until the location meets Rule 1003 standards, including stormwater and weed management.

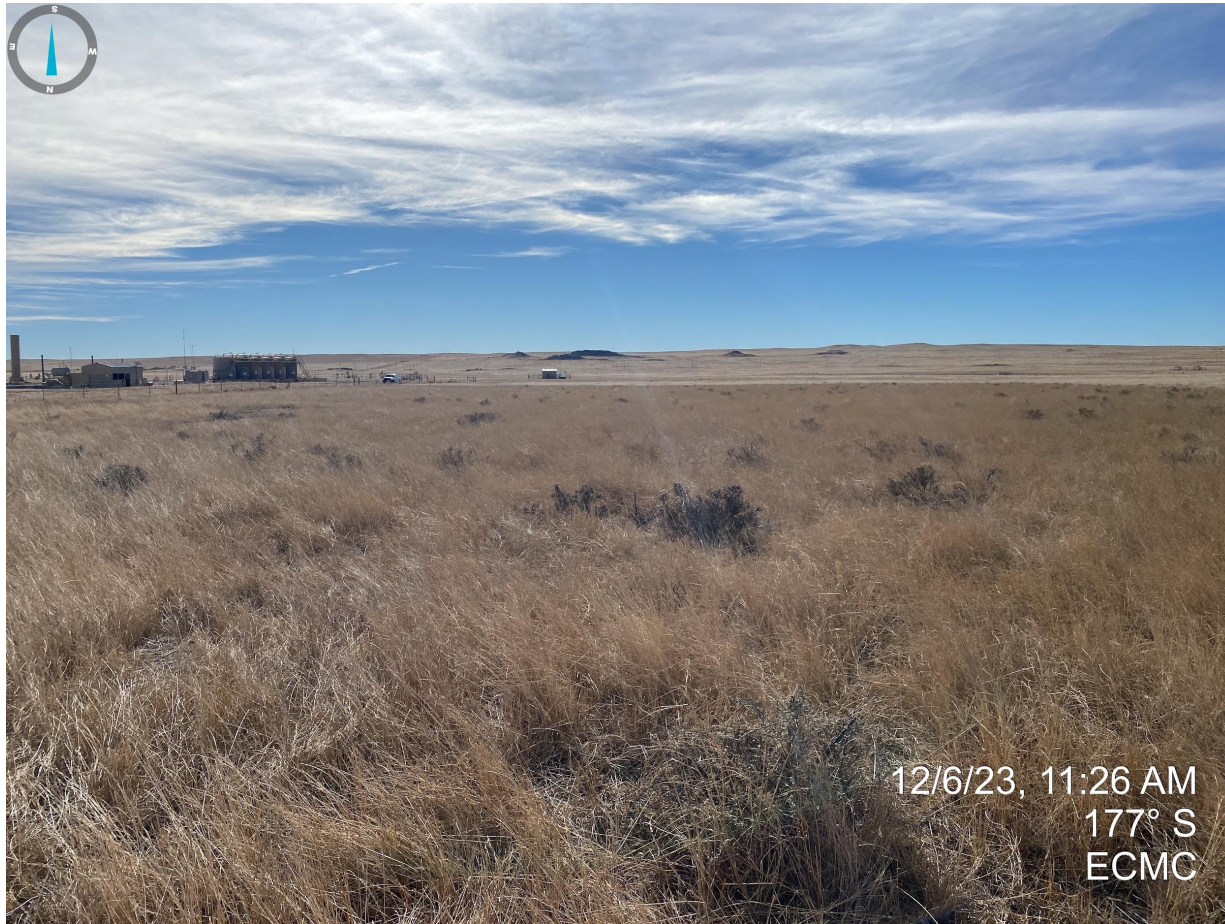
Photo 5. Taken from the northwest portion of the interim area. See comments in Photo 4.

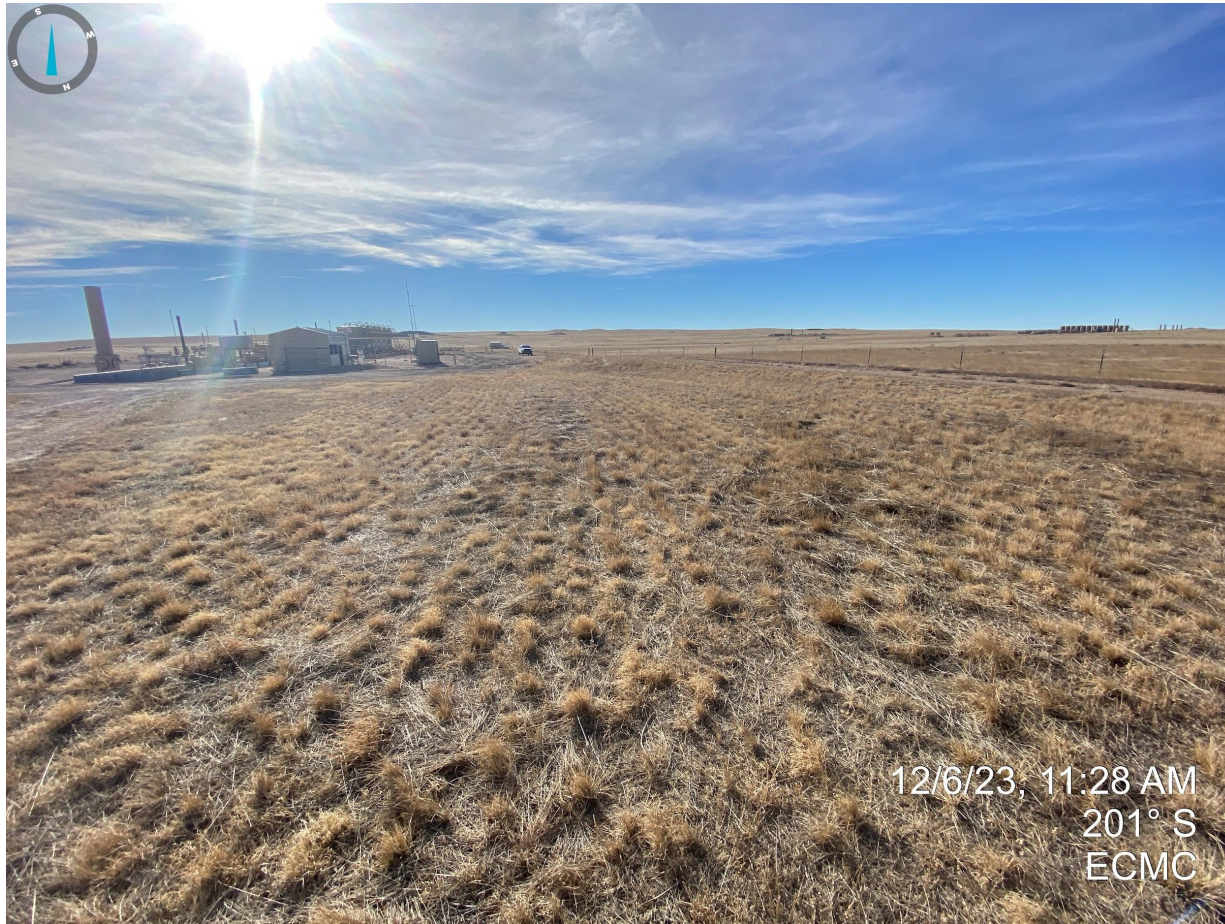
Photo 6. Taken from the western portion of the production areas. See comments in Photo 4.
