Interim Reclamation and Stormwater Inspection

Operator: NOBLE ENERGY INC - 100322

Inspection Document #: 708200747

Location Name: Timbro LC13-75-1HN Pad

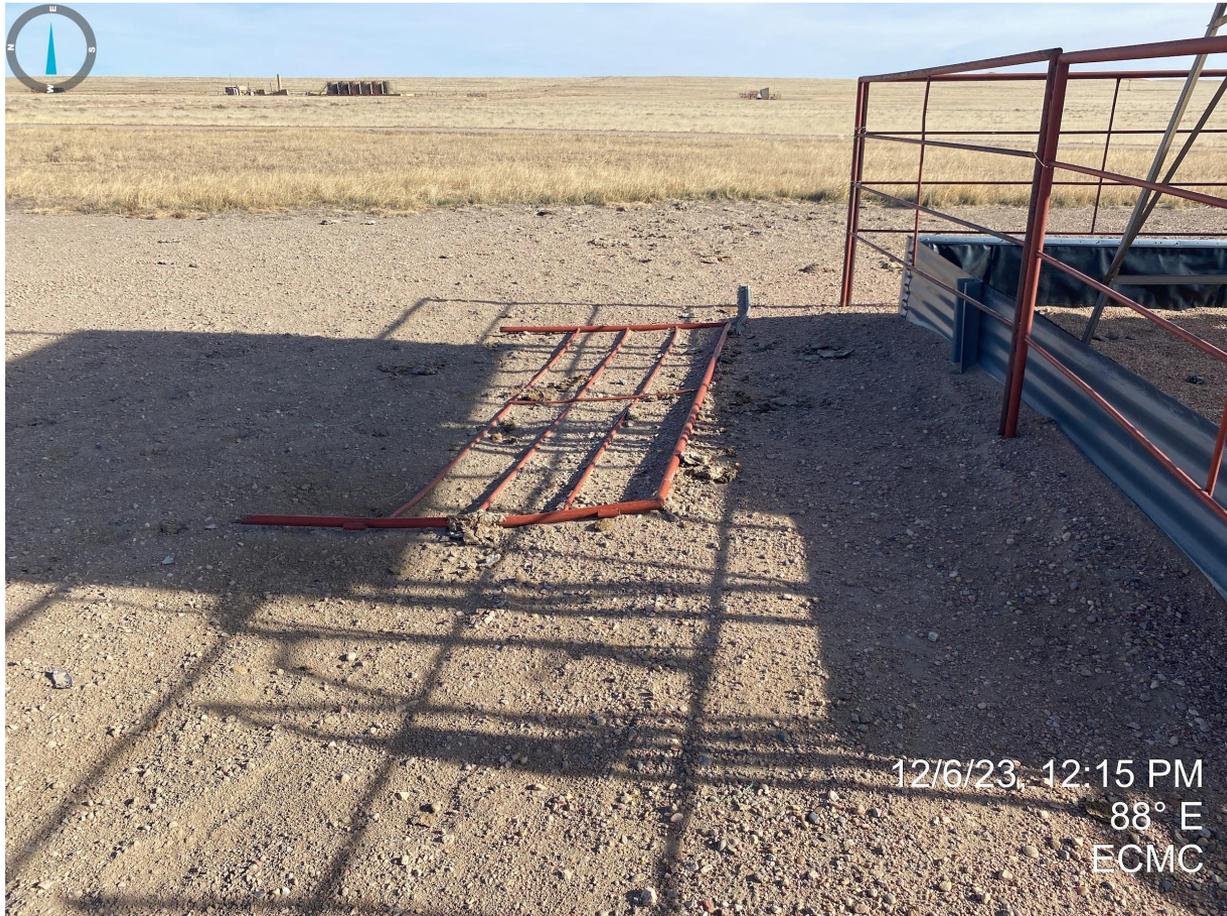
Photo 1. Cattle panel located on the east side of the production areas does not appear to be in use.

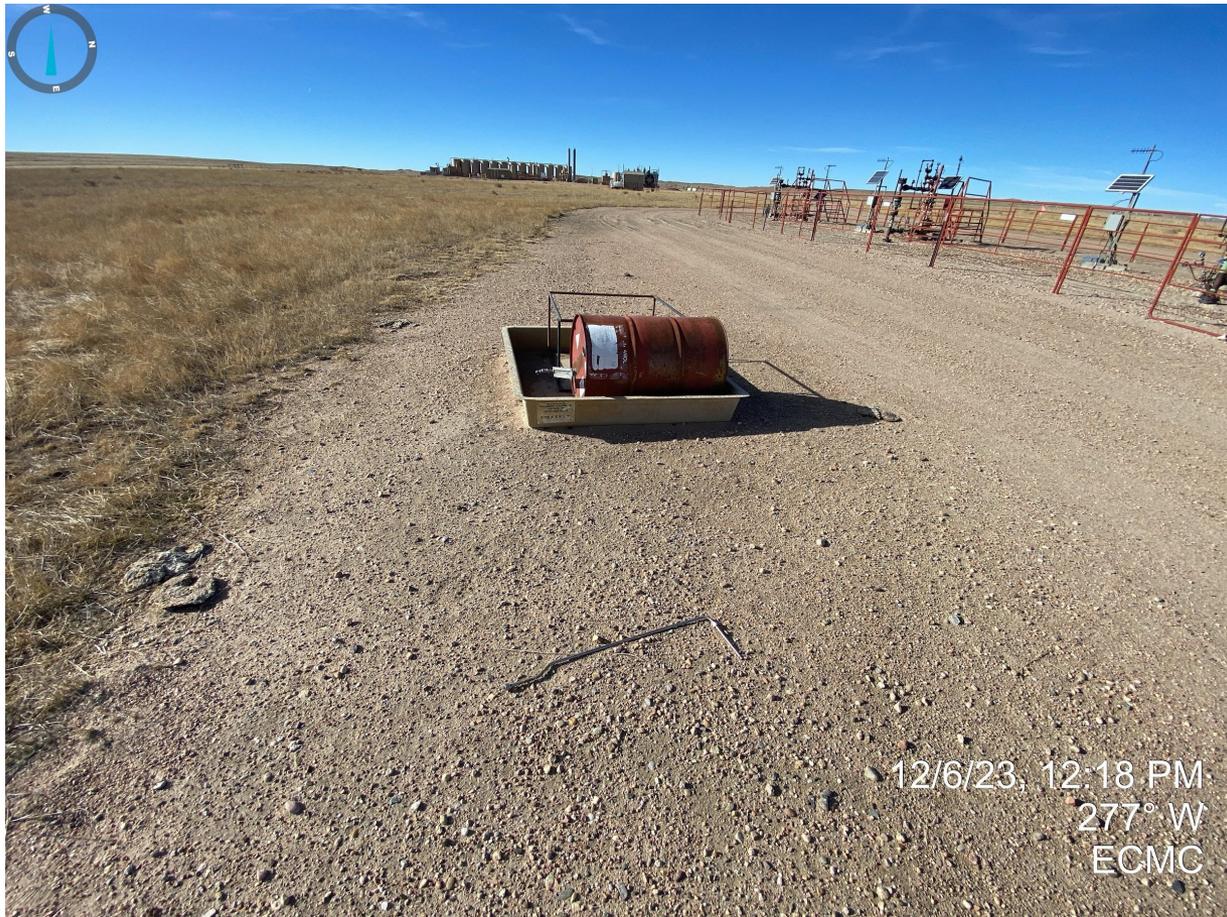
Photo 2. Unused equipment observed on the south side of the production areas.

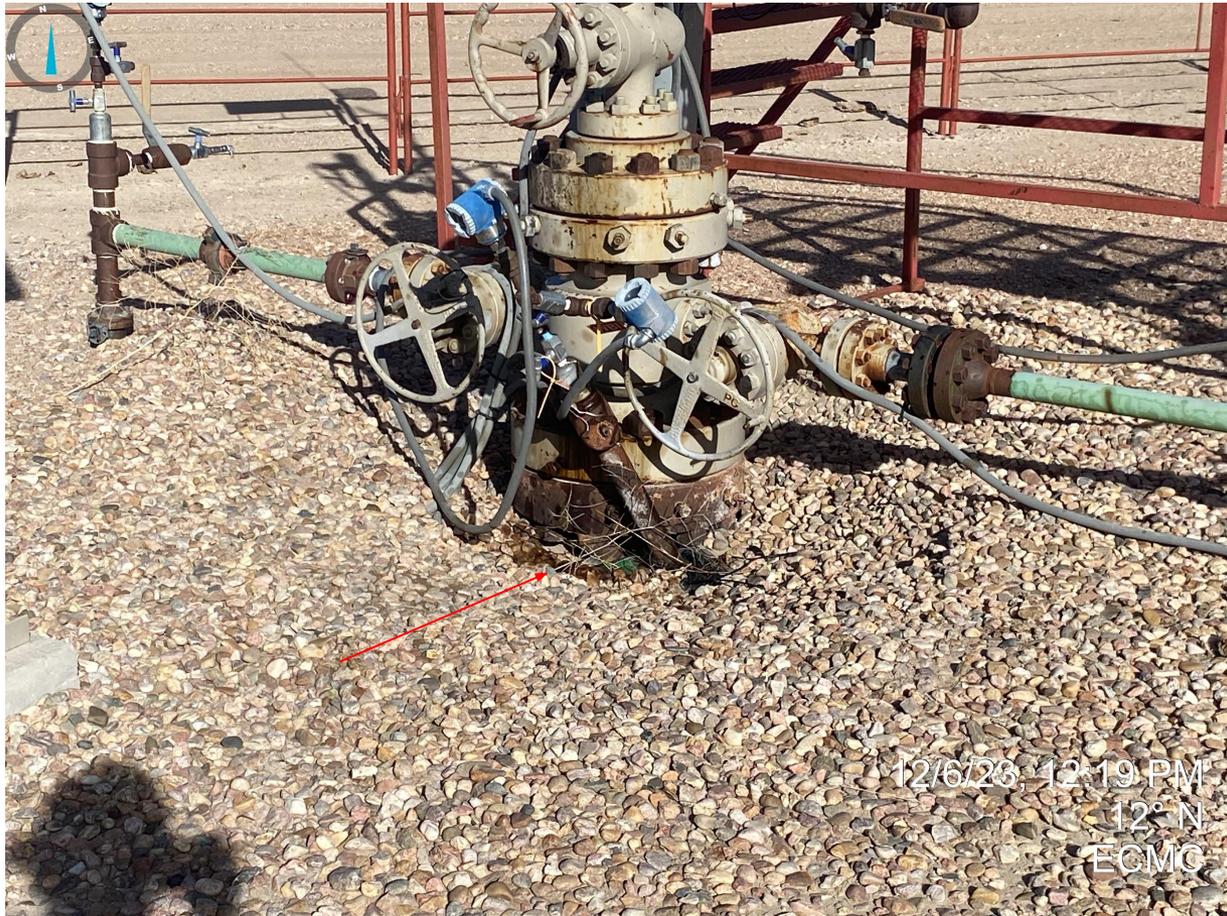
Photo 3. Stained soil observed near wellhead.

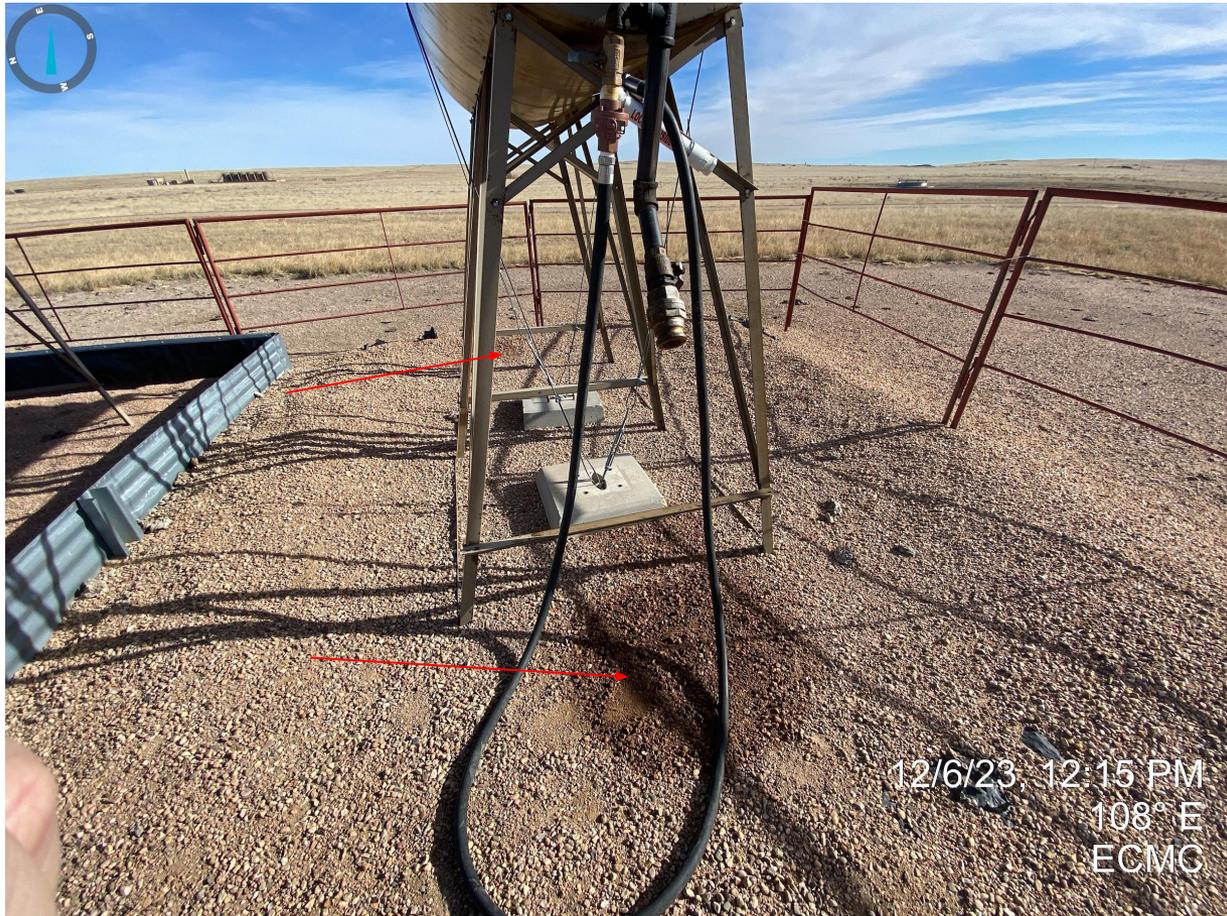
Photo 4. Stained soil observed underneath tank.

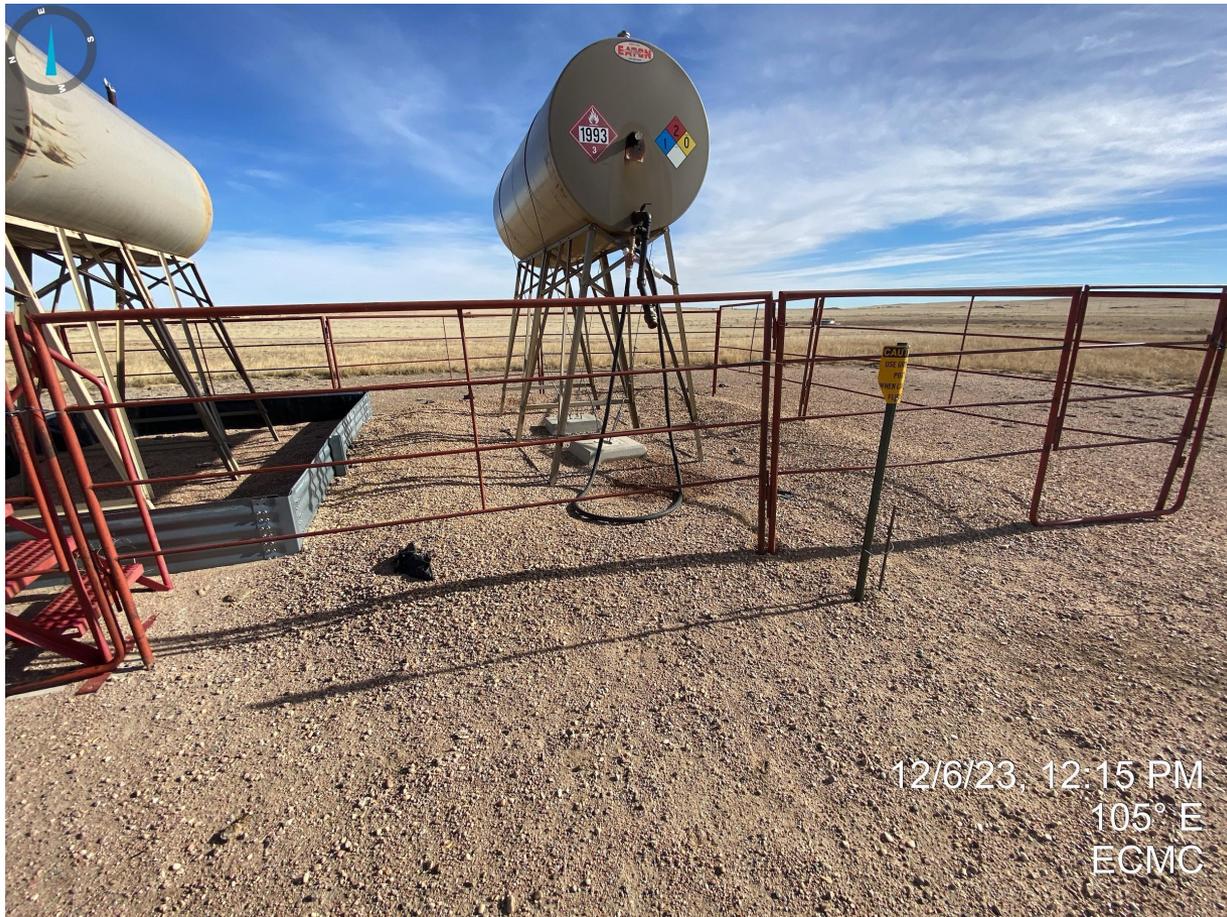
Photo 5. Earthen berms/secondary containment does not appear to be adequate to contain 150% of tank volume and requires repair/replacement.

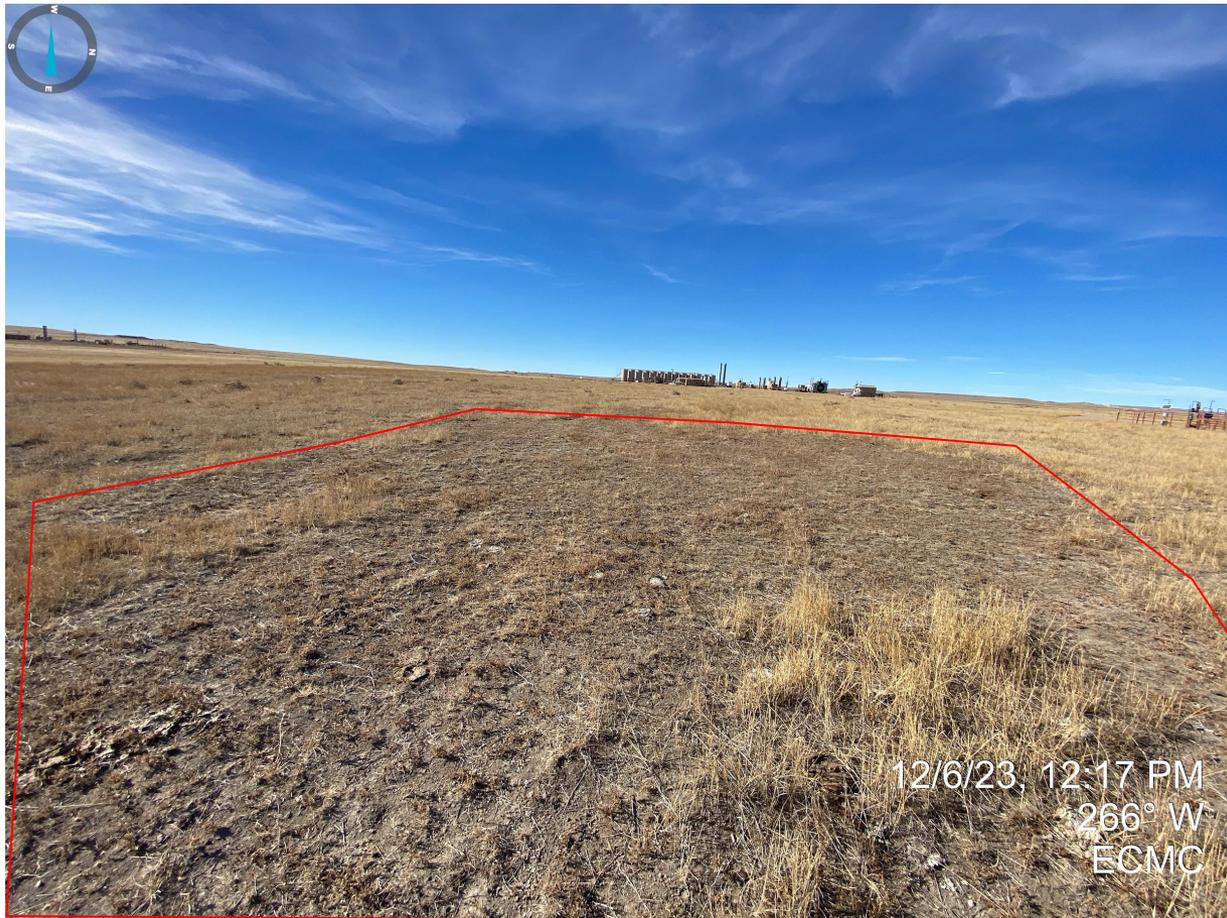
Photo 6. Southern portions of the interim areas are experiencing non-uniform vegetation cover resulting in bare soil and undesirable vegetation (e.g. russian thistle). Additional reclamation activities are required to stabilize the bare soil.

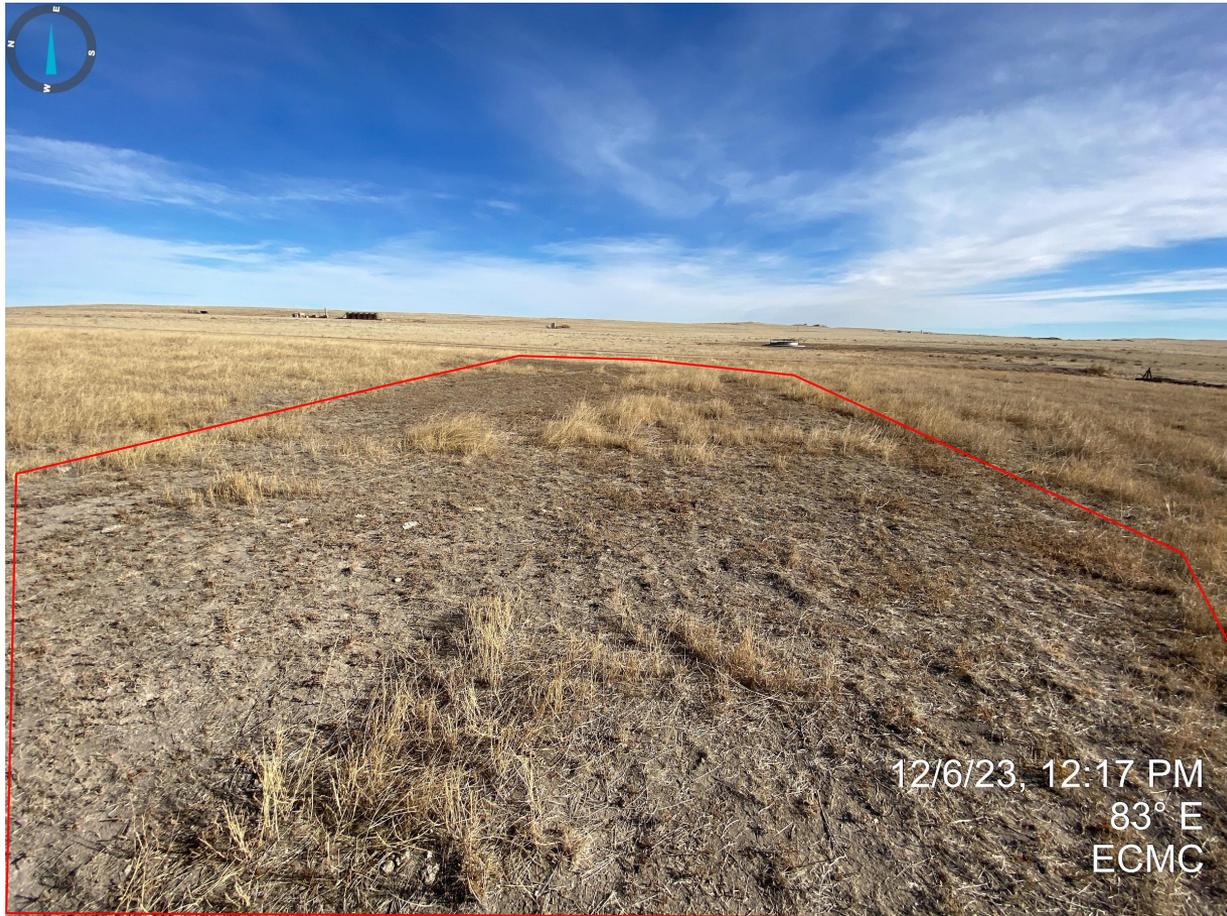
Photo 7. Continued from Photo 6, facing east.
