Inspection Photos

Location Name: CAERUS PICEANCE LLC BATTLEMENT MESA 27-44 (27P) Pad

Location ID: 334317

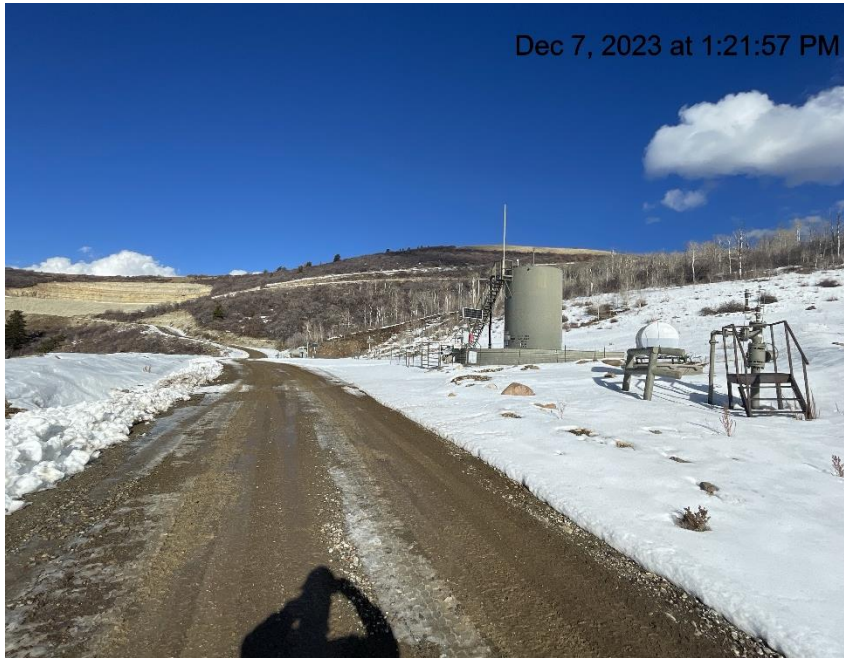
Photo # 8877 From entrance to location

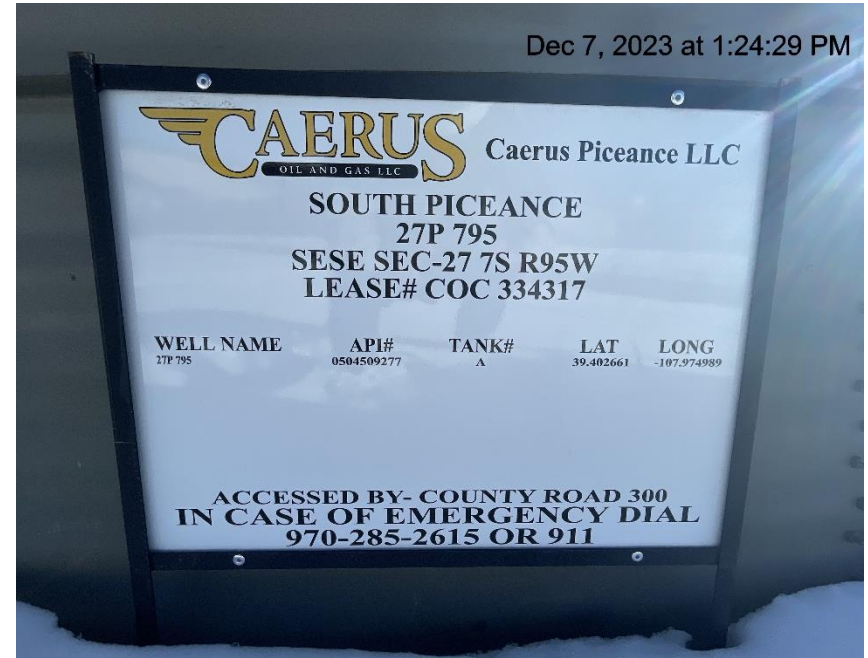
Photo # 8878 Location

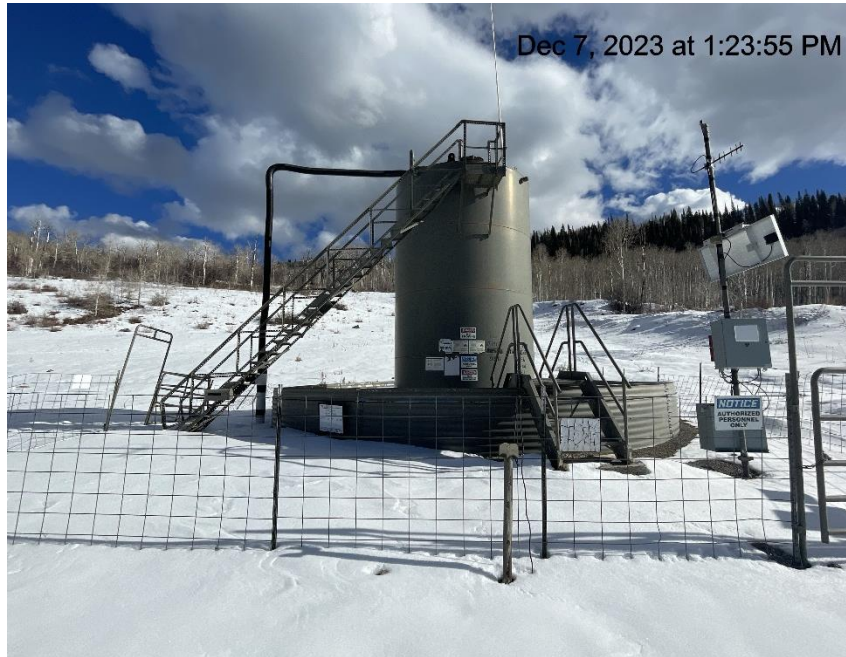
Photo # 8879 Location

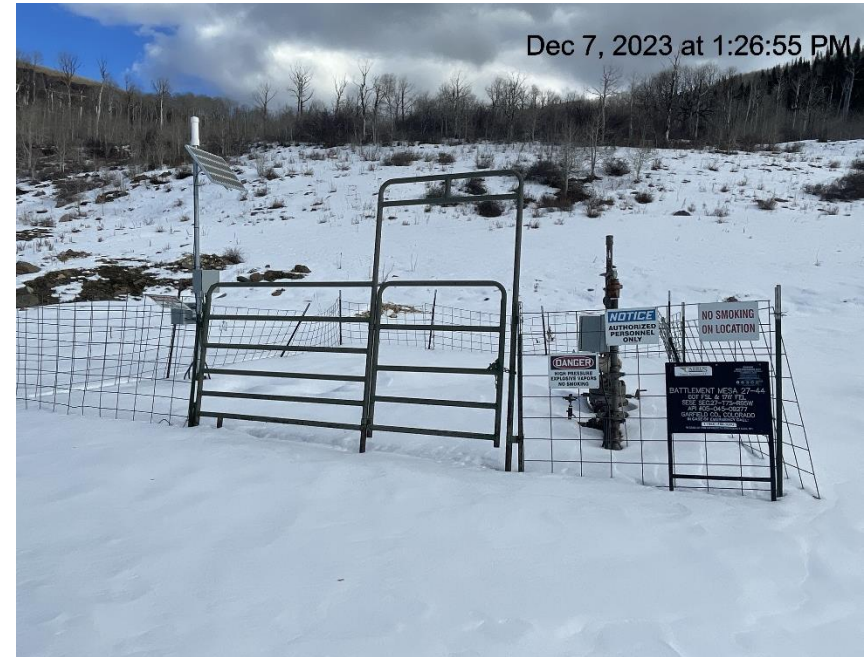
Photo # 8880 Location

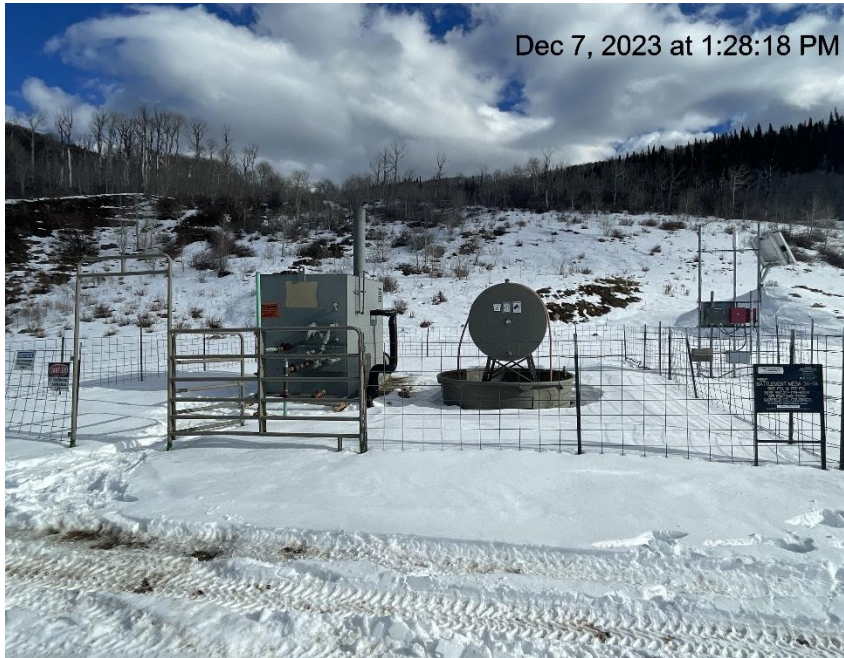
Photo # 8881 Location

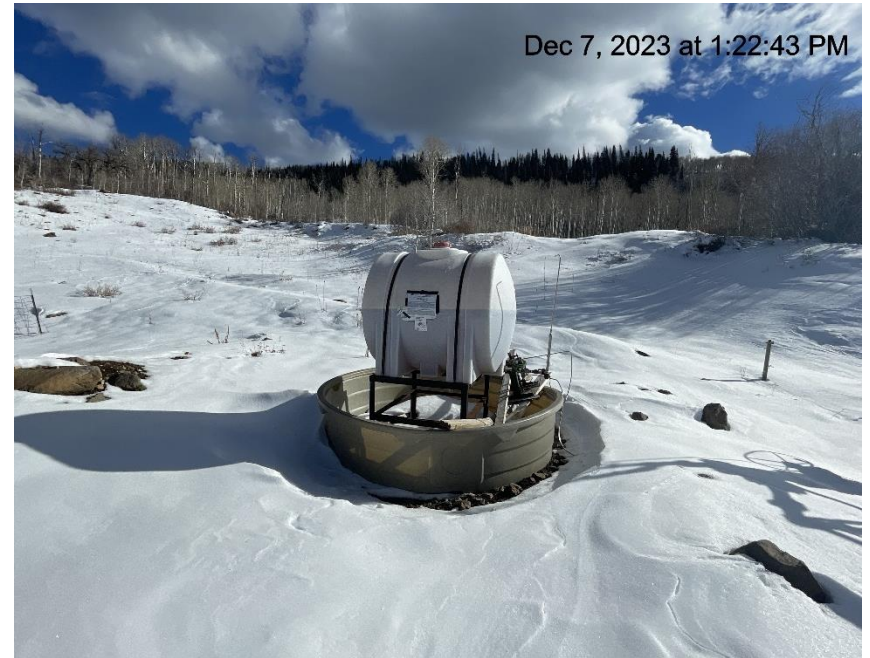
Photo # 8882 Location

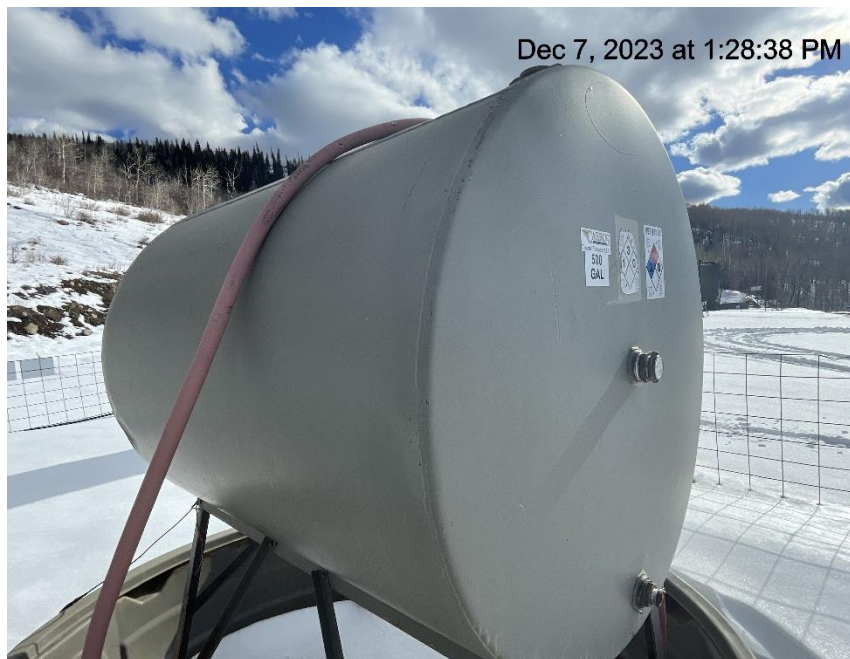
Photo # 8883 Methanol tank improperly labeled/lacks required information

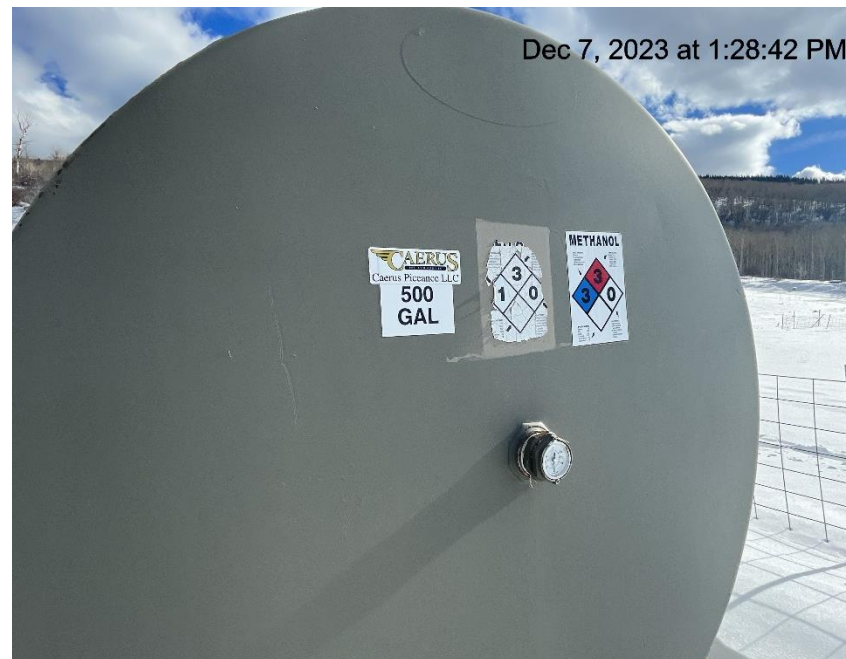
Photo # 8884 Methanol tank improperly labeled/lacks required information

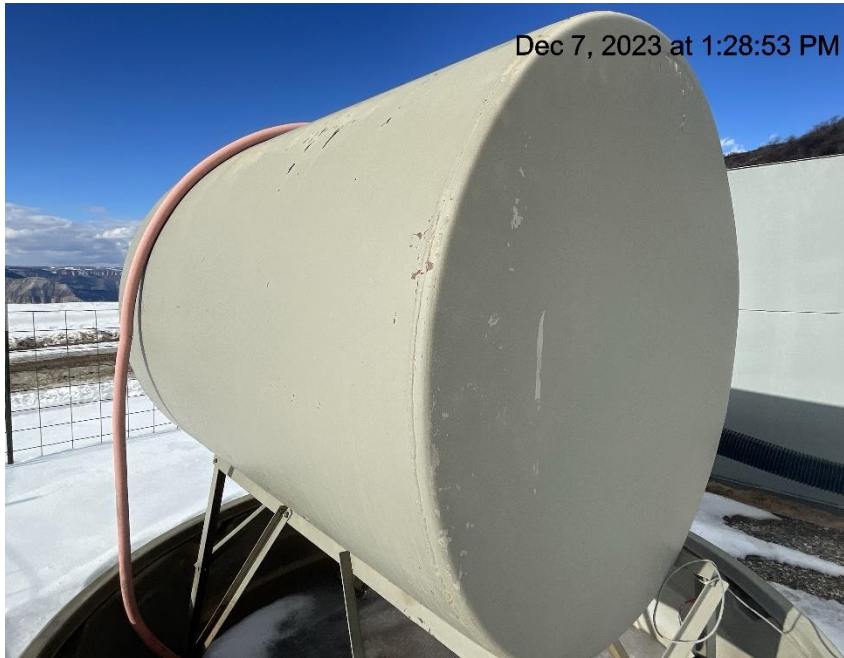
Photo # 8885 Methanol tank

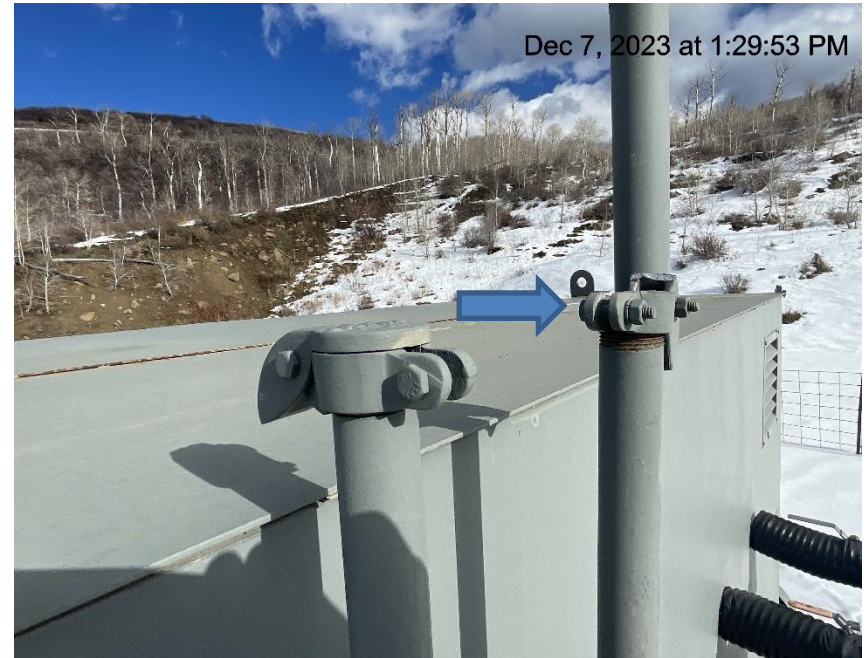
Photo # 8886 PRV vent line lacks cap

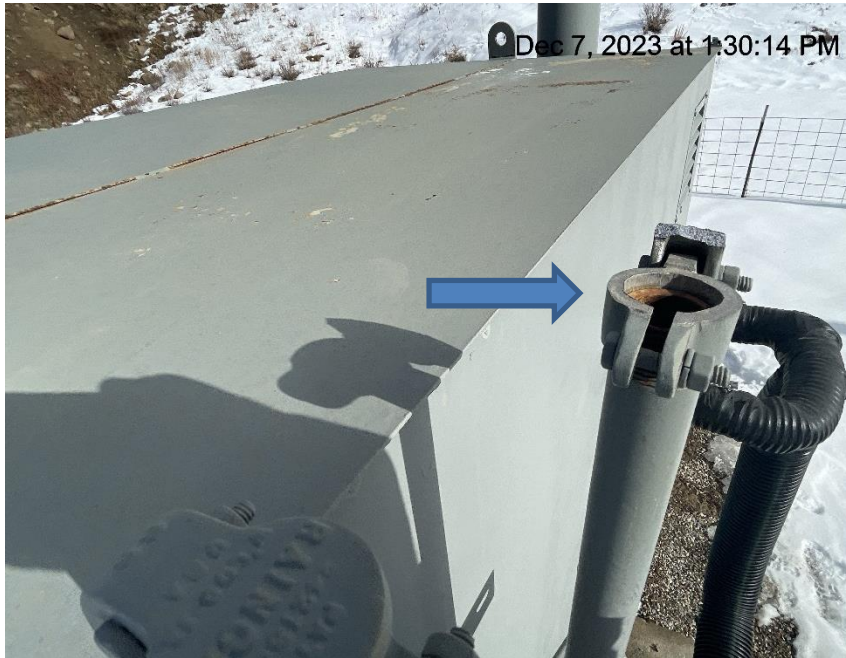
Photo # 8887 PRV vent line lacks cap

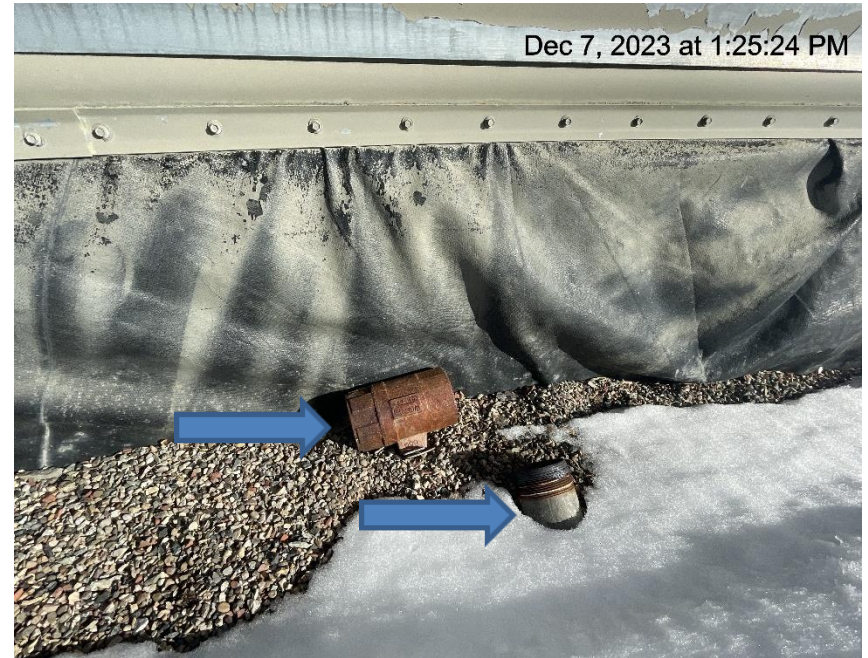
Photo # 8888 Debris

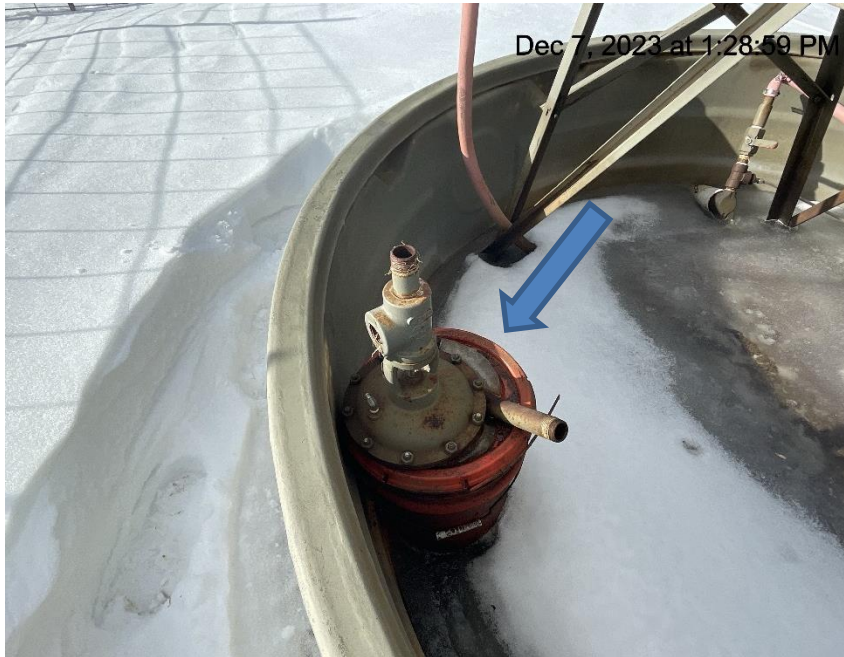
Photo # 8889 Debris
