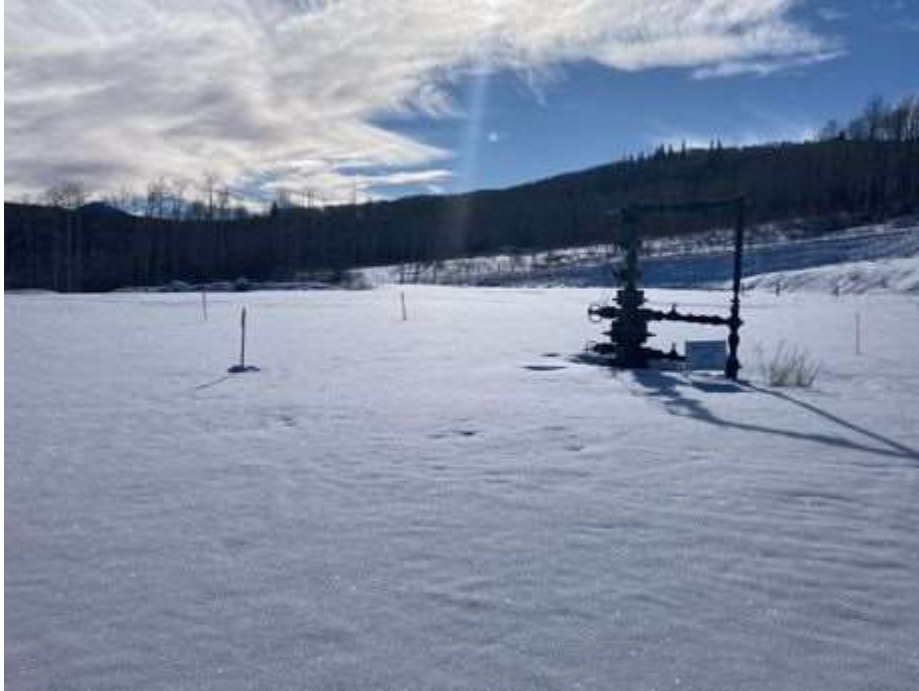
WPU-36-1-H2 pad looking south. Anchors are marked with 48" lathe with high visibility flagging and paint.

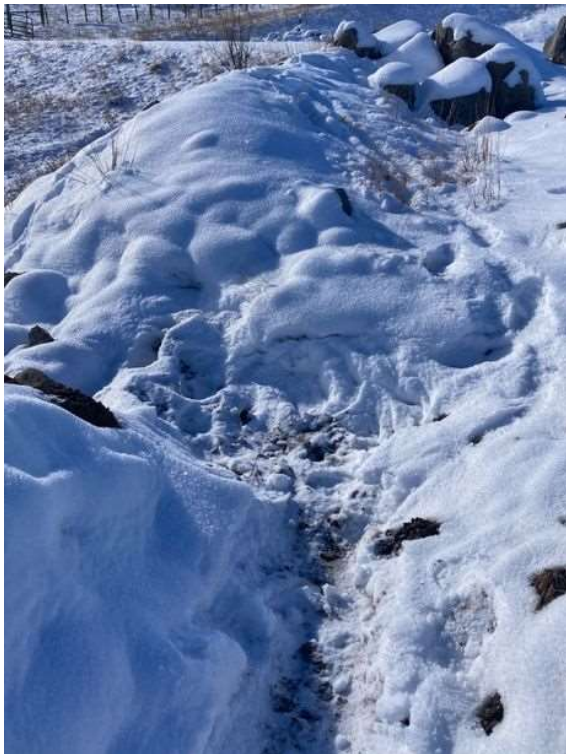
Stormwater ditch located along eastern edge of pad. No stormwater flow was noted during 11/03/2023 and 11/29/2023 inspection.

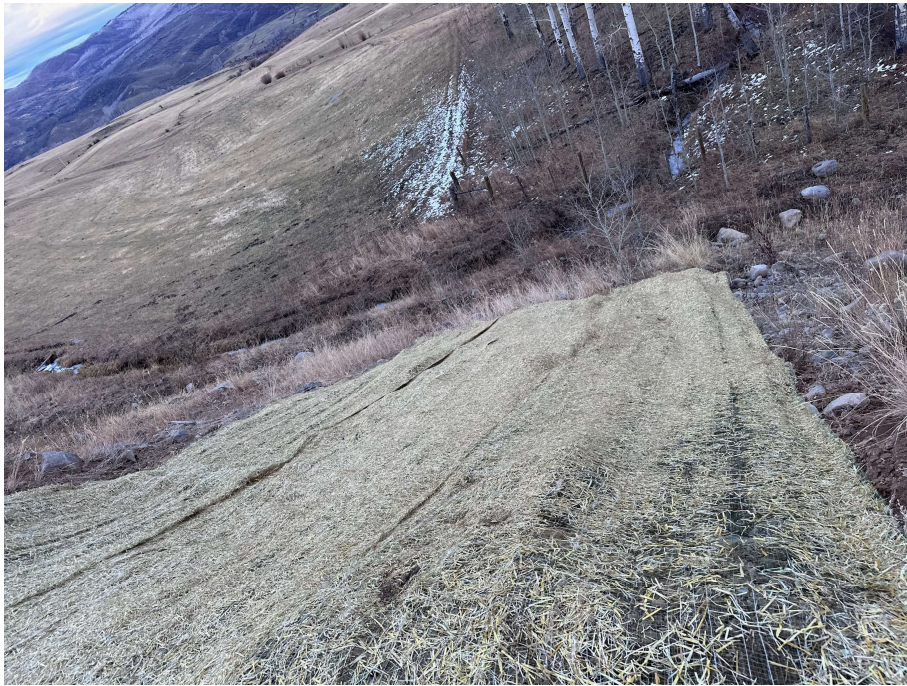
Sloping on the north and east areas of the pad were seeded and coconut matting was placed in areas of potential erosion.
