# Inspection Photos

Loc: 321097

Operator: INVESTMENT EQUIPMENT LLC

Inspection Date: 12/6/2023

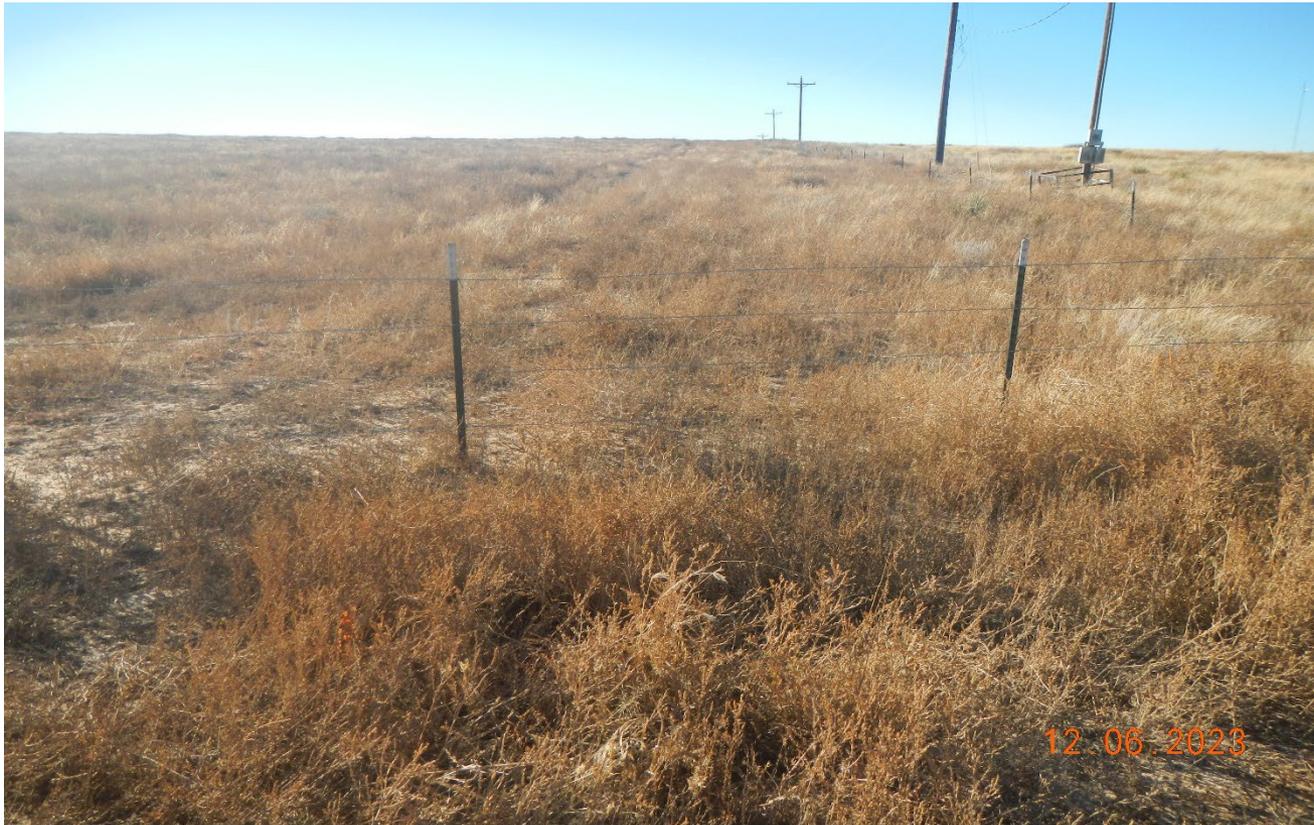
**Photo 1.** Facing west at the former access road. The cattleguard has been removed.

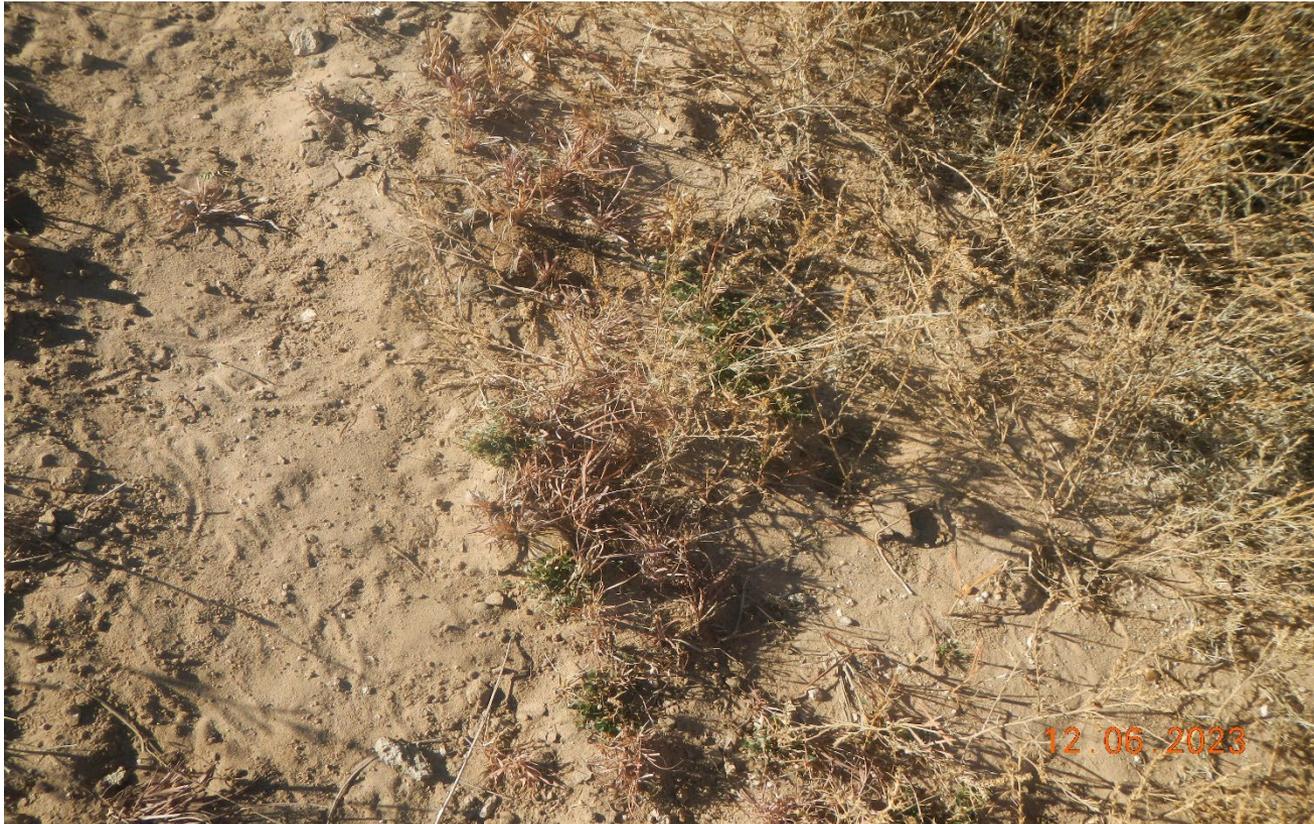
**Photo 2.** View of desirable vegetation beginning to establish along the road.

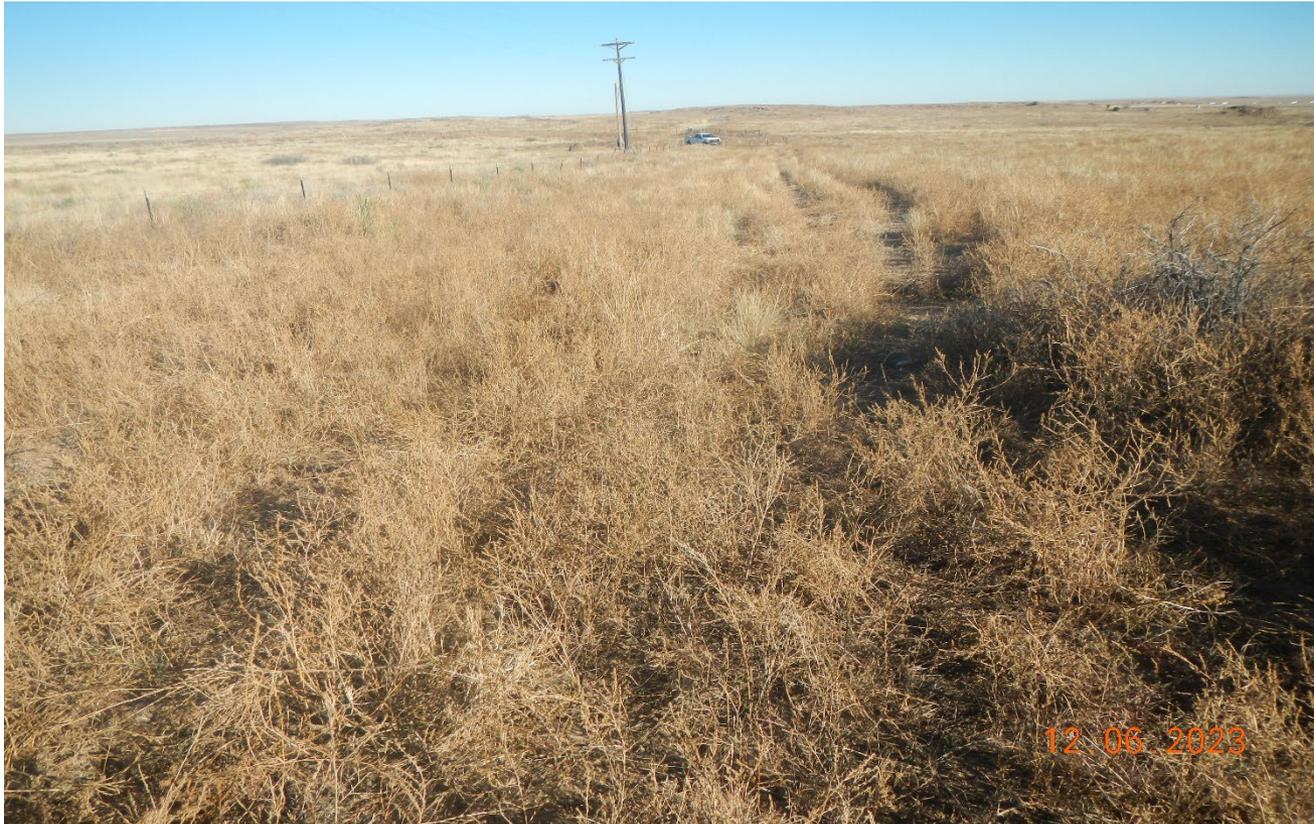
**Photo 3.** Facing back east toward the road. There is tall undesirable weeds which will need to be controlled.

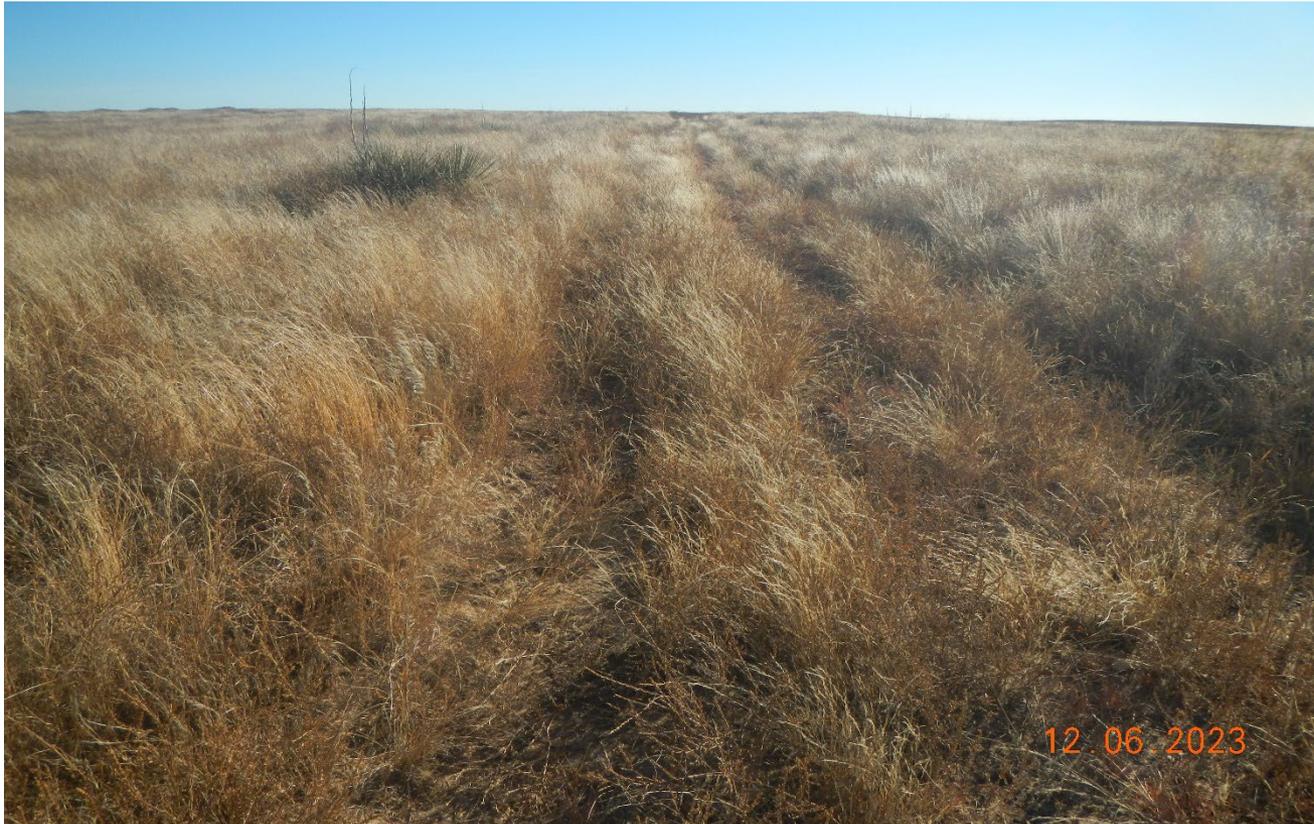
**Photo 4.** Facing south along the former access road.

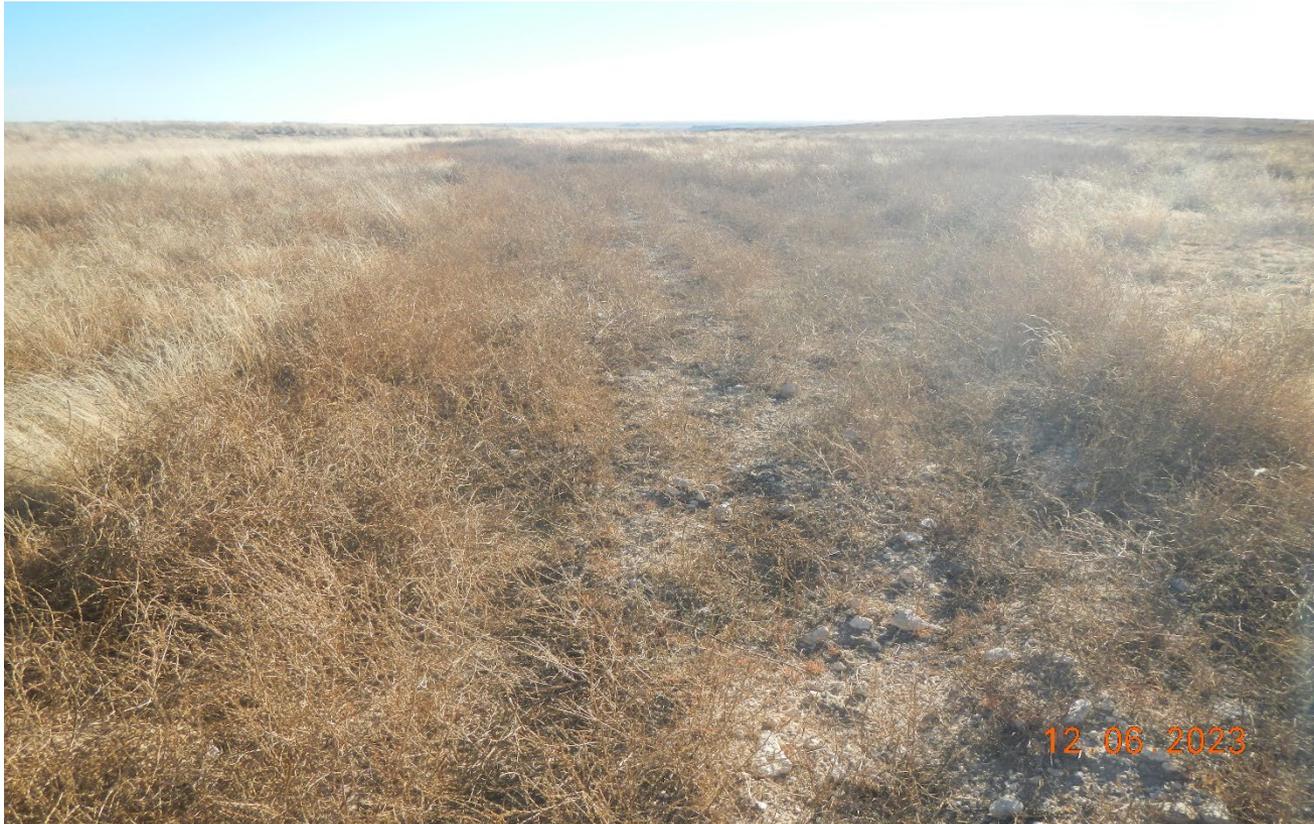
**Photo 5.** Facing south toward the wellsite. It appears soils were decompacted along the road at the location.

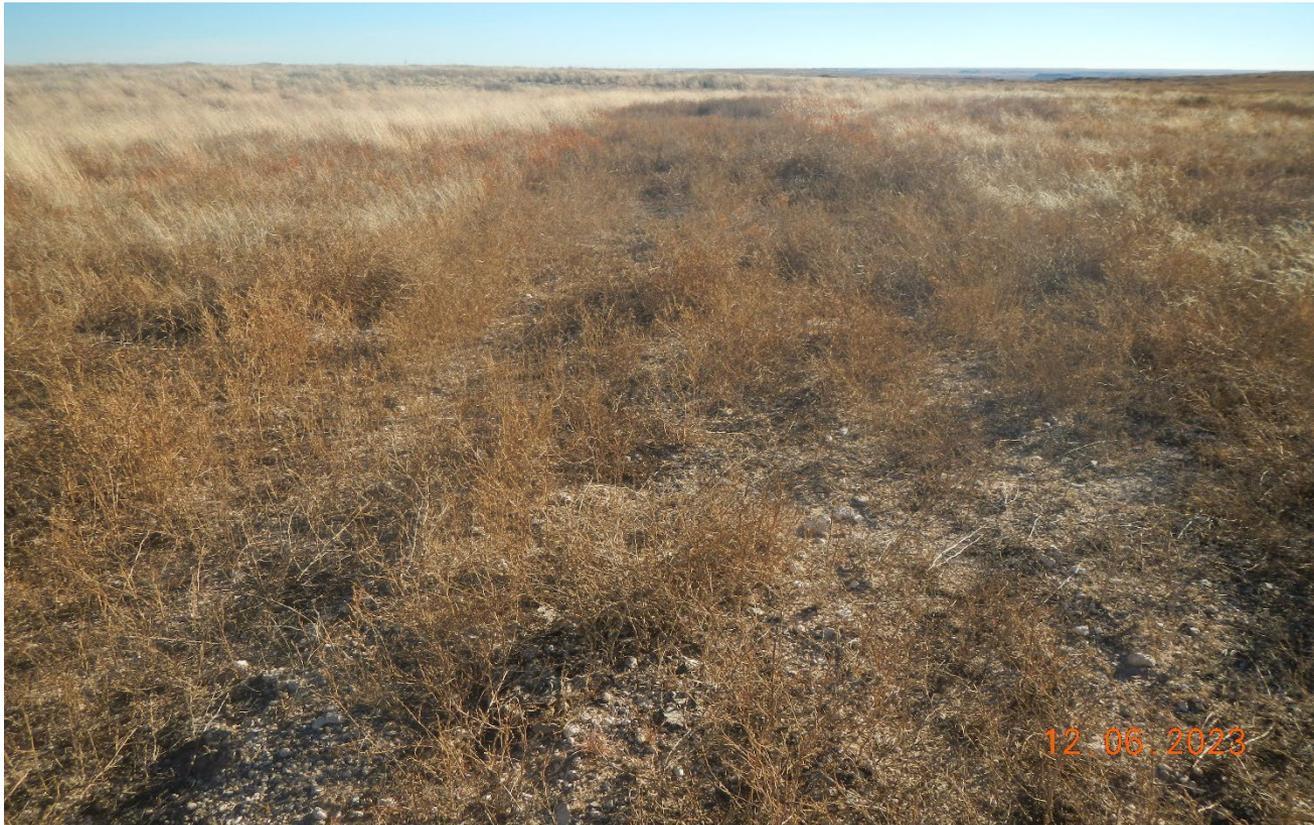
**Photo 6.** Facing south along the access road at the location. Soils were decompacted but desirable vegetation did not appear to be establishing, The dark brown vegetation is undesirable weeds that will need to be controlled..
