Inspection Photos

Location Name: CAERUS PICEANCE LLC, HYRUP-68S96W/12SWNE

Location ID: 334061

Date: 12/6/2023

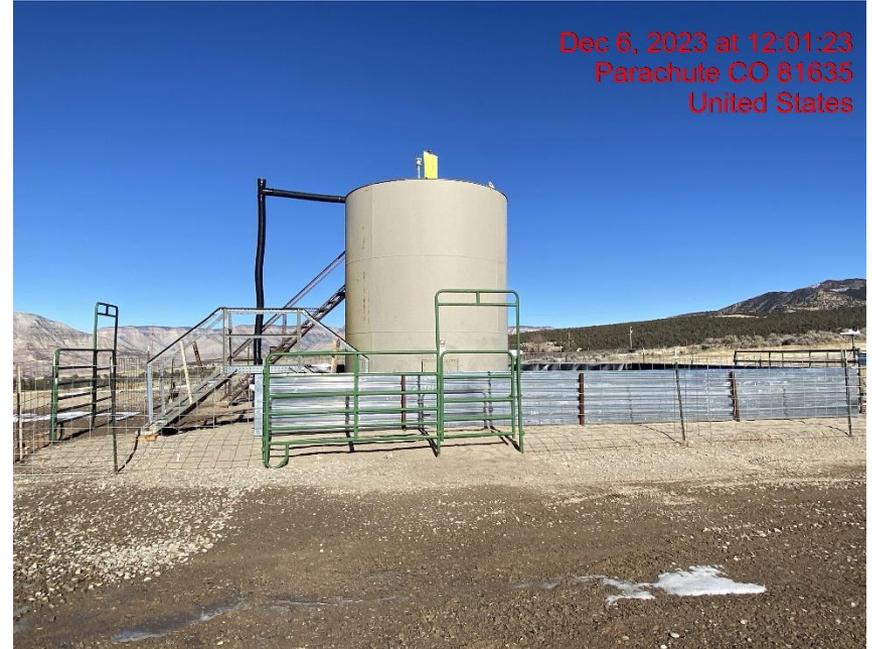
Tank Battery/No Battery Sign – Photo #08025

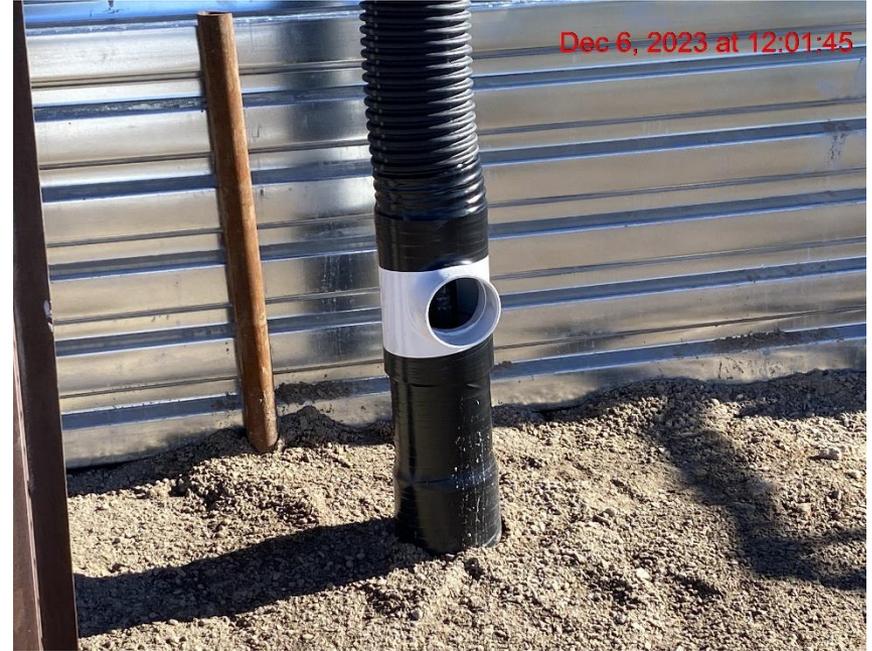
Wildlife Entry Hazard – Photo #08026

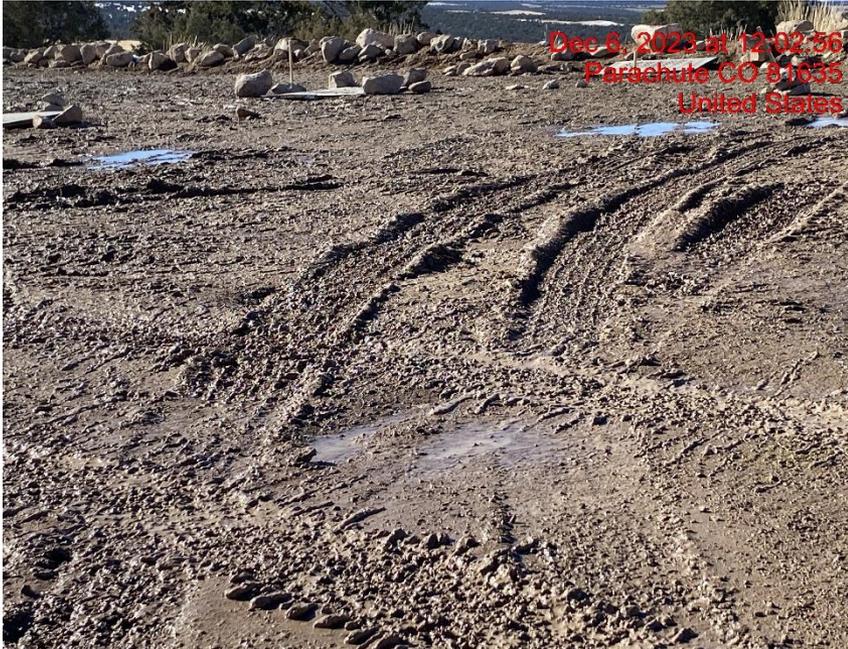
Lack of Stabilization – Photo #08028

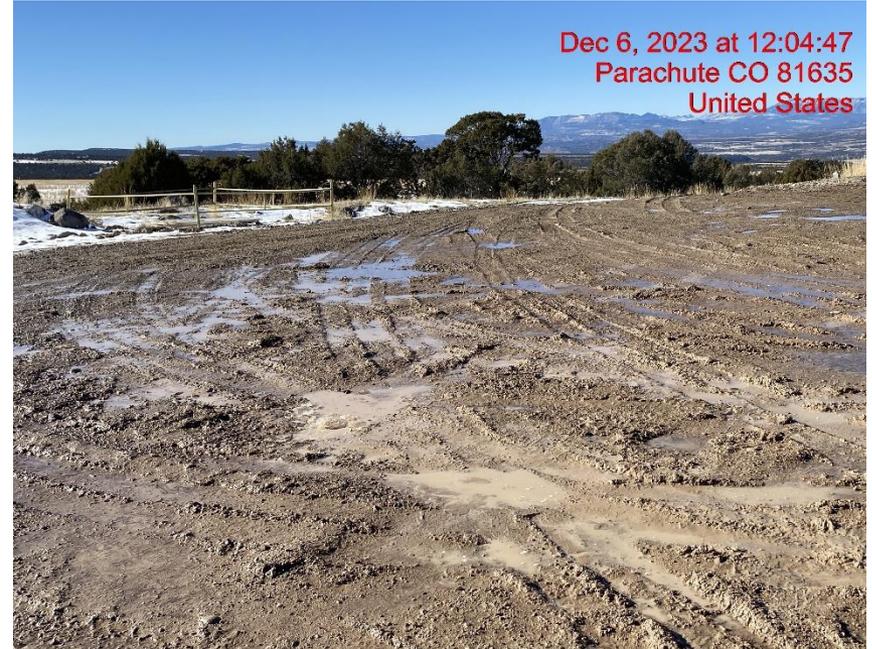
**Insufficient Vehicle Tracking BMPs at Location Entrance/Exit
– Photo #08033**
