Storm Water Management and Erosion control
Location Name: CAERUS PICEANCE LLC FEDERAL 1-42 (RN1) Pad
Location #: 323989

Location Overview: Location is within Black Bear Habitat area & in close proximity to High Priority/Density/NSO Habitat areas. Location is within Rule 411a Surface Water External Buffer. Location is approximately 480 yards from Beaver Creek.

Section/Township/Range: 1 7S94W

COLORADO
Energy & Carbon Management
Commission
Department of Natural Resources

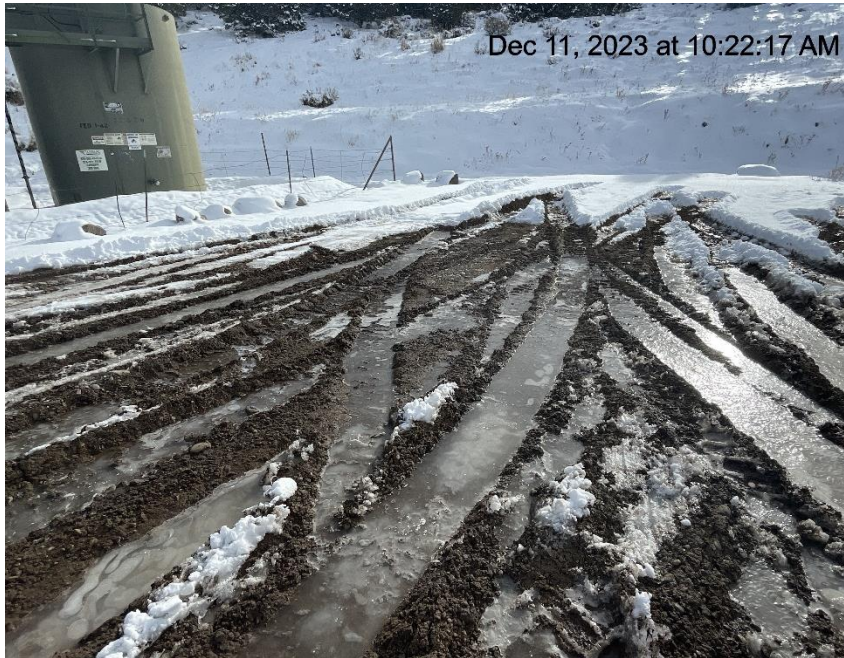
Photo # 9049 Lack of stabilization/compaction/insufficient BMP's

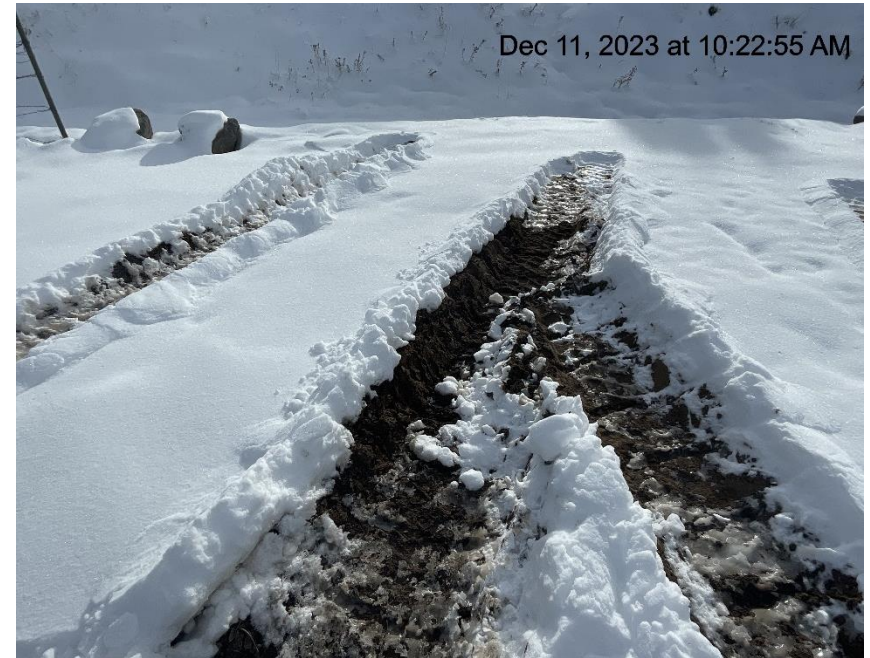
Photo # 9050 Lack of stabilization/compaction/insufficient BMP's

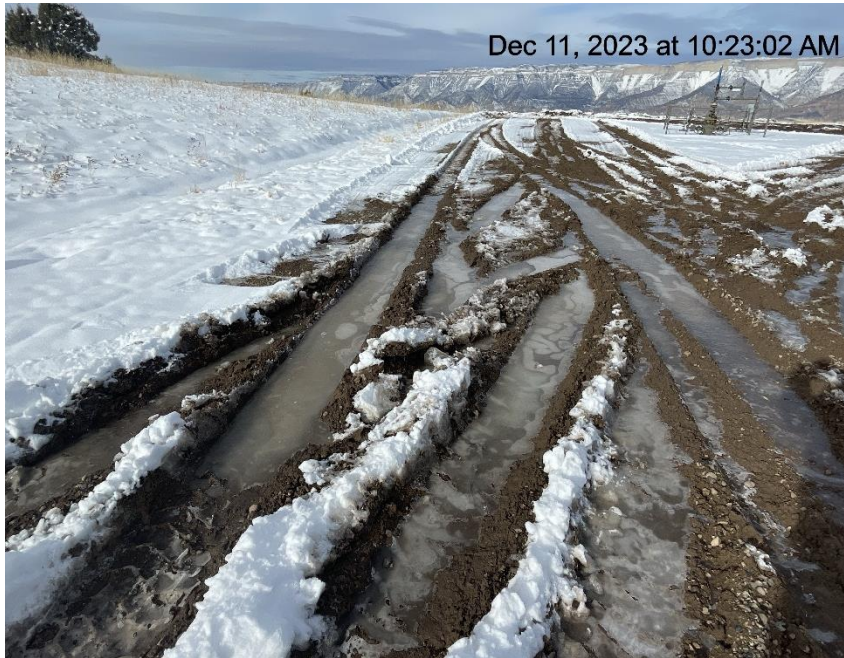
Photo # 9051 Lack of stabilization/compaction/insufficient BMP's

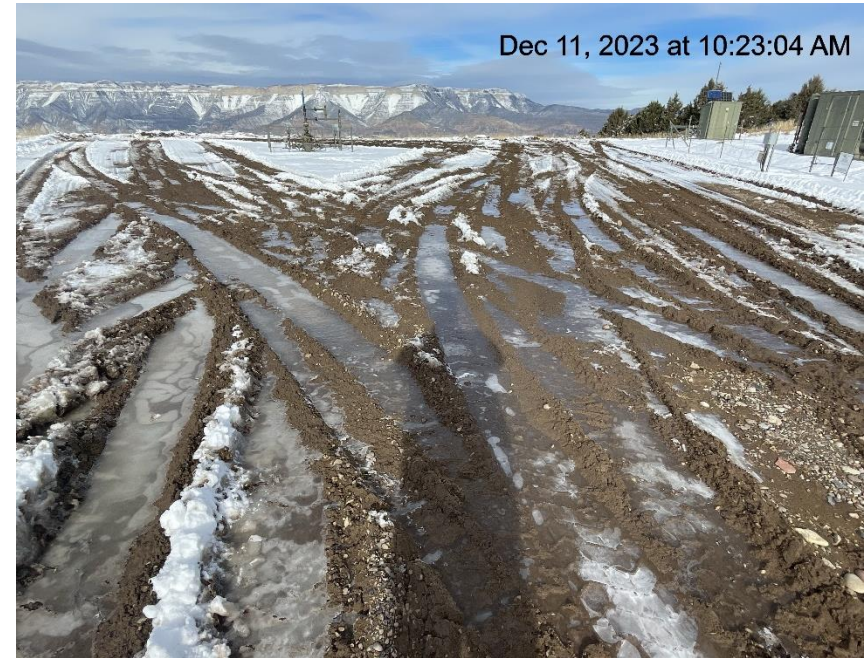
Photo # 9052 Lack of stabilization/compaction/insufficient BMP's

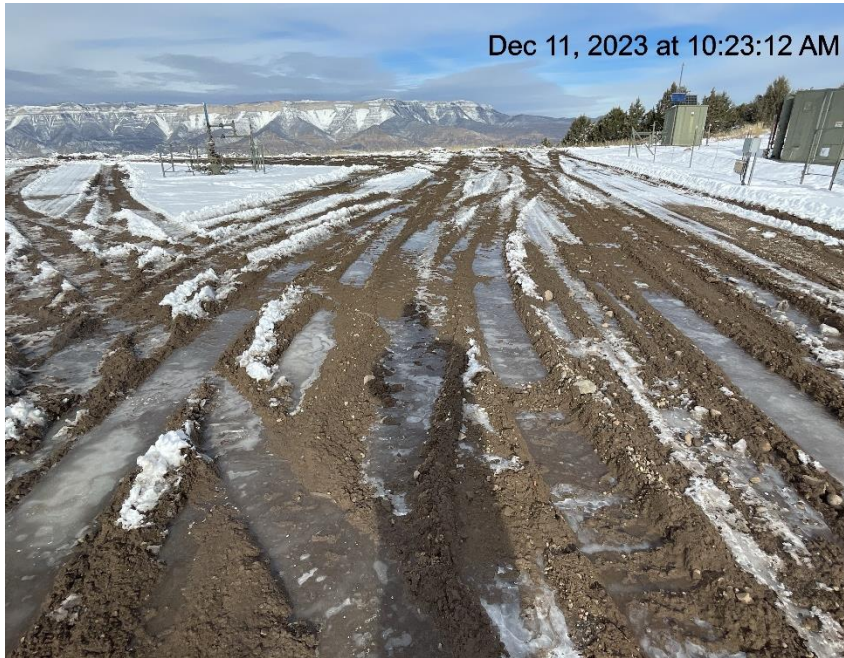
Photo # 9053 Lack of stabilization/compaction/insufficient BMP's

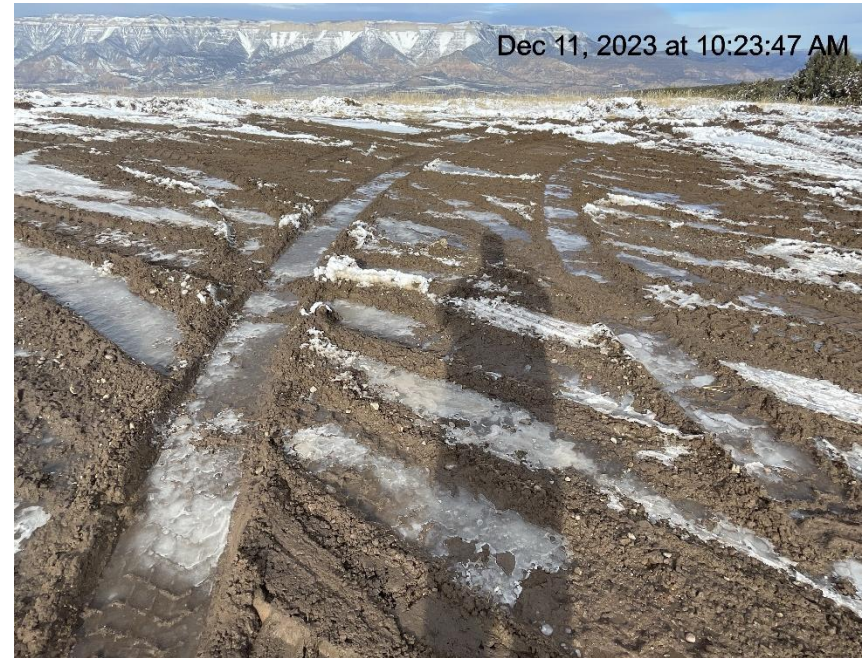
Photo # 9054 Lack of stabilization/compaction/insufficient BMP's

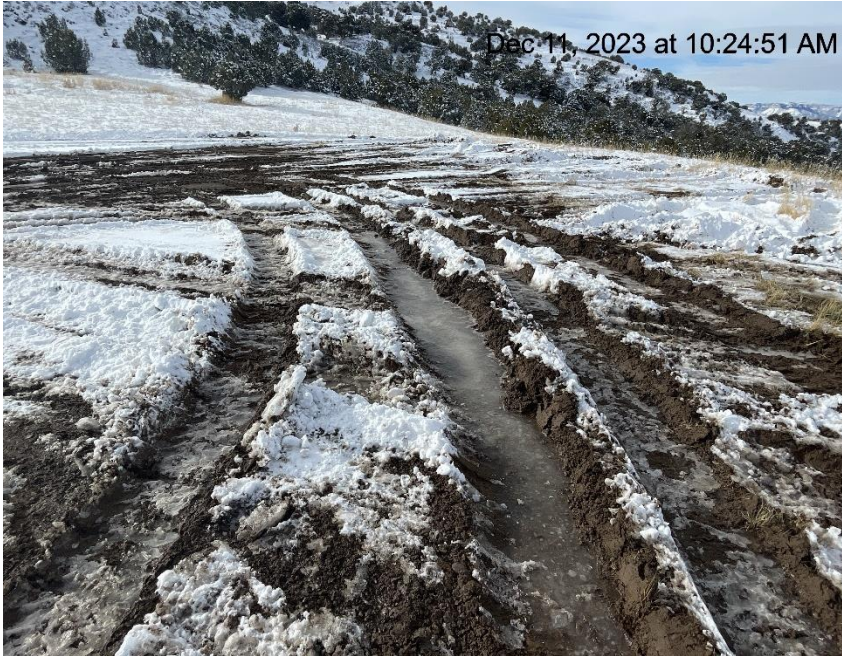
Photo # 9055 Lack of stabilization/compaction/insufficient BMP's

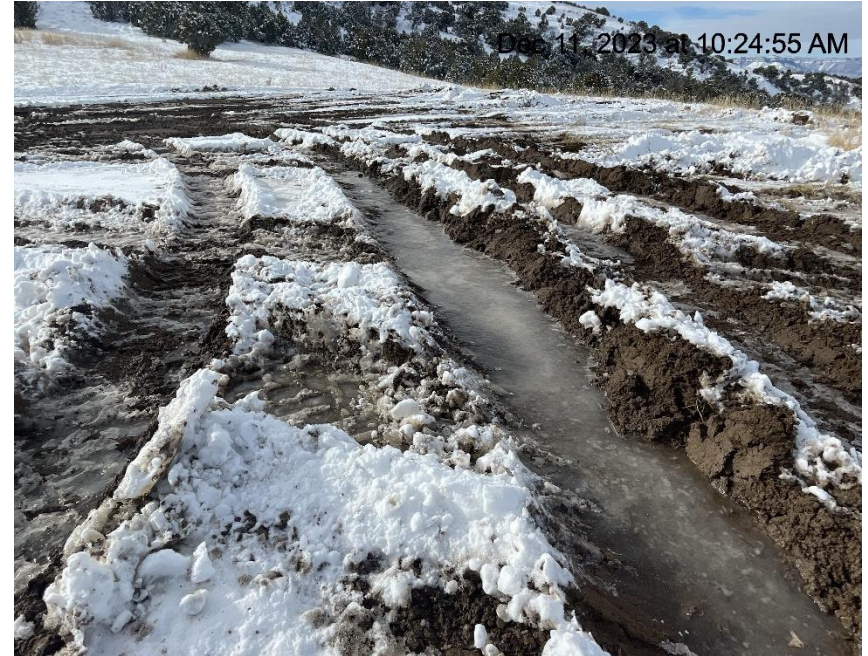
Photo # 9056 Lack of stabilization/compaction/insufficient BMP's

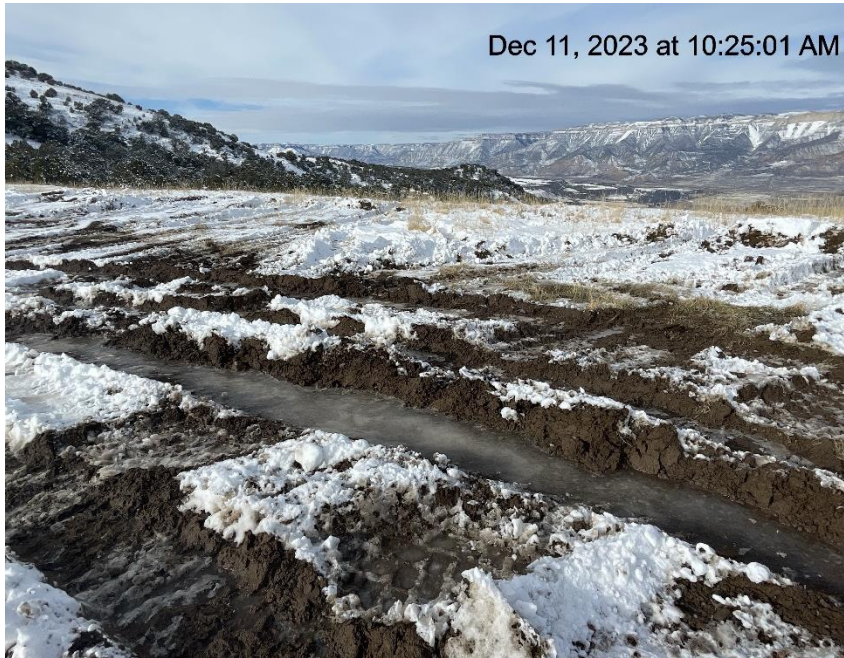
Photo # 9057 Lack of stabilization/compaction/insufficient BMP's

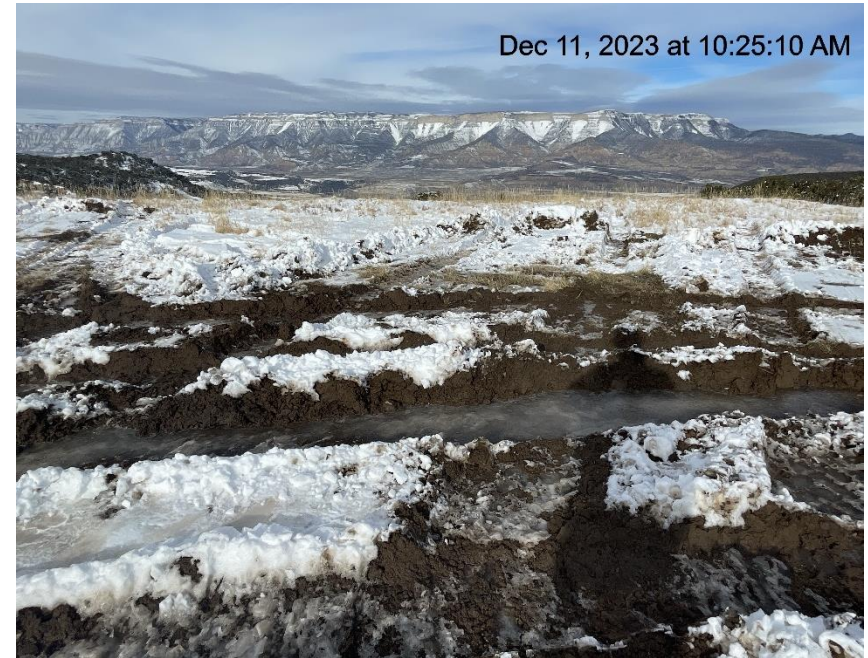
Photo # 9058 Lack of stabilization/compaction/insufficient BMP's

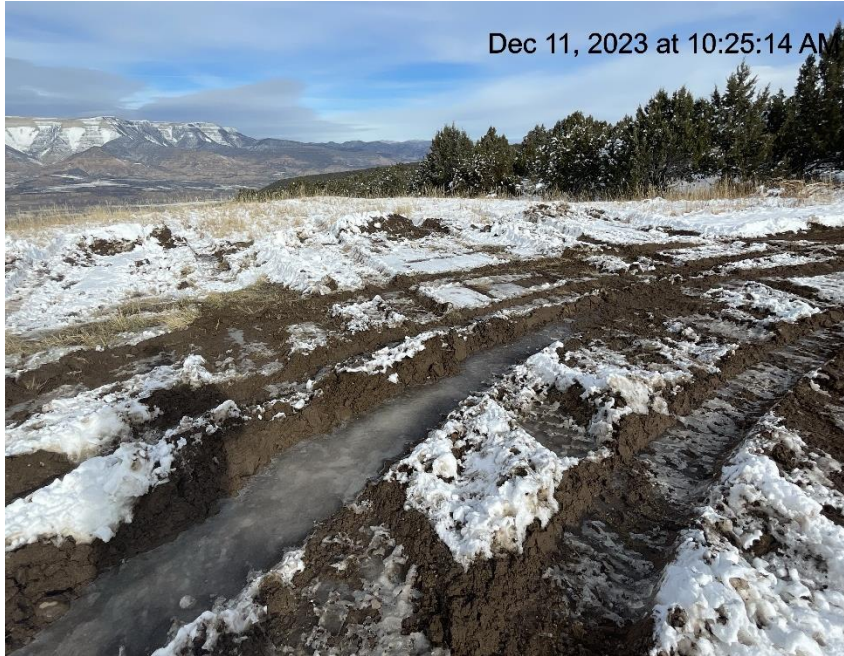
Photo # 9059 Lack of stabilization/compaction/insufficient BMP's

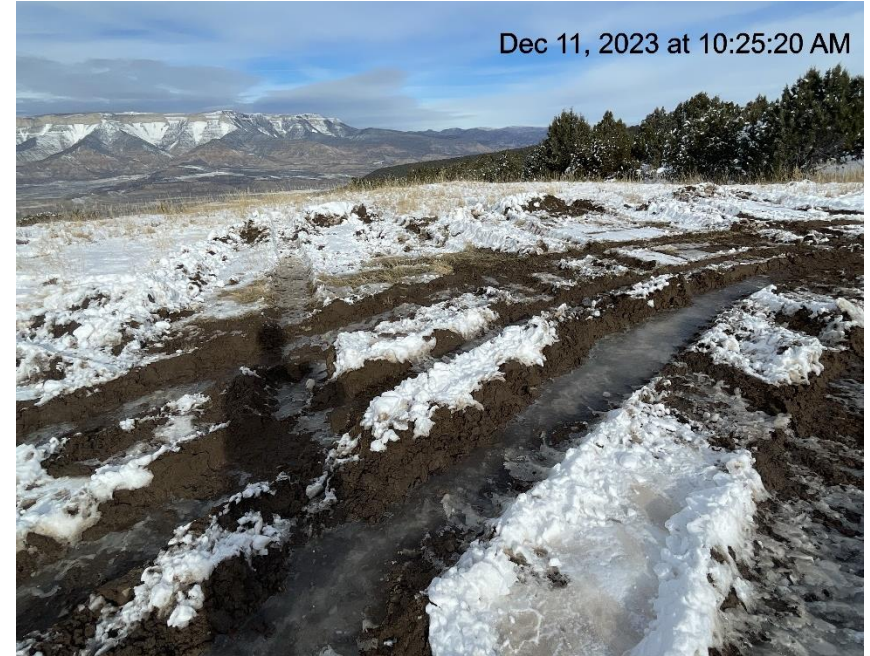
Photo # 9060 Lack of stabilization/compaction/insufficient BMP's

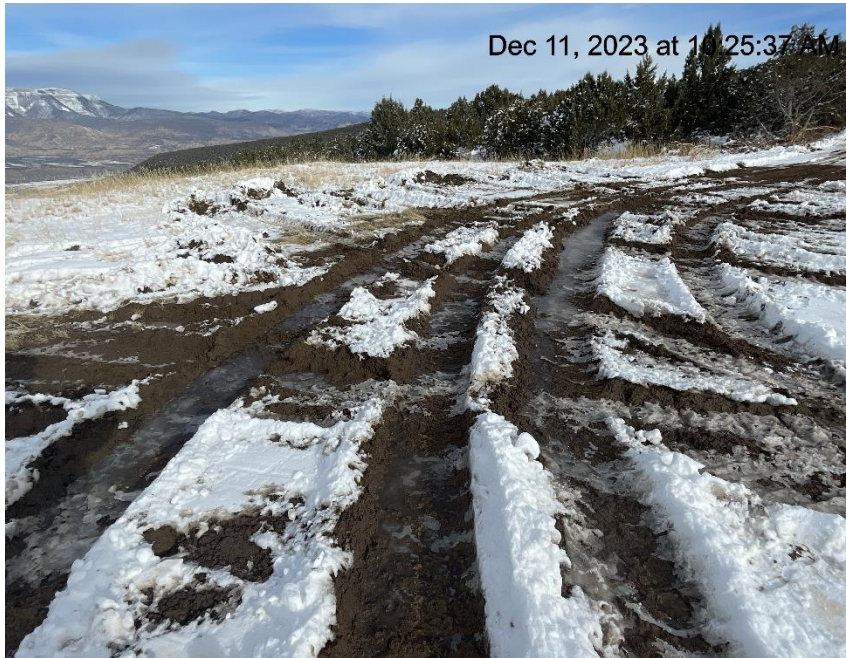
Photo # 9061 Lack of stabilization/compaction/insufficient BMP's

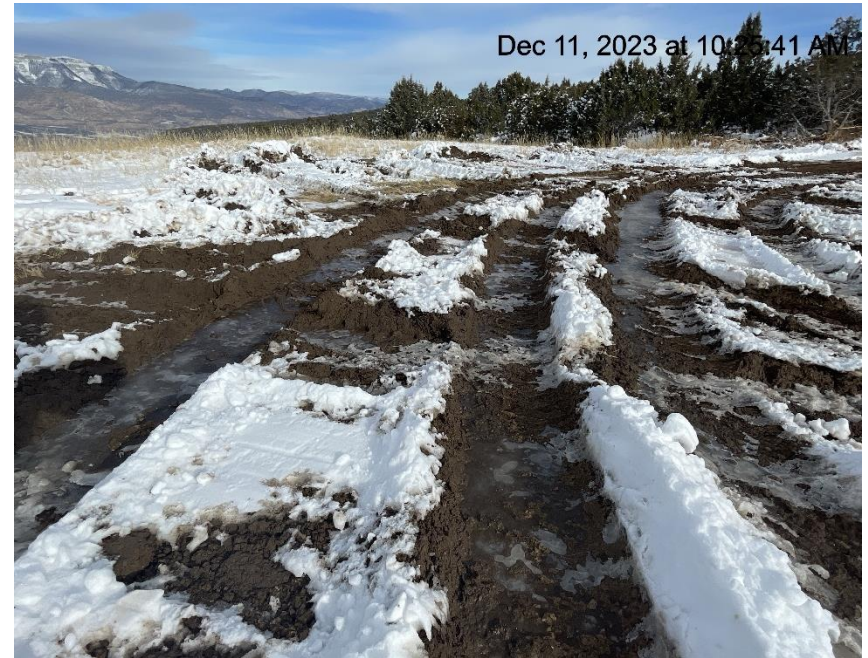
Photo # 9062 Lack of stabilization/compaction/insufficient BMP's

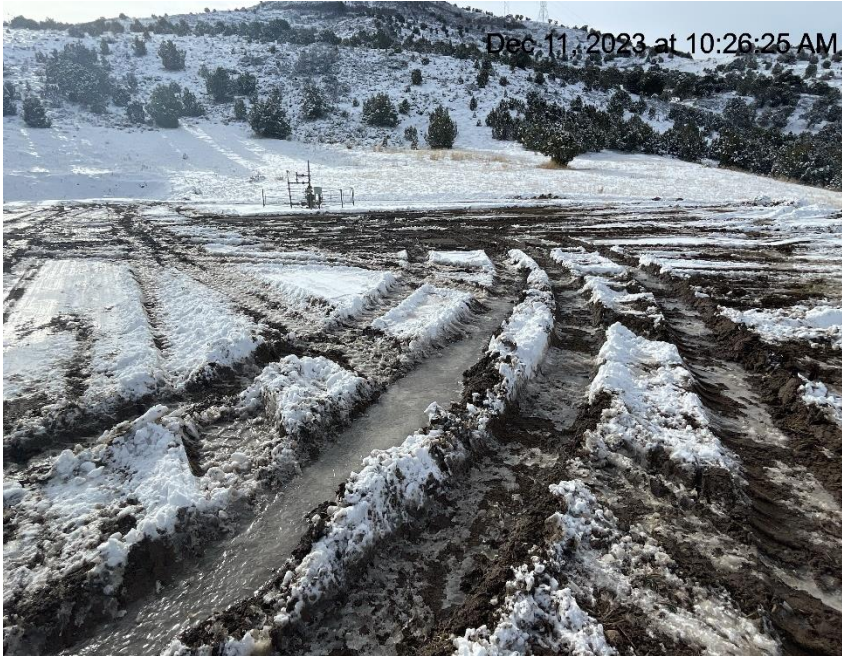
Photo # 9063 Lack of stabilization/compaction/insufficient BMP's

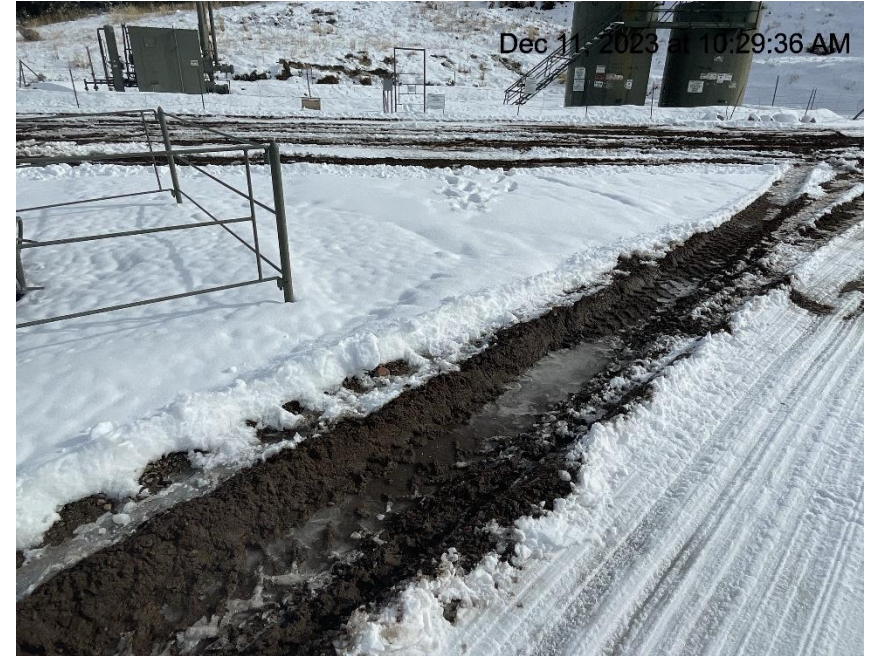
Photo #9064 Lack of stabilization/compaction/insufficient BMP's

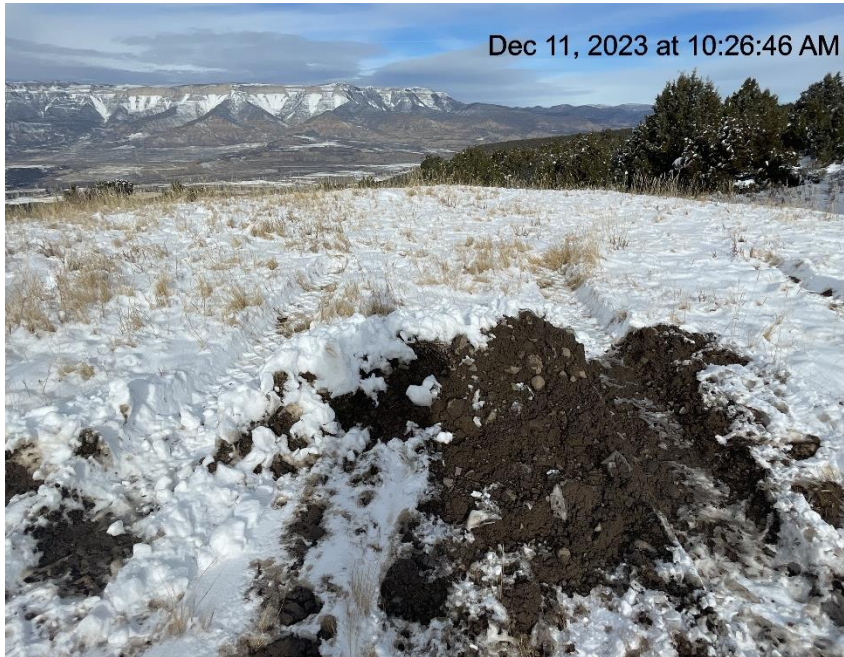
Photo # 9065 Sediment/soils transported into the interim area

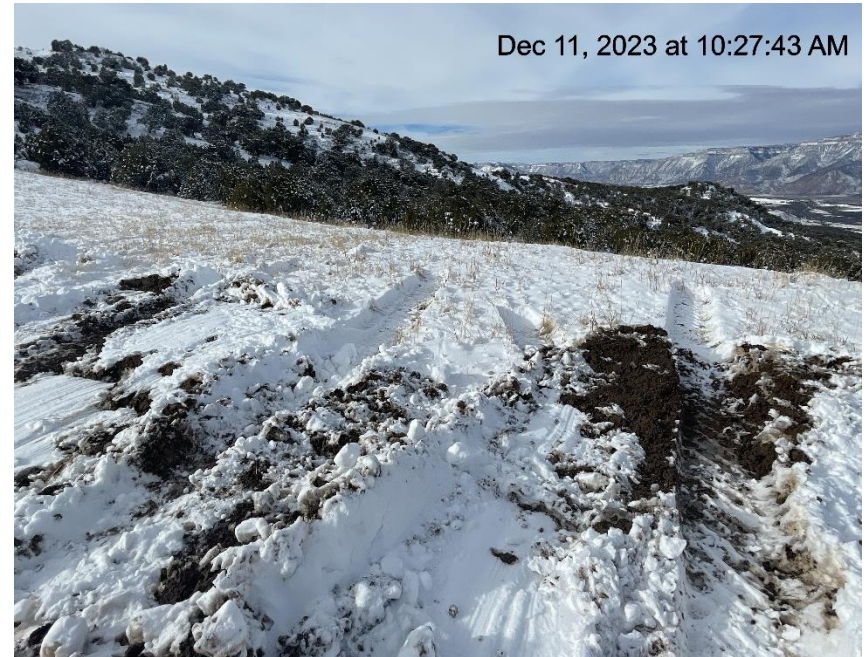
Photo #9066 Sediment/soils transported into the interim area
