**Operator: BONANZA CREEK ENERGY OPERATING COMPANY LLC**

**Location Name: Antelope B-33 Pad**

**Loc ID: 432287**

**Inspection: 713900095**

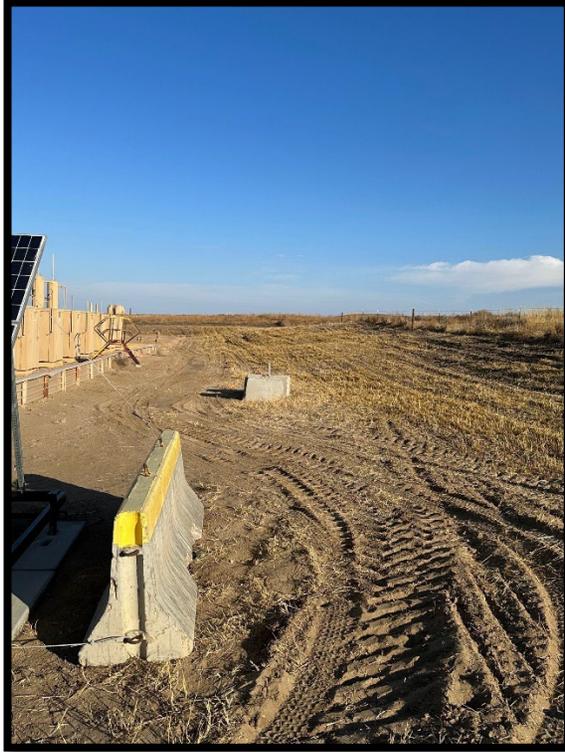
**Exhibit A**

**CA:** Weed debris in the form of tumbleweeds were observed along the perimeter fence of the location. Tumbleweeds are a troublesome annual non-native weed that easily breaks off at the stem. Operator failed to control and manage weeds to prevent weed waste and prevent the spread of seeds onto adjacent lands. Comply with Rule 606 to remove weed debris.

**CA Resolution:** Operator has addressed and cleared weed debris and mowed location to comply with Rule 606.

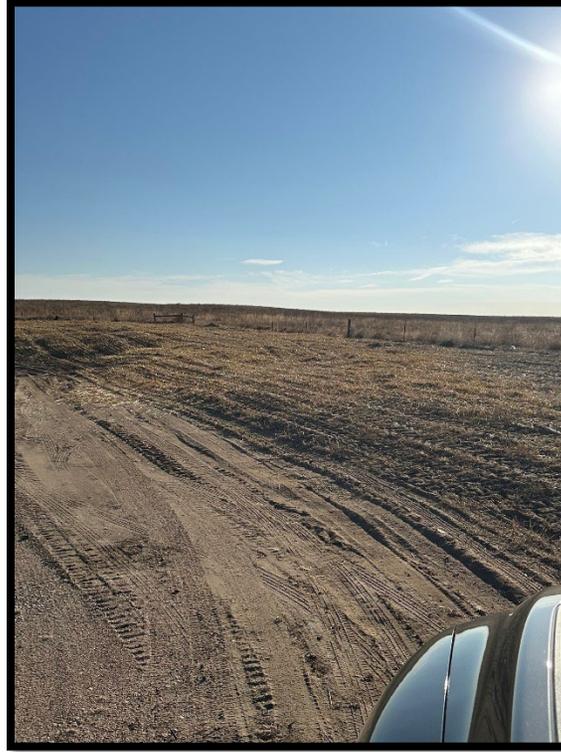
**Exhibit B**

**CA:** Boards and stakes left across the location area. Refer to photo 8 as an example. Comply with Rule 606.

**CA Resolution:** Operator has addressed and removed identified trash/unused equipment on location to comply with Rule 606.
