Inspection Photos
Location Name: State 44-36
Location ID: 306091

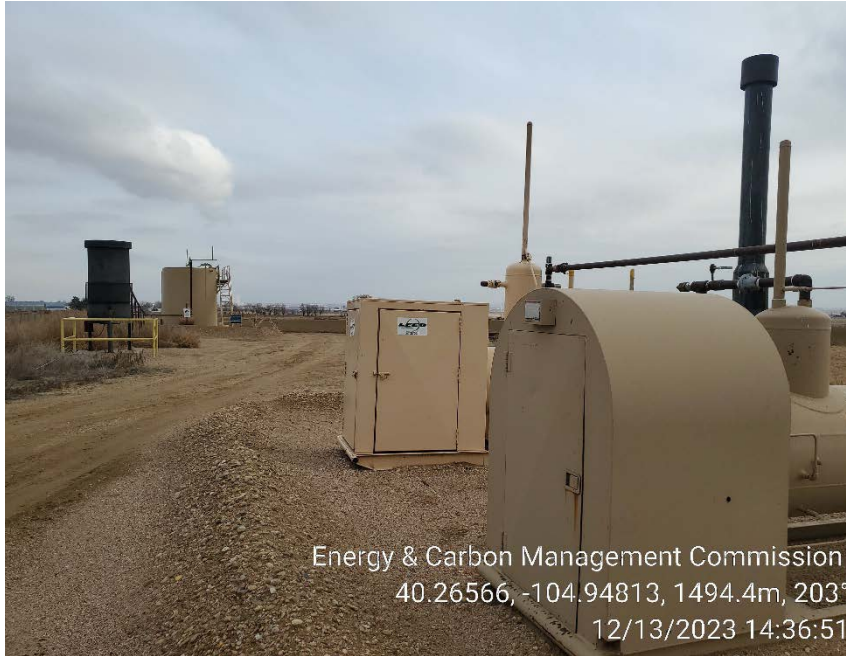
Production facility

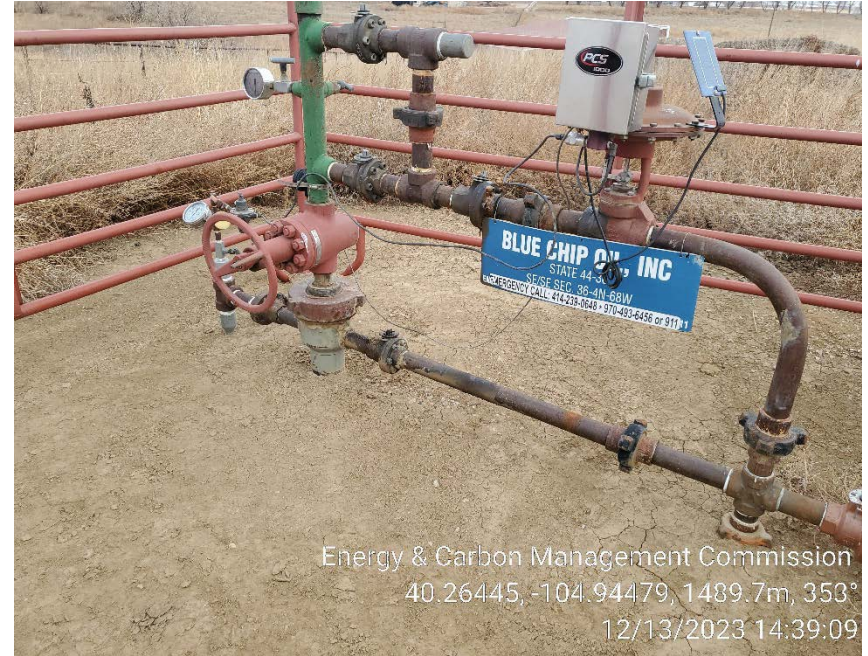
Wellhead

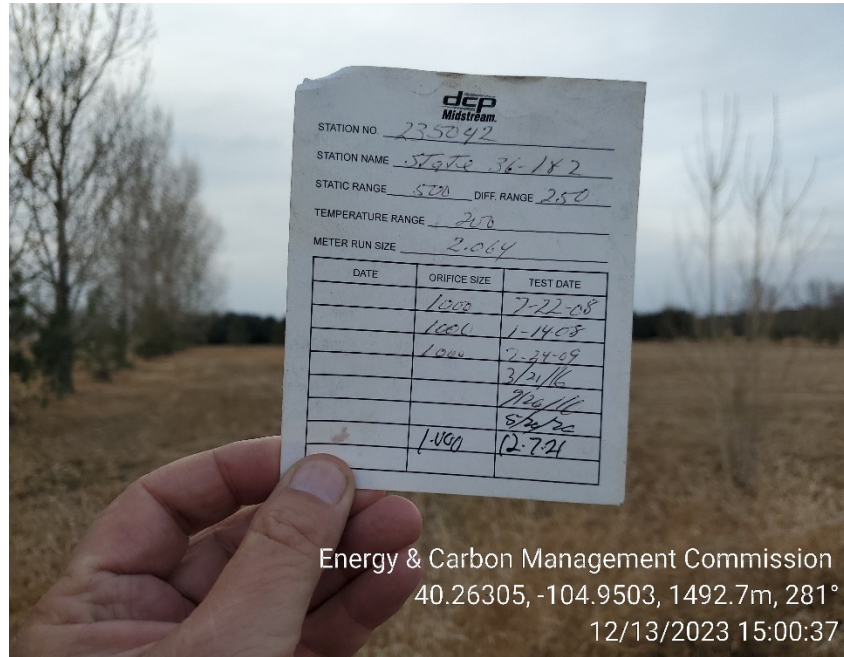
DCP meter calibration card
