Inspection Photos

Location Name: AMIGO-66N64W/17NWNE

Location ID: 330135

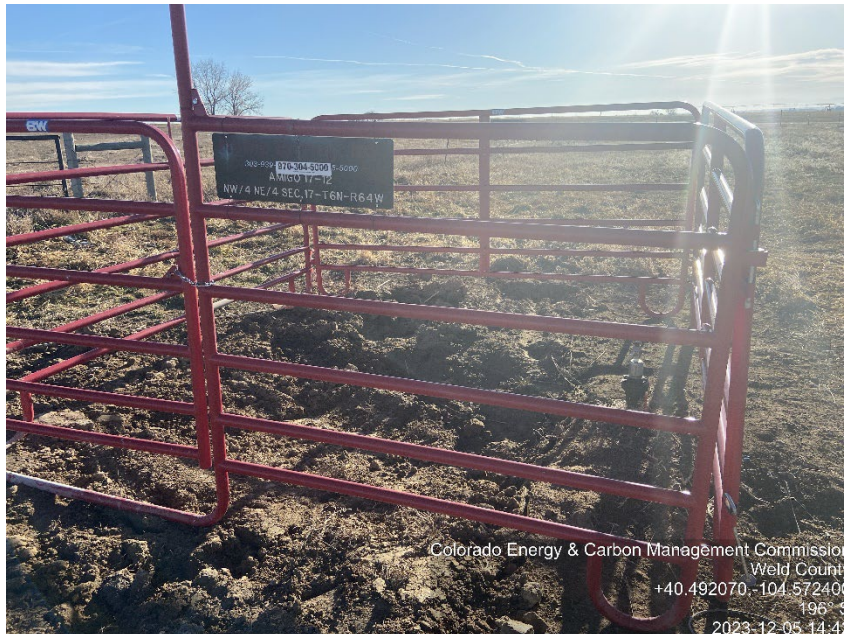
Photo #1

Amigo 17-12 (123-18484) Wellsite

Plugged & Abandoned | PA

Cut / Capped

Flowline is Locked-Out, Tagged-Out | LOTO

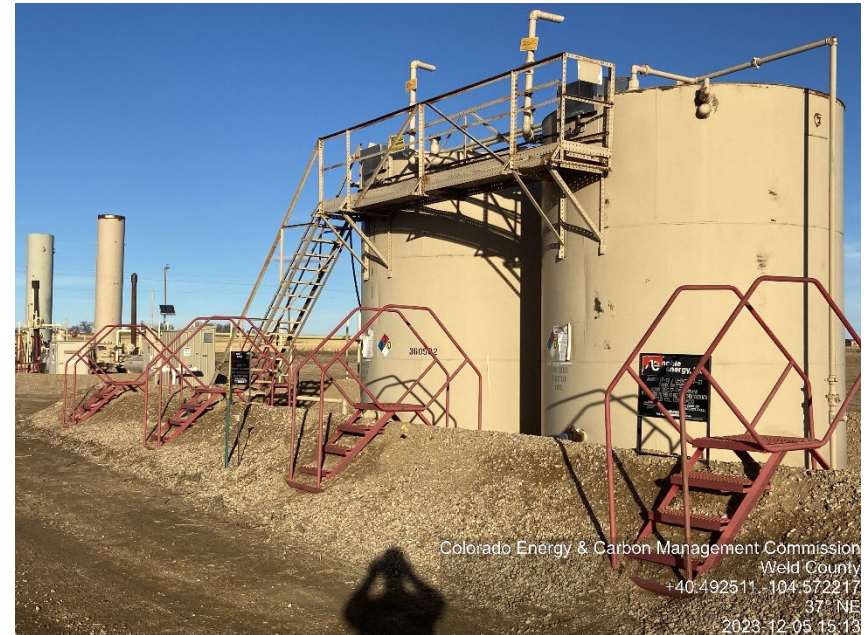
Photo #2

Amigo 17-12 Battery site

Inactive | Shut-down

Formerly served:

Amigo 17-12, Gulley 17-15, Uhrich 17-21 ;

Plugged & Abandoned | PA

Equipment Documented; Loc ID: 330135

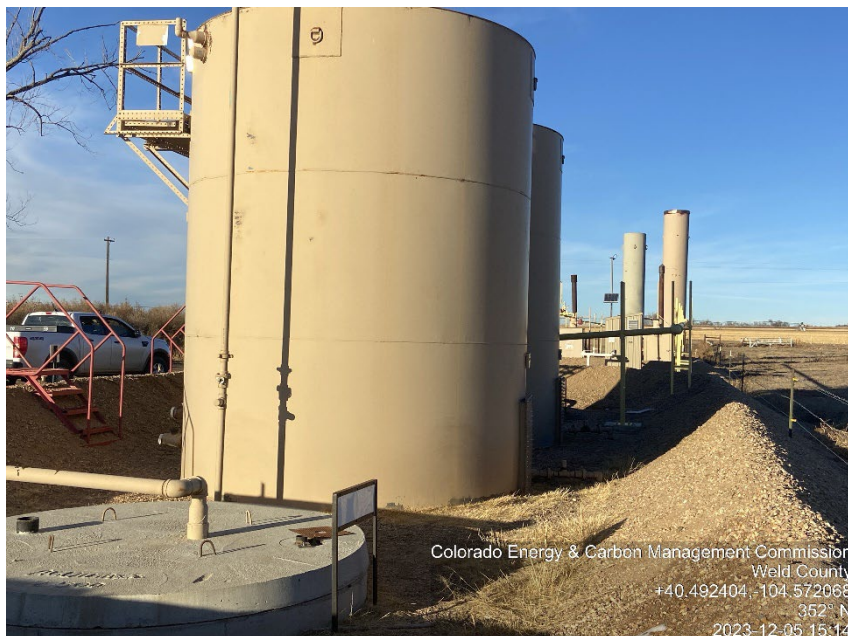
Photo #3

Amigo 17-12 Battery site

Inactive | Shut-down

Tank(s): SE corner

Corrective Action: Unnecessary Equipment

All wells have been PA'd; Remove Equipment

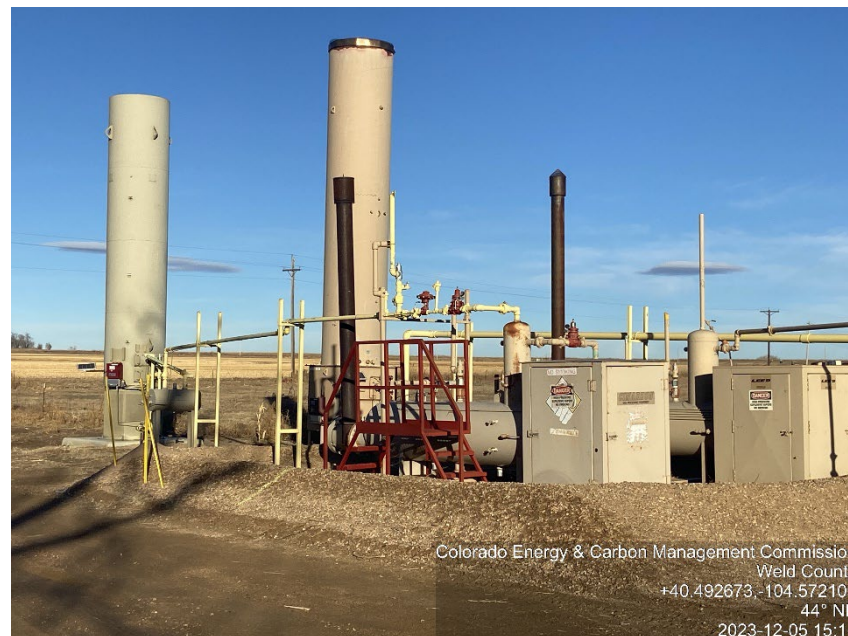
Photo #4

Amigo 17-12 Battery site

Inactive | Shut-down

ECD(s), Separator(s)

Corrective Action: Unnecessary Equipment

All wells have been PA'd; Remove Equipment
