Inspection Photos

Location Name: CAERUS PICEANCE LLC FEDERAL GARDNER (PK-21) Pad

Location ID: 334769

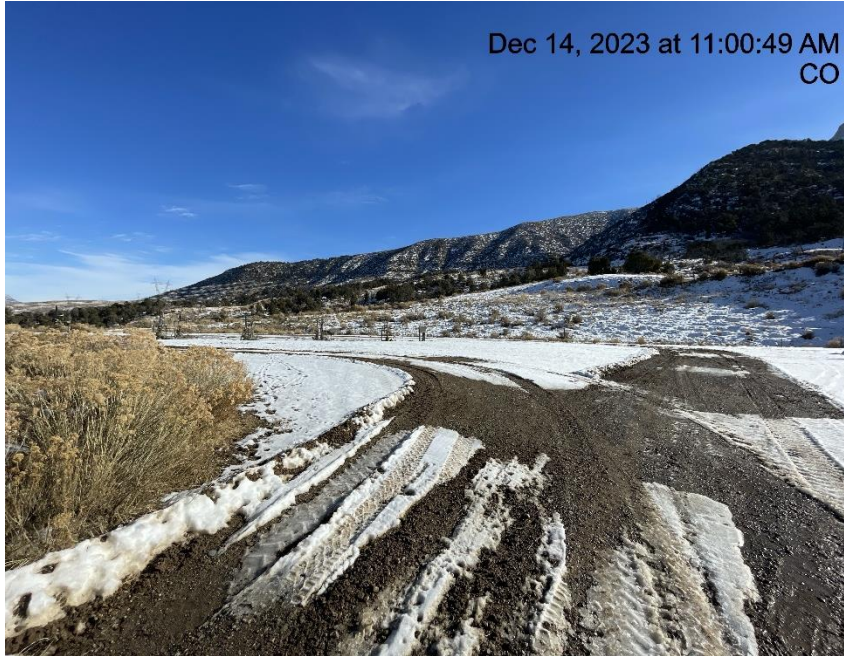
Photo # 9743 From entrance to location

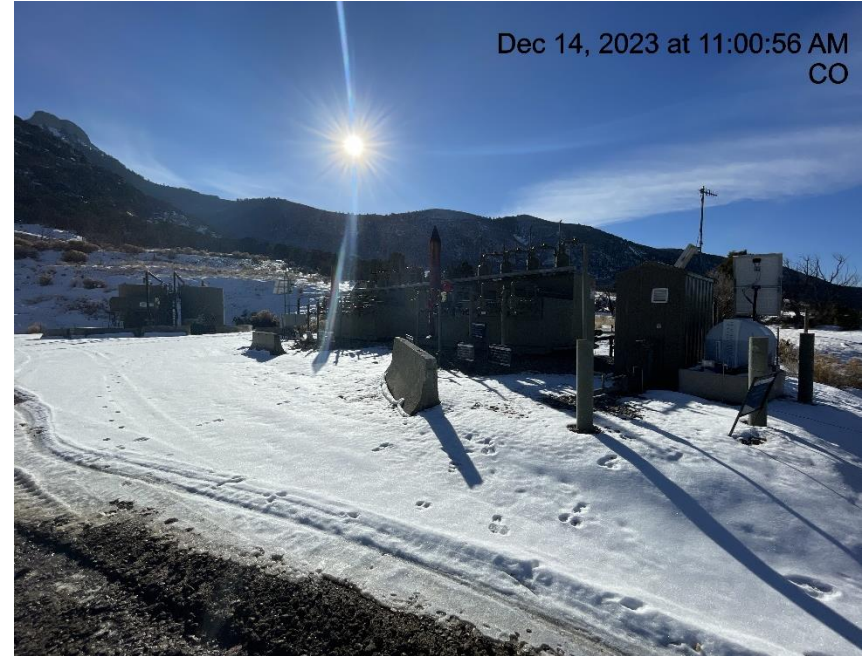
Photo # 9744 From entrance to location

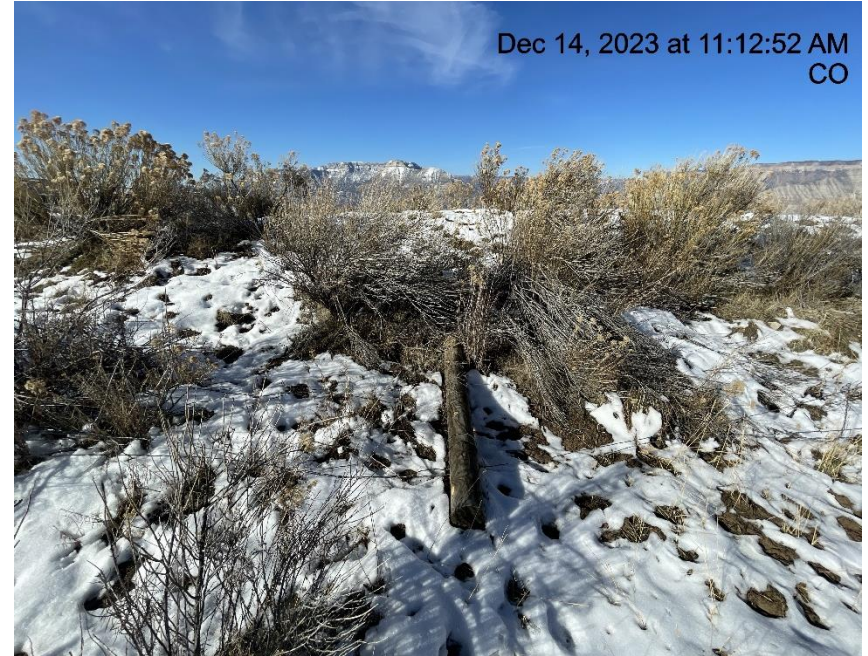
Photo # 9750 Barbed wire fence needs maintenance/wildlife hazard

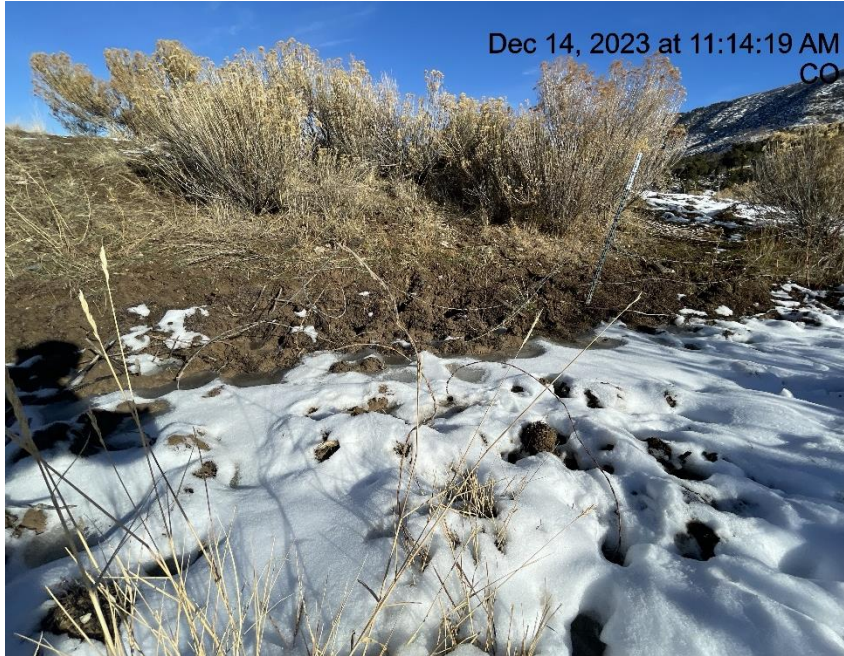
Photo # 9751 Barbed wire fence needs maintenance/wildlife hazard

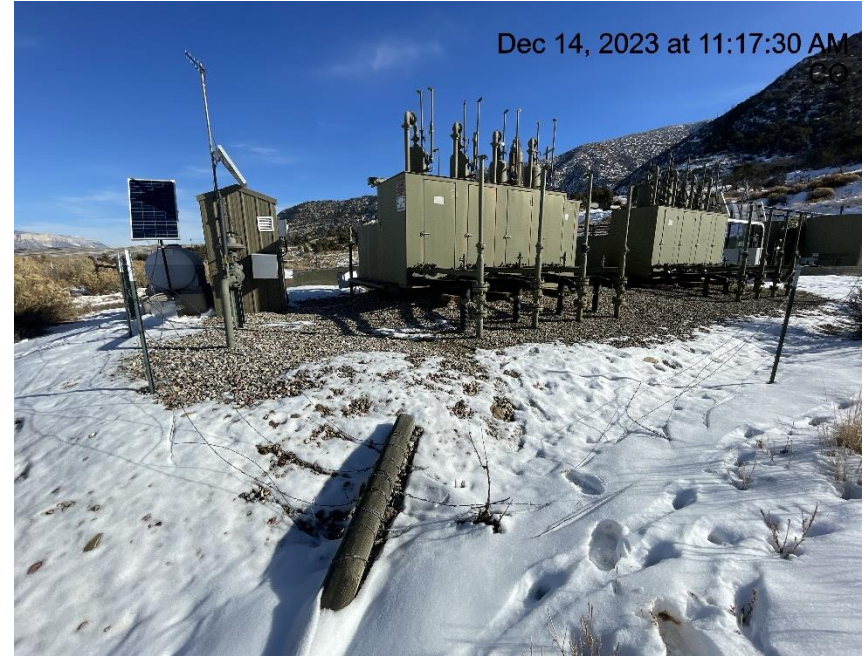
Photo # 9752 Barbed wire fence needs maintenance/wildlife hazard

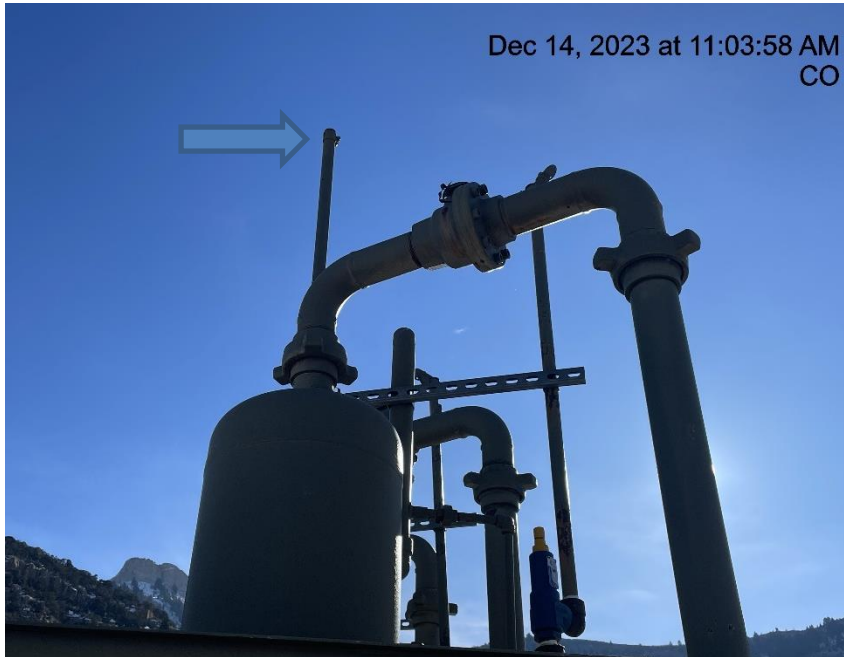
Photo # 9753 Rupture disc vent line lacks cap

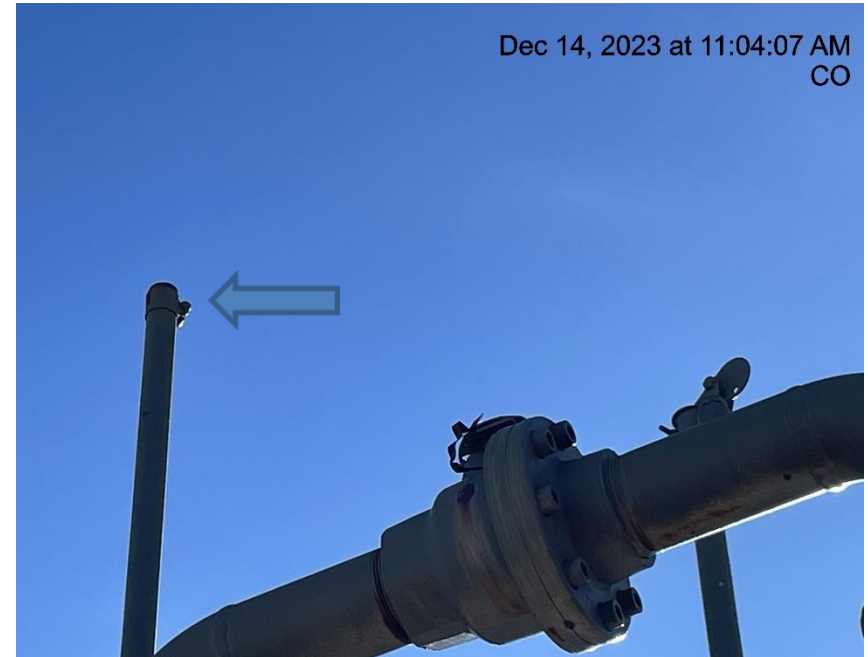
Photo # 9754 Rupture disc vent line lacks cap
