Inspection Photos

Location Name: CAERUS PICEANCE LLC SAVAGE RE1 Pad

Location #: 334639

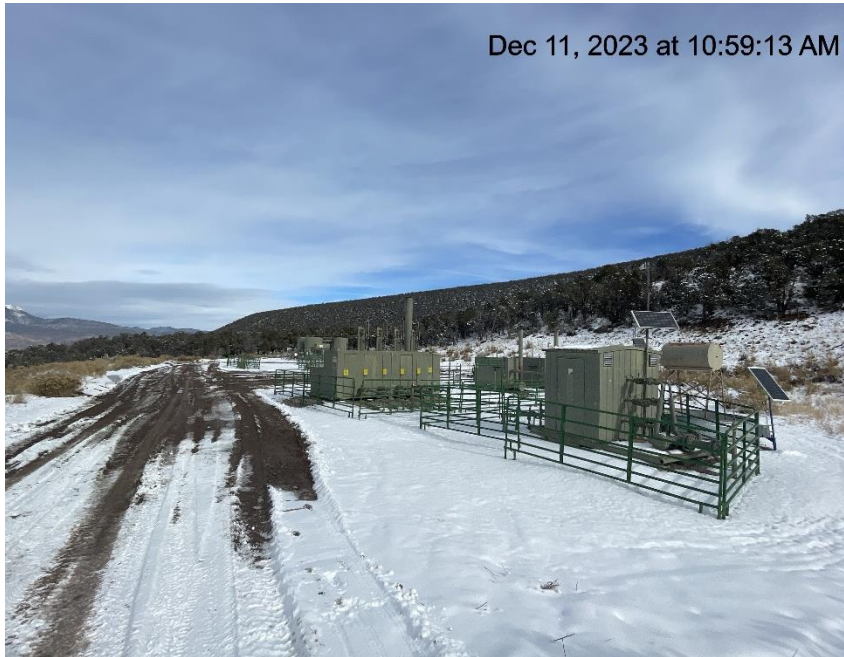
Photo # 9179 From entrance to location

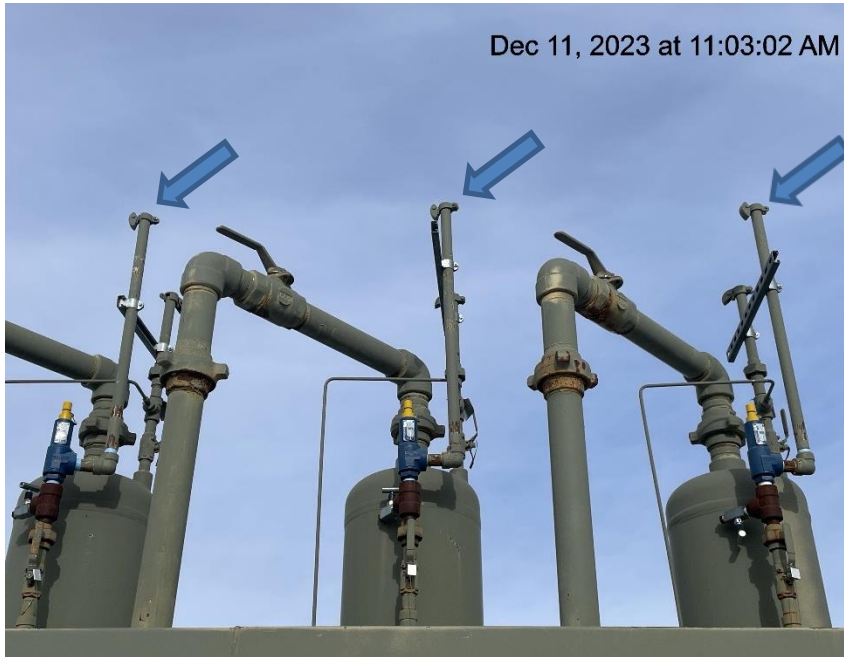
Photo # 9189 PRV vent lines lack caps

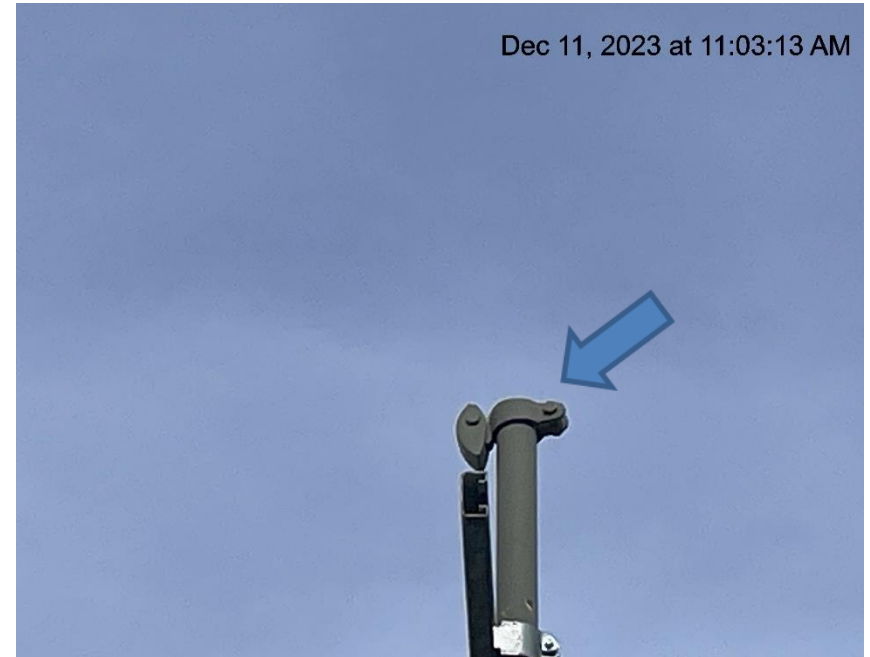
Photo # 9190 PRV vent line lacks cap

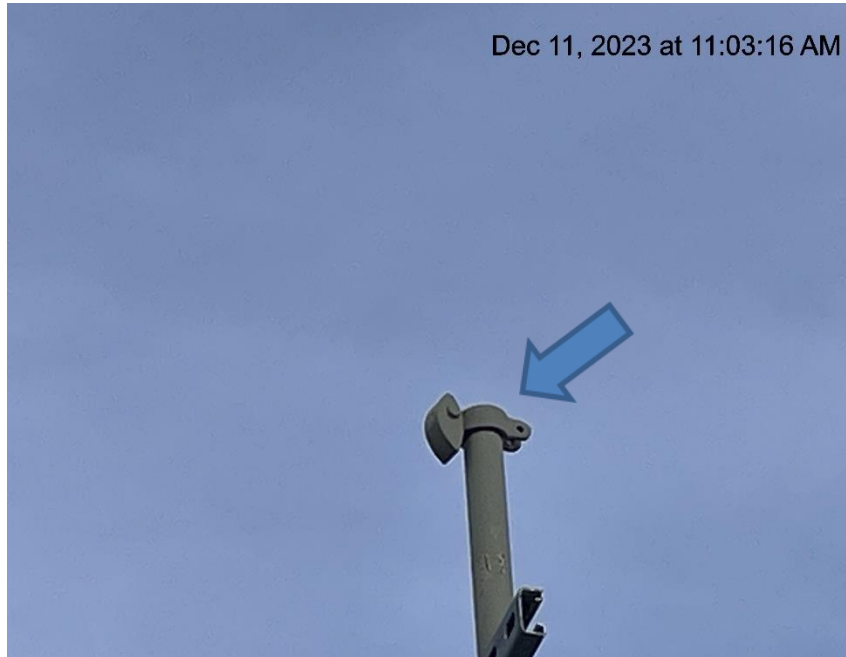
Photo # 9191 PRV vent line lacks cap

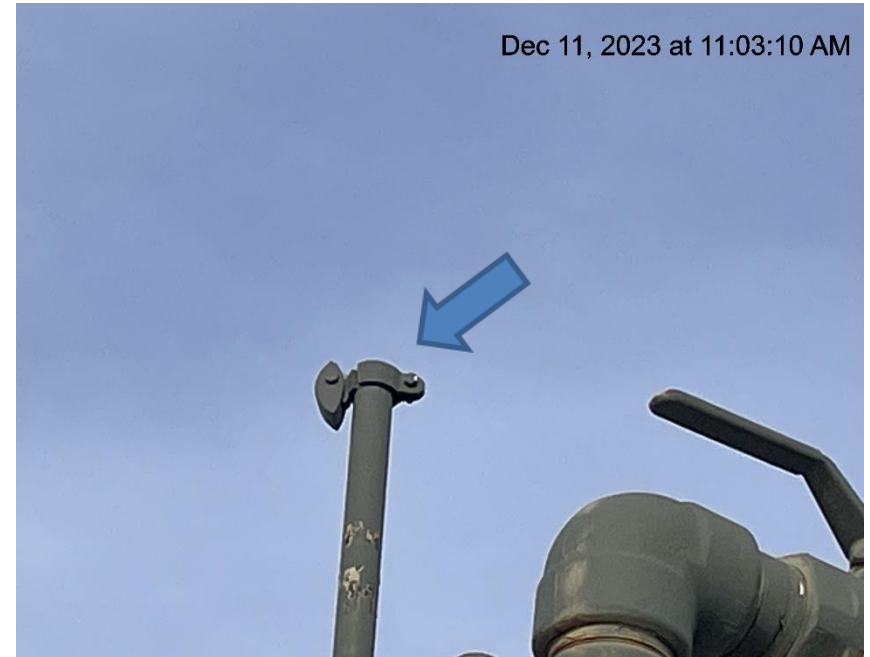
Photo # 9192 PRV vent line lacks cap
