**Storm Water Management and Erosion control**  
**Location Name: CAERUS PICEANCE LLC SAVAGE RE1 Pad**  
**Location #: 334639**

**Location Overview: Location is within High  
Priority/Density/Black Bear Habitat areas. Location is in close  
proximity to Rule 411a Surface Water External Buffer  
Section/Township/Range: 1 7S94W**

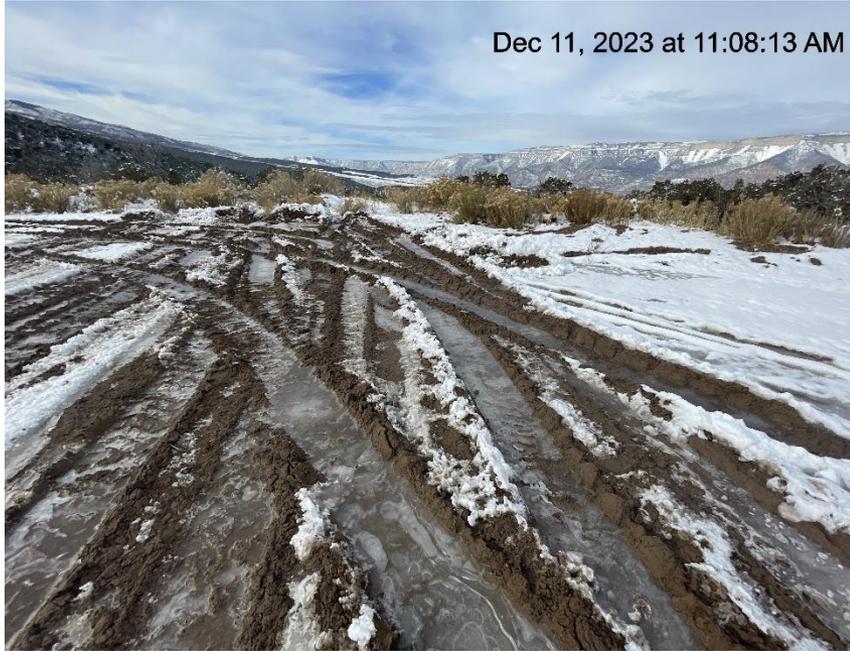
**Photo # 9193 Lack of stabilization/compaction/insufficient BMP's**

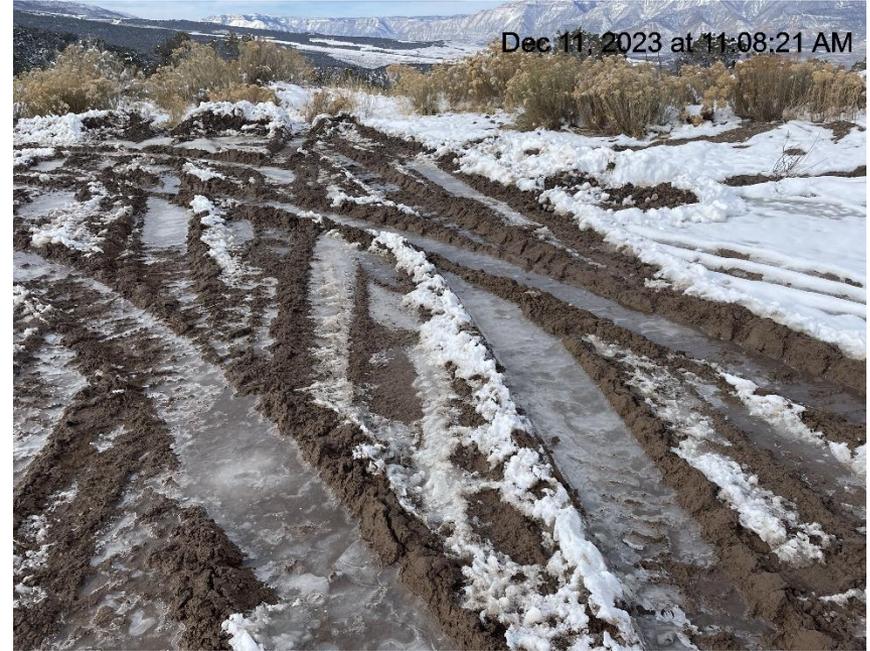
**Photo # 9194 Lack of stabilization/compaction/insufficient BMP's**

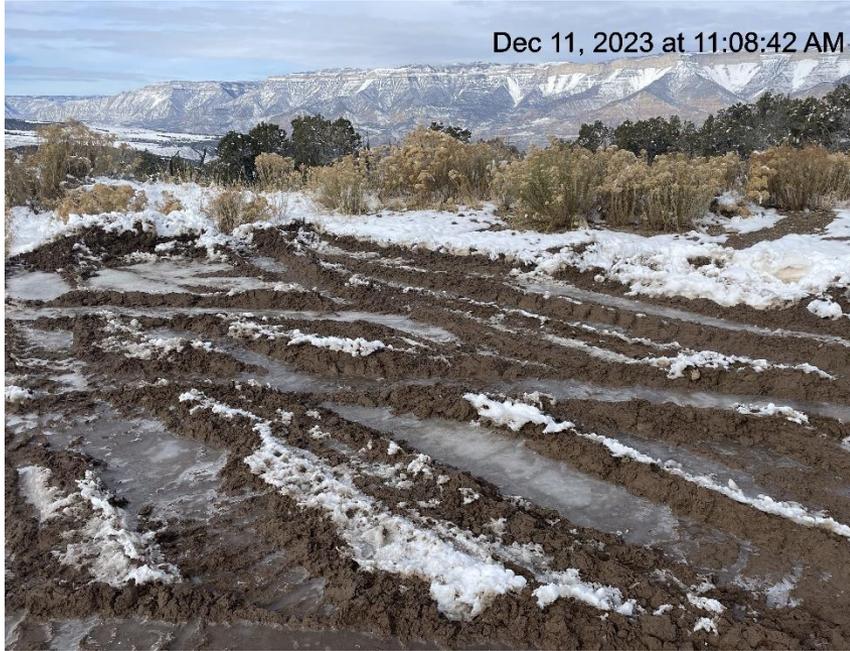
**Photo # 9195 Lack of stabilization/compaction/insufficient BMP's**

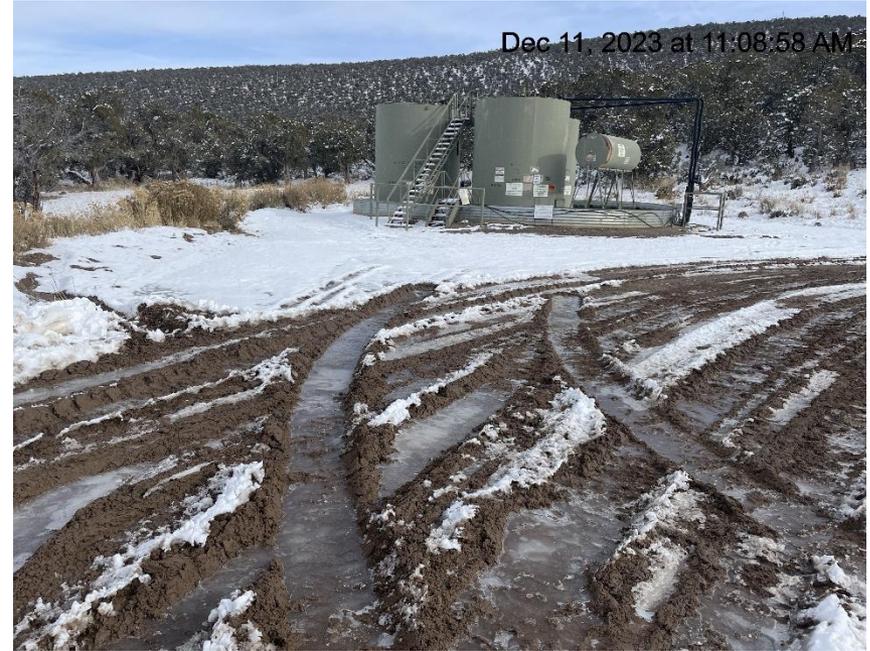
**Photo # 9196 Lack of stabilization/compaction/insufficient BMP's**

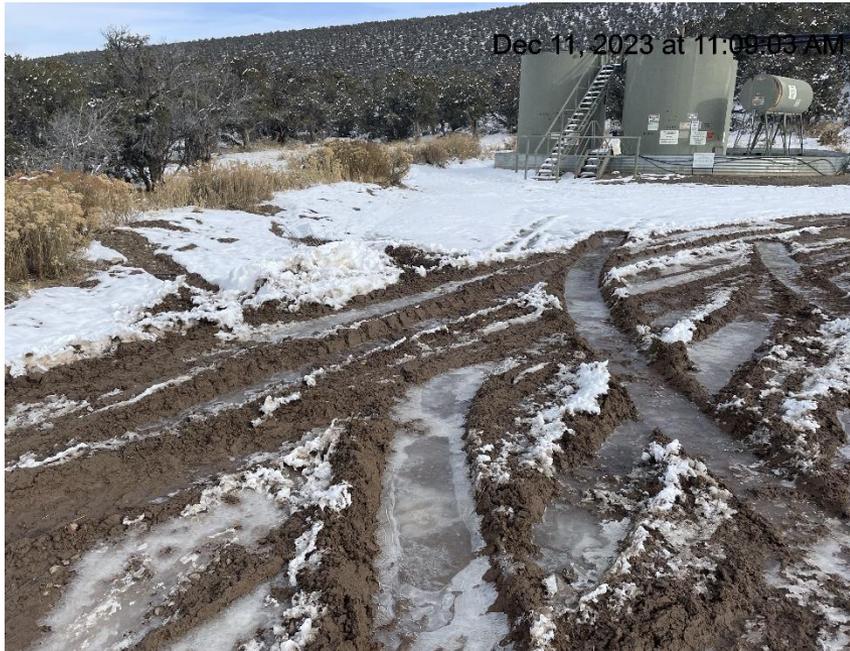
**Photo # 9197 Lack of stabilization/compaction/insufficient BMP's**

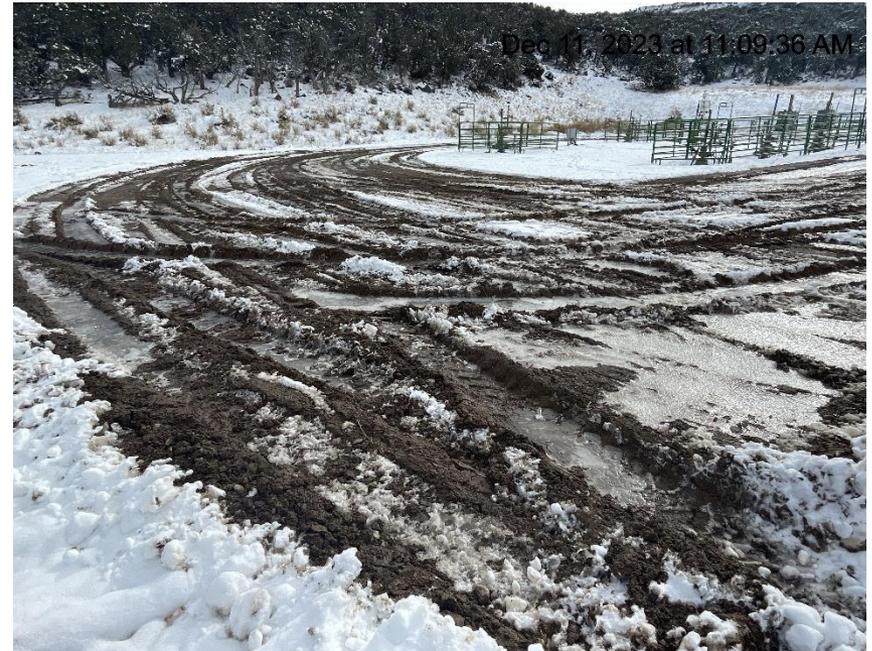
**Photo # 9198 Lack of stabilization/compaction/insufficient BMP's**

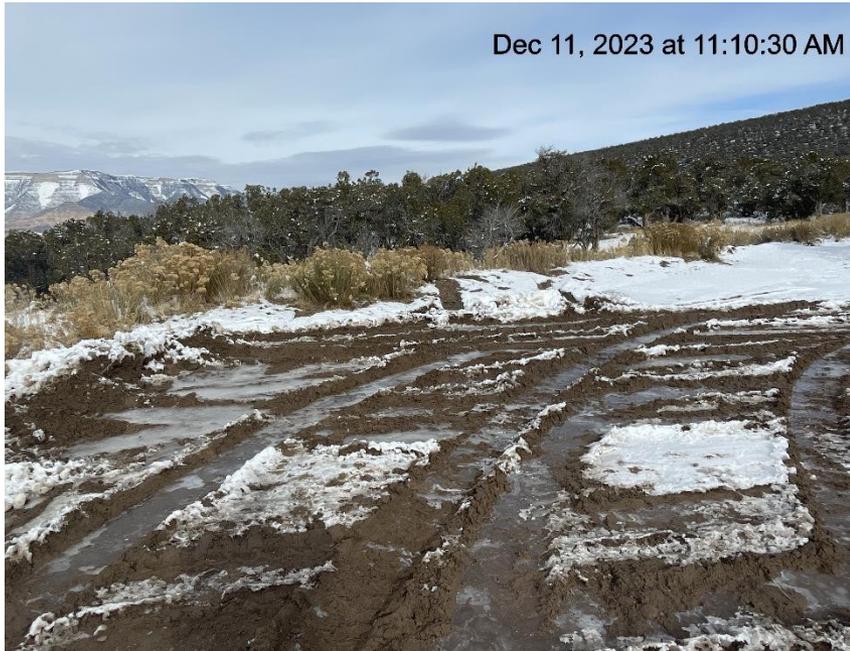
**Photo # 9199 Lack of stabilization/compaction/insufficient BMP's**

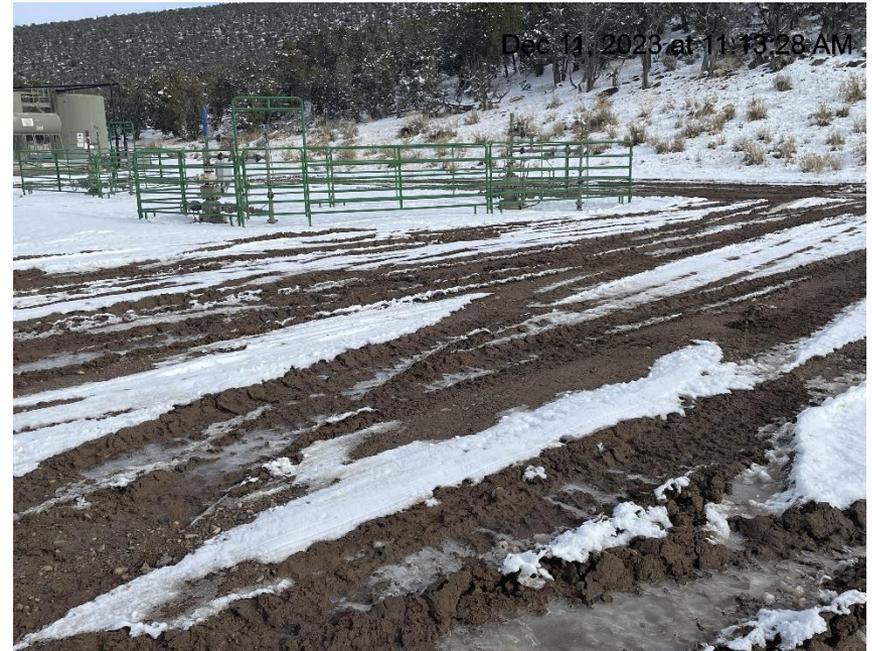
**Photo # 9200 Lack of stabilization/compaction/insufficient BMP's**

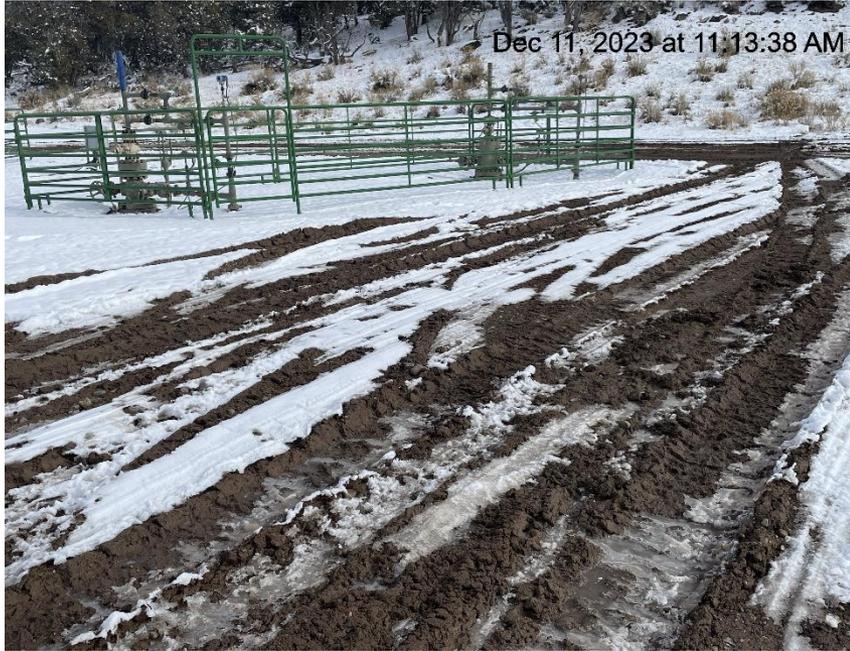
**Photo # 9201 Lack of stabilization/compaction/insufficient BMP's**

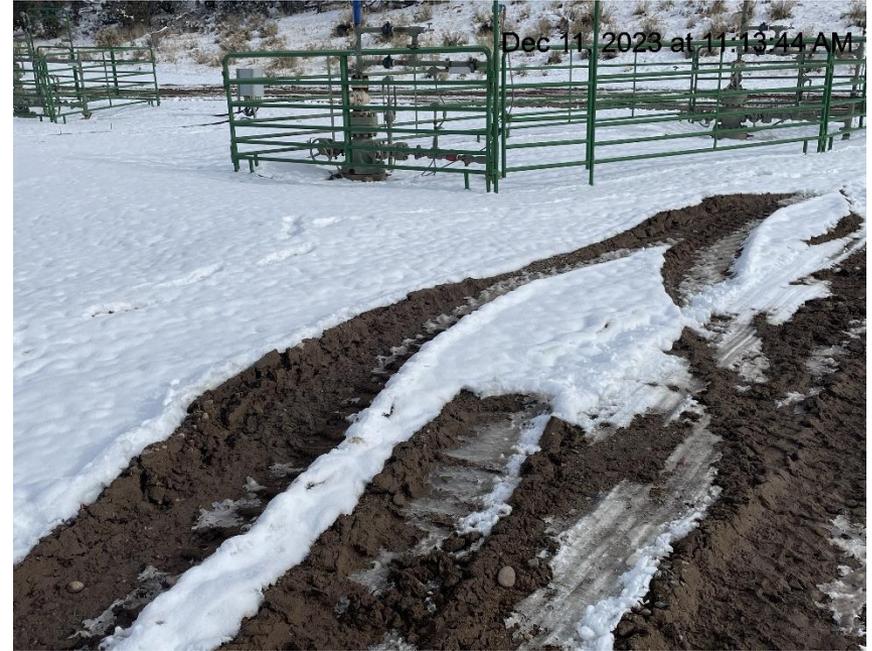
**Photo # 9202 Lack of stabilization/compaction/insufficient BMP's**
