Inspection Photos

Location: Tanner "E" 1

Facility ID: 321098

API #: 05-009-06450

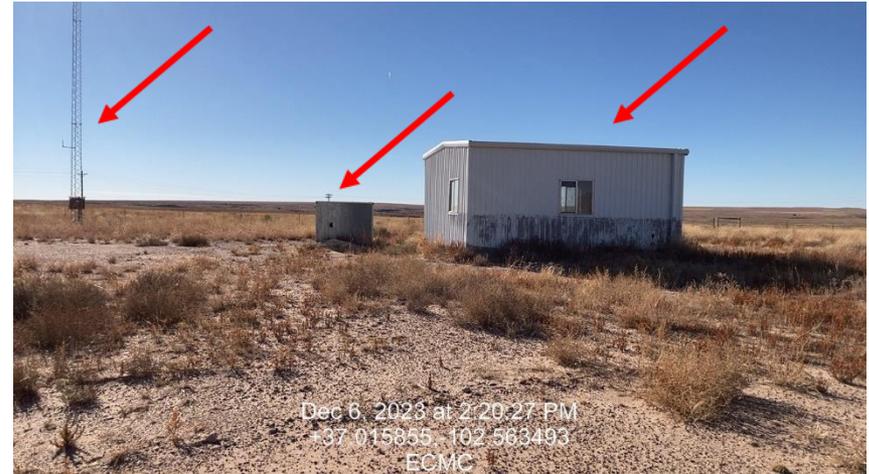
Photo 1 –Location Information

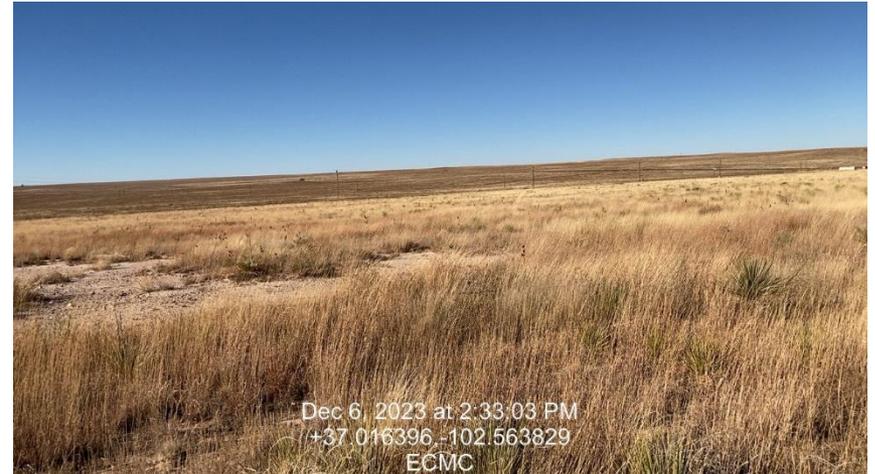
Photo 5 – View north west

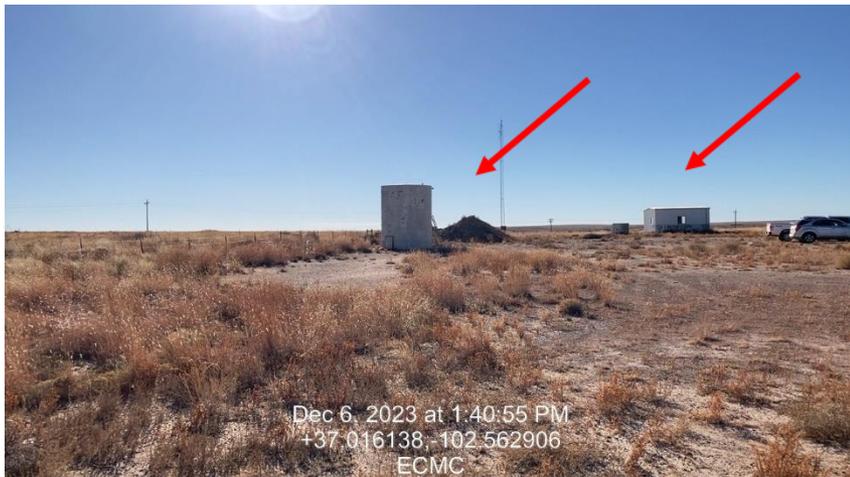
Photo 6 – View north east

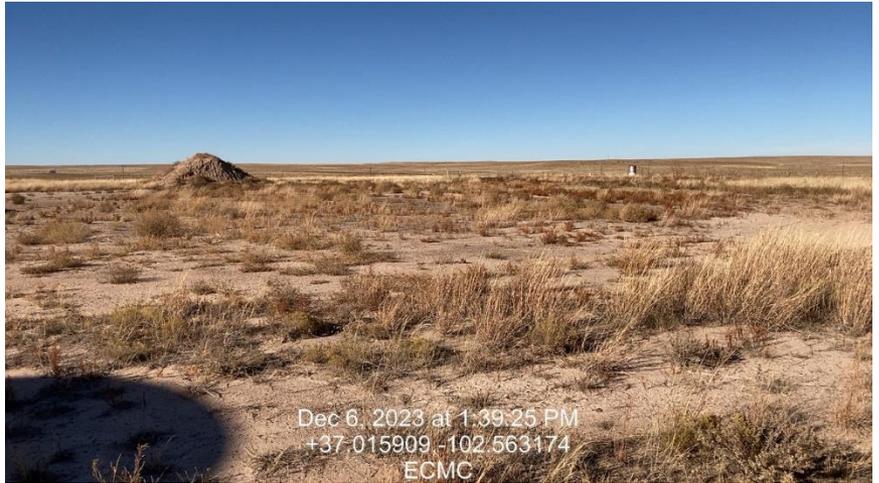
Photo 7 – Location and equipment overview

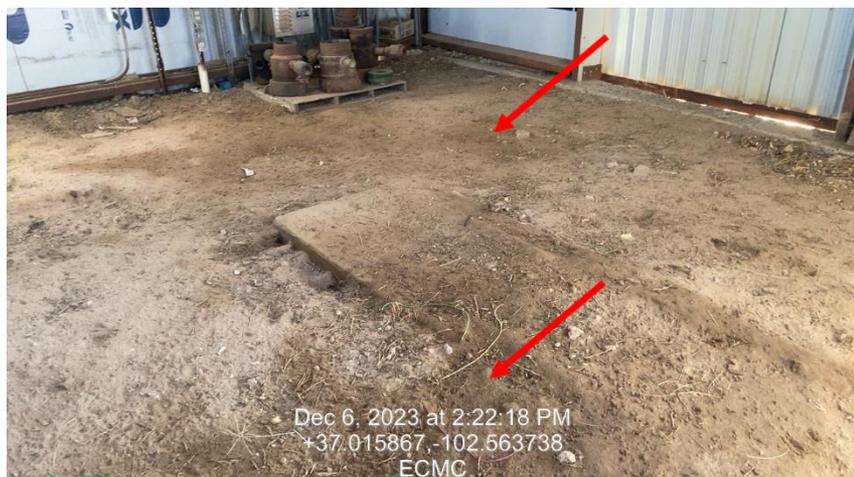
Photo 8 – View west

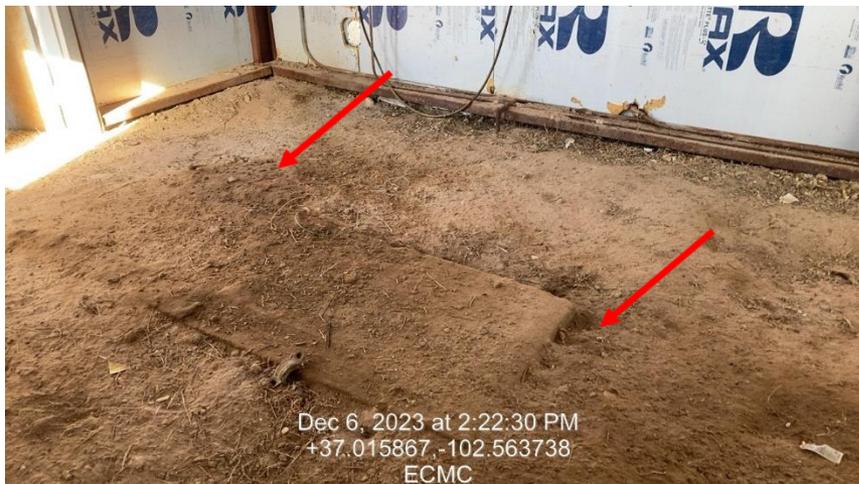
Photo 9 – Inside Building, Impacted soils observed

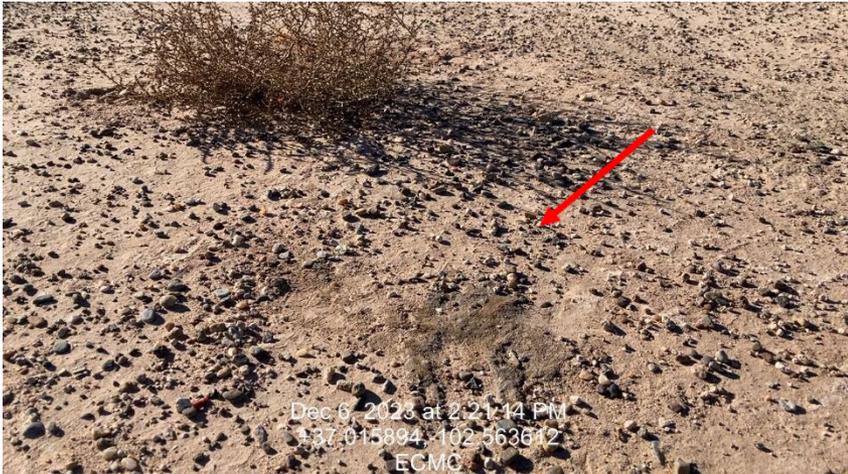
Photo 11 – Impacted soils on location

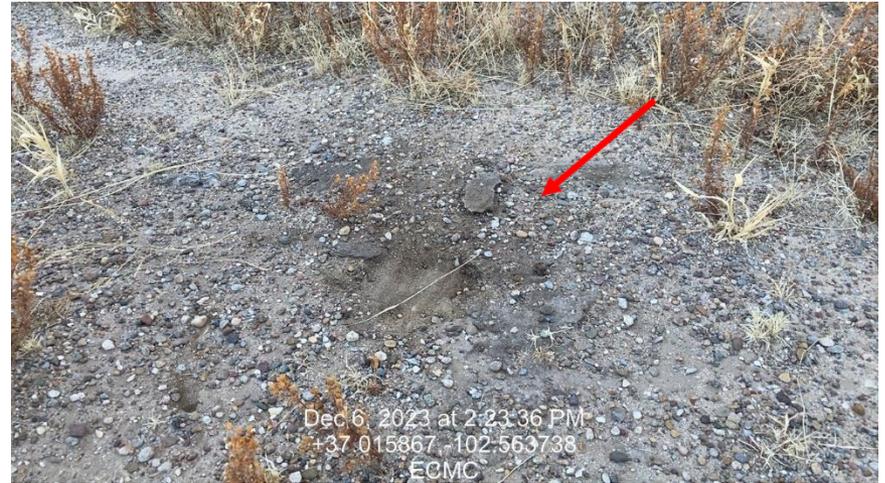
Photo 12 – Impacted soils on location

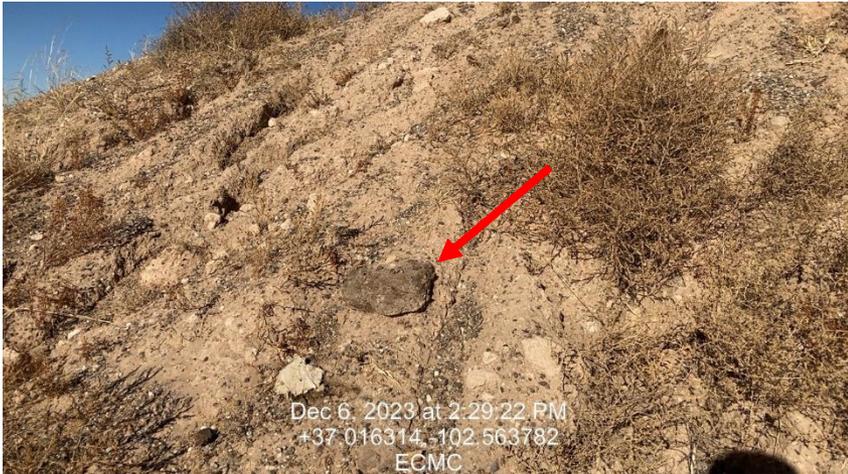
Photo 13 – Mound of impacted soils on North Side of location

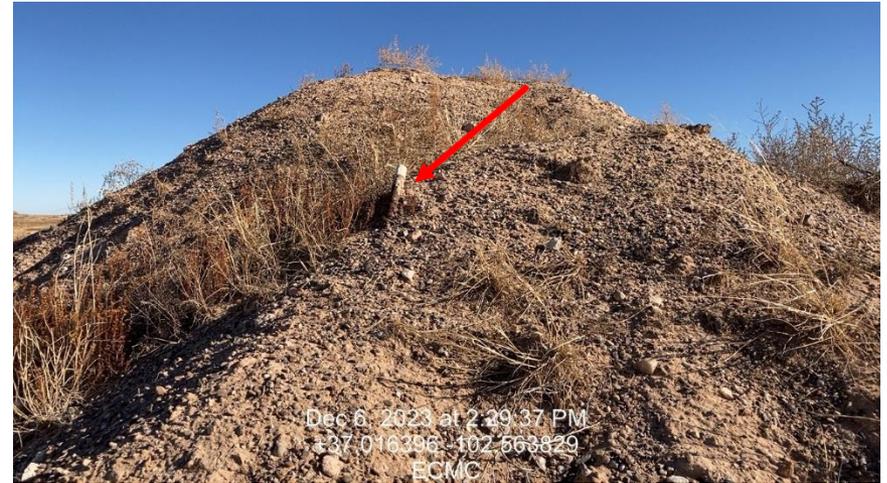
Photo 14 – Mound of impacted Soils with Debris

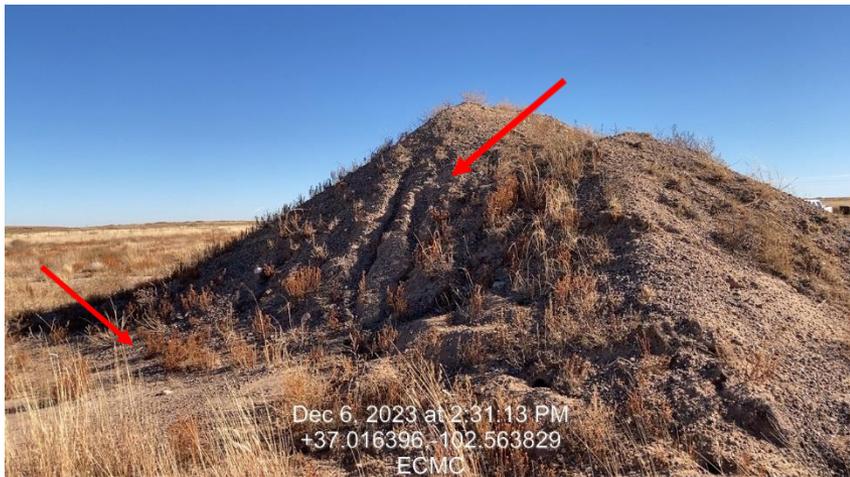
Photo 15 – Mound of impacted soils showing signs of erosion and soil migrating to Native un-impacted areas

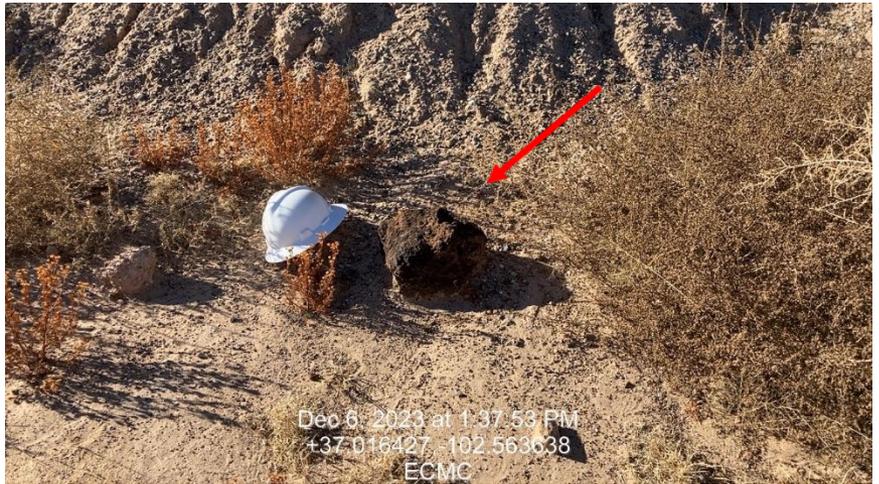
Photo 16 – Impacted material next to mound of soil
