## Inspection Photos

Location Name: CAERUS PICEANCE LLC, S.PARACHUTE TBI-67S96W/36NESE

Location ID: 334080

Date: 12/12/2023

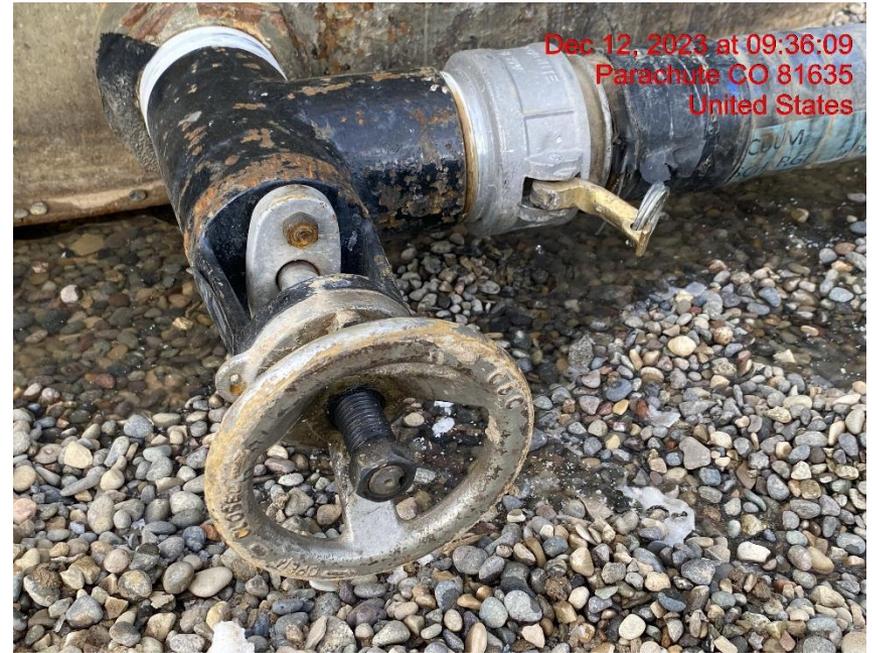
Leaking Load Line Connection – Photo #08146

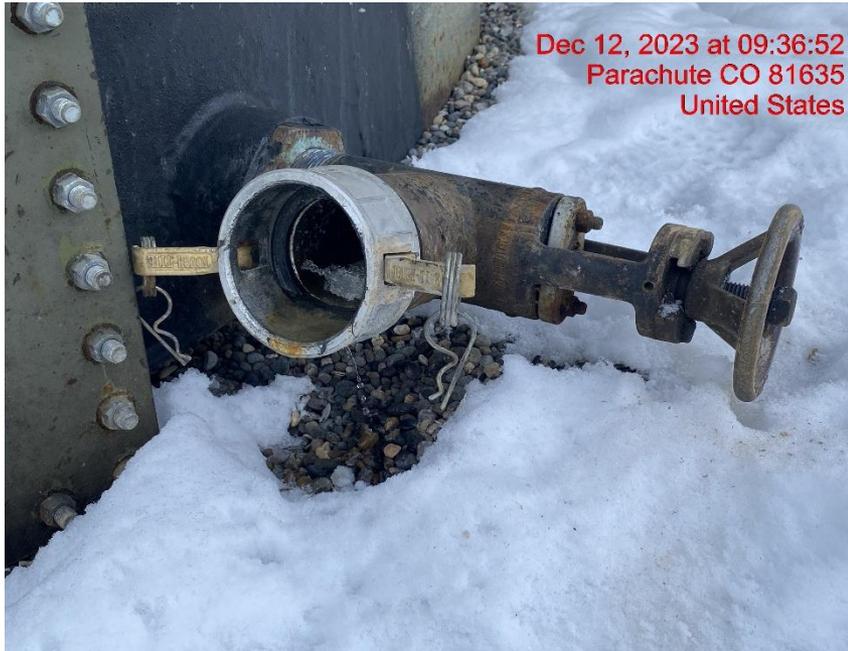
Leaking and Uncapped Load Line – Photo #08147

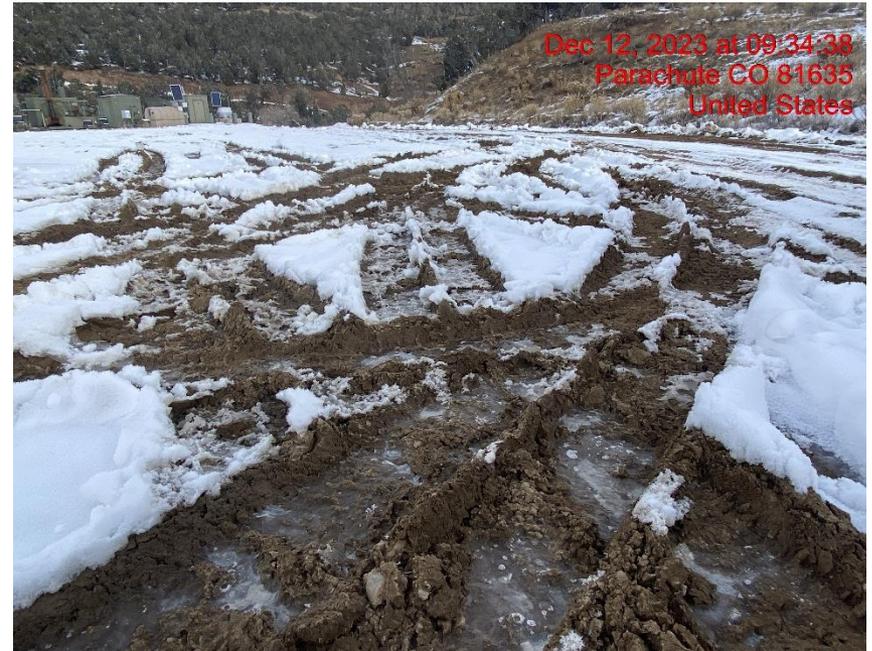
Lack of Stabilization – Photo #08143

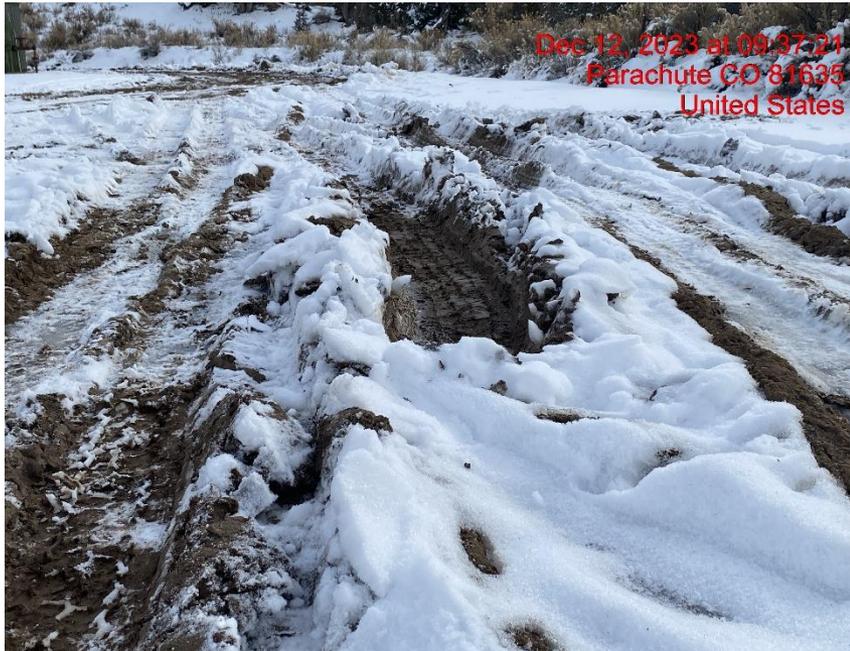
**Lack of Stabilization – Photo #08148**

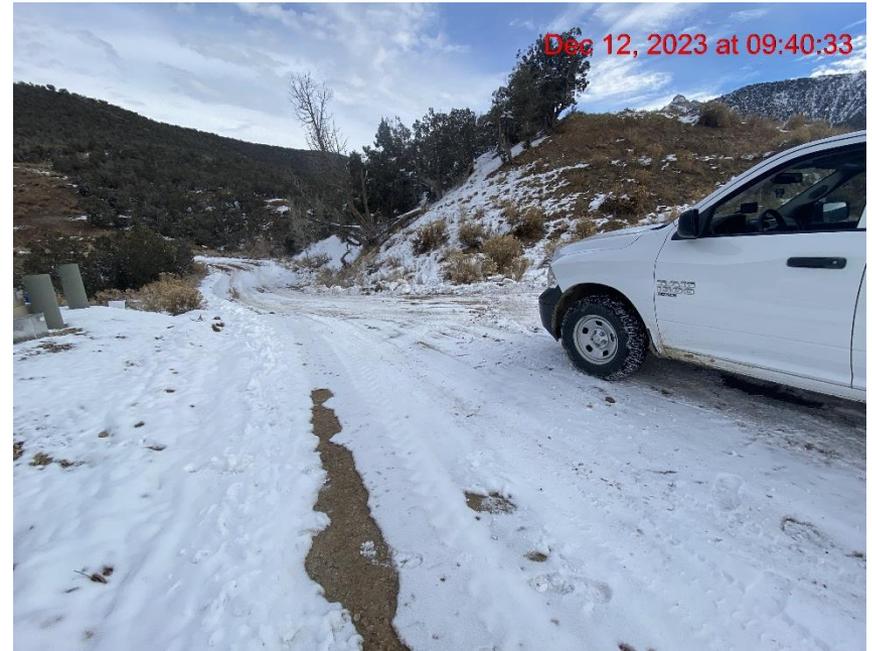
**Insufficient Vehicle Tracking BMPs at Location Entrance/Exit  
– Photo #08154**
