# Inspection Photos

API: 011-06032

Operator: STRACHAN EXPLORATION INC

Inspection Date: 12/15/2023

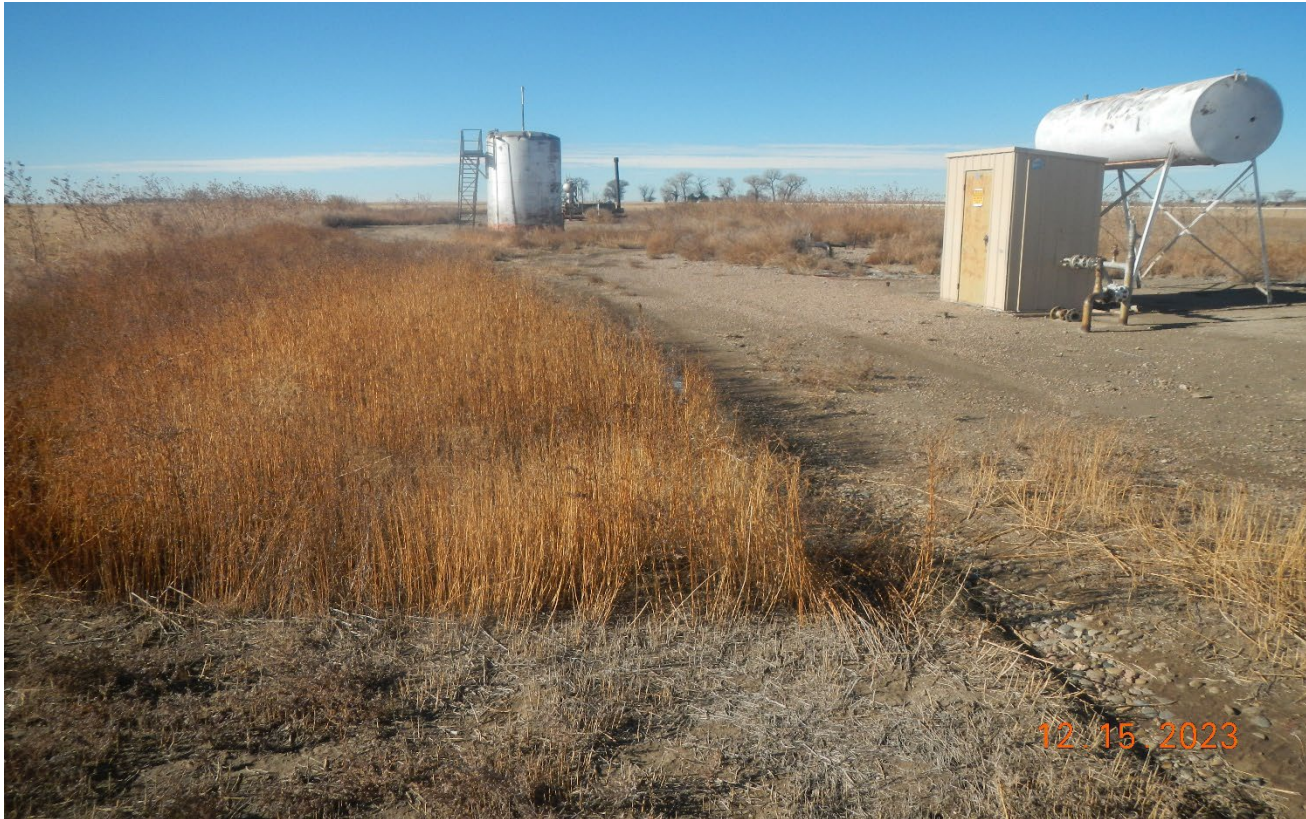
**Photo 1.** Facing west toward the location. There are tall undesirable weeds at the location that need to be controlled and removed.

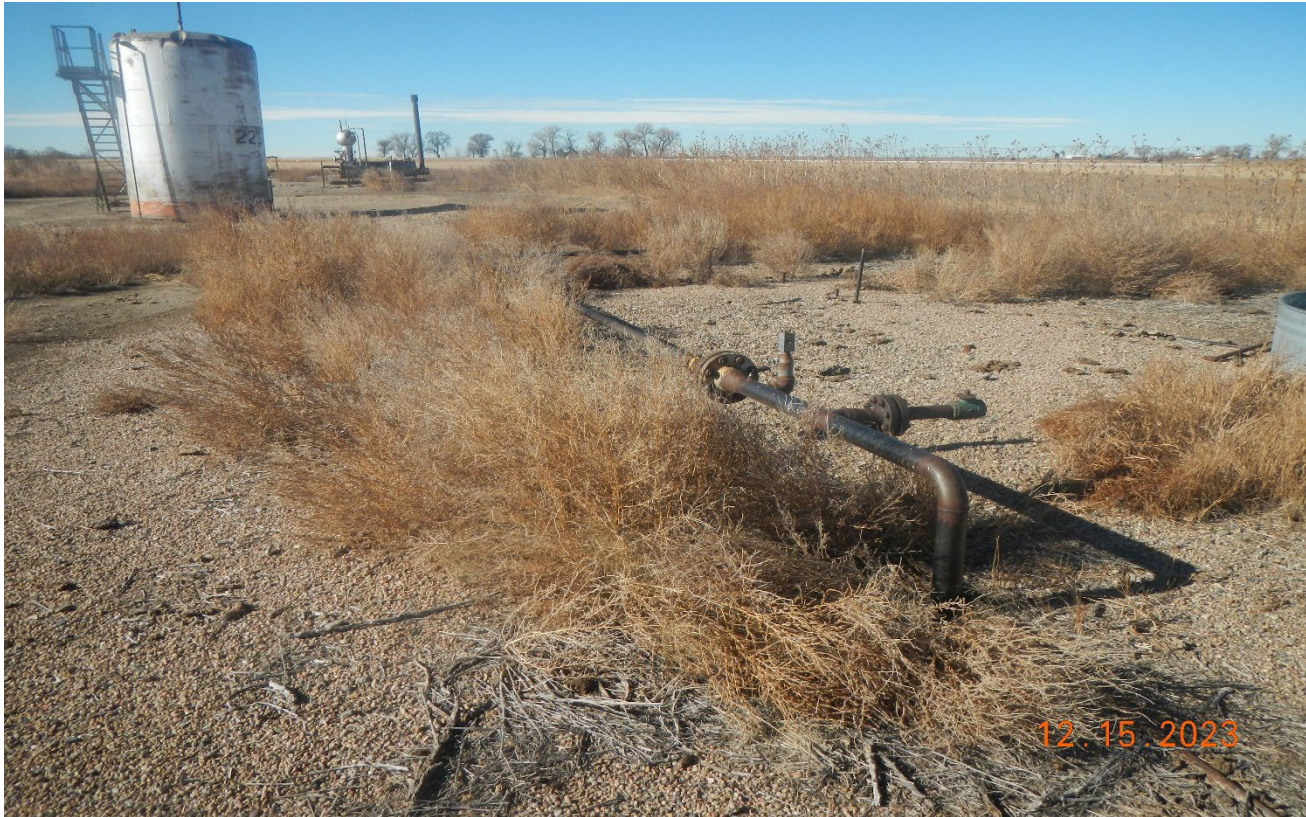
**Photo 2.** Facing west toward the location. There are tall undesirable weeds at the location that need to be controlled and removed.

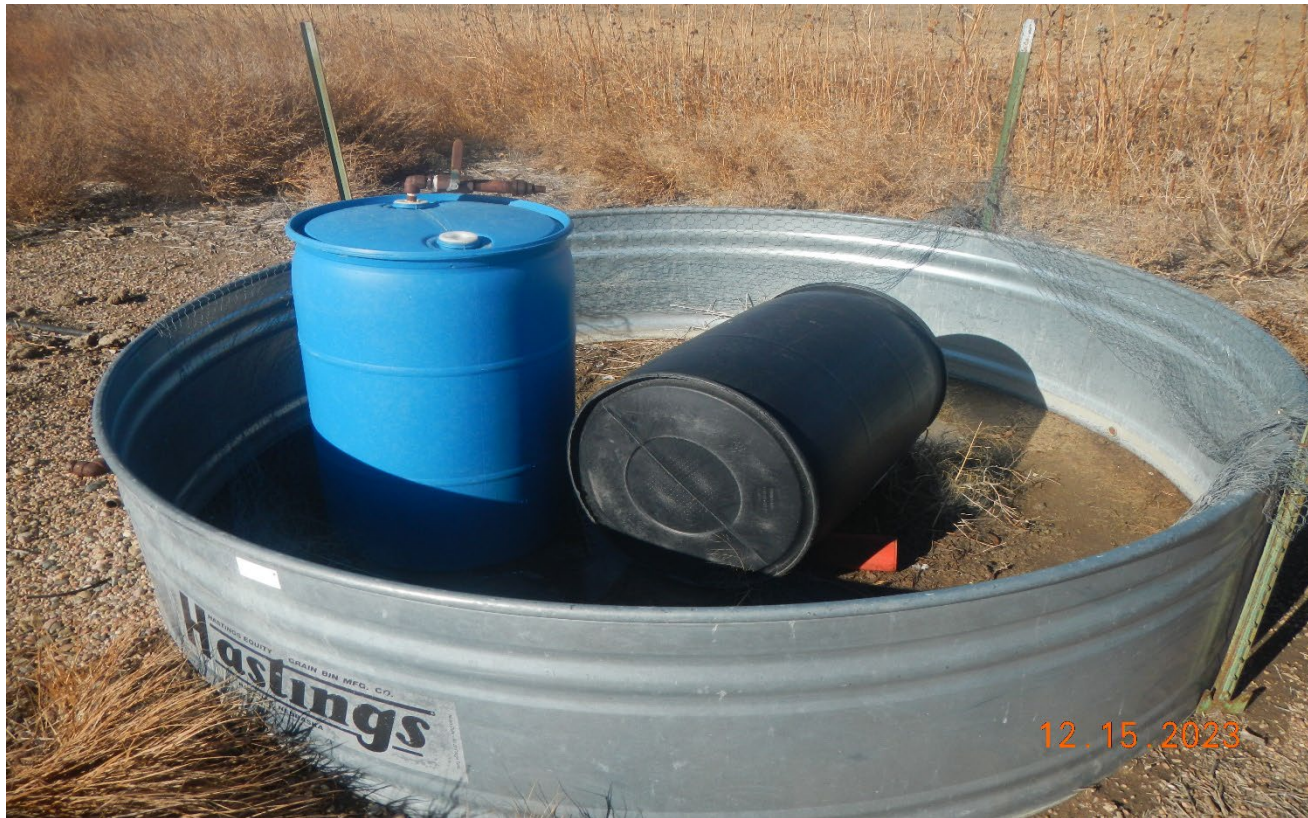
**Photo 3.** There are plastic drums with no labeling and one appears to be empty and not in use.

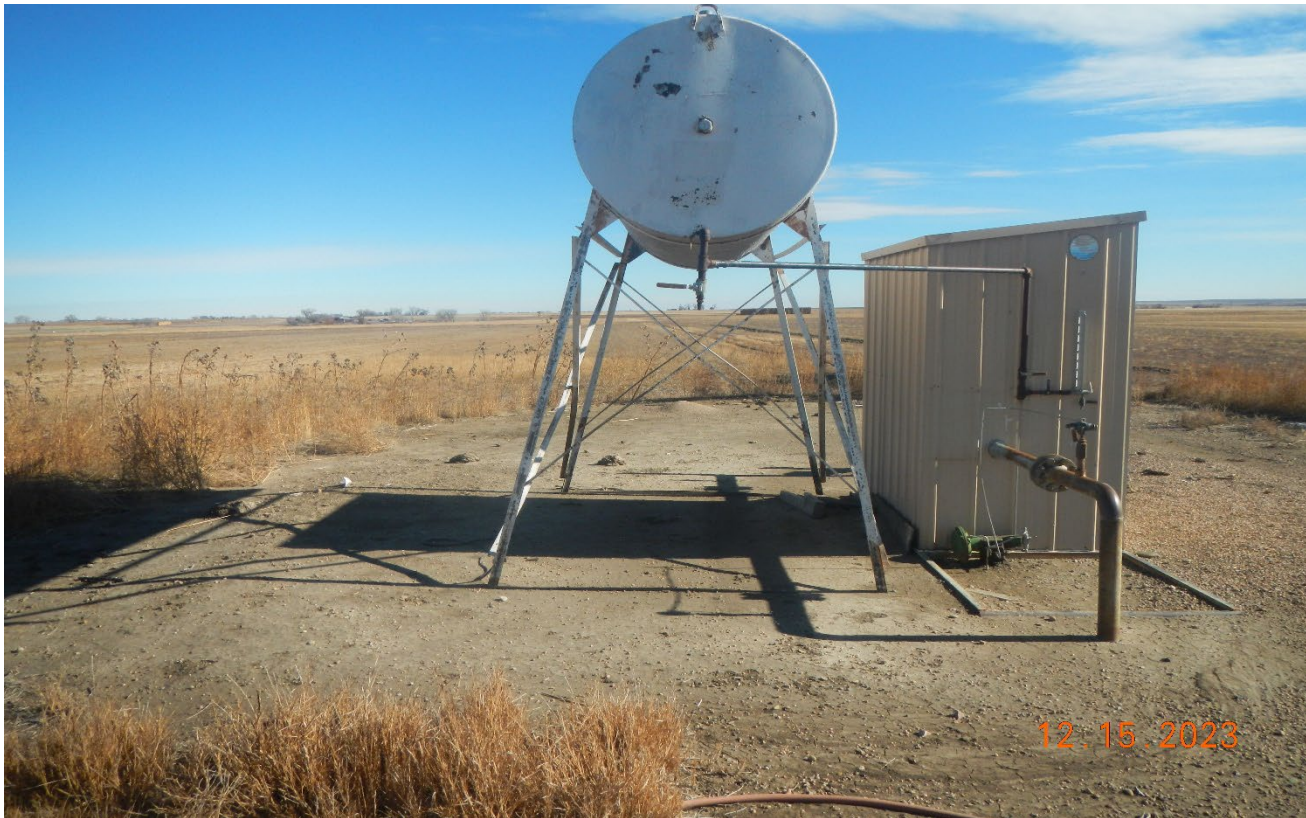
**Photo 4.** There is no secondary containment of the elevated metal container.

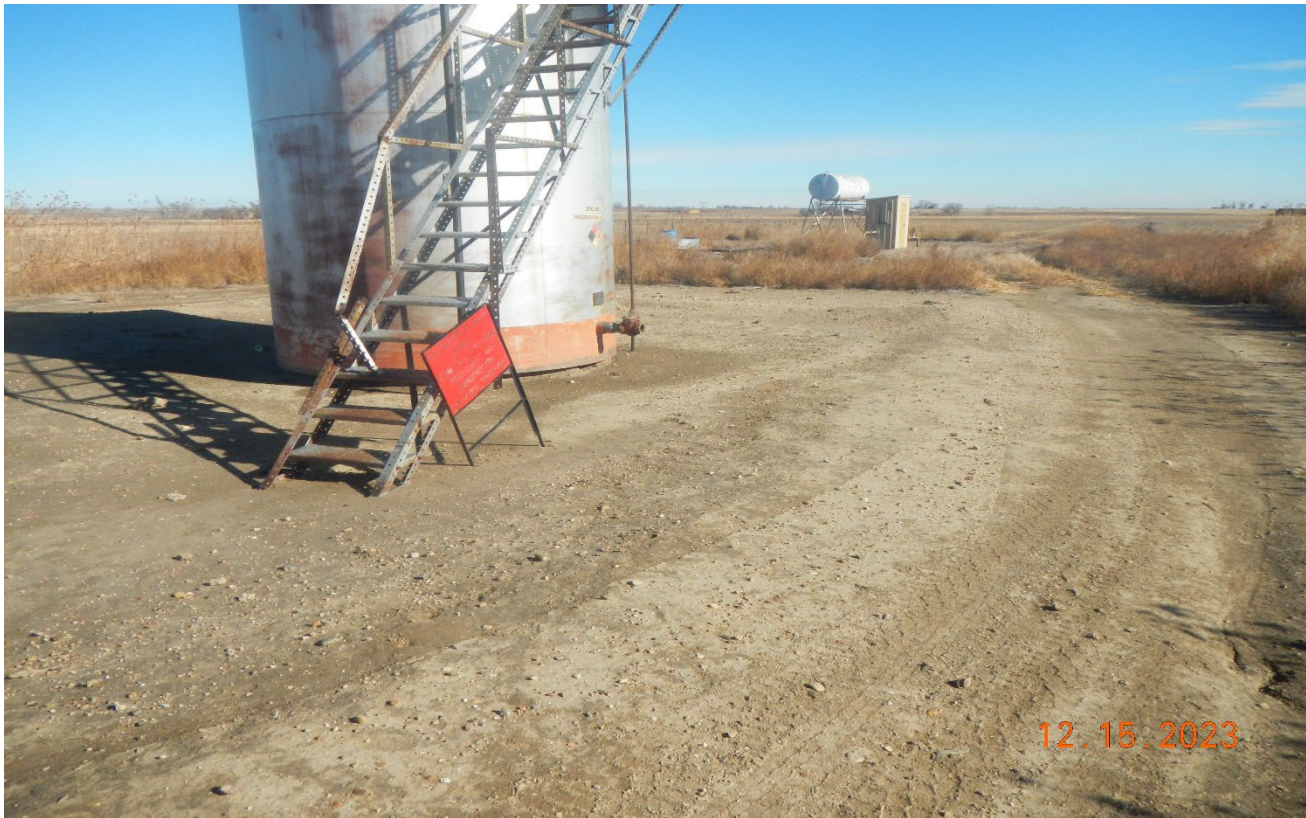
**Photo 5.** Facing toward the tank battery. There is insufficient secondary containment to contain a spill. The sign at the tank does not reflect the current Operator sand is faded

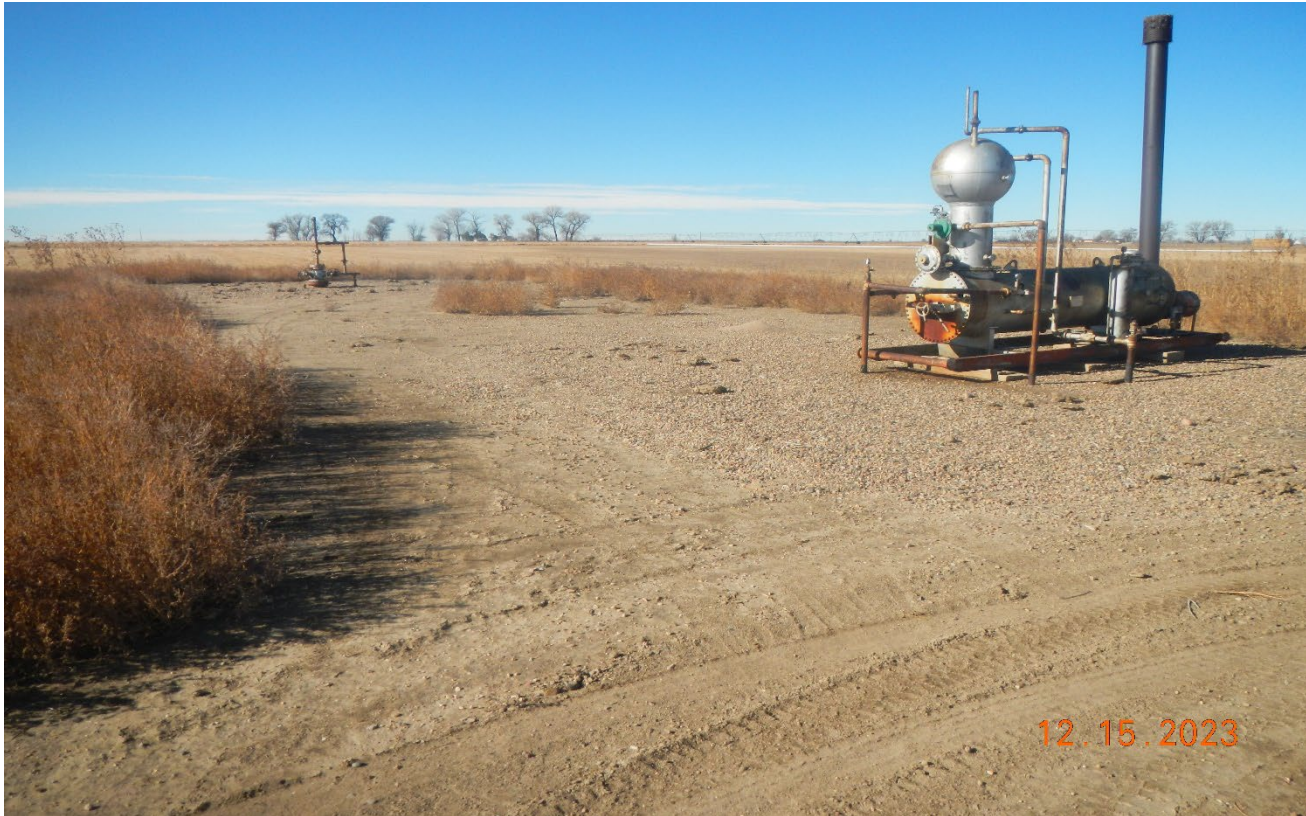
**Photo 6.** Facing northwest at the location. The weeds around the location need to be controlled.

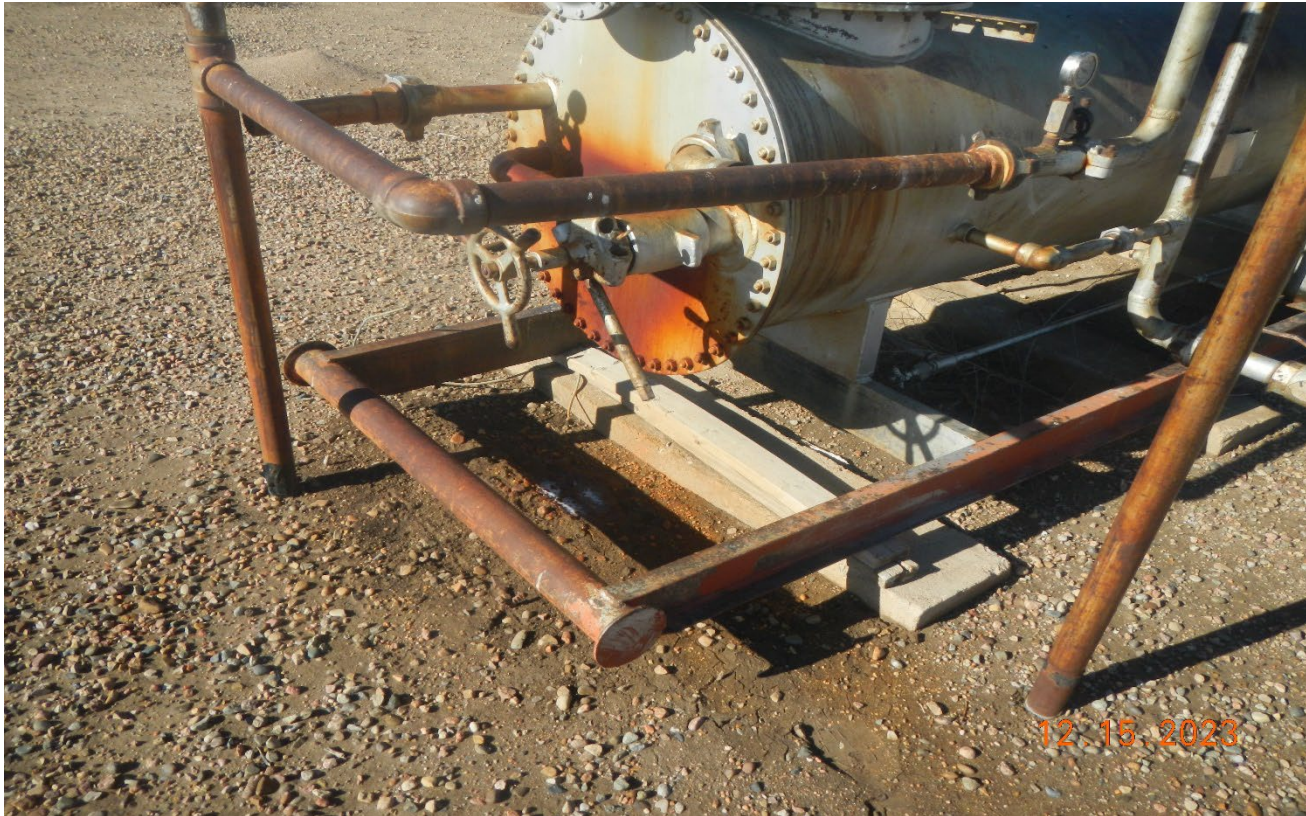
**Photo 7.** There is a dripping leak at the separator and stained soils.

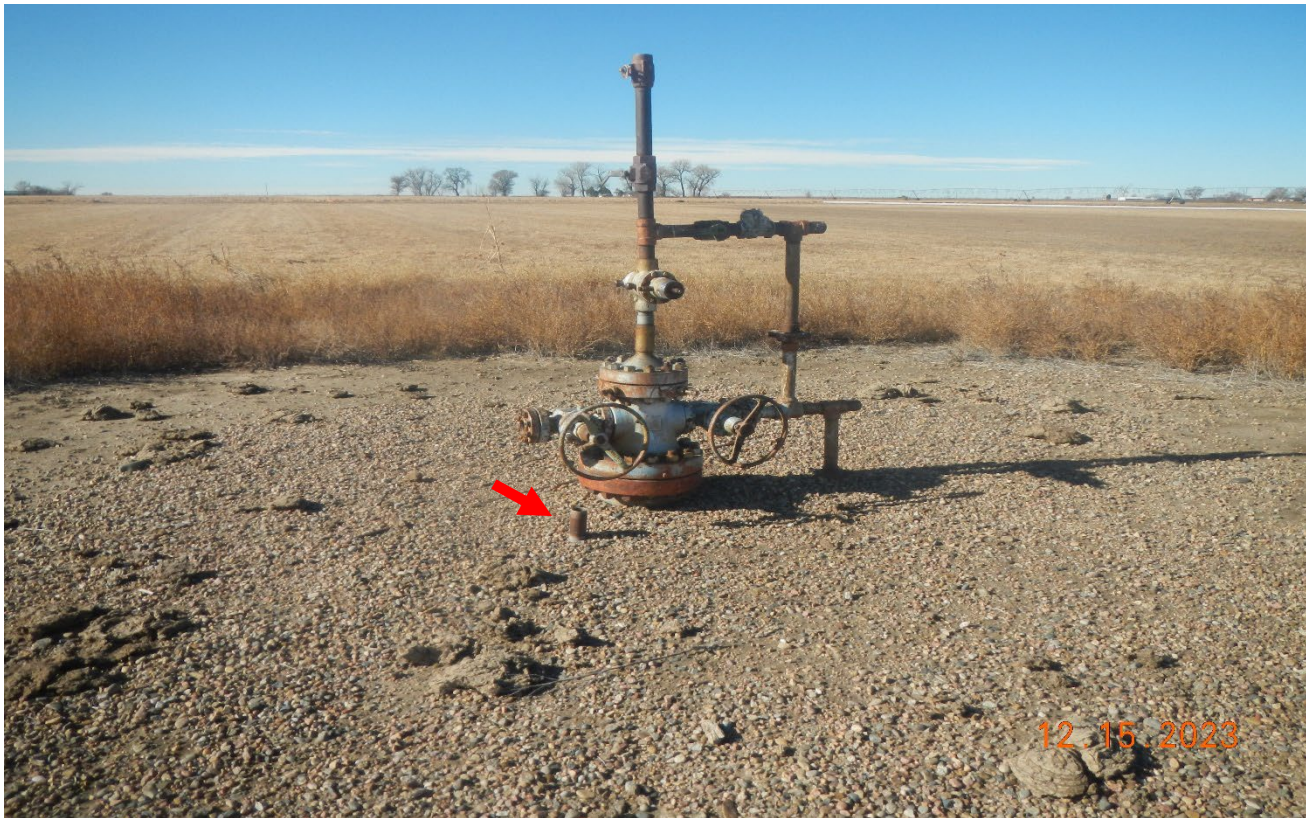
**Photo 8.** Facing toward the well. There is an uncapped pipe riser shown at red arrow.
