# Final Reclamation and Stormwater Inspection

Date: 12/6/23

Location ID: 330481

Inspection Photos  
Location Name: Western 13-35  
Location ID: 330481

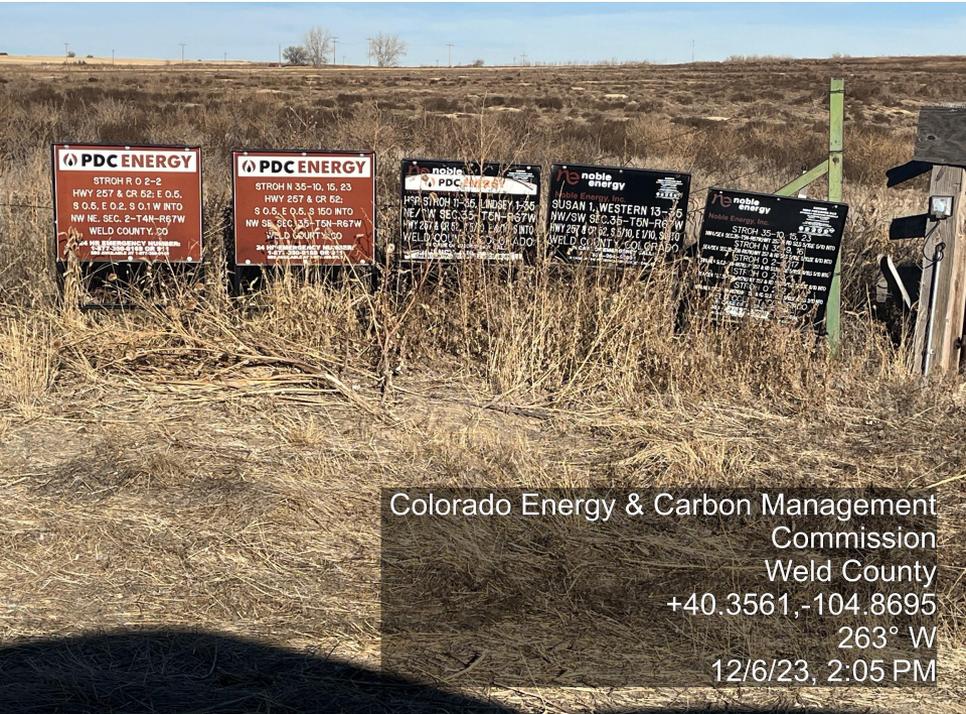
**Photo 1.** The photo was taken at the location entrance facing West. The photo illustrates the operator signage.

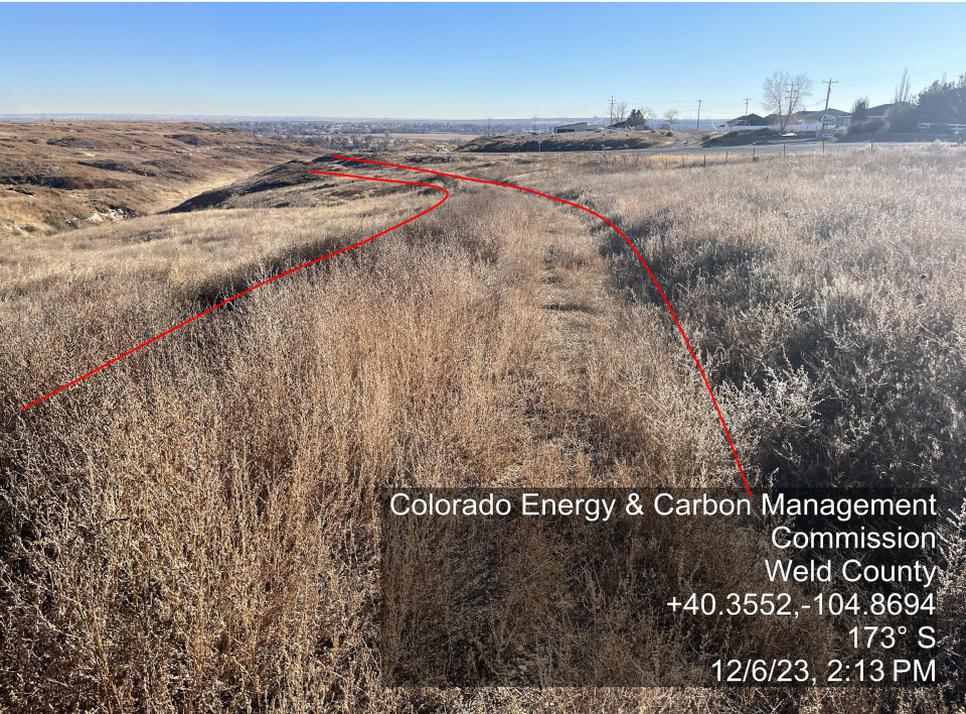
**Photo 2.** The photo was taken at the well entrance facing South. The photo illustrates the access road is dominated by kochia and russian thistle and has not been re-contoured or graded.

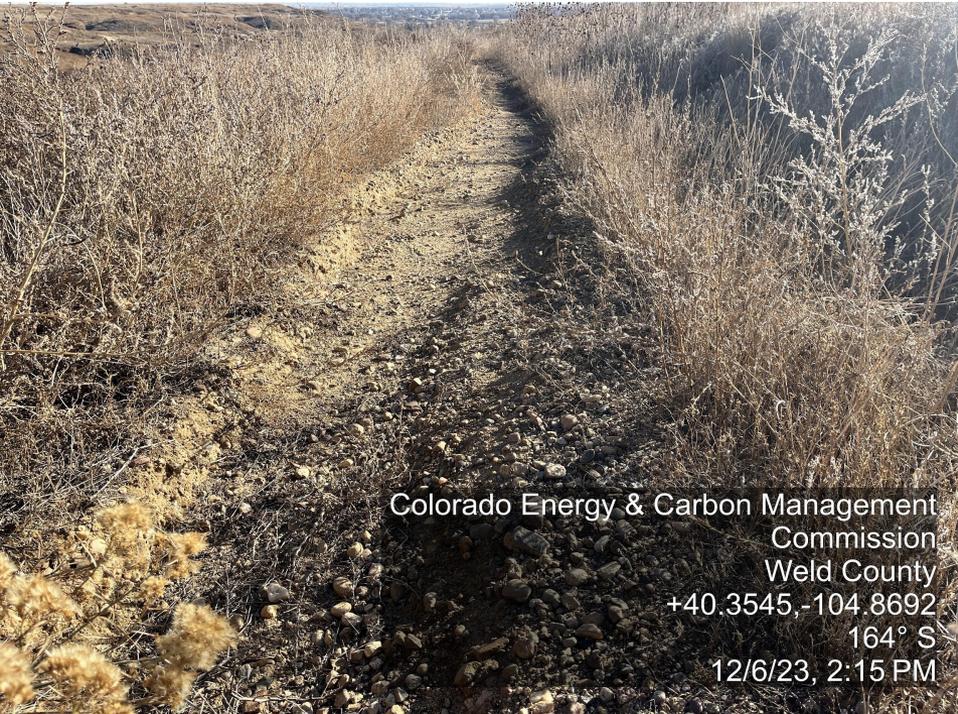
**Photo 3.** The photo was taken along the access road facing South. The photo illustrates pervasive erosion that ran along the majority of the access road.

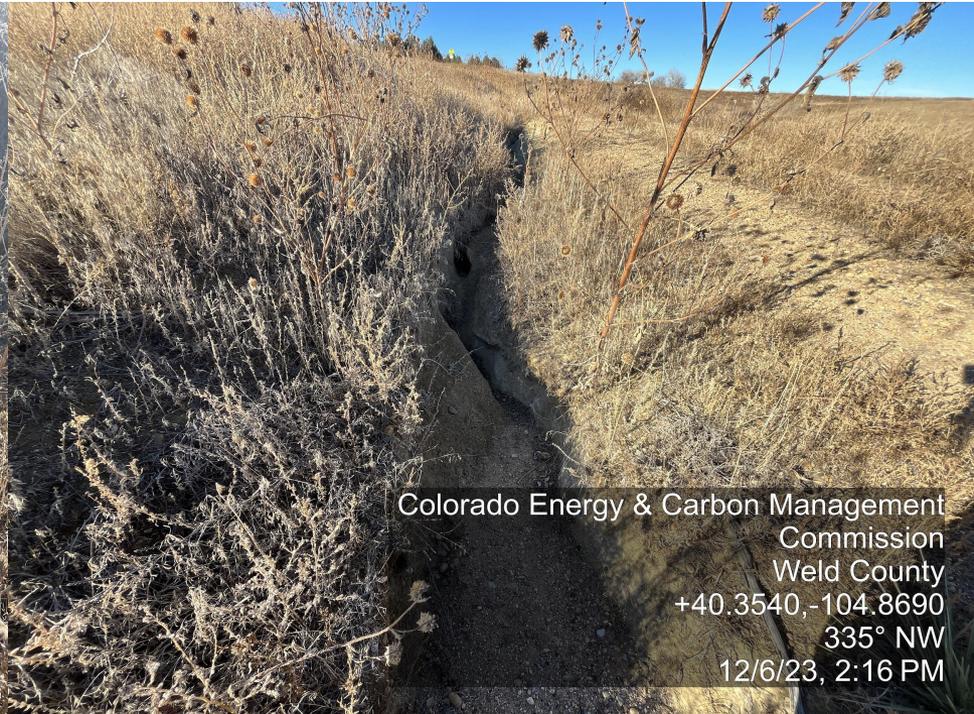
**Photo 4.** The photo was taken along the access road facing Northwest. The photo illustrates large rill erosion building to gully erosion in the following photos.

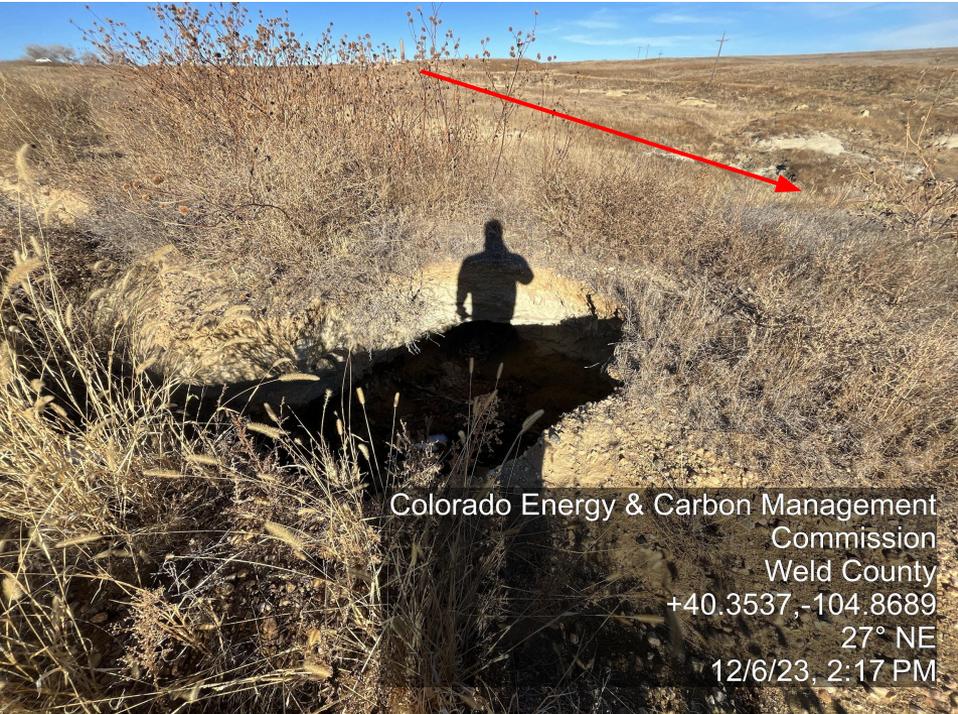
**Photo 5.** The photo was taken along the access road facing Northeast. The photo illustrates a large gully erosional feature that has blown out the road and run into the drainage below.

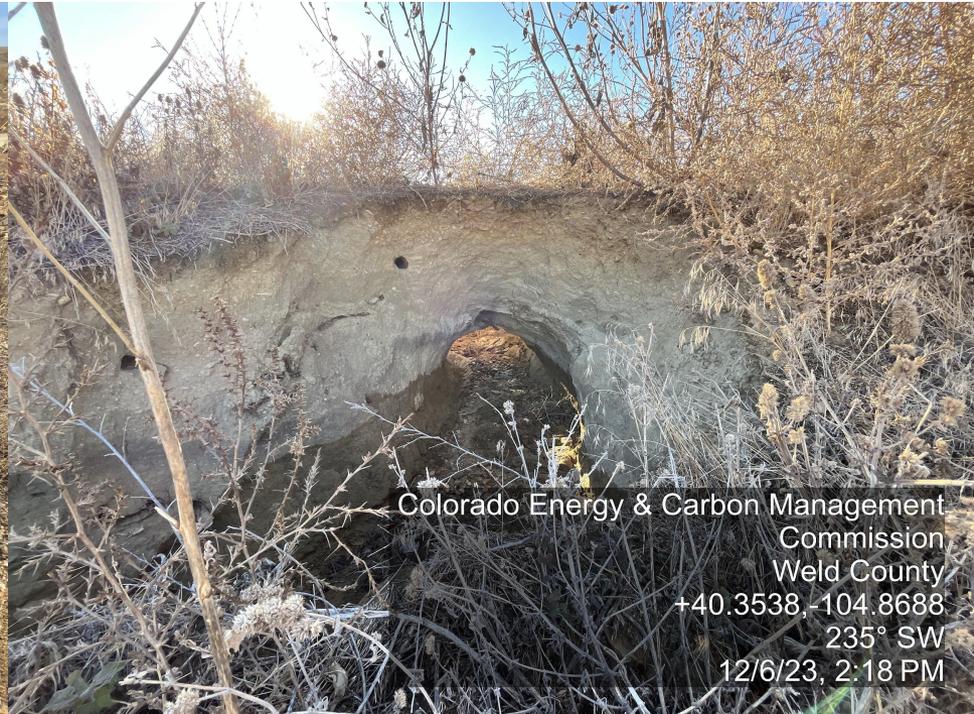
**Photo 6.** The photo was taken below the access road facing Southwest. The photo illustrates the bottom side of the road blow out described in photo 5.

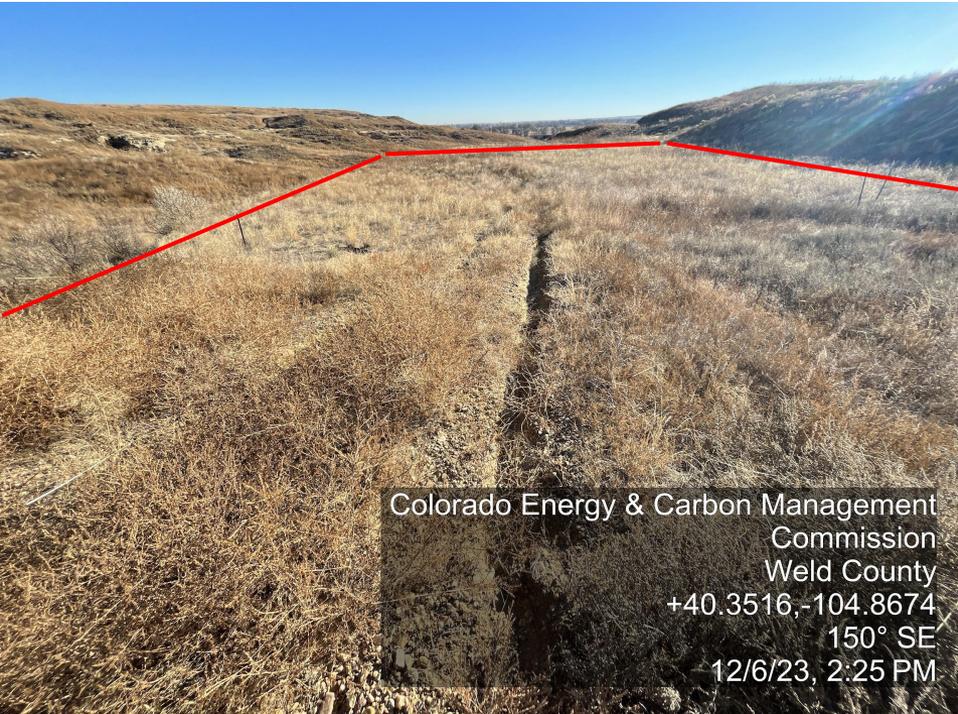
**Photo 7.** The photo was taken at the well location facing Southeast. The photo illustrates the pad is still apparent as well as there being erosion and undesirable vegetation throughout. Reclamation has not been started on the location or access road.

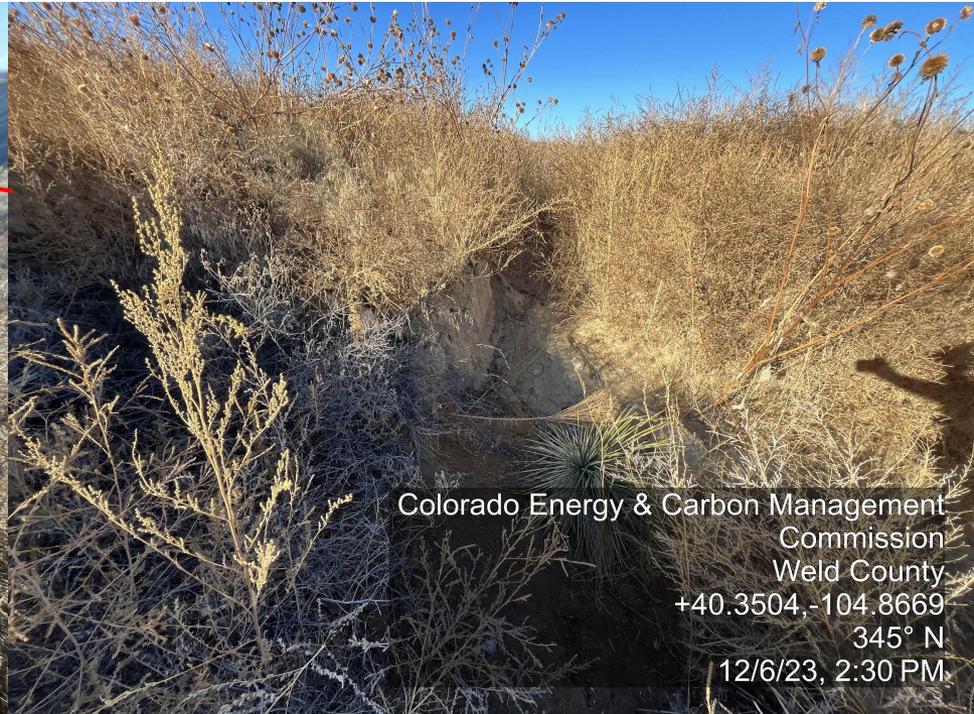
**Photo 8.** The photo was taken at the well location facing North. The photo illustrates another erosional feature on the South end of the still existing pad.

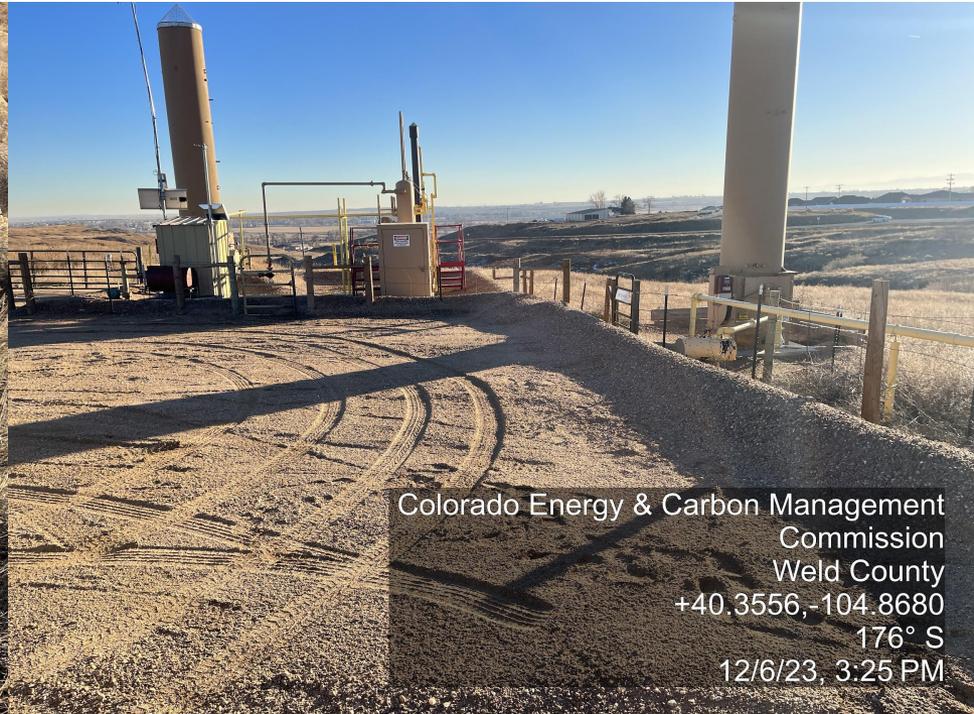
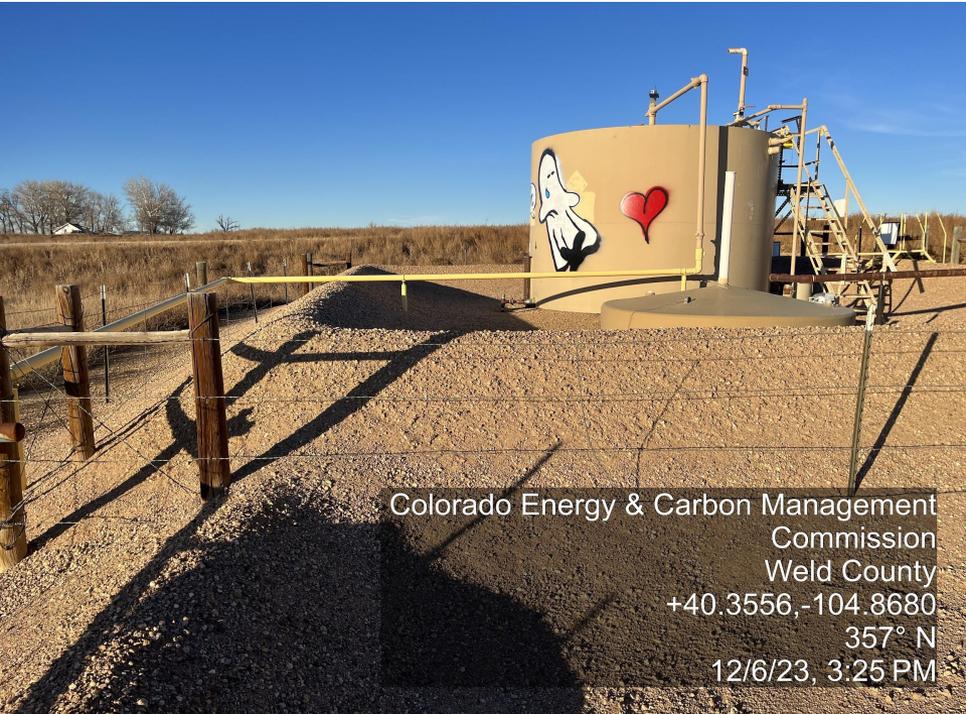
**Photo 10.** The photo was taken at the tank battery location facing South. The photo illustrates proper fencing as well as a gravel berm surrounding the location.

**Photo 11.** The photo was taken at the tank battery location facing North. Refer to the comment for photo 10.

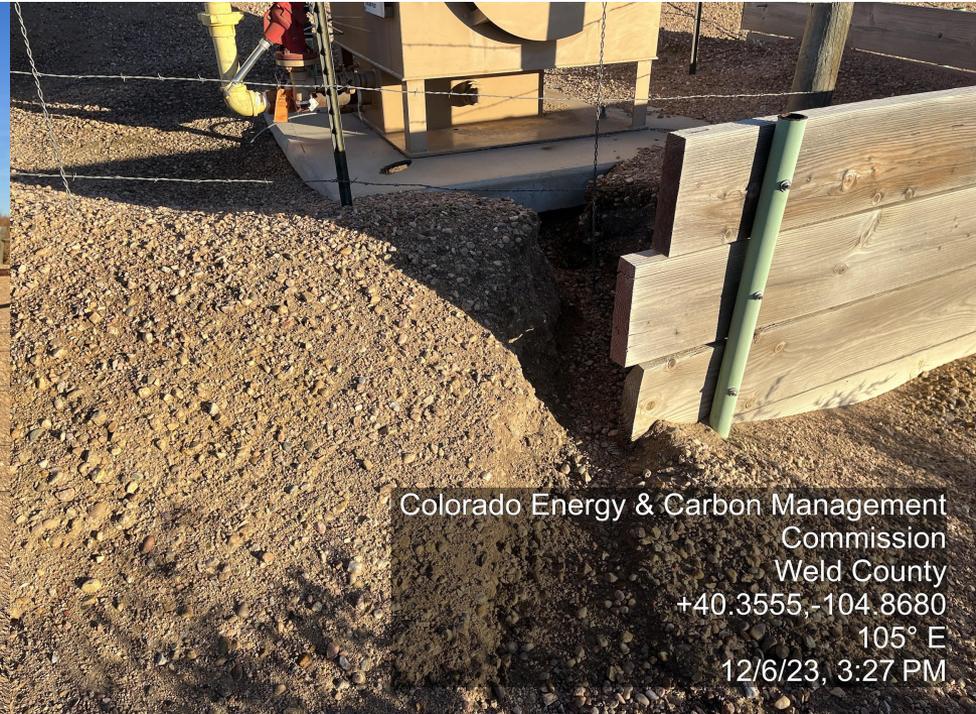
**Photo 12.** The photo was taken at the tank battery location facing East. The photo illustrates erosion occurring under the concrete pad of some oil and gas equipment.
