**Antler Energy LLC
Amoco Federal 21-1
Loc ID: 312970**

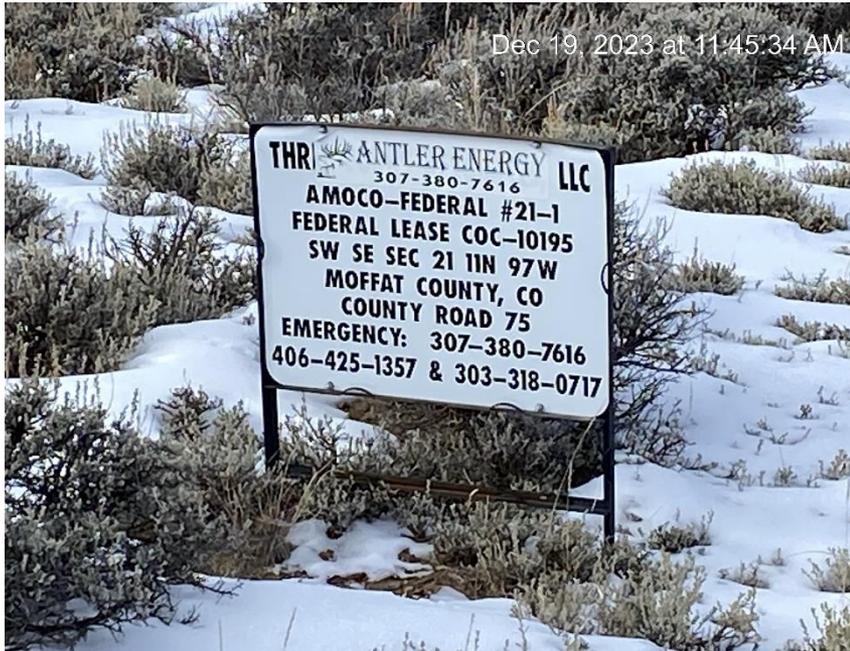
Entrance sign when replaced will require additional information.

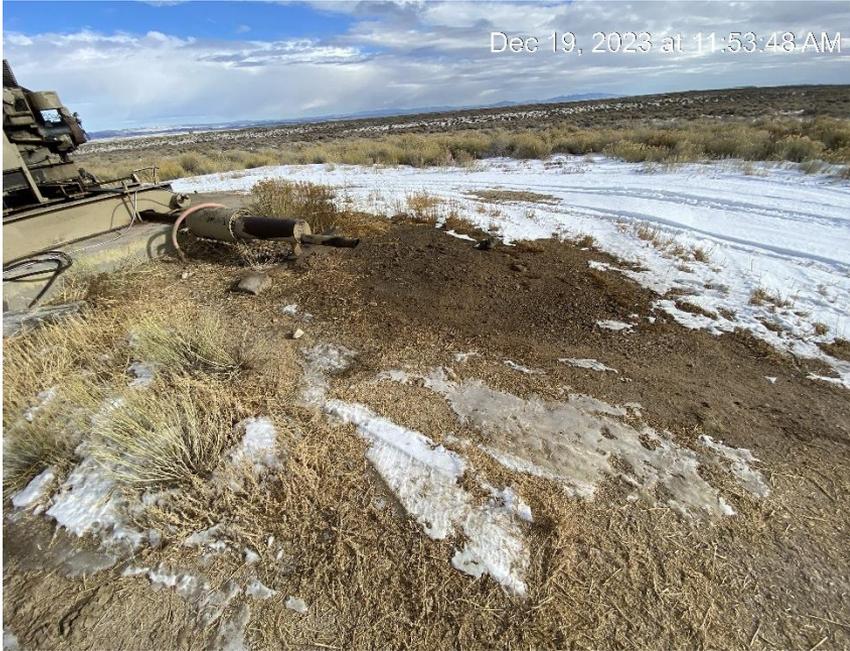
Exhaust staining

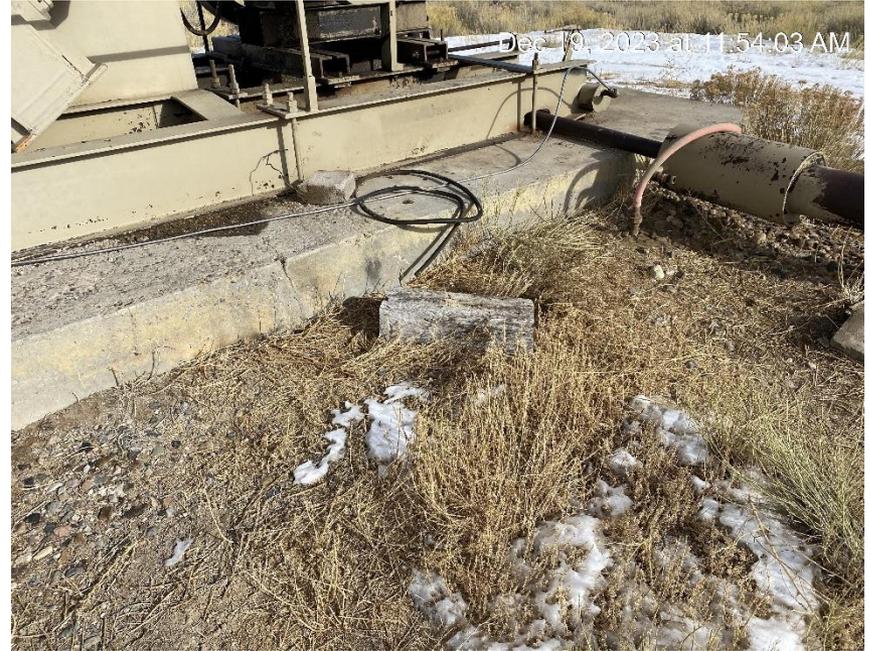
Debris from previous inspection

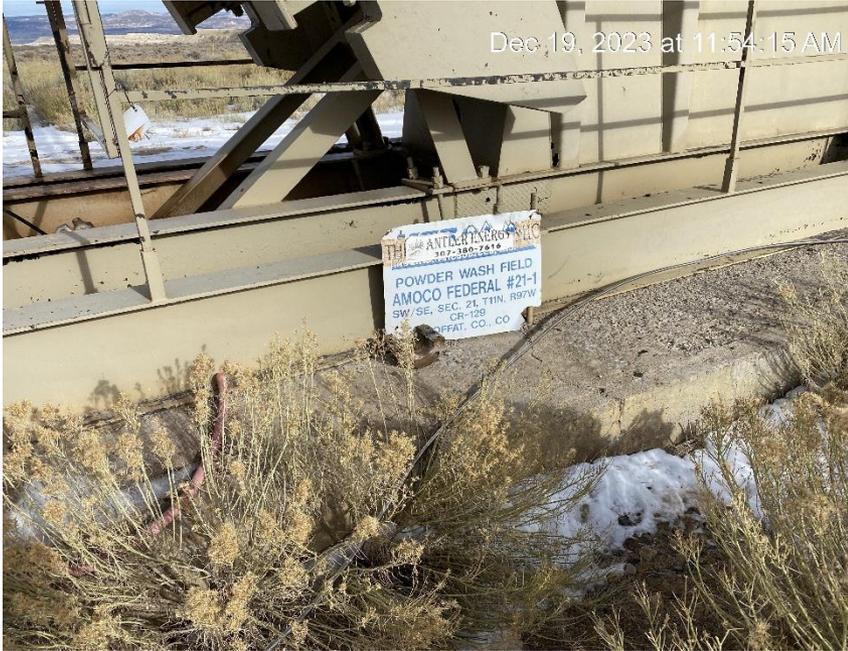
Wellhead sign missing required information

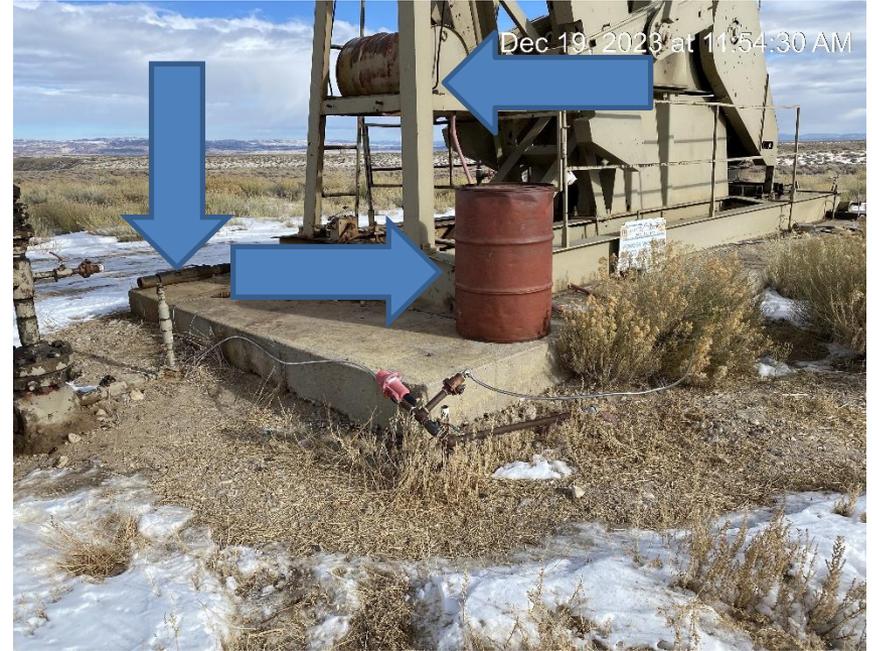
Debris still on location

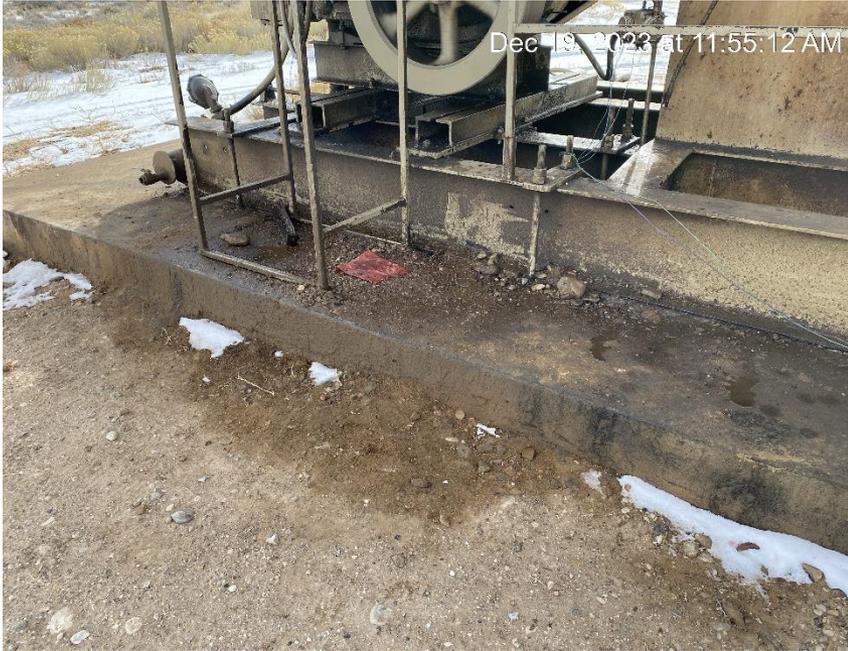
Unit still leaking oil on equipment and into soil

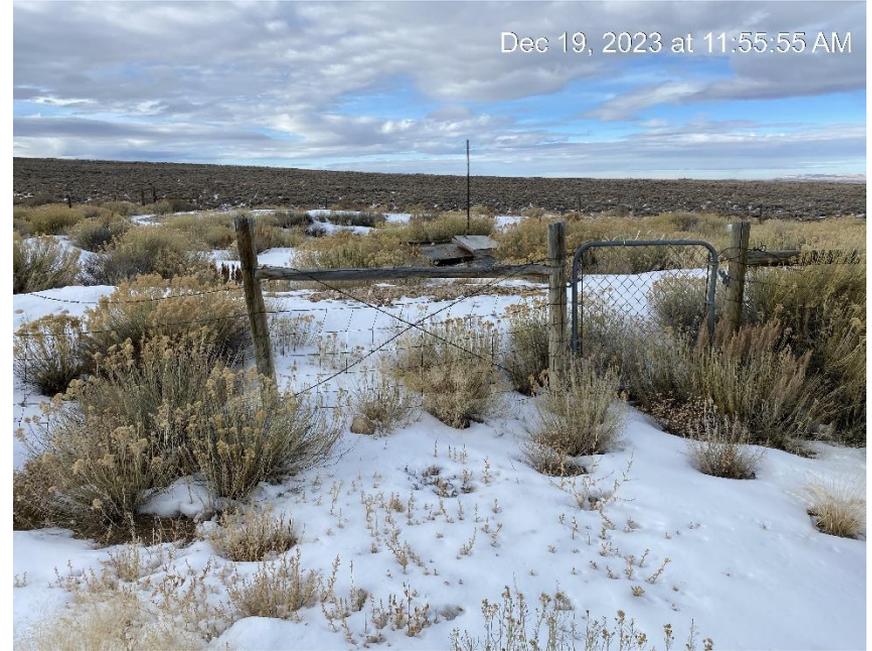
Pit not in use. No pit ID.

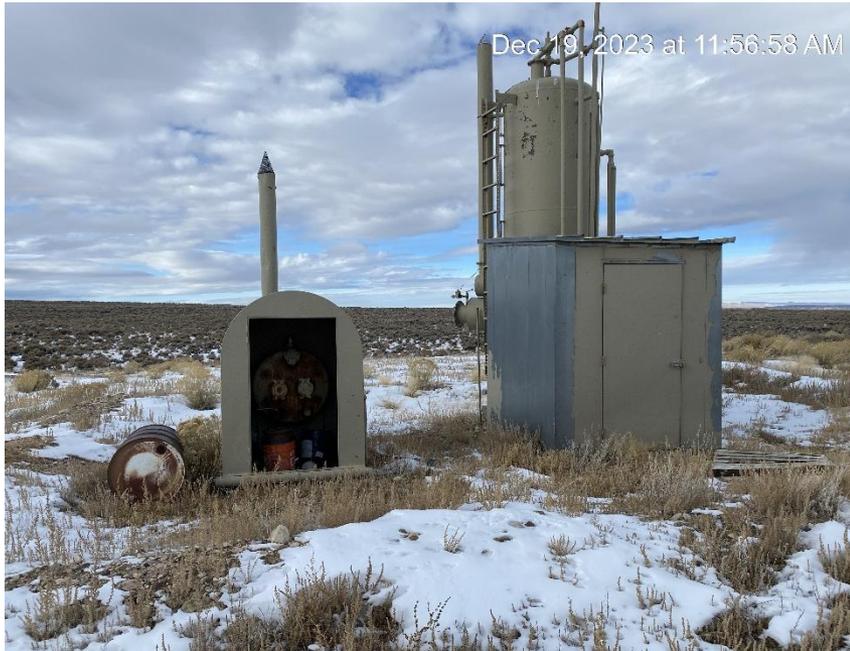
Debris and unused equipment still on location

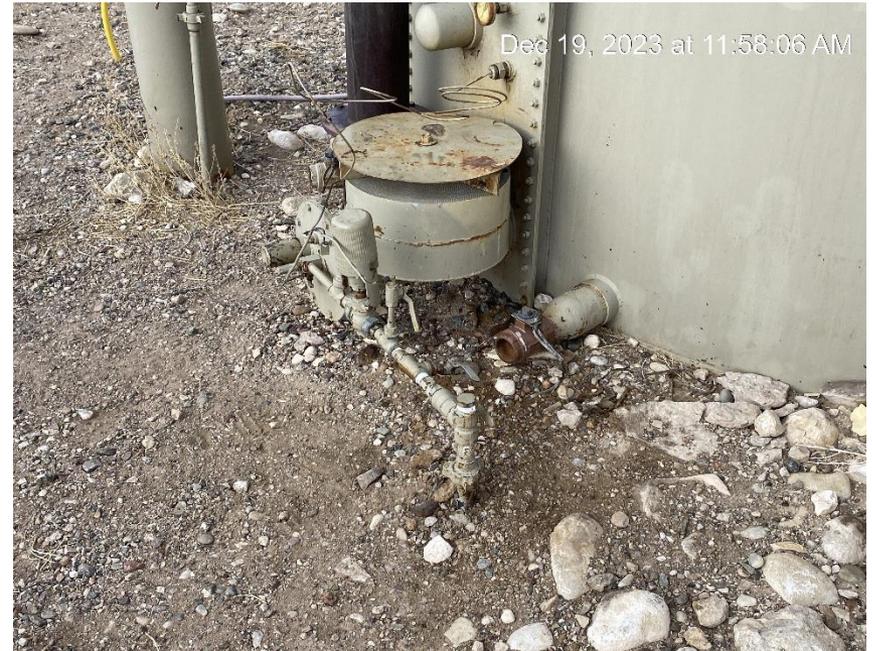
Open end tank valve still lacking plug

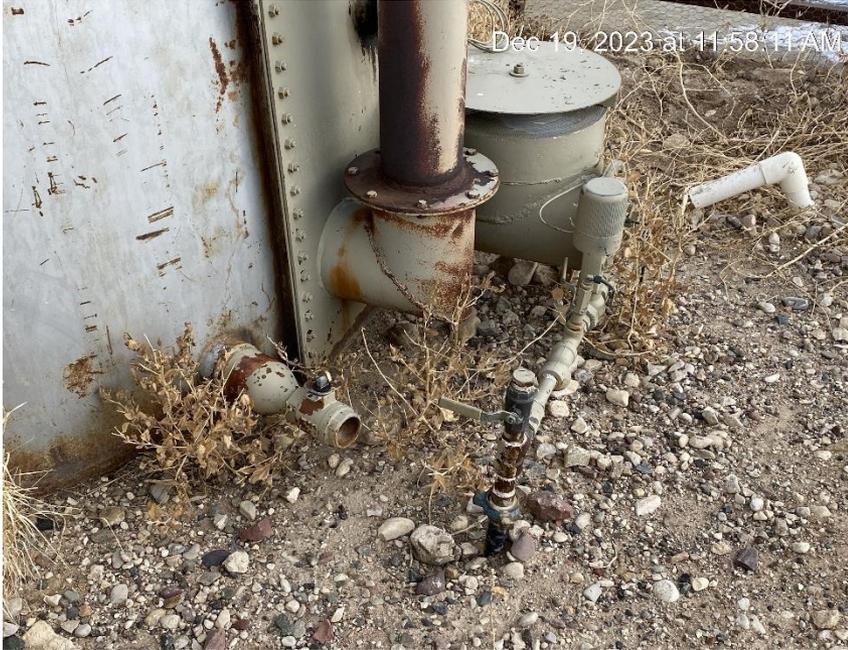
Open end tank valve still lacking plug

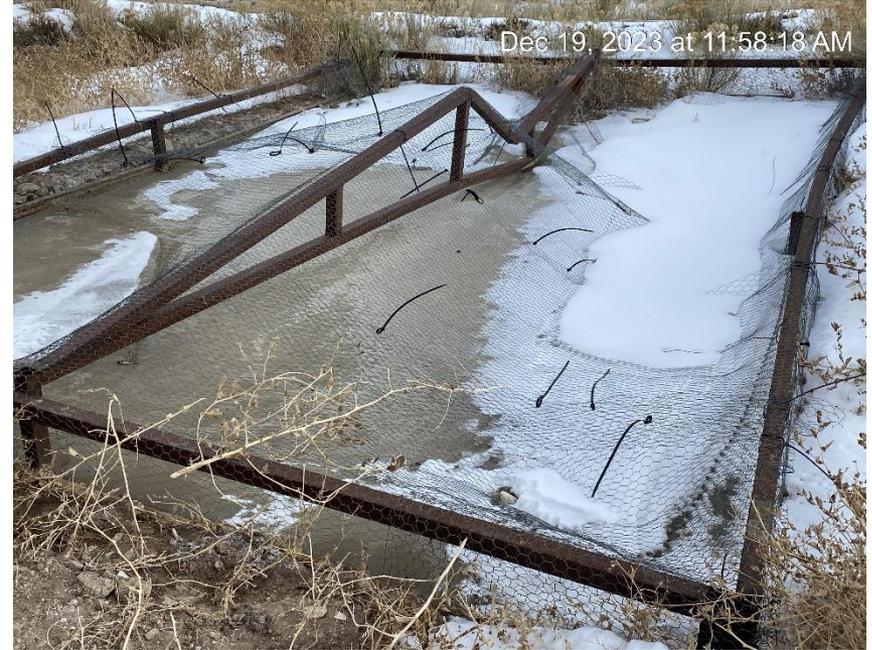
Unresolved wildlife mitigation

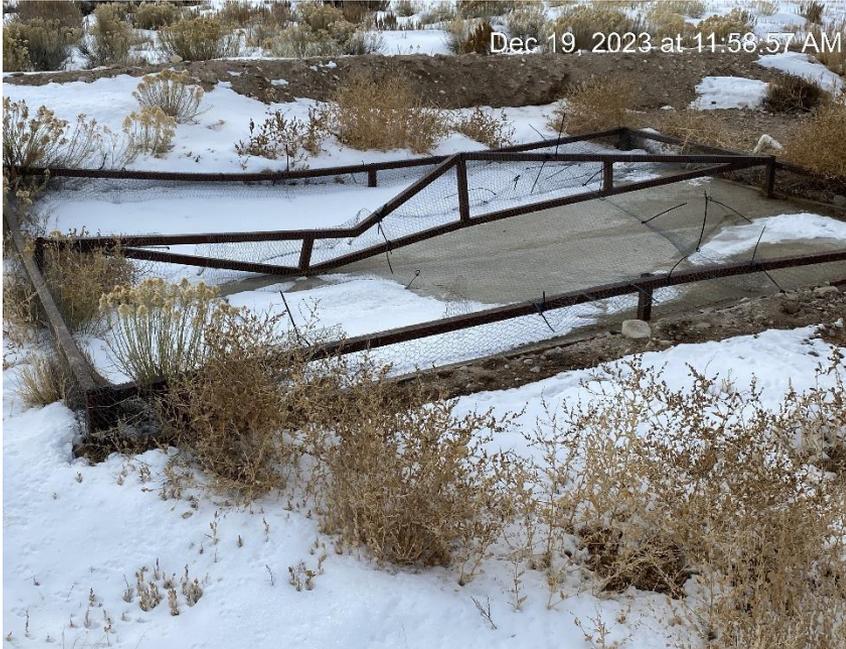
Unresolved wildlife mitigation

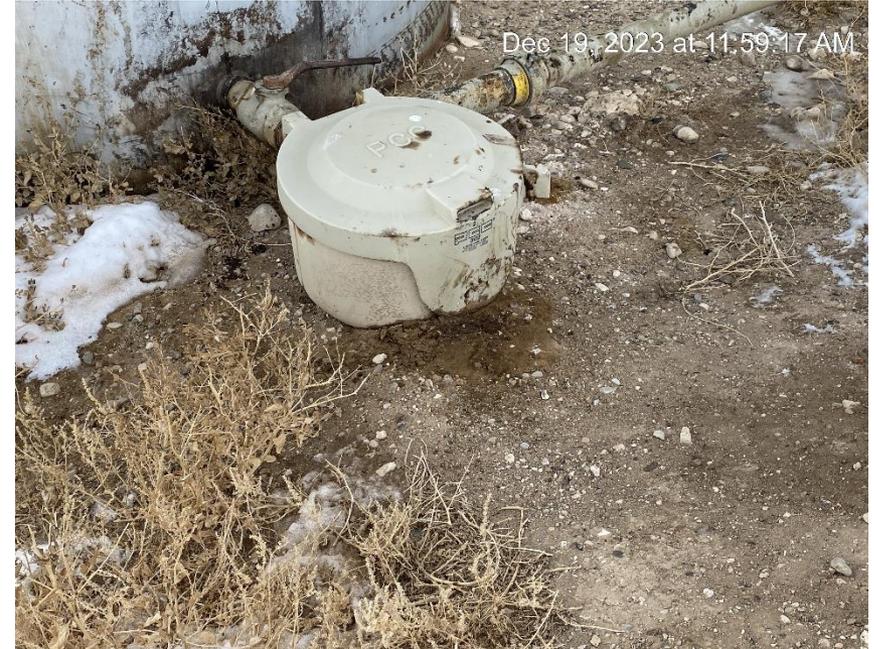
Staining not cleaned up

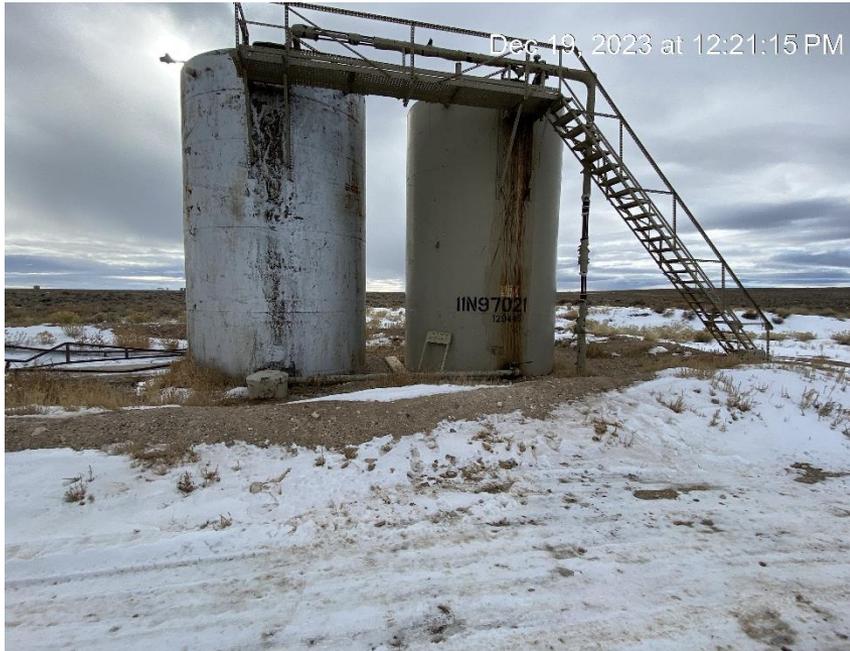
Sign at tank battery still unresolved

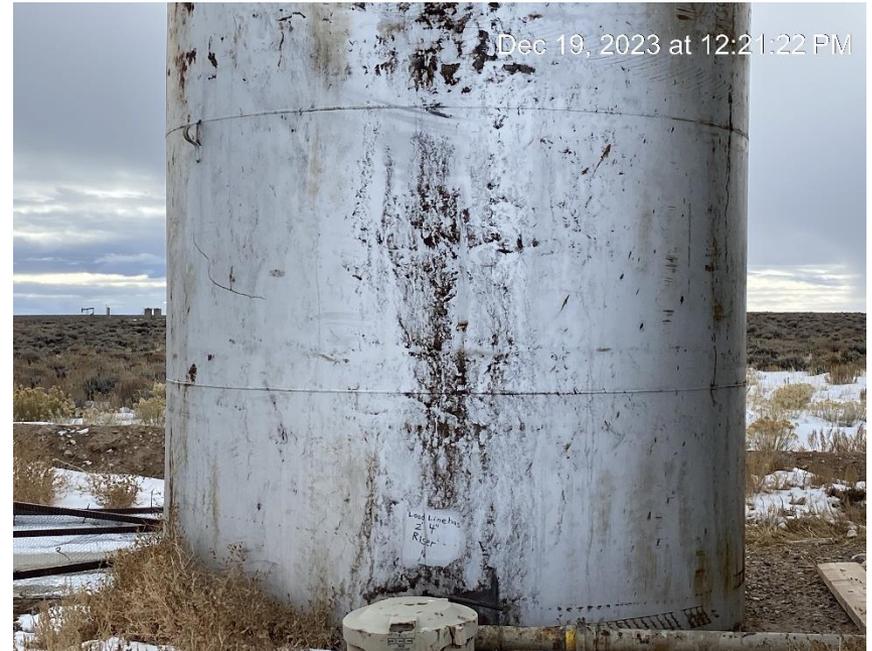
No tank labels installed.
