Construction and Stormwater Inspection

Operator: CIVITAS NORTH LLC - 10661

Location ID: 454749

Inspection Photos
Location Name: Hunt Fed 8-60 19 Pad
Location ID: 454749

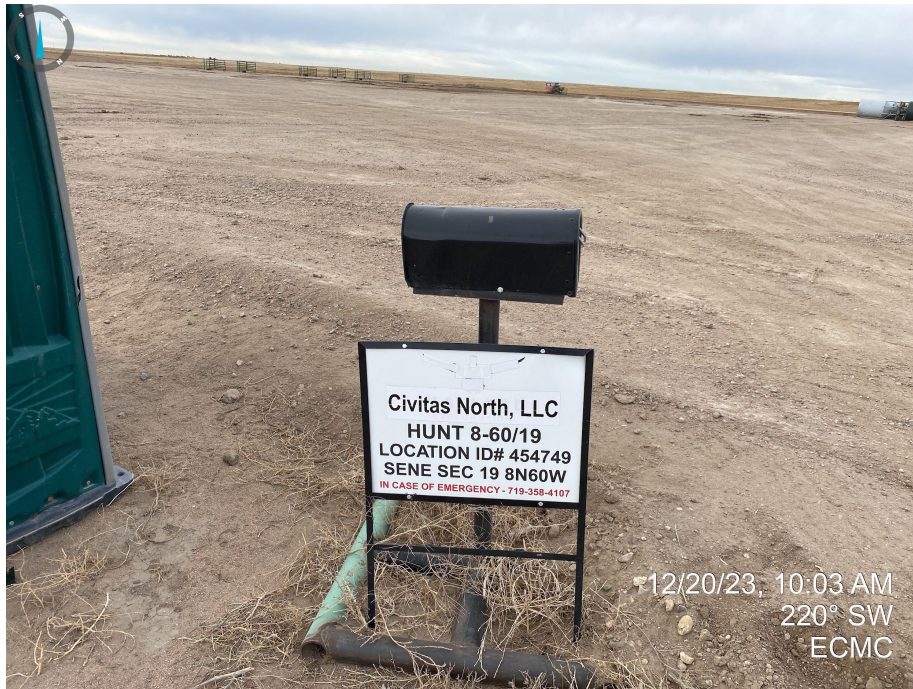
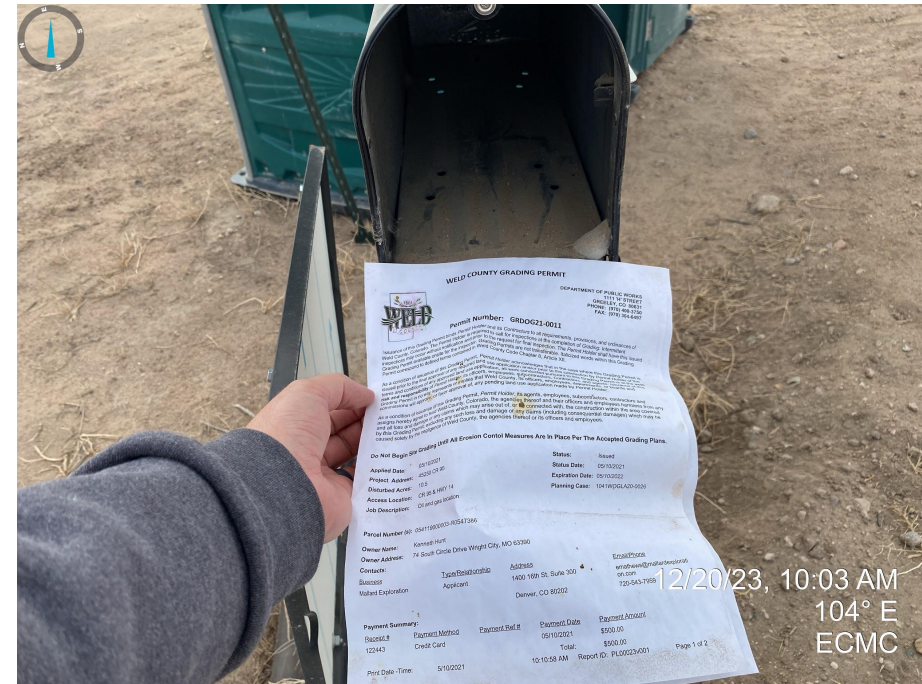
Photo 1. Taken from the entrance to the location. A copy of the approved From 2A was not posted on location as required by Rule 406.c. The only document within the mailbox was a Weld County grading permit.

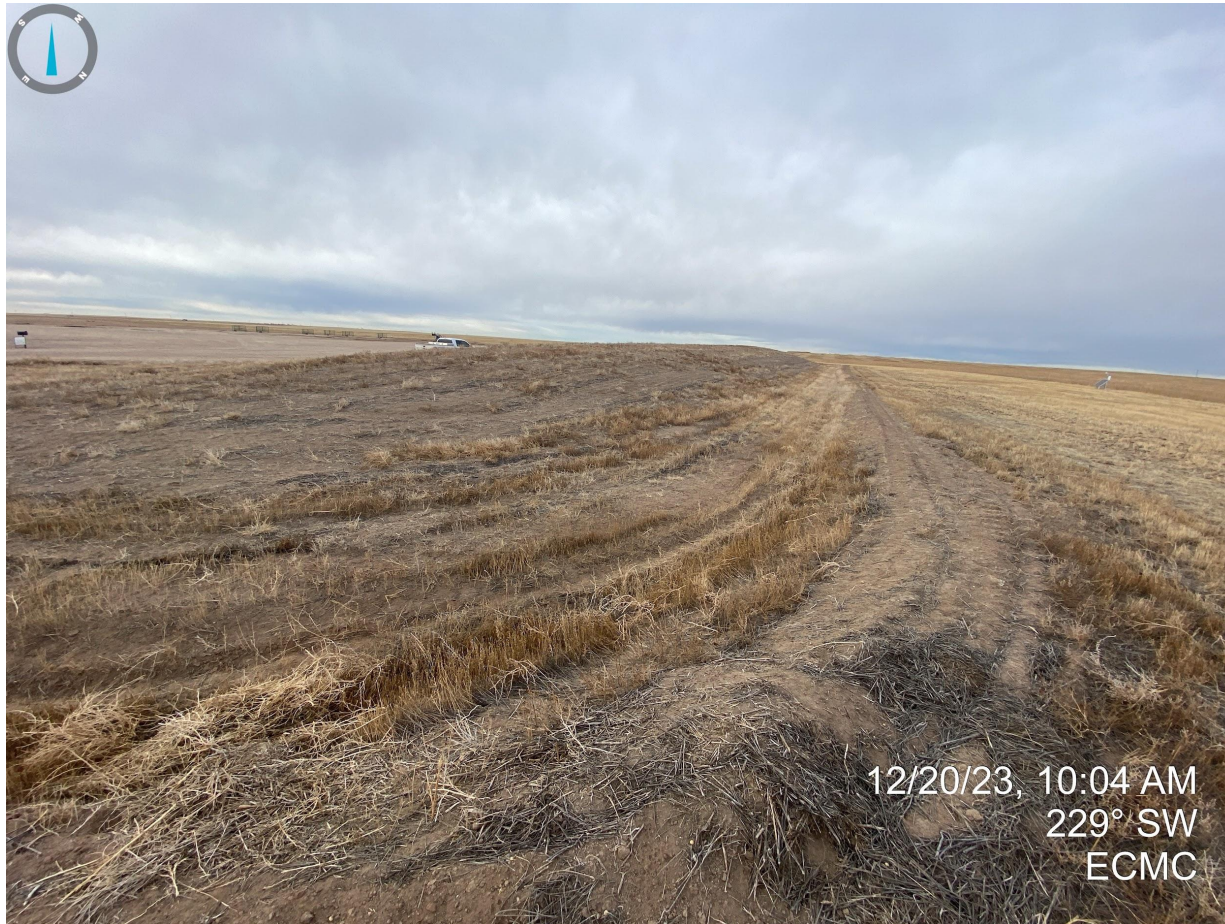
Photo 2. Taken from the northeast corner of the location. Photo illustrates that a perimeter stormwater control (ditch and berm) has been constructed around the entire perimeter of the disturbance area. Also pictured, the eastern side of the topsoil stockpile.

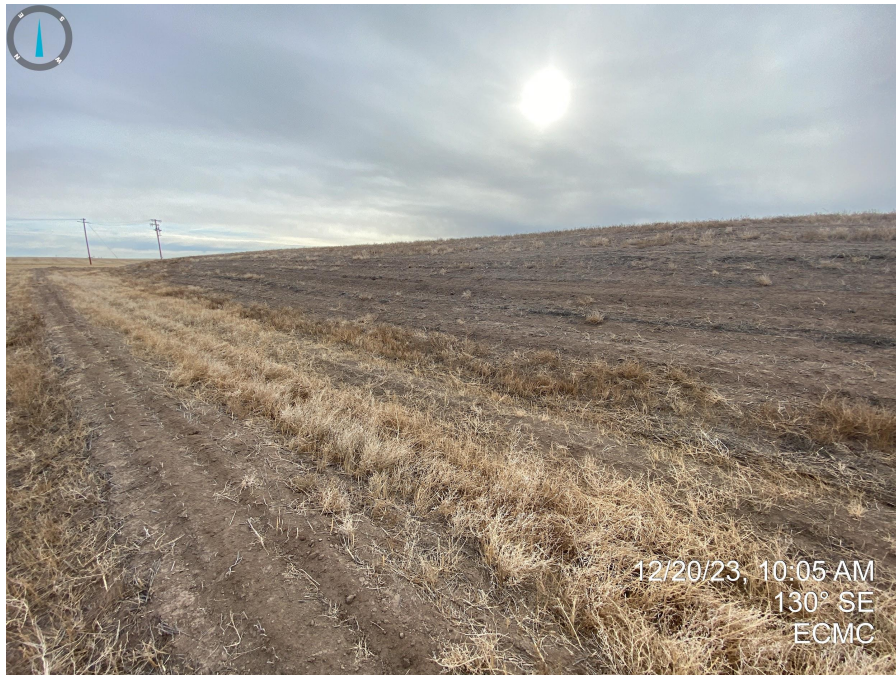
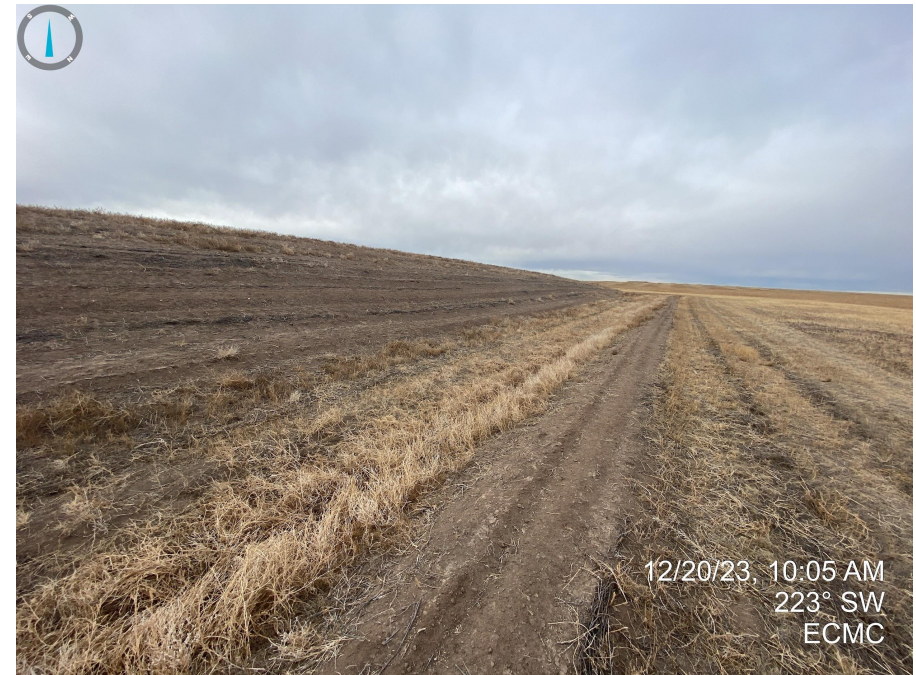
Photos 3 & 4. Taken from the northern/center portion of the disturbance area. The topsoil stockpile appears to have been previously seeded/mulched with evidence of drill rows. However, during this inspection, it was observed that the topsoil stockpile is predominantly bare/exposed soils with undesirable vegetation (e.g. russian thistle and kochia) observed throughout. Additional revegetation/stabilization techniques are required to prevent wind and water erosion degradation.

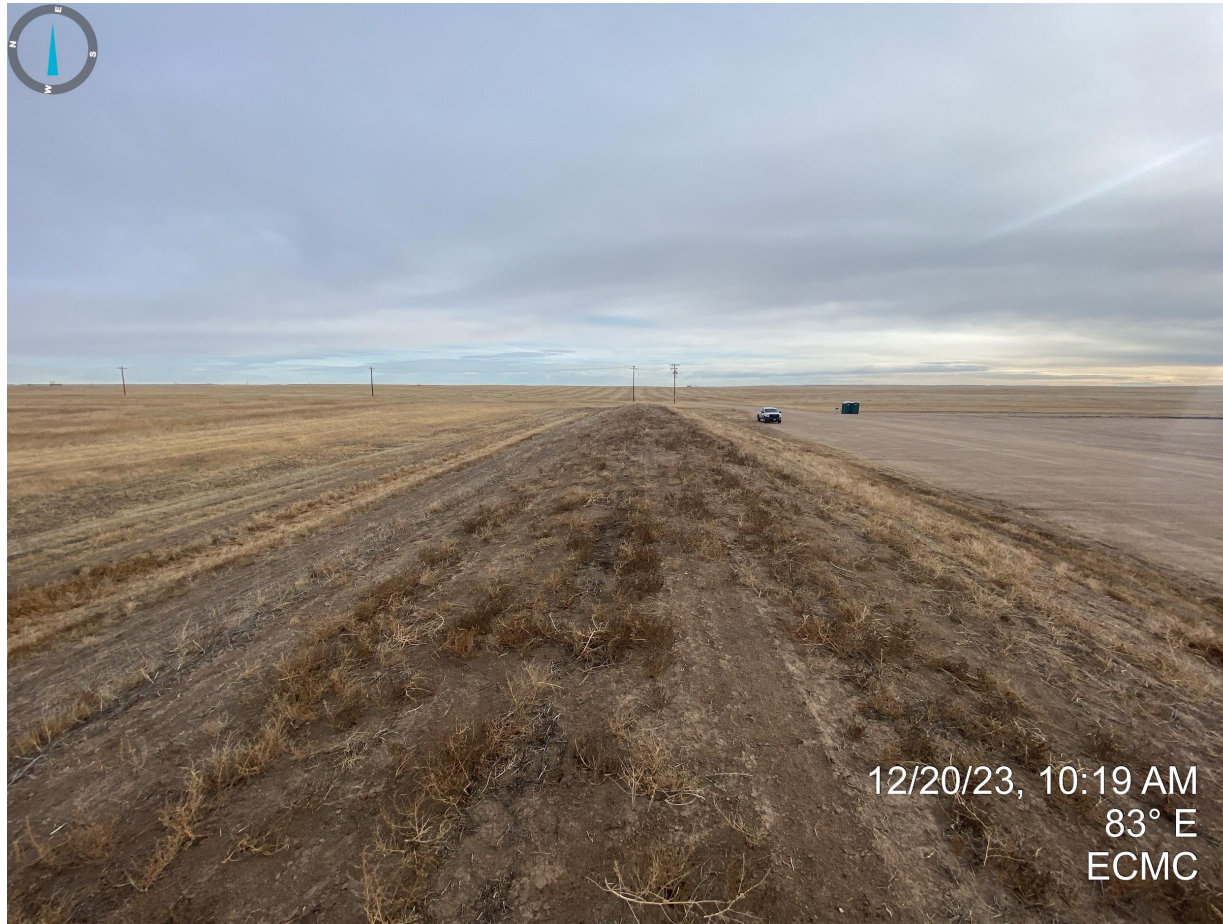
Photo 5. Taken from the top of the stockpile, facing east. See comments in Photos 3 & 4.

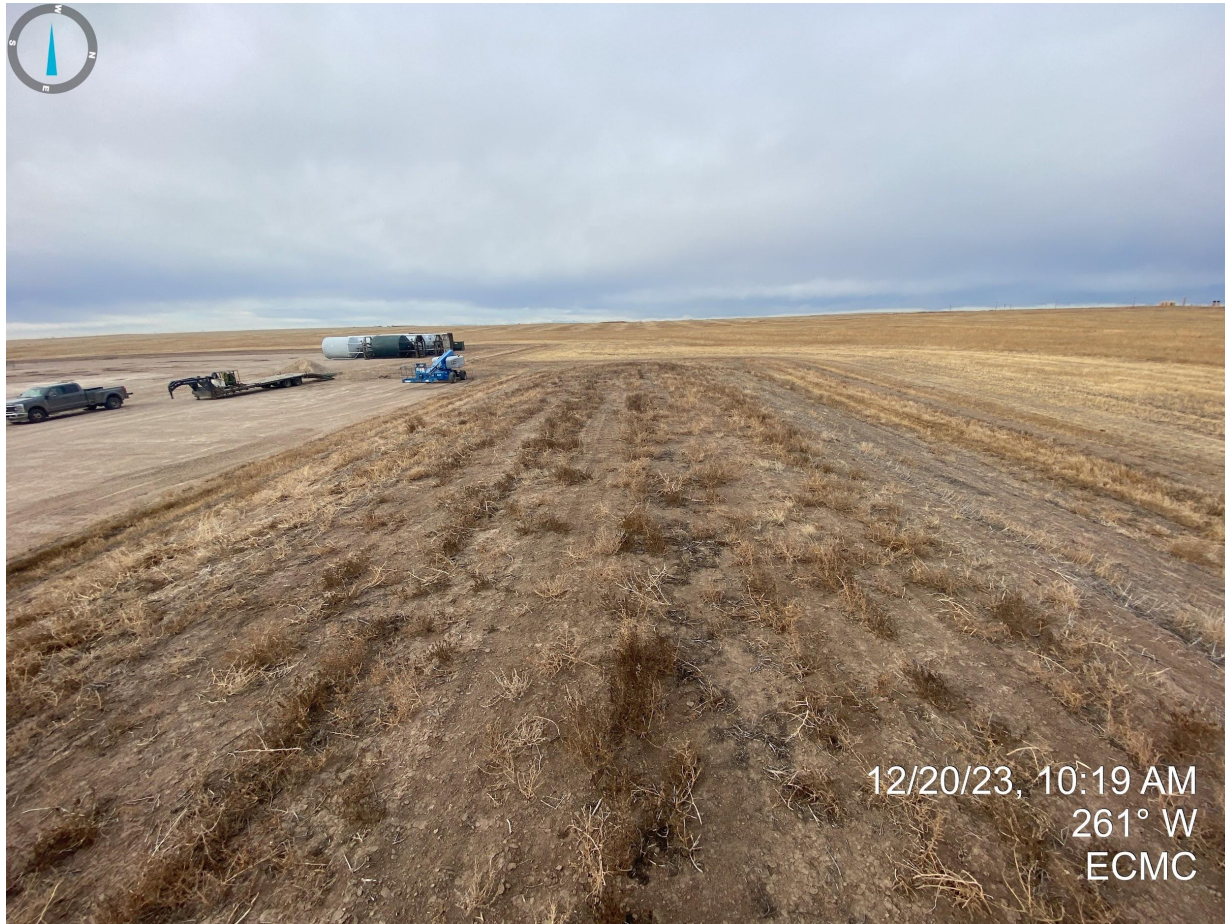
Photo 6. Continued from Photo 5, facing west; See comments in Photos 3 & 4.

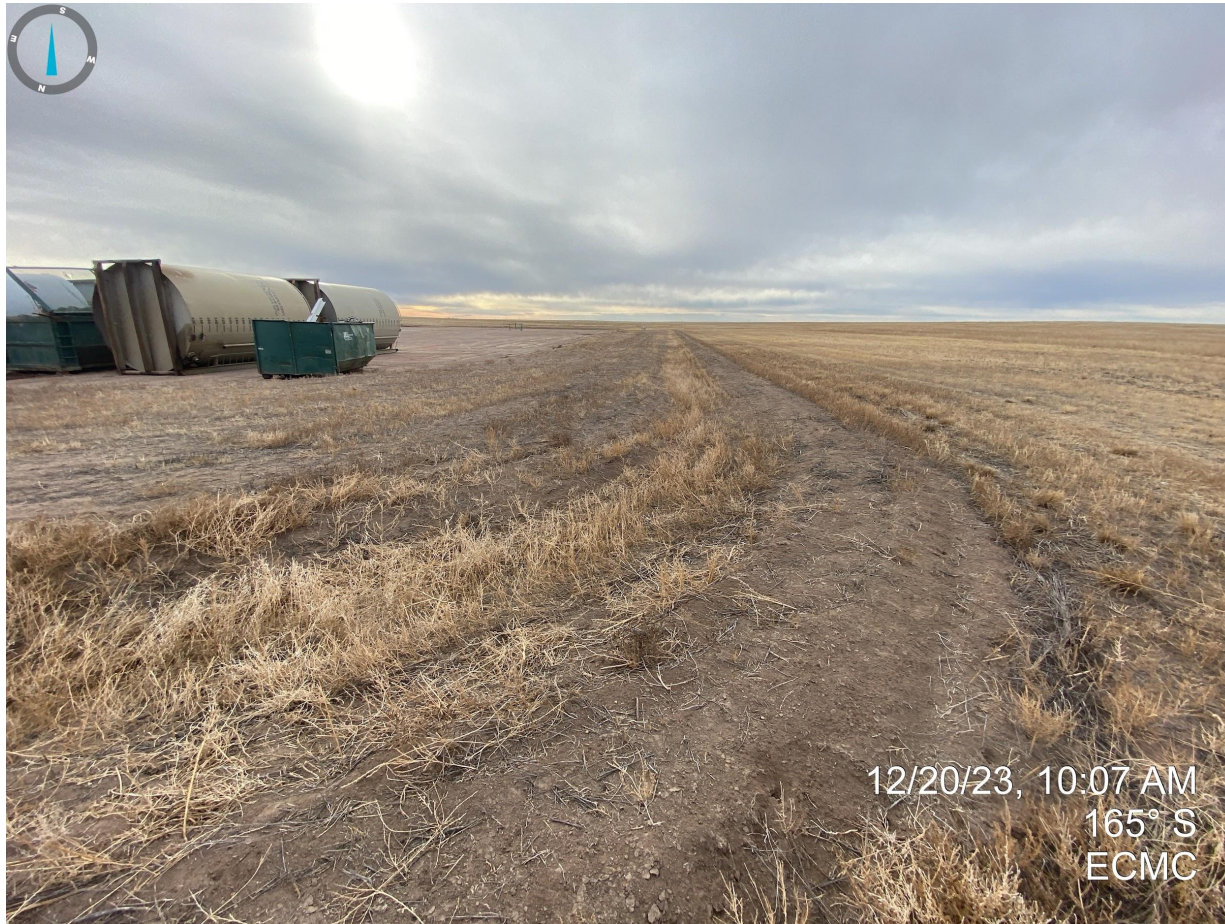
Photo 7. Taken from the northwest corner of the disturbance area. A temporary stormwater control/BMP (ditch and berm) has been constructed around the entire perimeter of the location.

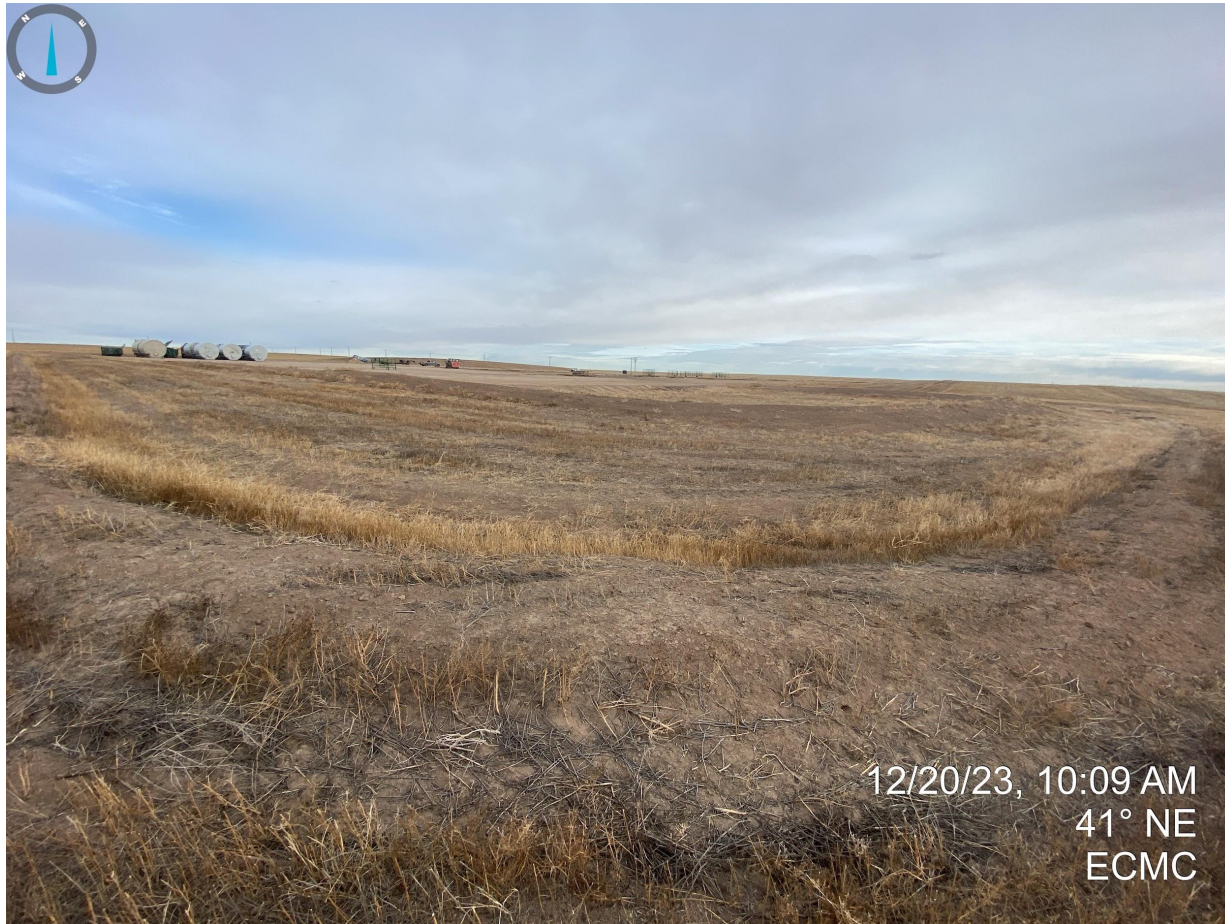
Photo 8. Taken from the southwest corner of the disturbance area, facing the stormwater detention area.

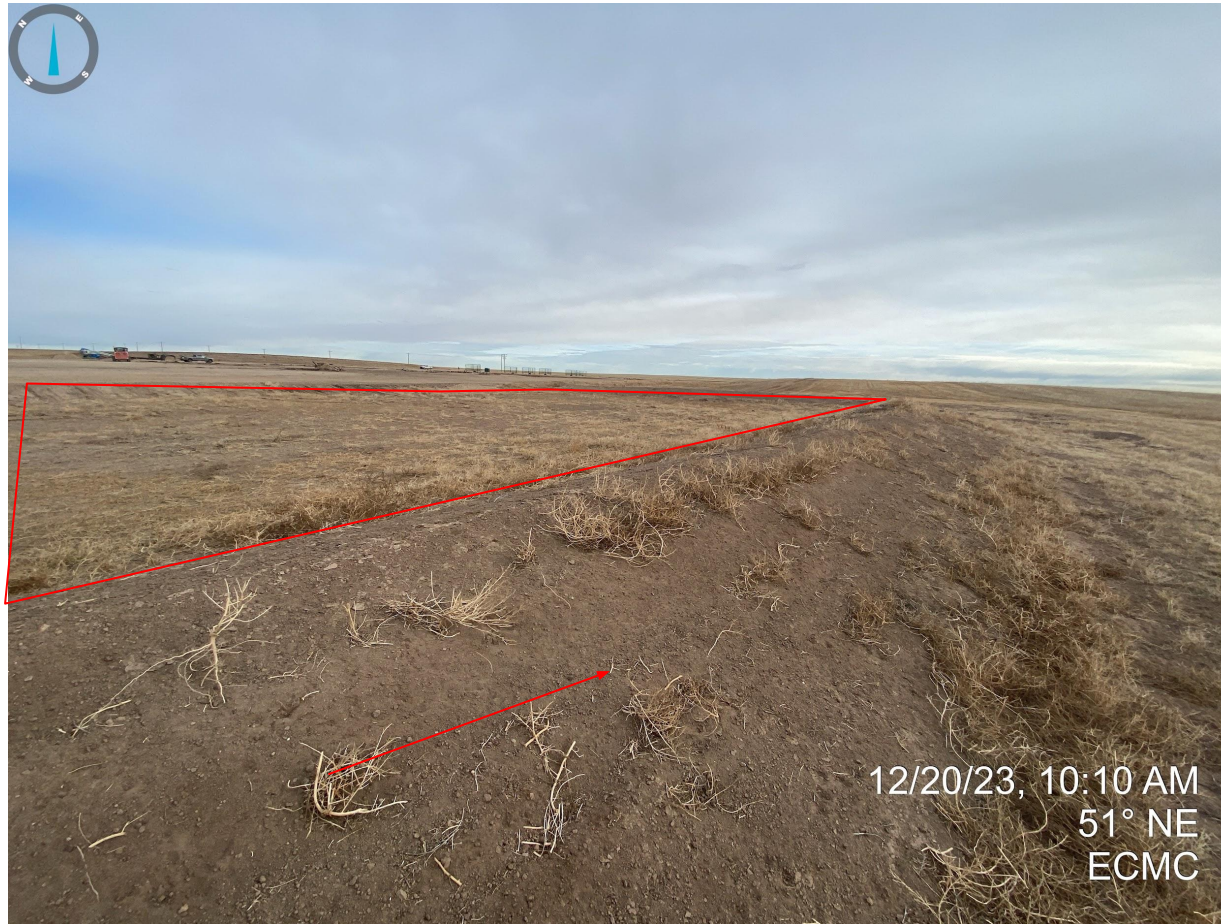
Photo 9. Red outlined area represents the stormwater detention area. Portions of the earthen berms require additional stabilization techniques to prevent wind and water erosion as they are comprised of bare/exposed soils.

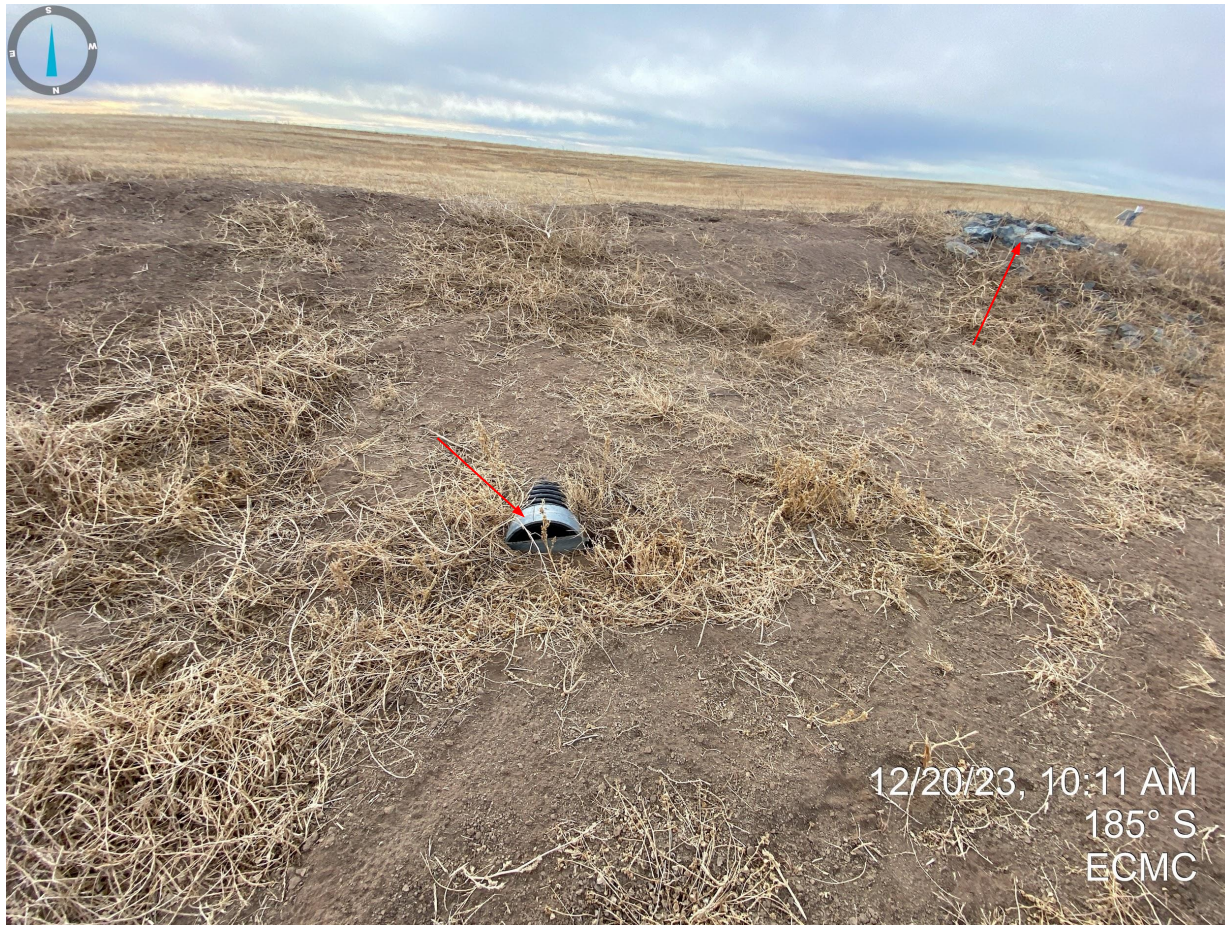
Photo 10. Taken within the stormwater detention area. Photo illustrates the outflow culvert and rip rap overflow. See also comments in previous photo.

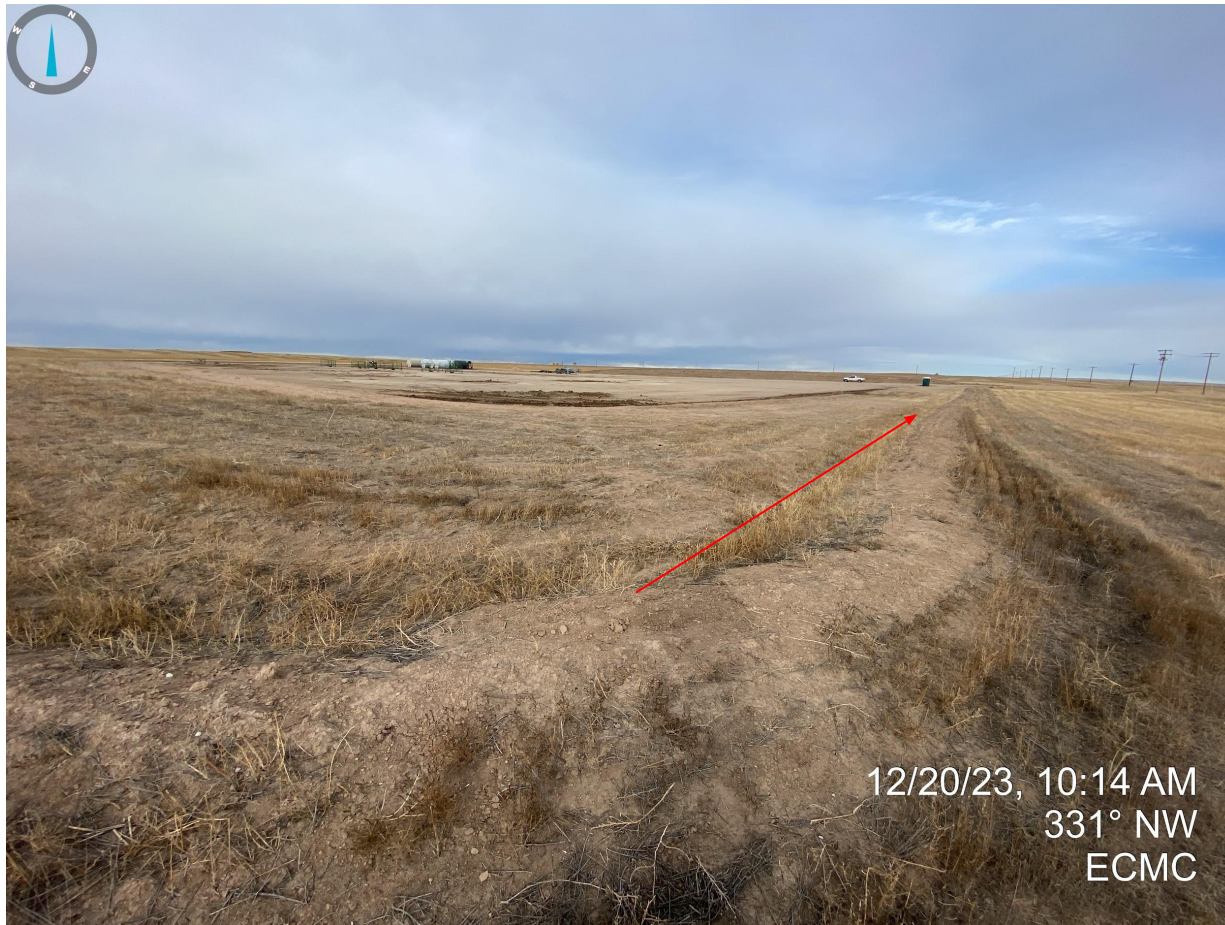
Photo 11. Taken from the southeast corner of the disturbance area. Photo illustrates that the temporary stormwater ditch and berm has been installed throughout the entire perimeter of the location.

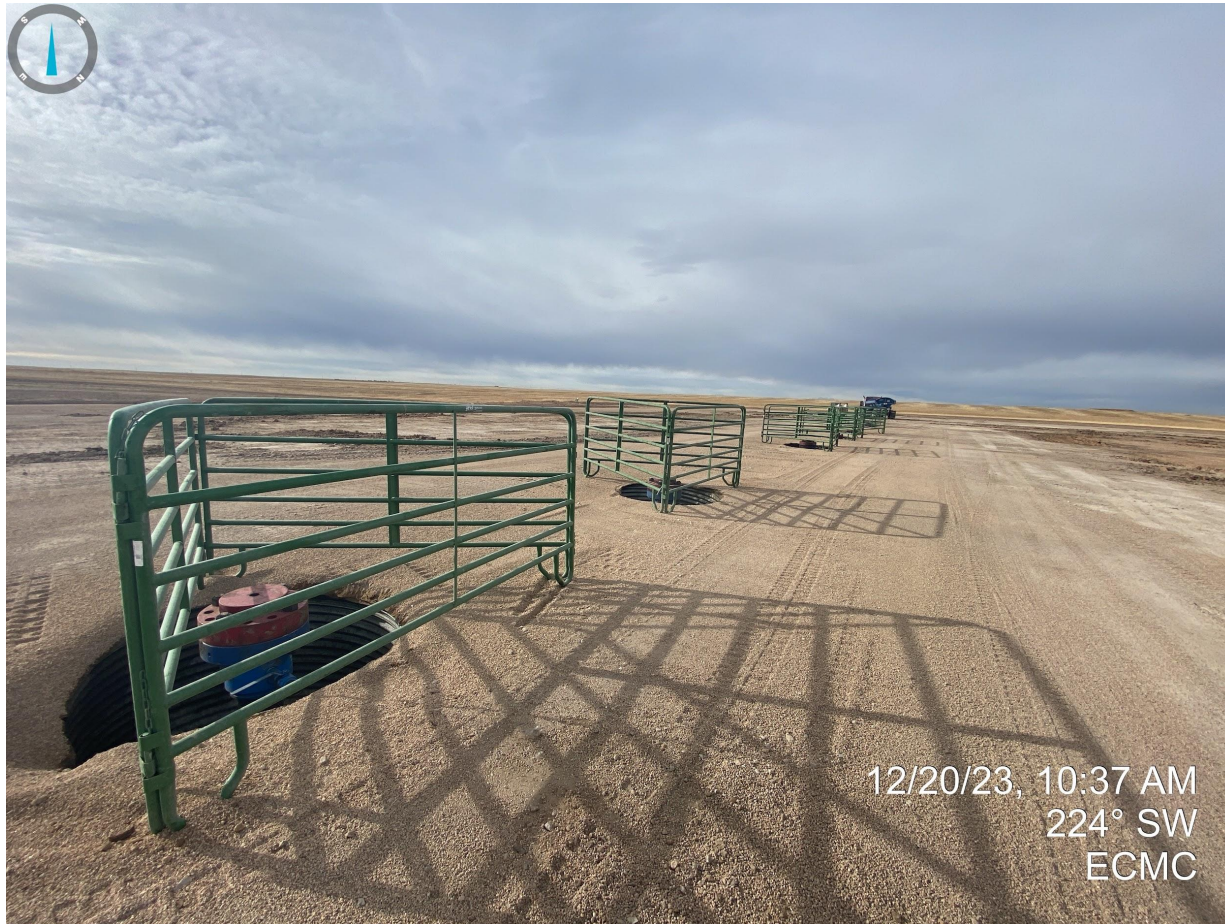
Photo 12. Taken from the center portion of the drilling areas. Photo illustrates six (6) wells have been drilled.
