Inspection Photos

Location Name: TEP ROCKY MOUNTAIN LLC, PA-66S95W/33NESW

Location ID: 335316

Date: 12/18/2023

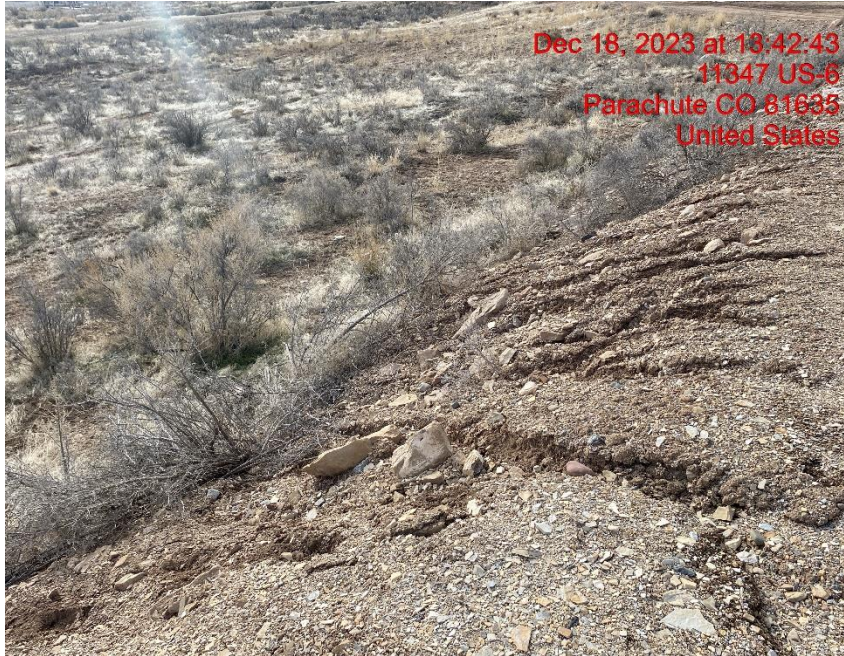
Rill Erosion Transporting Sediment Off Location – Photo #08280

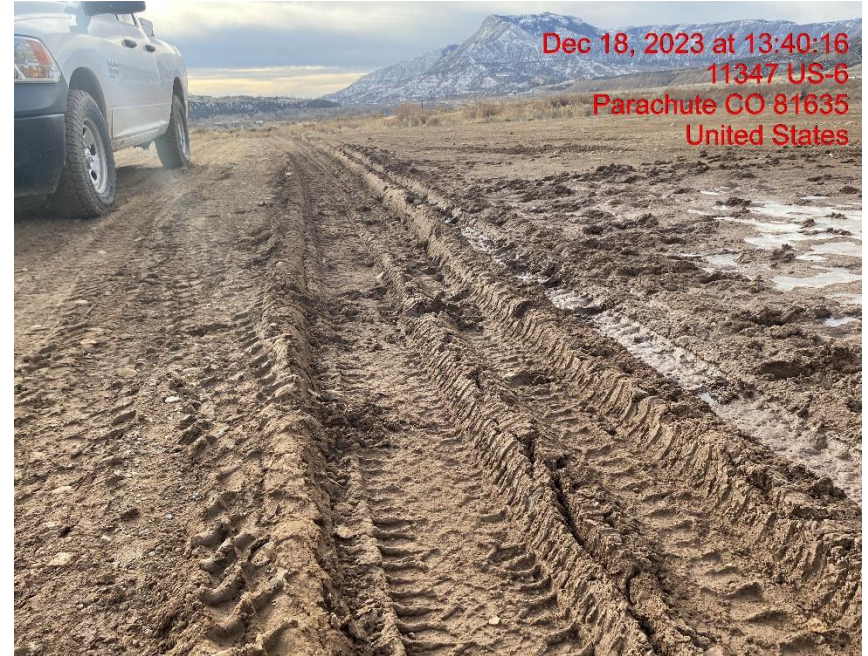
Lack of Stabilization – Photo #08274

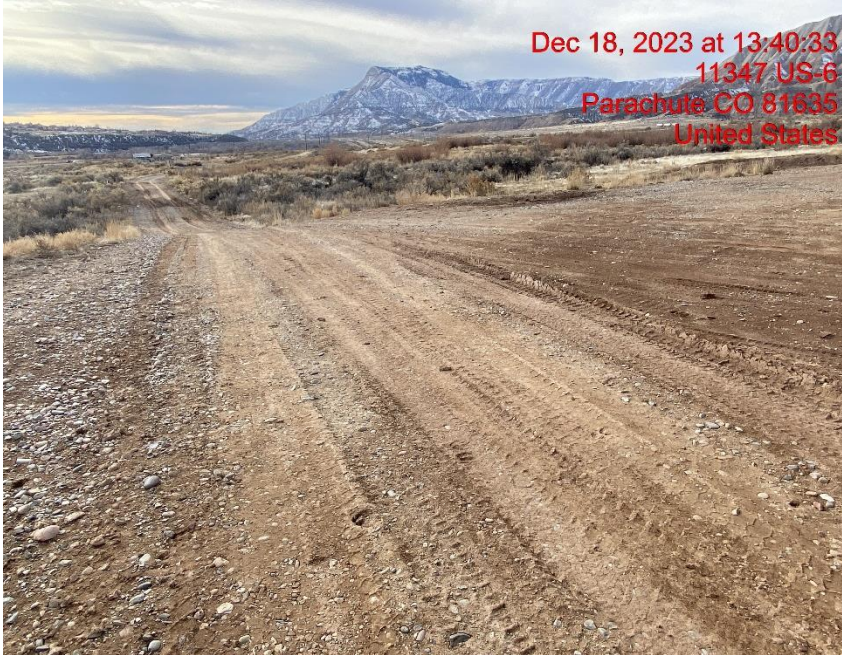
Insufficient Vehicle Tracking BMPs at Location Entrance/Exit
– Photo #08275
