Inspection Photos

Location Name: TEP ROCKY MOUNTAIN LLC, EXXON-66S95W/32NESE

Location ID: 335296

Date: 12/18/2023

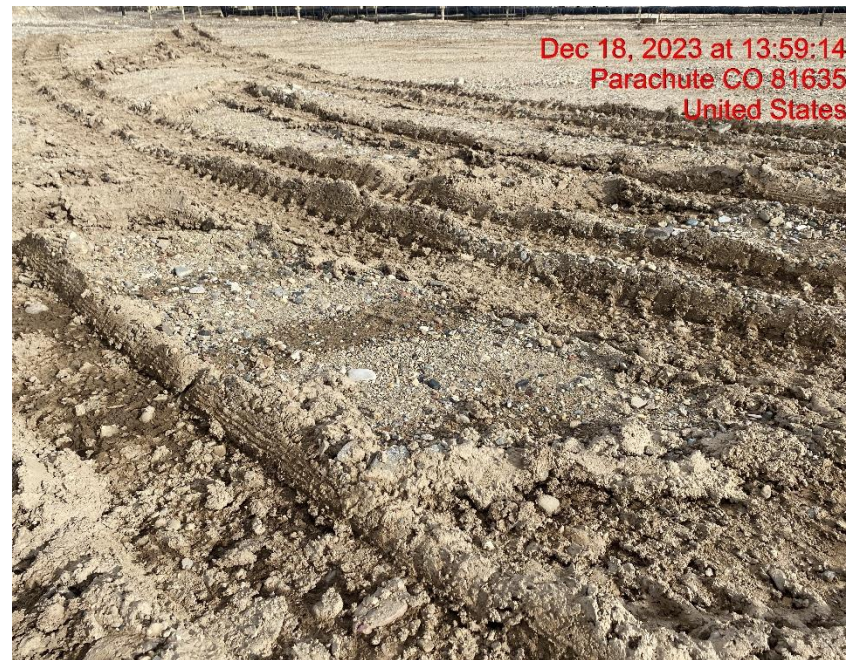
Lack of Stabilization – Photo #08299

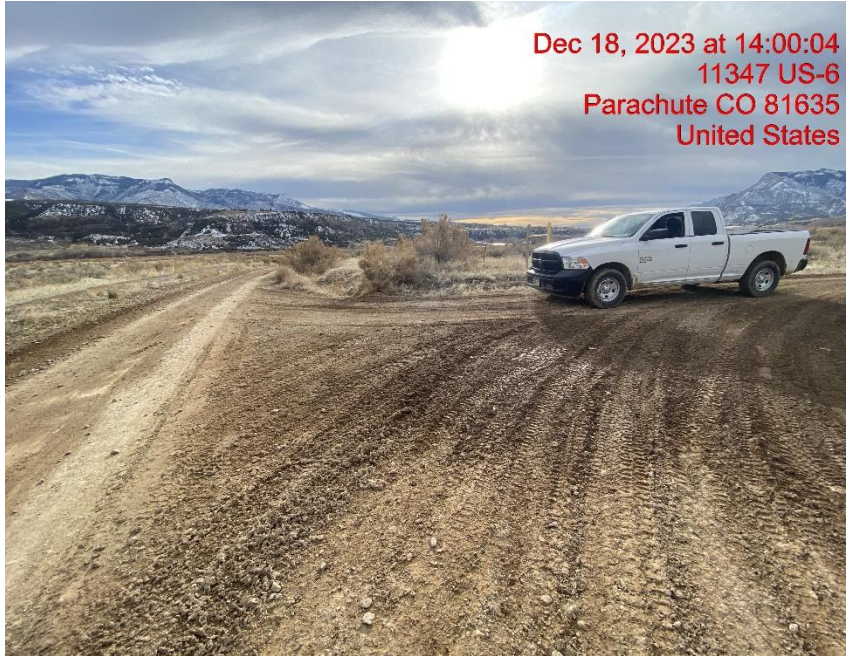
Insufficient Vehicle Tracking BMPs at Location Entrance/Exit
– Photo #08300
