Inspection Photos

Location Name: CAERUS PICEANCE LLC N PARACHUTE EF12A-19 L19595 Pad

Location #: 335635

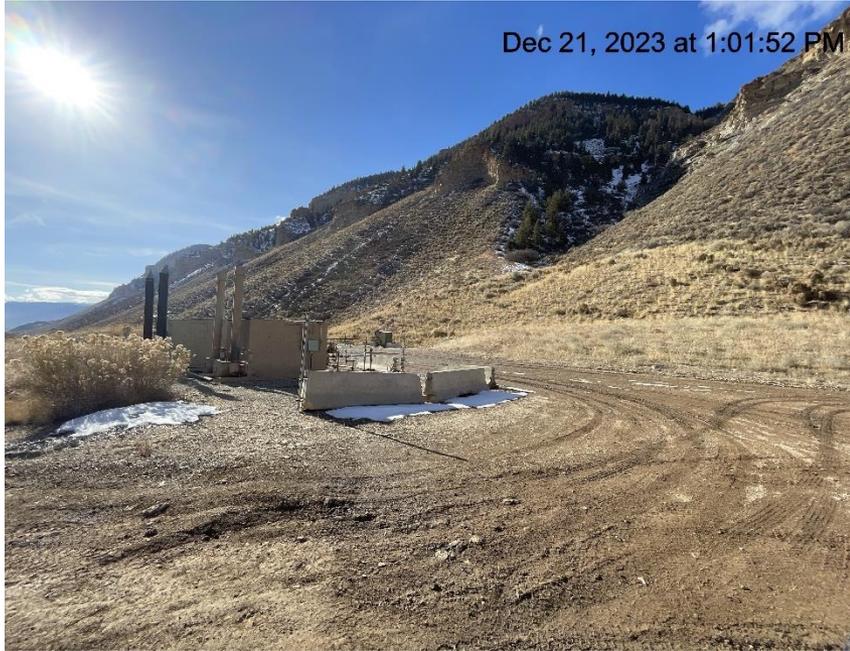
Photo # 691 From entrance to location

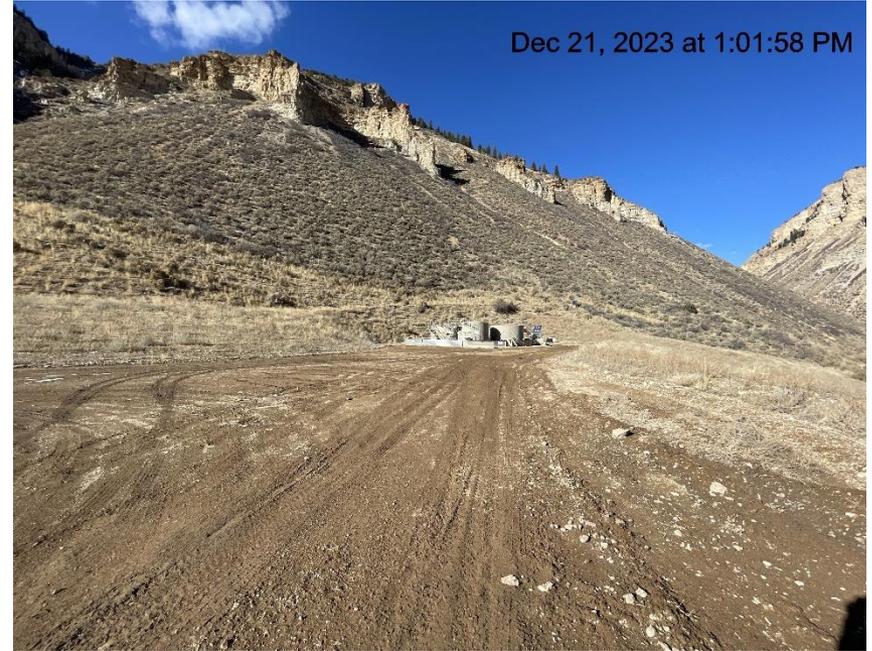
Photo # 692 From entrance to location

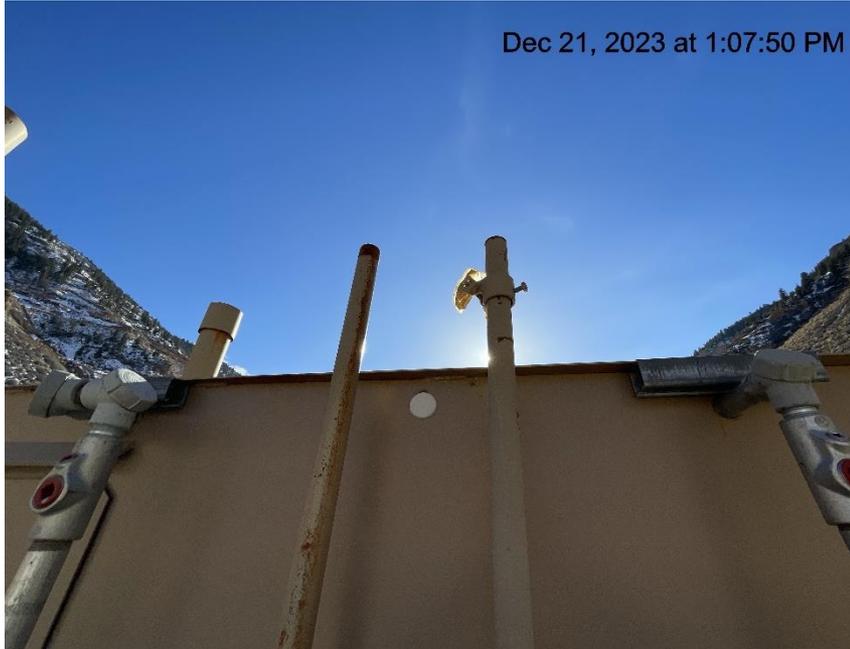
Photo # 697 PRV & Rupture disc vent lines lack caps

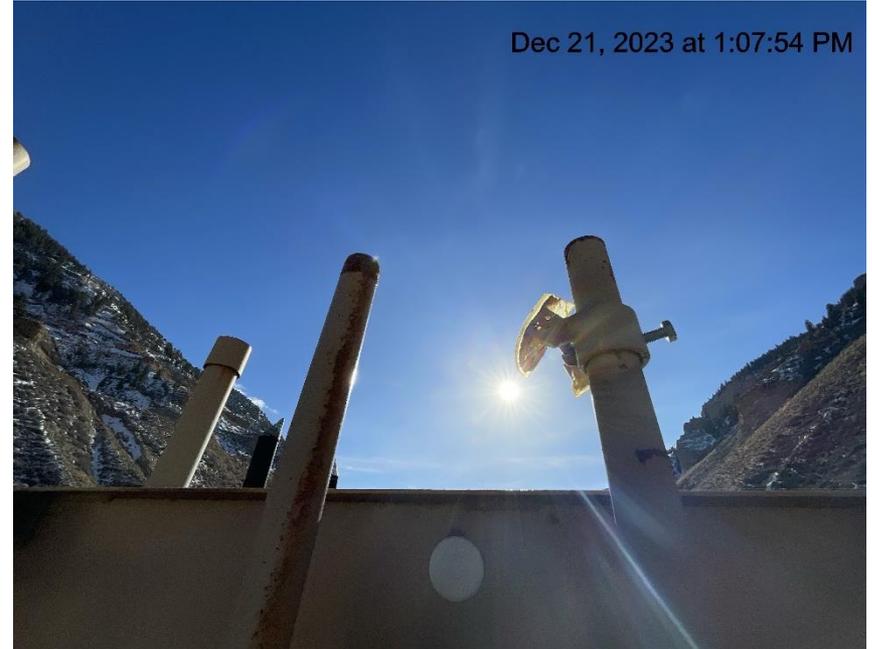
Photo # 698 PRV & Rupture disc vent lines lack caps

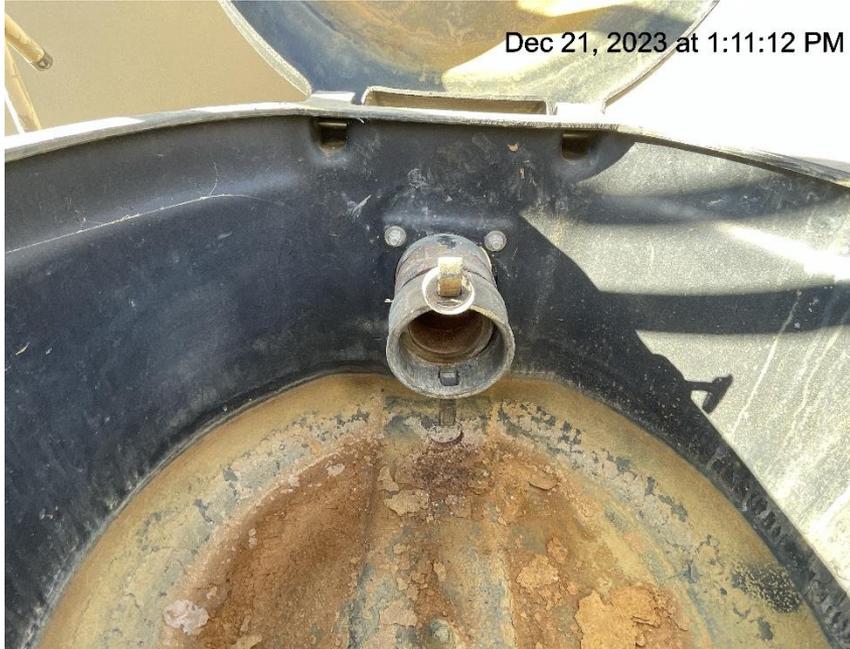
Photo # 699 Open ended load line

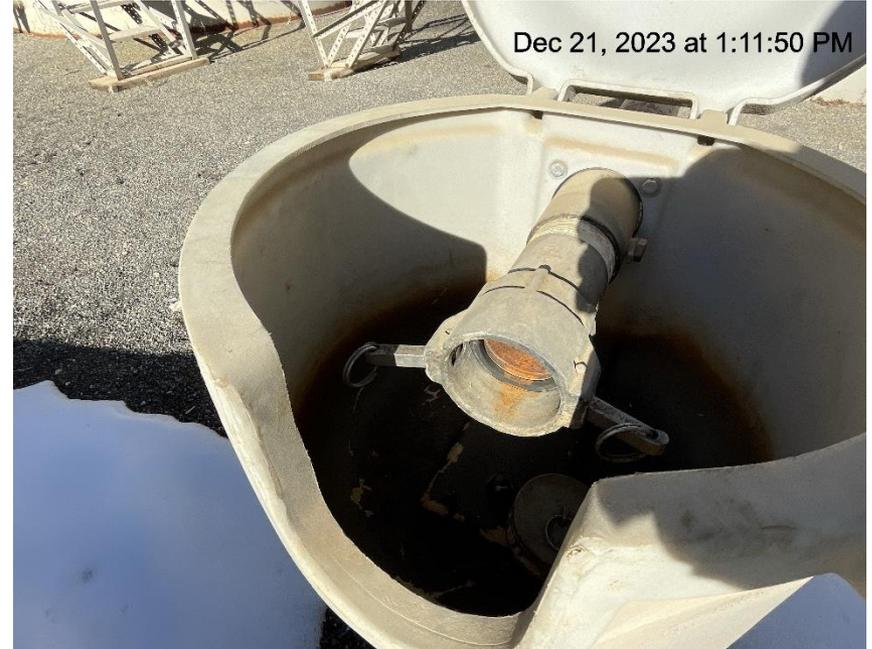
Photo # 700 Open ended load line

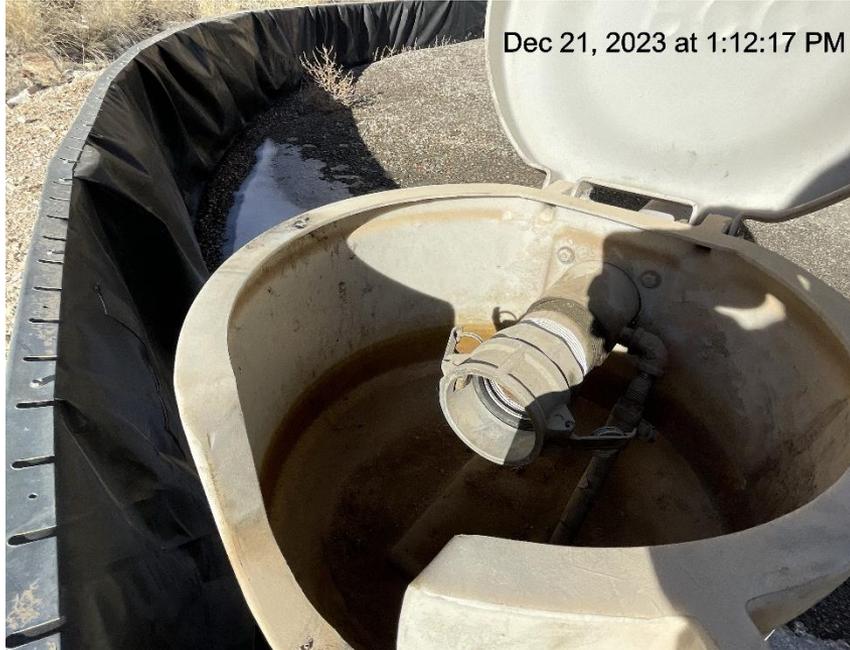
Photo # 701 Open ended load line
