# Interim Reclamation and Stormwater Inspection

Date: 12/20/2023

Operator: NOBLE ENERGY INC - 100322

Inspection Photos  
Location Name: State 8-60 16-2H  
Location ID: 427008

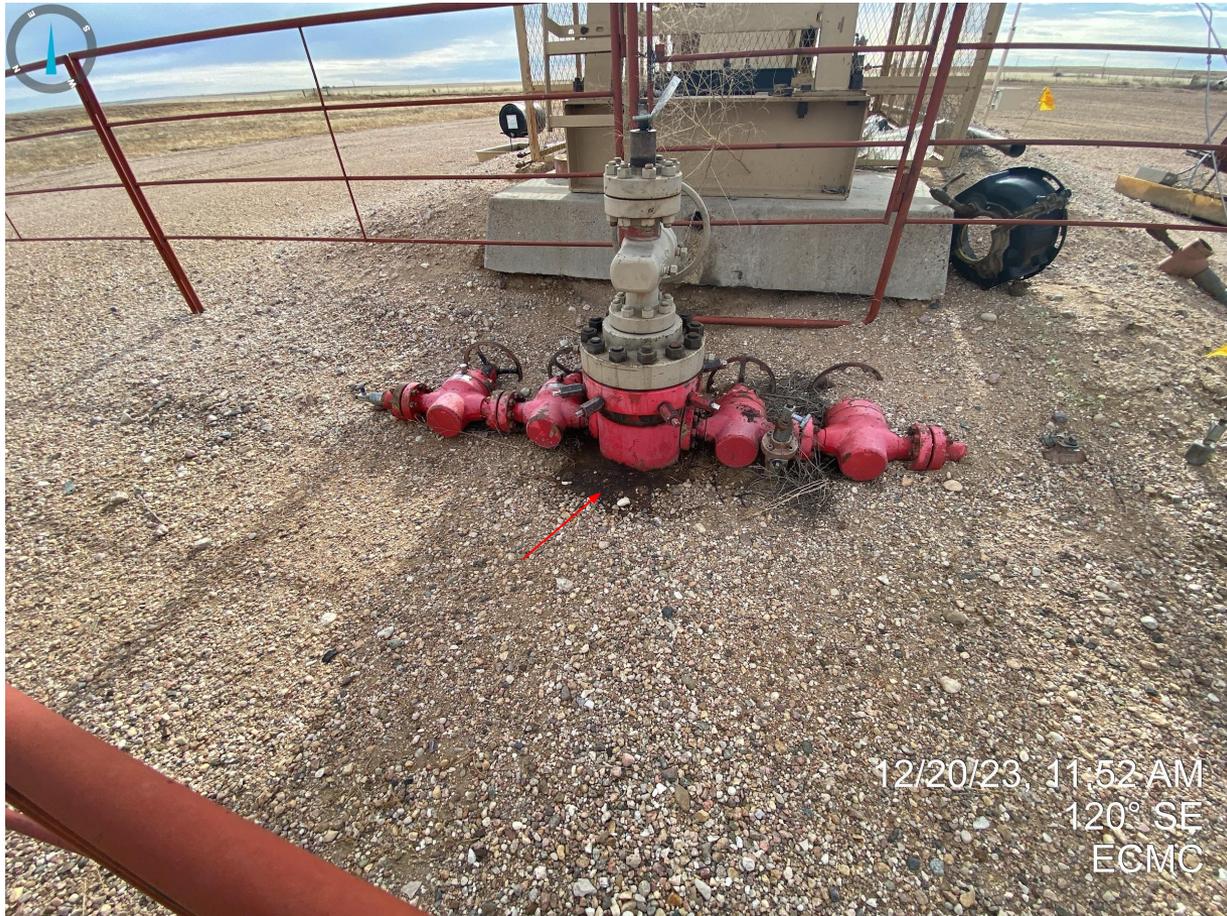
**Photo 1.** Stained soil observed at wellhead.

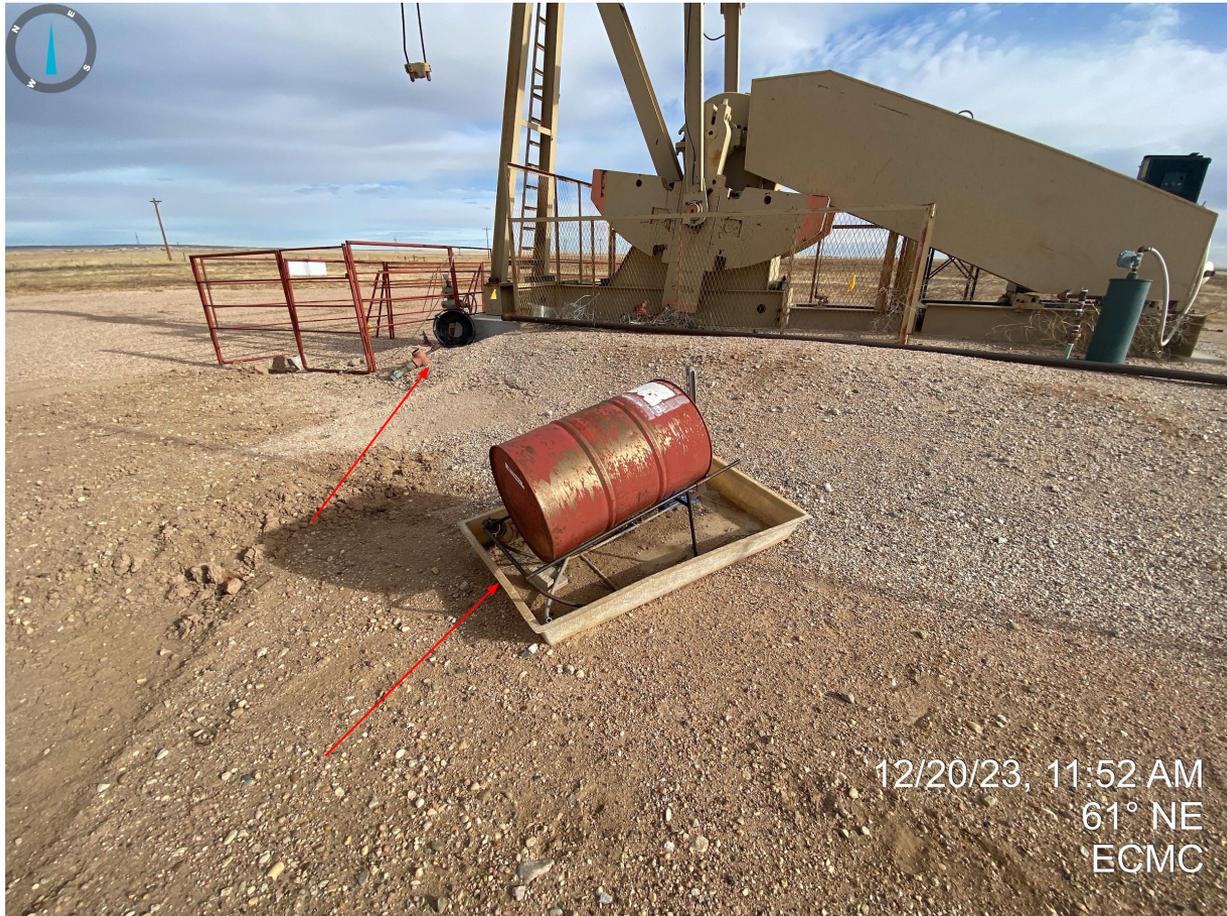
**Photo 2.** Unused equipment observed near wellhead.

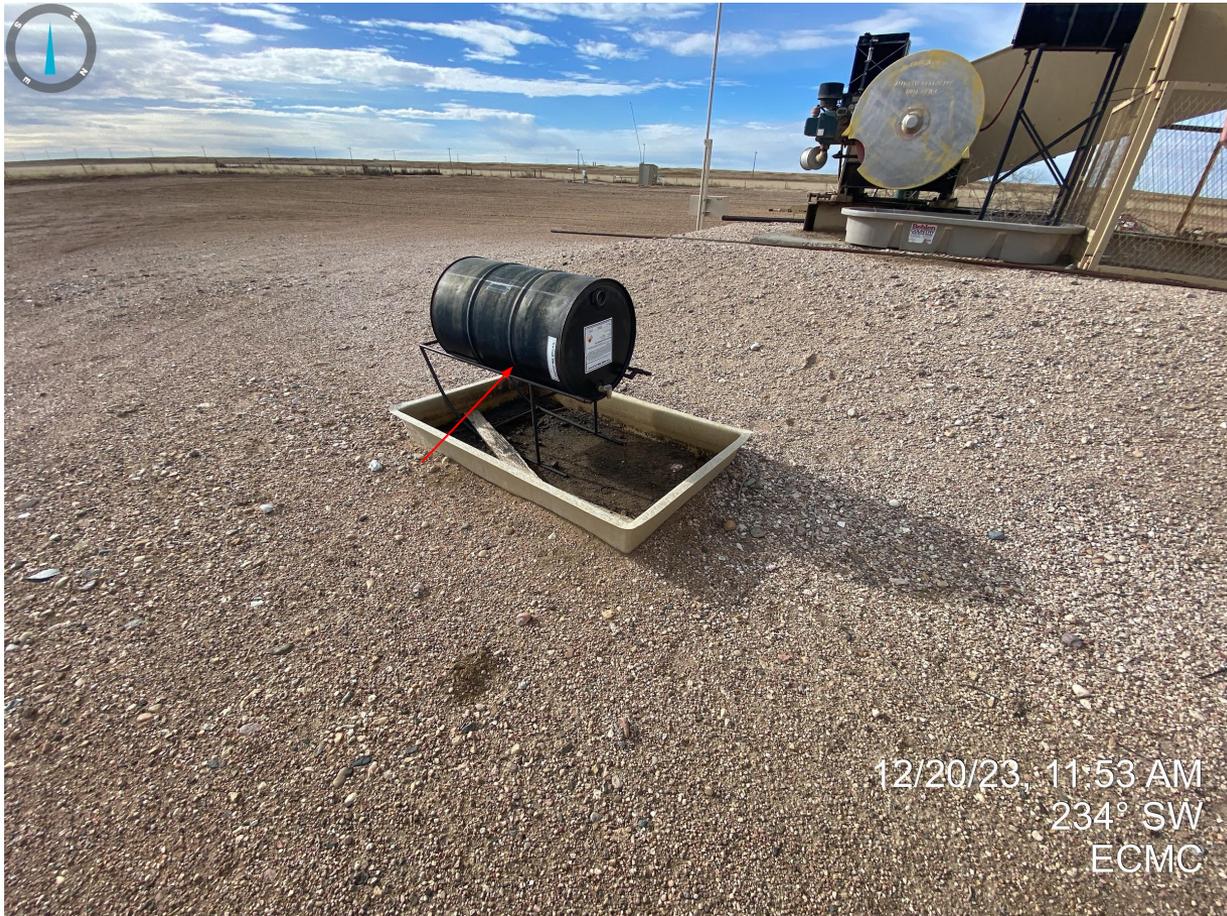
**Photo 3.** Unused equipment observed near wellhead.

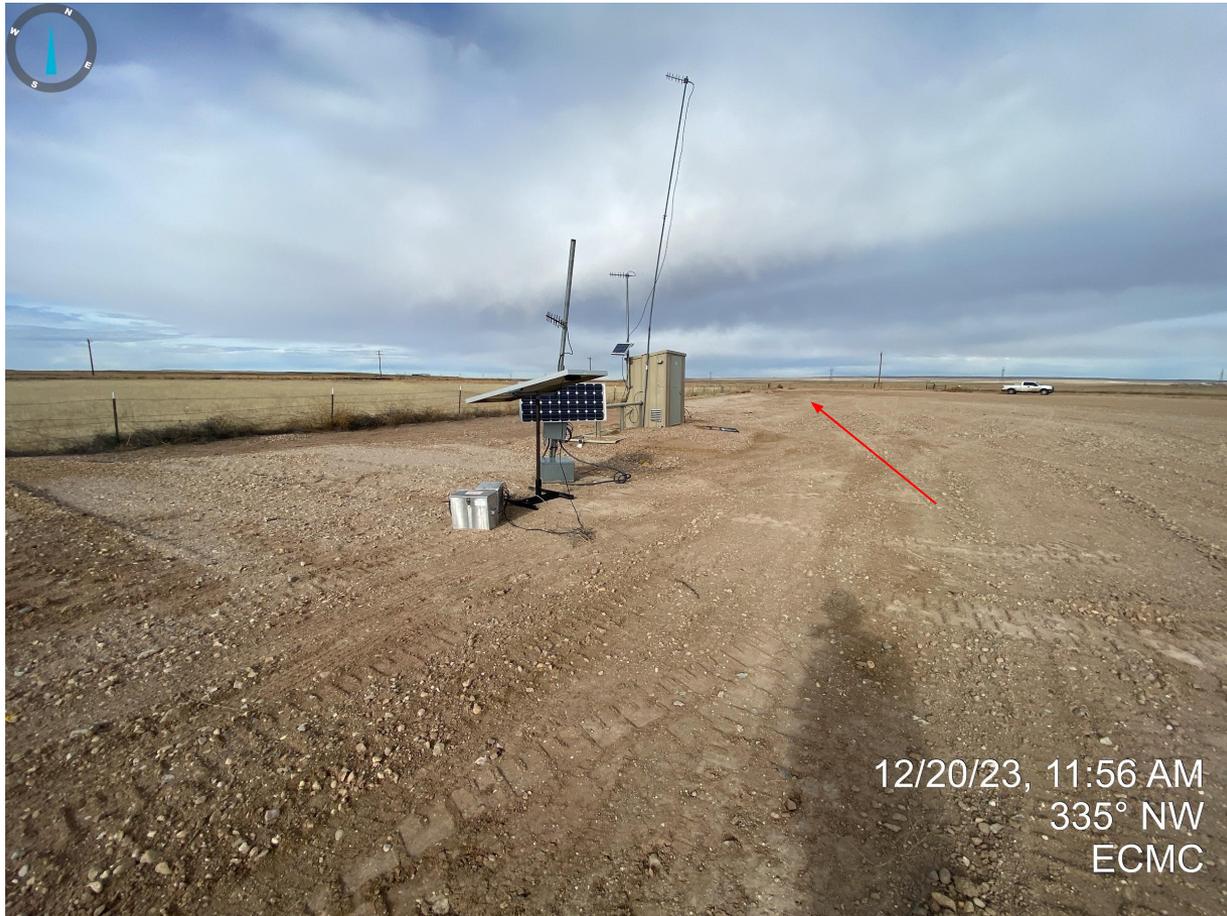
**Photo 4.** It appears the location is in the process of being decommissioned as the former tank battery equipment has been removed.

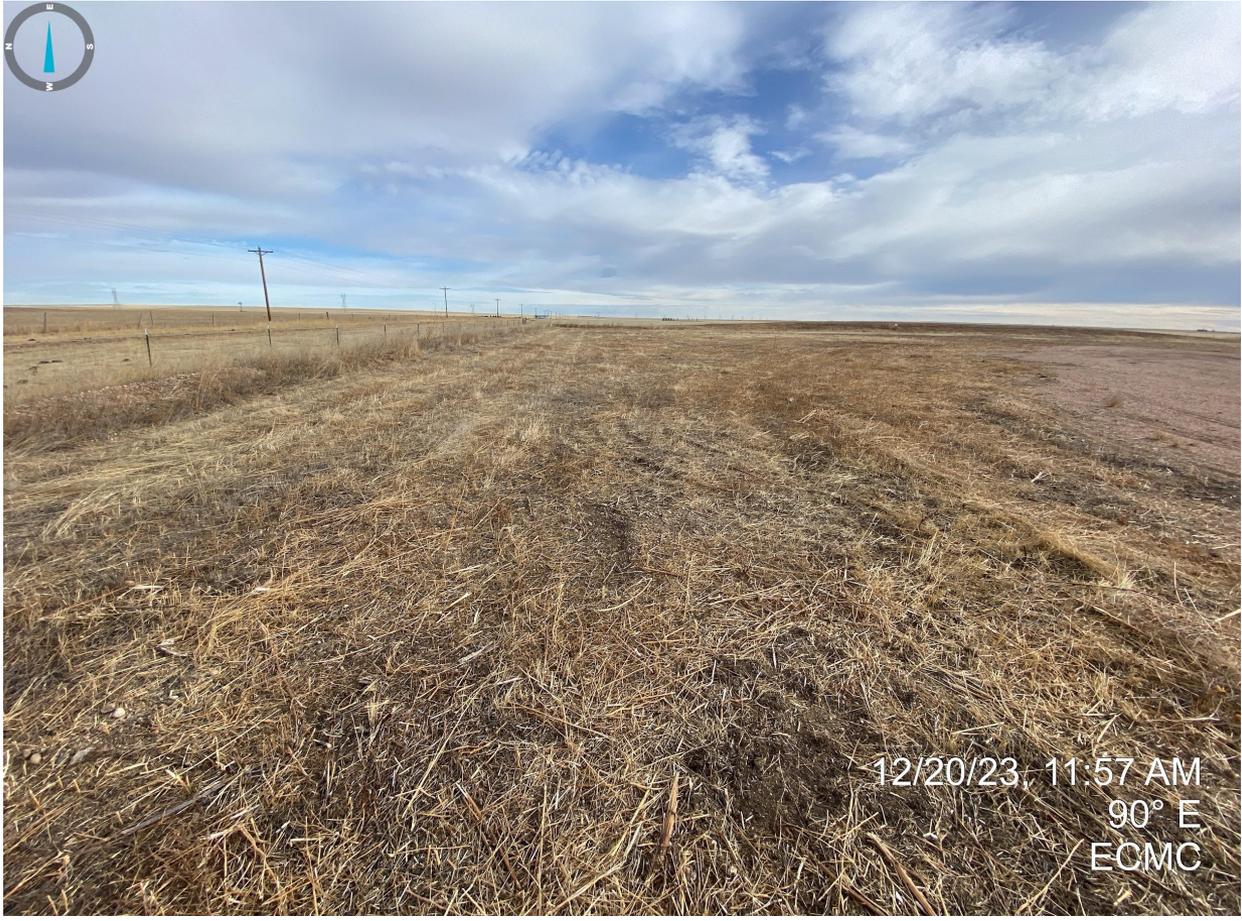
**Photo 5.** Northern interim areas appear to have been recently mowed. A follow-up inspection will be conducted during the active growing season to verify vegetative compliance with Rule 1003, and is therefore “In-process”.

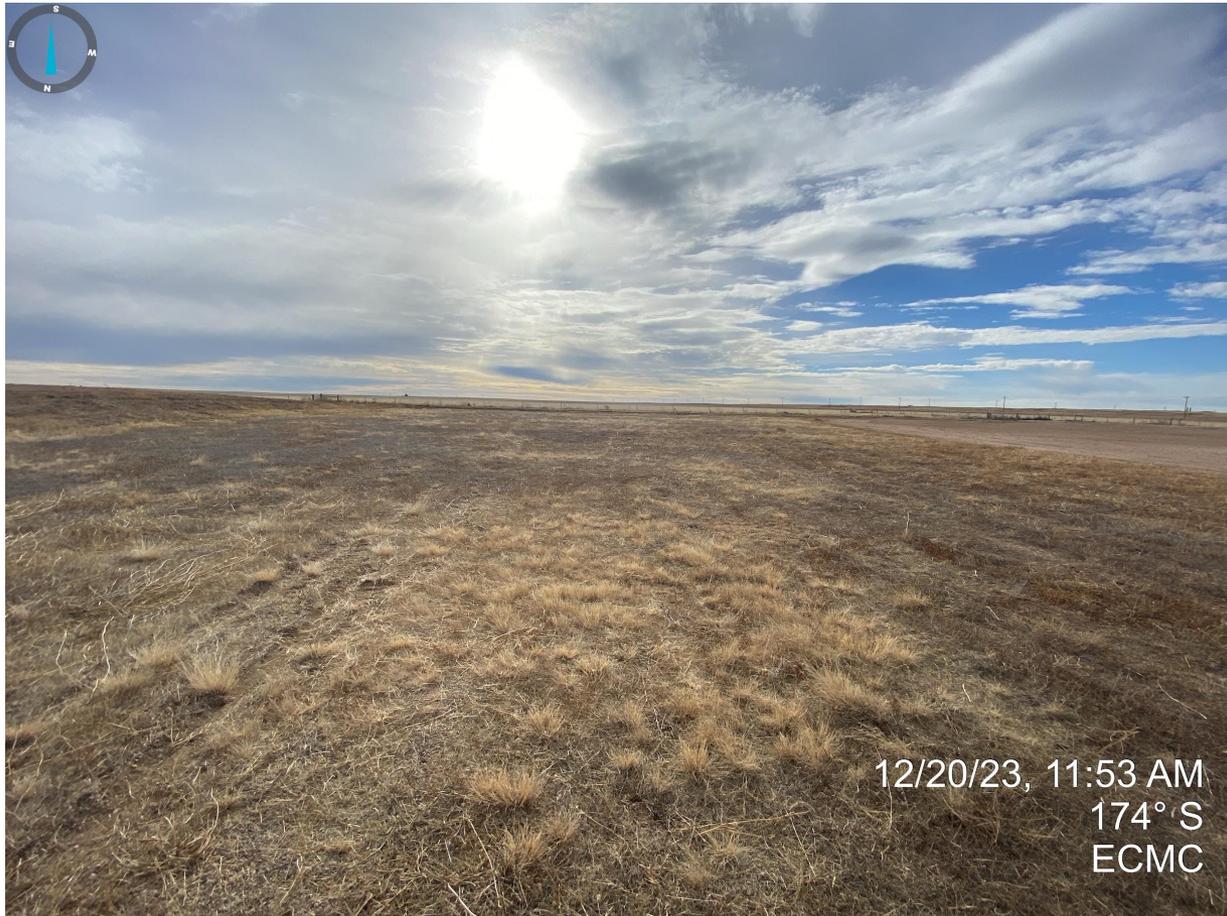
**Photo 6.** Eastern interim areas, facing south. See comments in Photo 5.

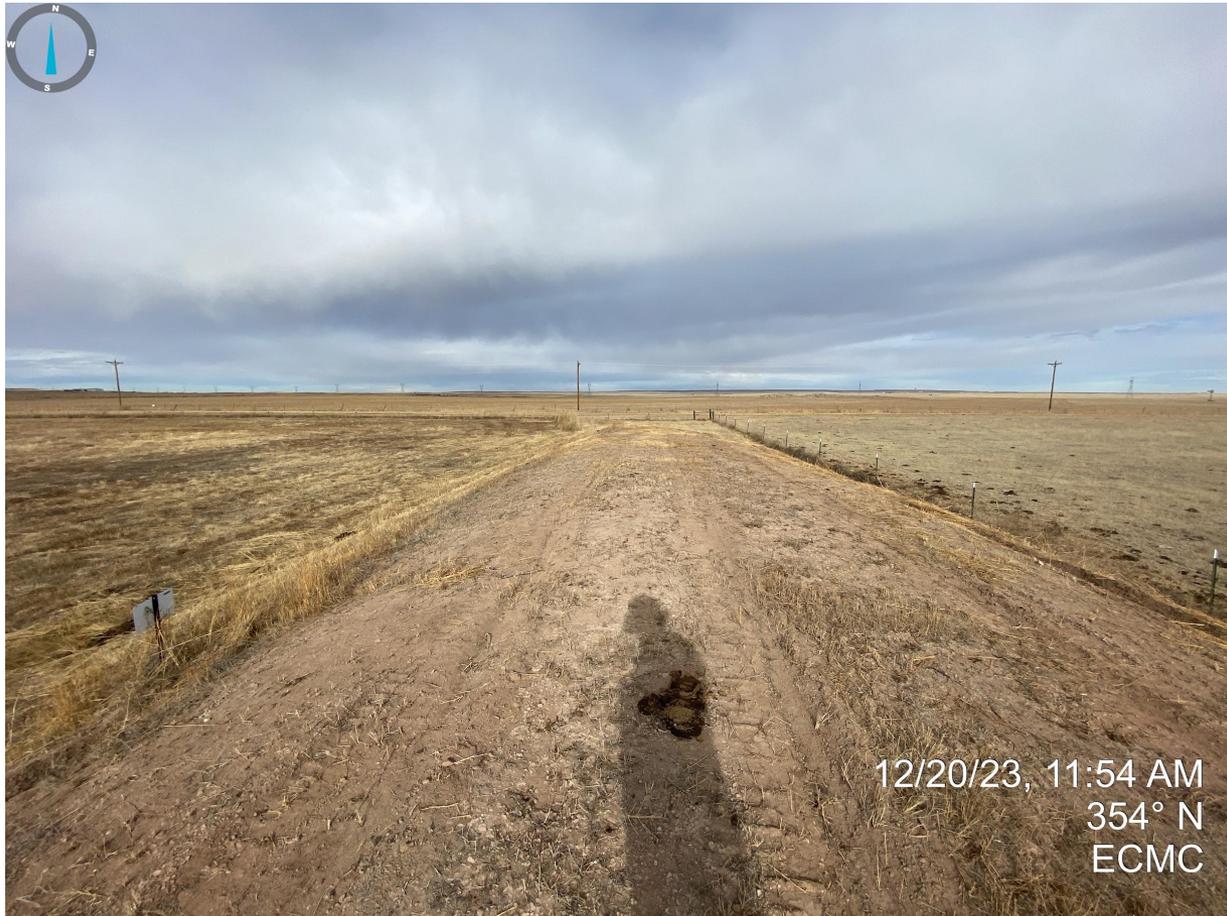
**Photo 7.** Taken from the center portion of the topsoil stockpile, facing north. The stockpile does not comply with Rule 1002.c as evidenced by bare/exposed soils. Additional BMPs and/or revegetation activities are required in order to comply with Rule 1002.c.

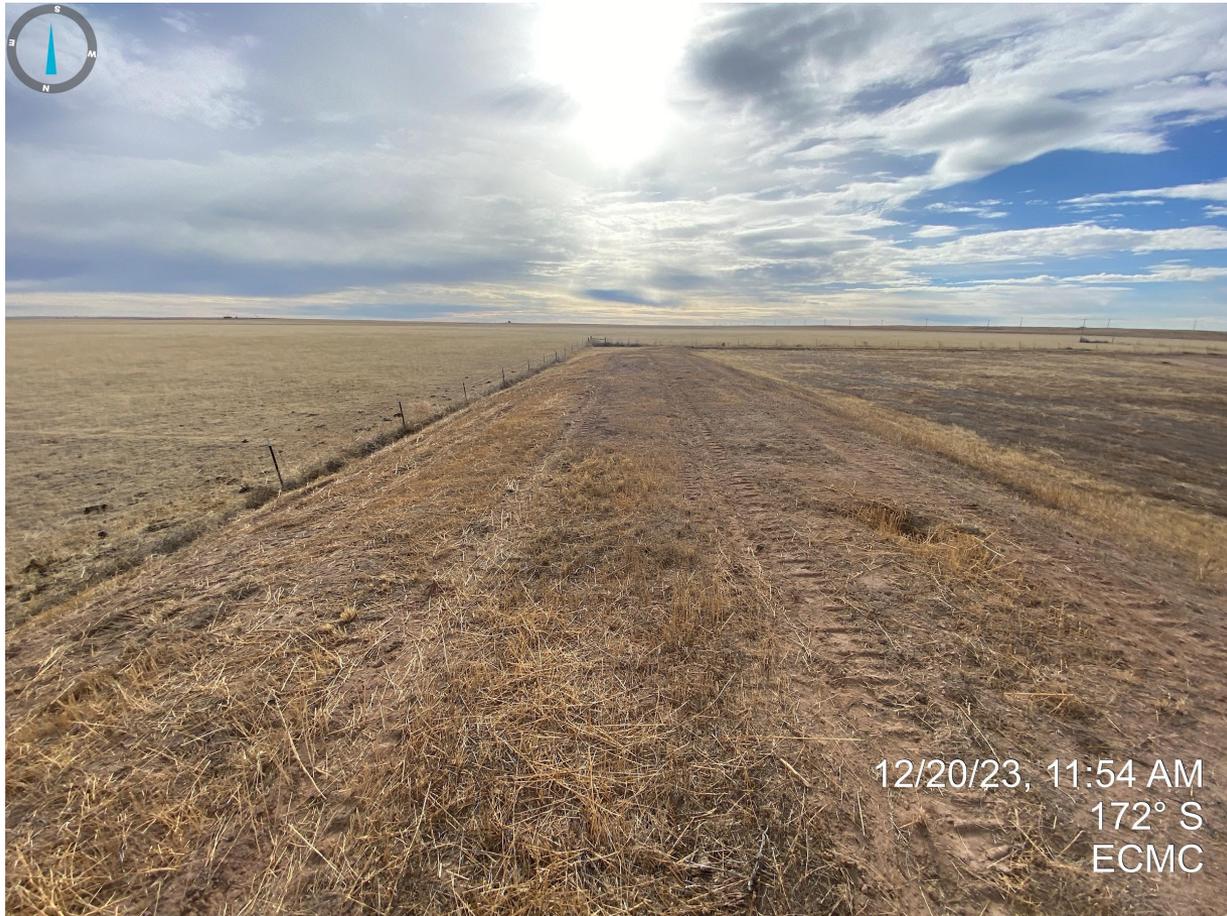
**Photo 8.** Taken from the center portion of the topsoil stockpile, facing south. See comments in Photo 7.
