Interim Reclamation and Stormwater Inspection

Date: 12/15/23

Operator: Bonanza Creek Energy Operating
Company LLC - 8960

Location Name: North Platte I-24 Pad

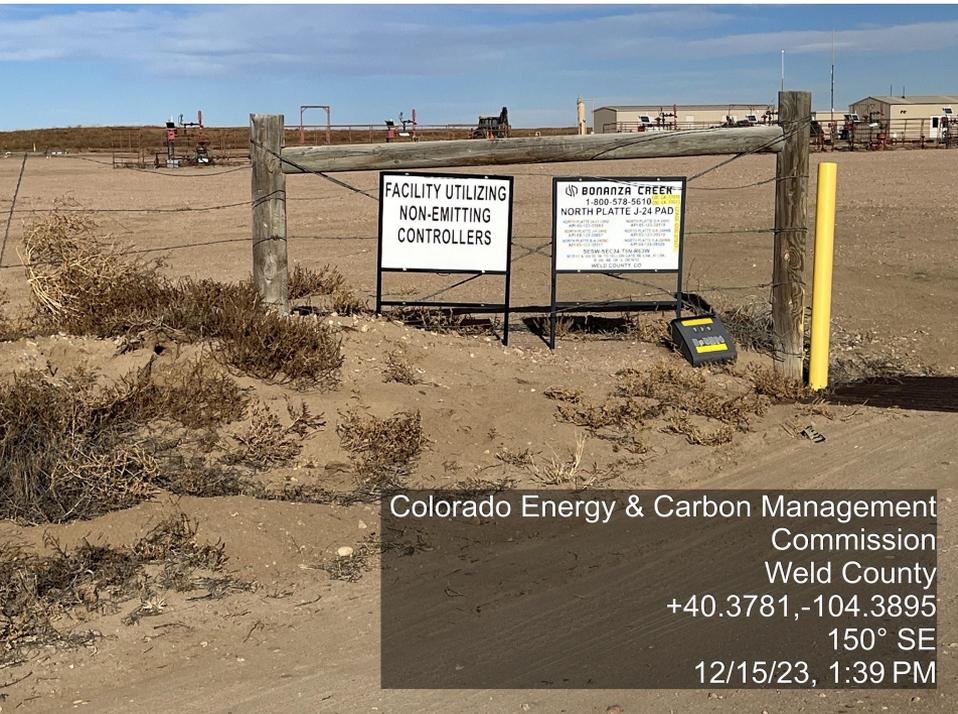
Photo 1. The photo was taken at the entrance to the well location facing Southeast. The photo illustrates the operator signage.

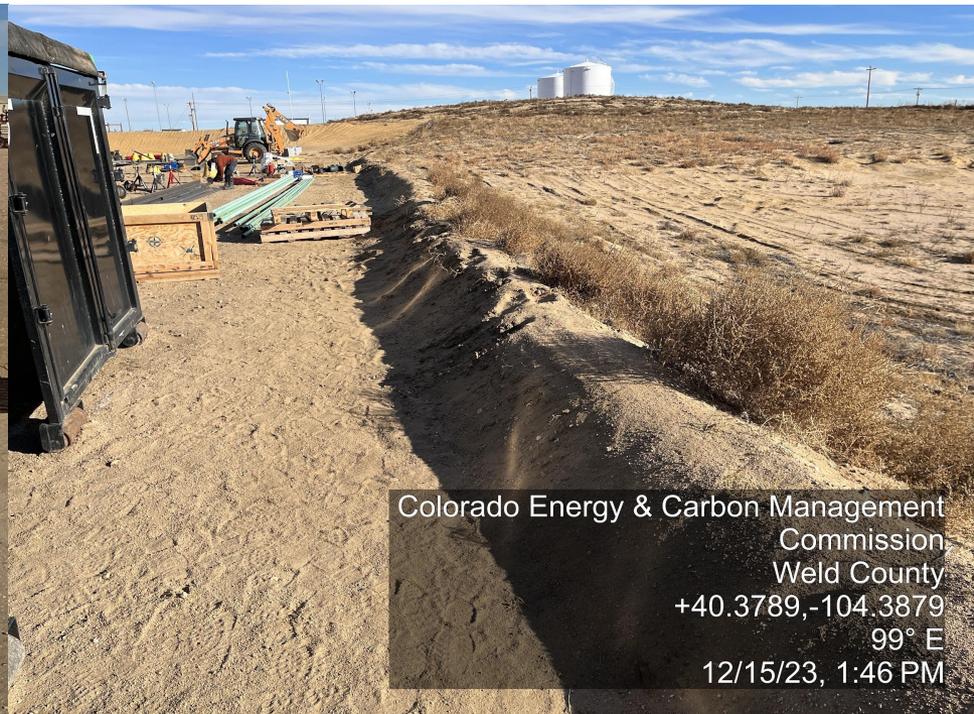
Photo 2. The photo was taken at the center of the well location facing East. The photo illustrates a berm around the pad with tumbleweeds growing along it as well as equipment being used in construction on location.

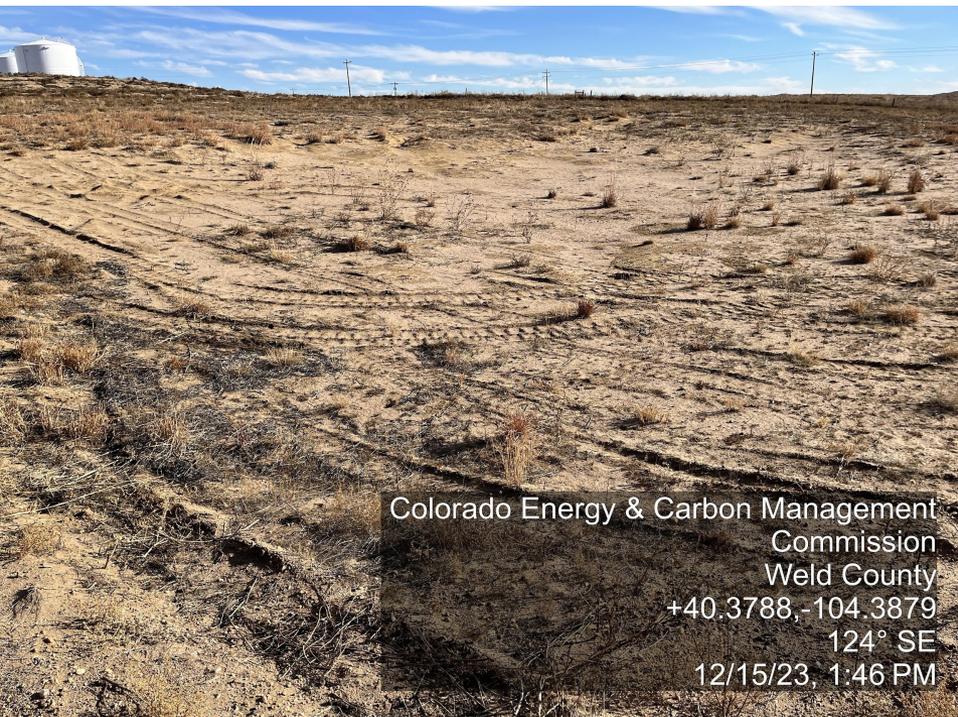
Photo 3. The photo was taken at the center of the well location facing Southeast. The photo illustrates bare areas of bare soil at the location.

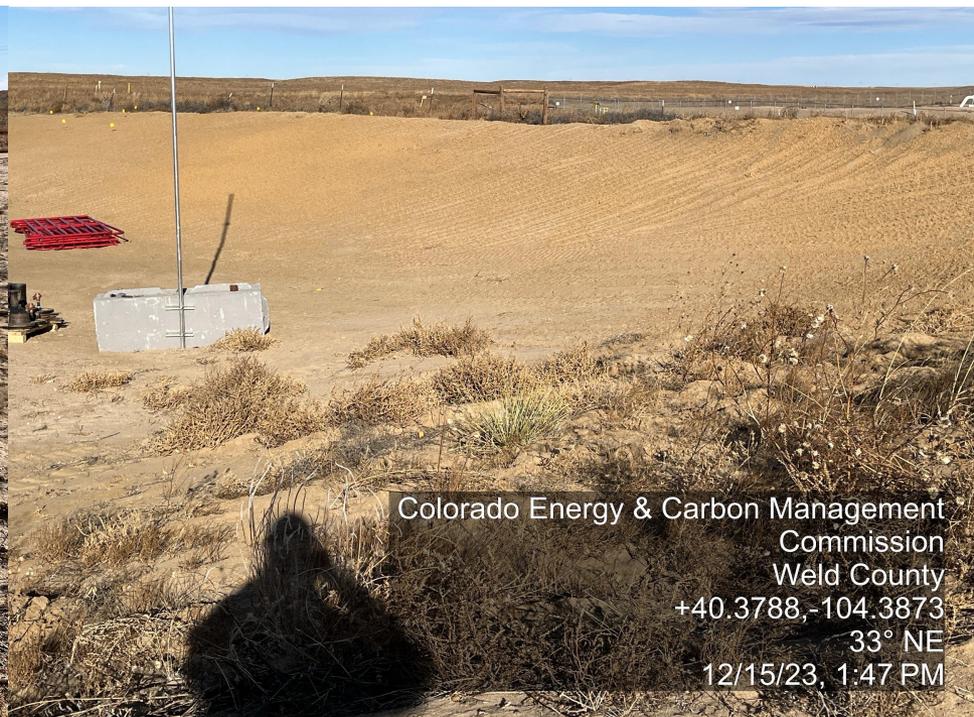
Photo 4. The photo was taken at the East end of the well location facing Northeast. The photo illustrates a bare slope that is part of their construction area.

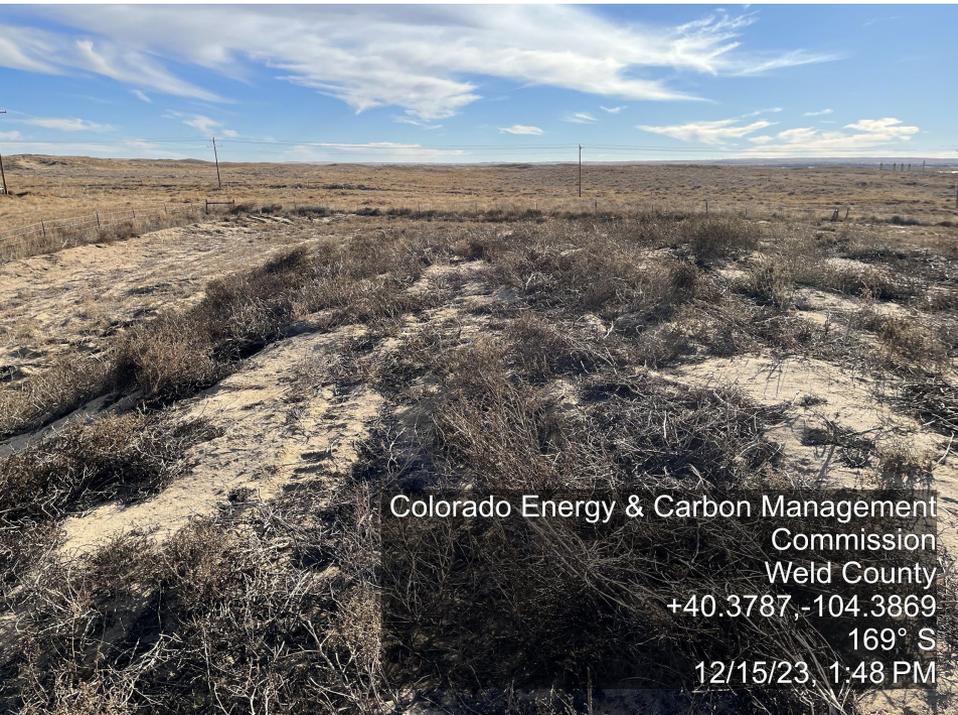
Photo 5. The photo was taken at the East end of the well location facing South. The photo illustrates the top of the topsoil stockpile is dominated by tumbleweeds and bare soil.

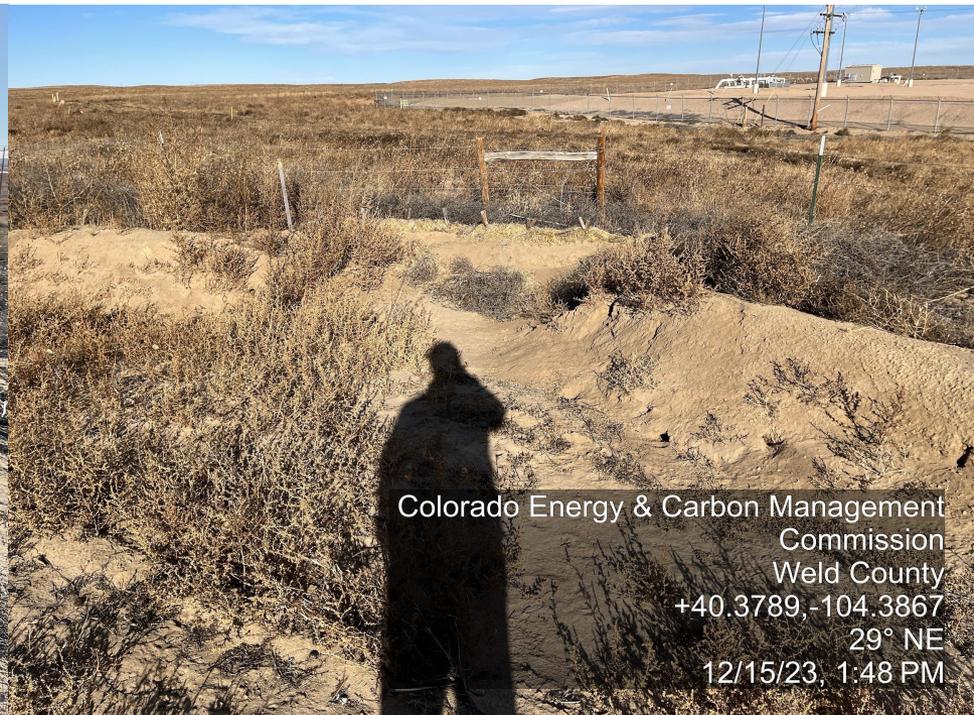
Photo 6. The photo was taken at the East end of the well location facing Northeast. The photo illustrates a representative sediment trap photo that is covered in tumbleweeds. At the well location there are 4 sediment traps that all need repair and new straw wattle.

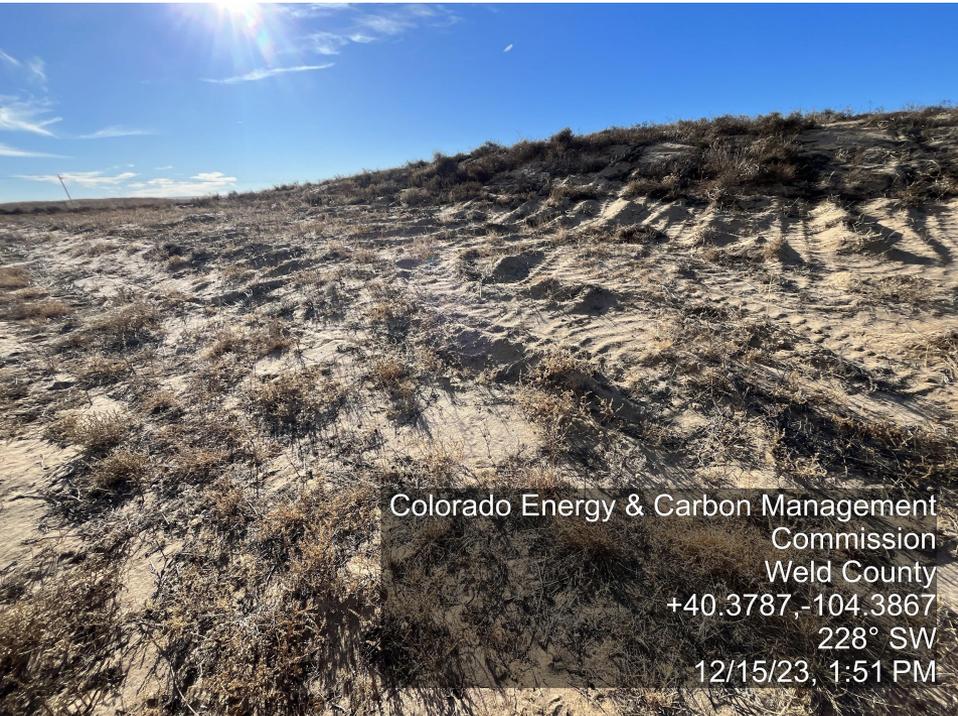
Photo 7. The photo was taken at the East end of the well location facing Southwest. The photo illustrates the side of the topsoil stockpile is dominated by bare soil and tumbleweeds.

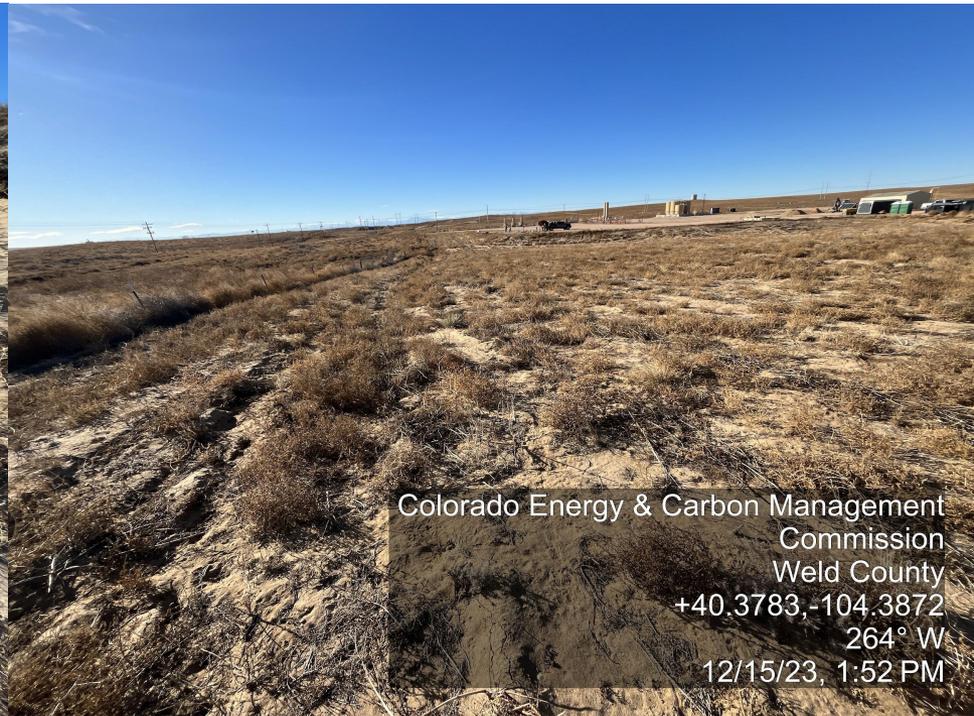
Photo 8. The photo was taken at the South end of the well location facing West. The photo illustrates the interim areas are dominated by tumbleweeds and bare soil.

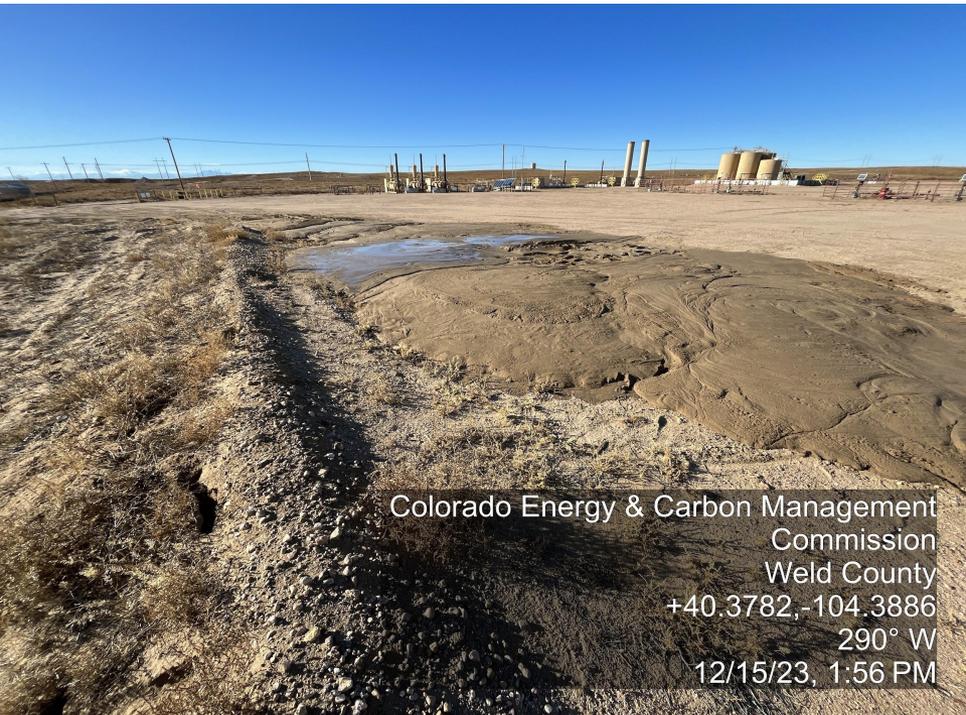
Photo 9. The photo was taken at the South end of the well location facing West. The photo illustrates mud being stored on the well location.

Note - ECMC staff had a conversation with a representative Civitas on location that mentioned once the mud from the vacuum truck dried out the material would be spread back on location.

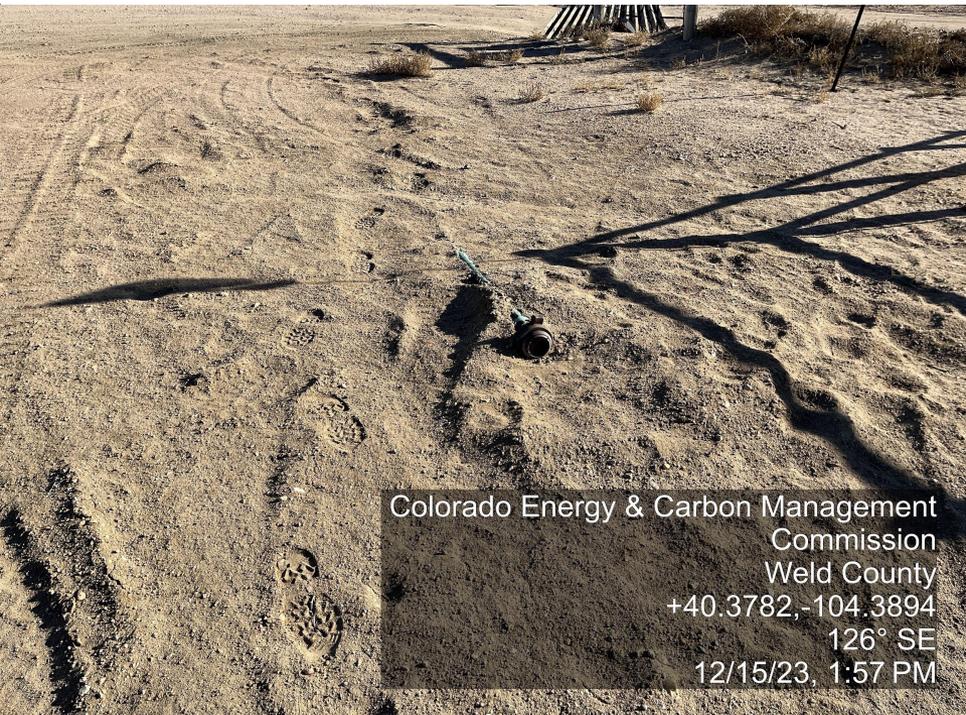
Photo 10. The photo was taken at the entrance of the well location facing Southeast. The photo illustrates a partially buried pipe with no cap.

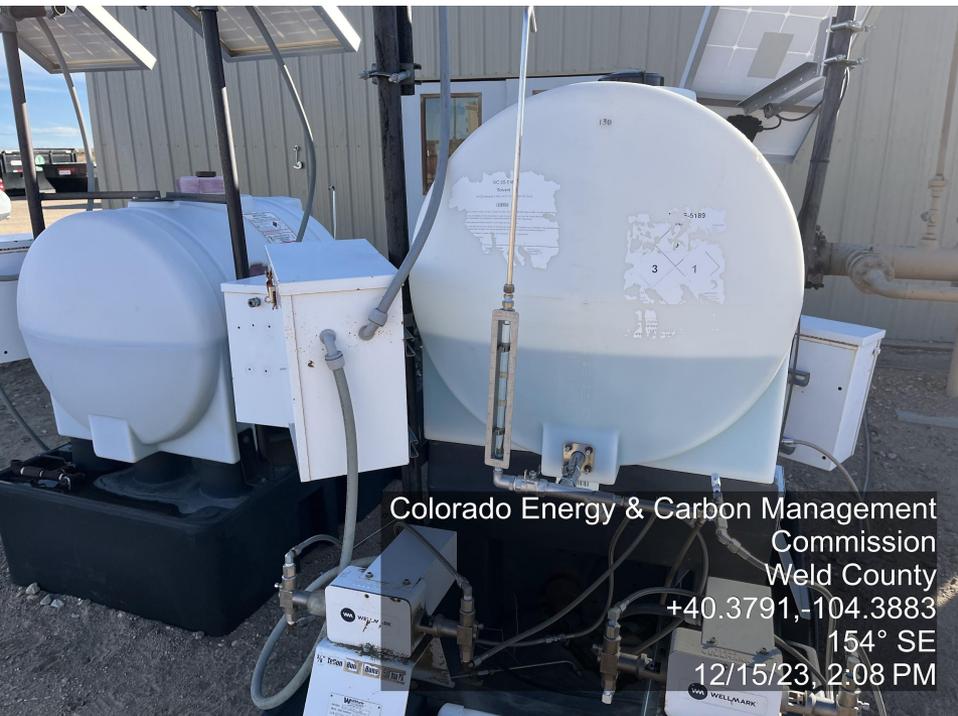
Photo 11. The photo was taken at the center of the well location facing Southeast. The photo illustrates a tank without proper labels.

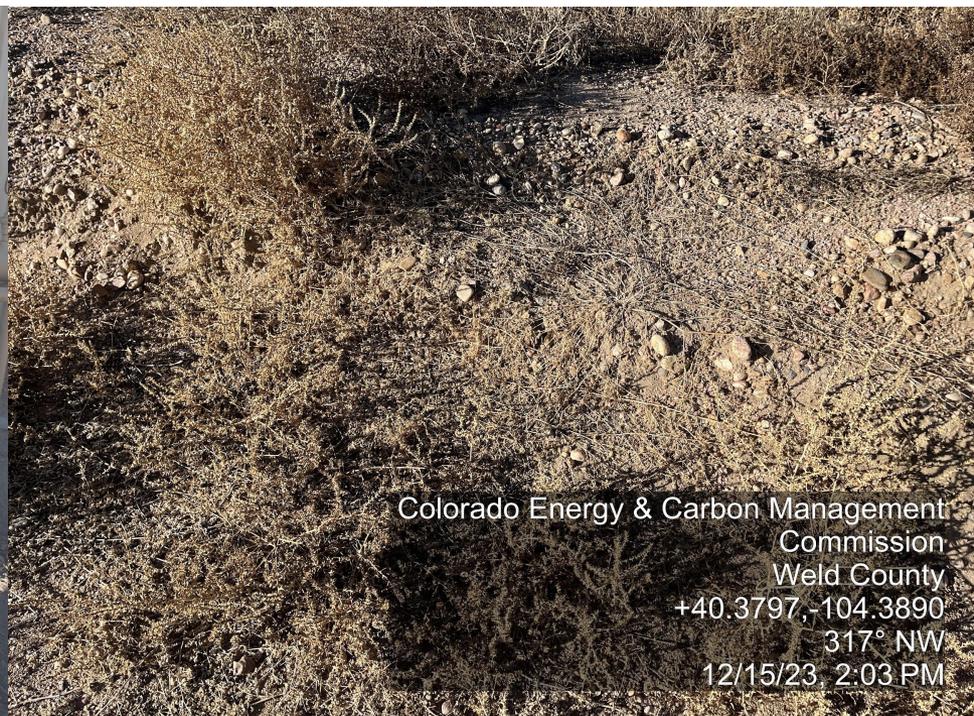
Photo 12. The photo was taken at the North side of the well location facing Northwest. The photo illustrates Puncturevine growing along the Northern edge of the well location.
