Interim Reclamation and Stormwater Inspection

Operator: Extraction Oil & Gas Inc - 10459

Location ID: 458215

Inspection Photos
Location Name: VIC 20-E Pad
Location ID: 458215

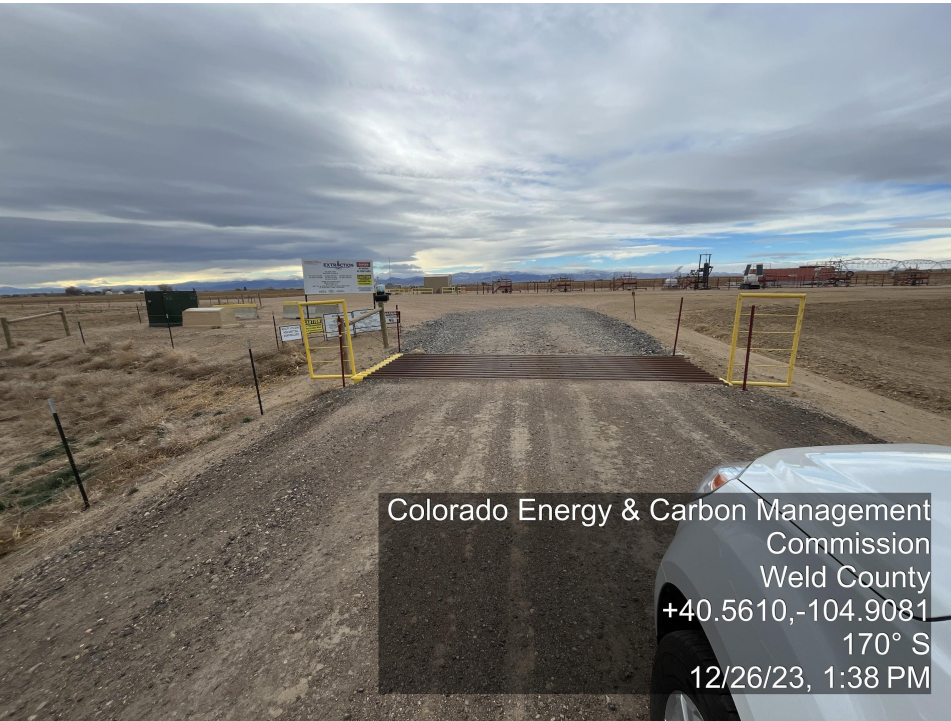
Photo 1. The photo was taken at the entrance to the well location facing South. The photo illustrates the locations entrance and operator signage.

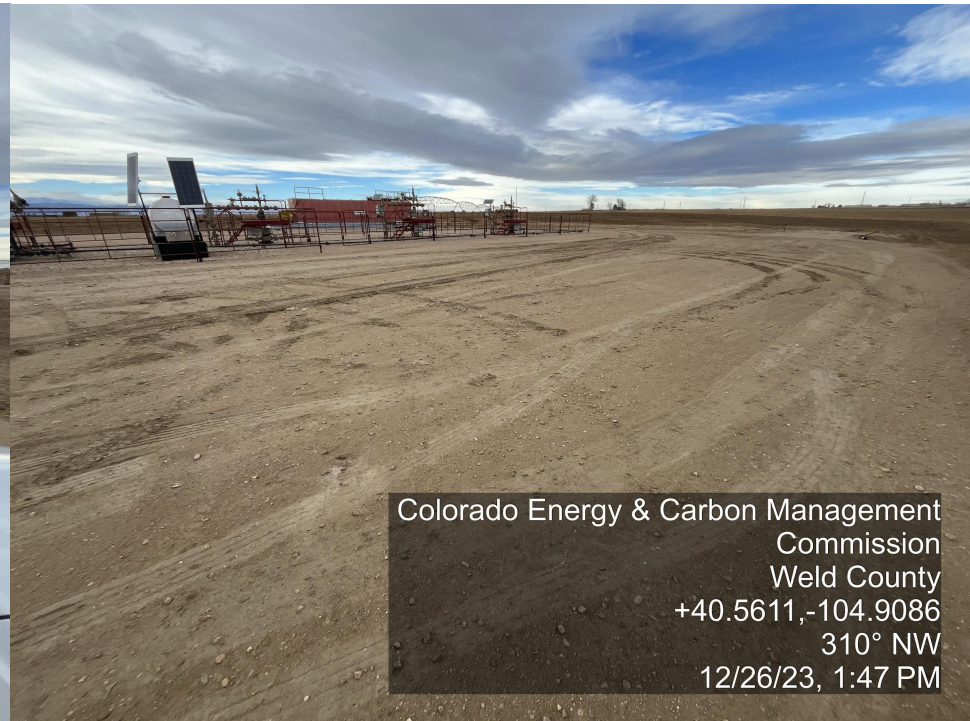
Photo 2. The photo was taken from the well location facing Northwest. The photo illustrates the wellheads.

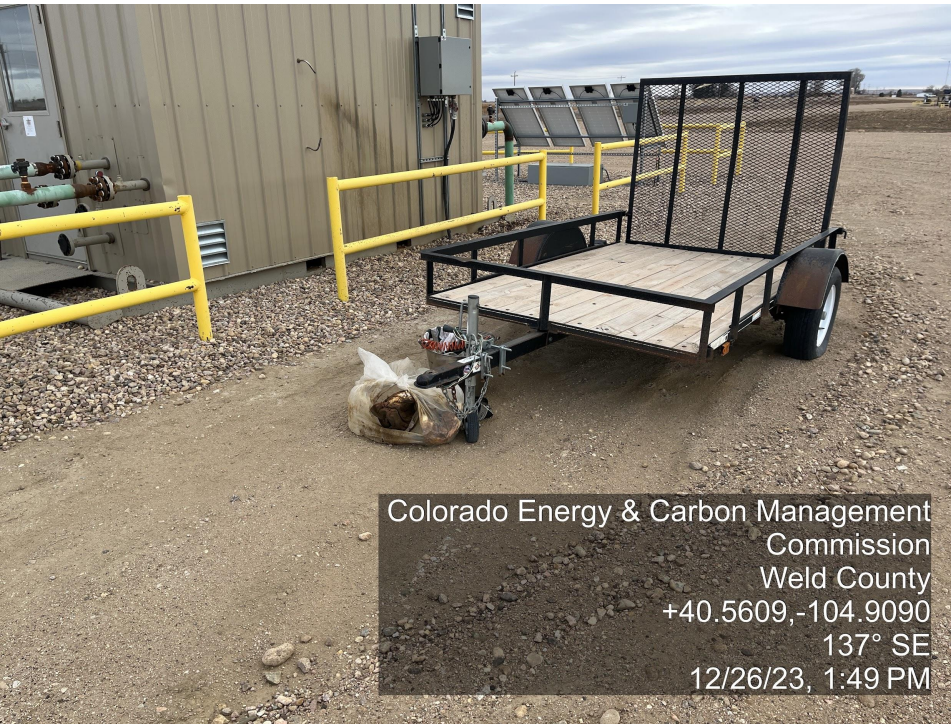
Photo 3. The photo was taken from the well location facing Southeast. The photo illustrates unused equipment and debris on location.

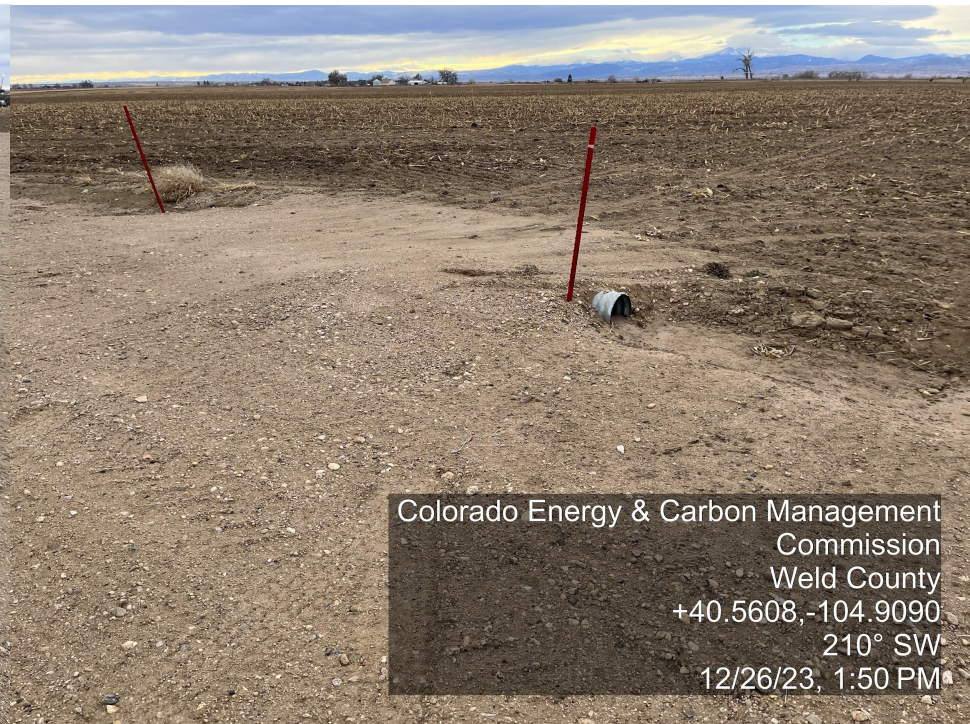
Photo 4. The photo was taken from the well location facing Southwest. The photo illustrates a representative marked culvert used for the surface owner to access the neighboring ag field.

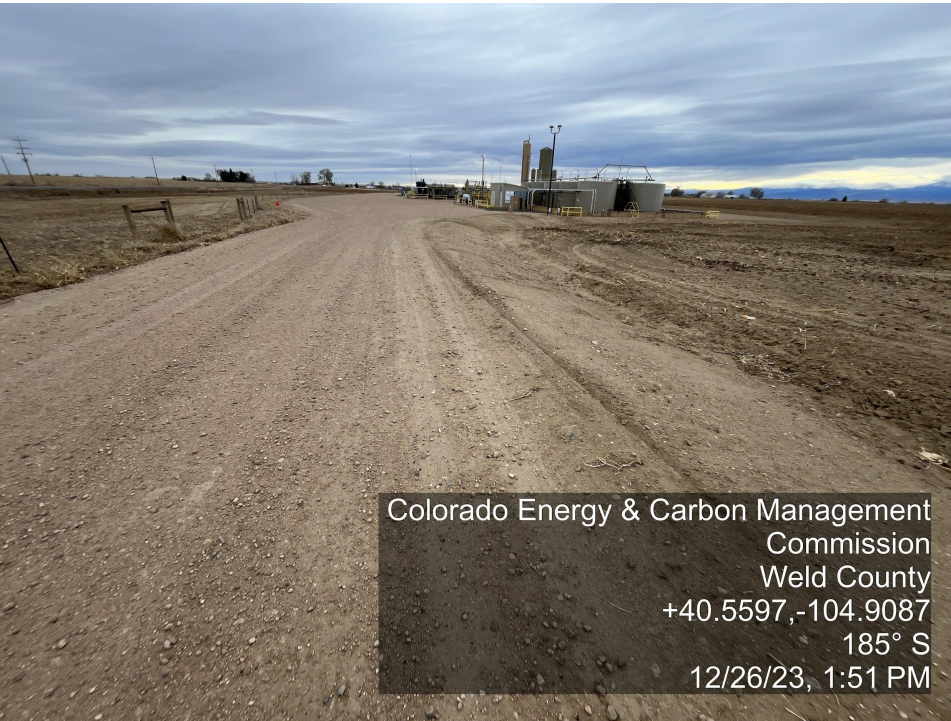
Photo 5. The photo was taken from the well location facing South. The photo illustrates the access road connecting the tank battery and well locations.

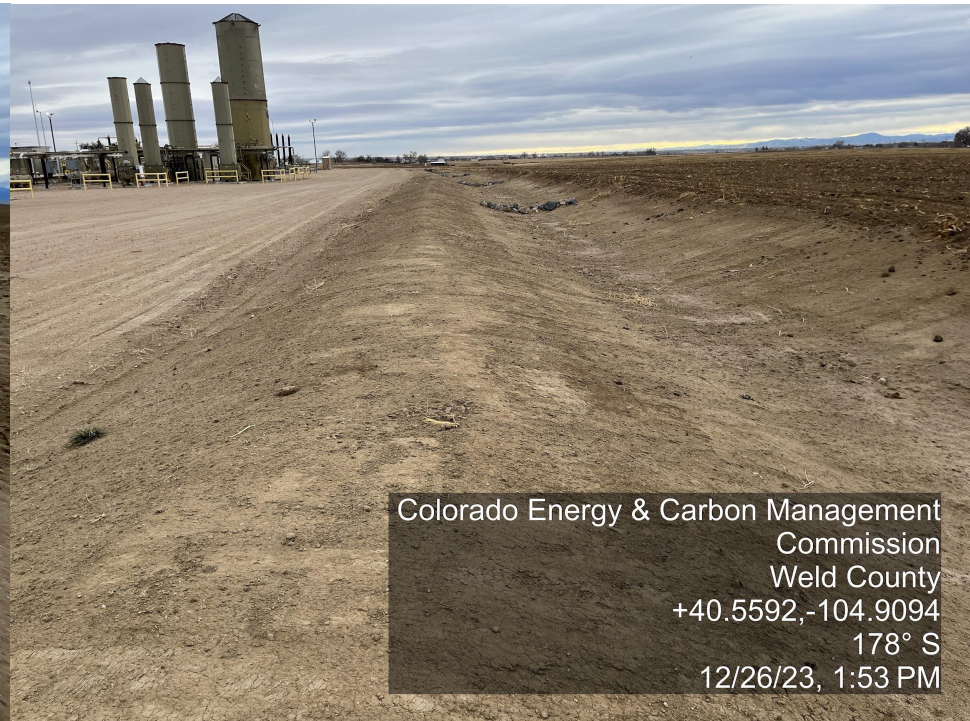
Photo 6. The photo was taken from the tank battery location facing South. The photo illustrates the ditch and berm that runs along the West side of the tank battery location to the sediment trap as well as the rip rap check dams placed along it.

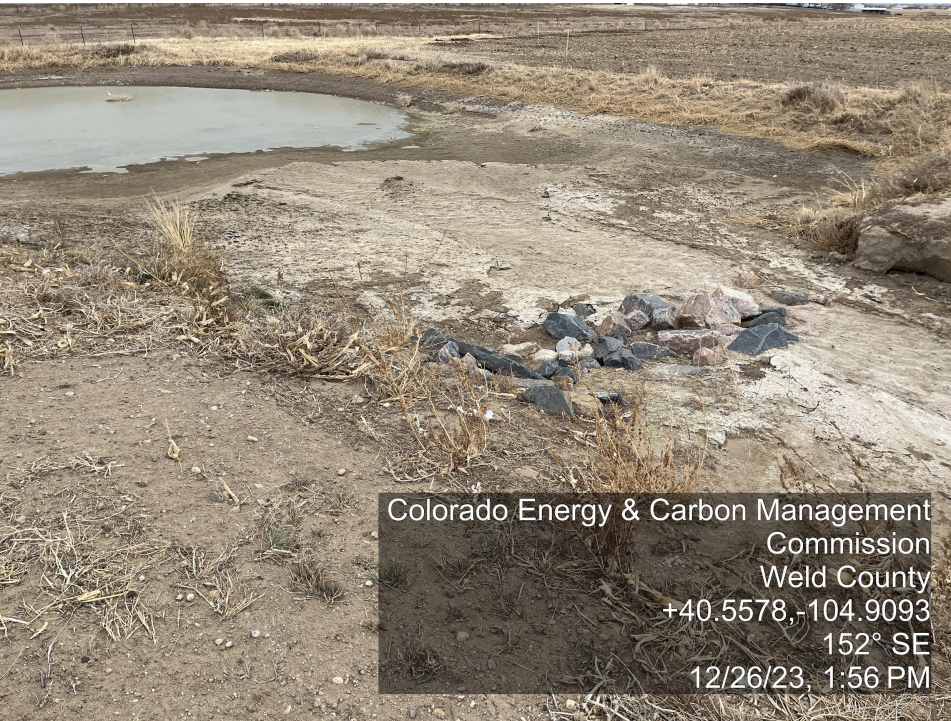
Photo 7. The photo was taken from the tank battery location facing Southeast. The photo illustrates the run in to the sediment trap as well as a rip rap check dam that is sedimented in.

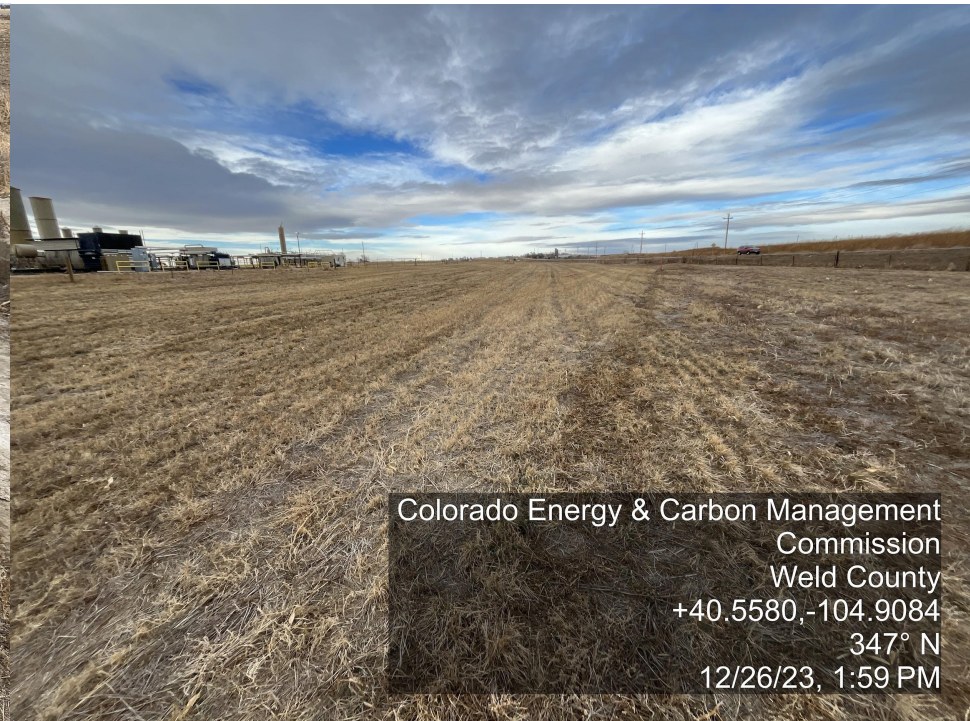
Photo 8. The photo was taken from the tank battery location facing North. The photo illustrates the Eastern interim area has been mowed.

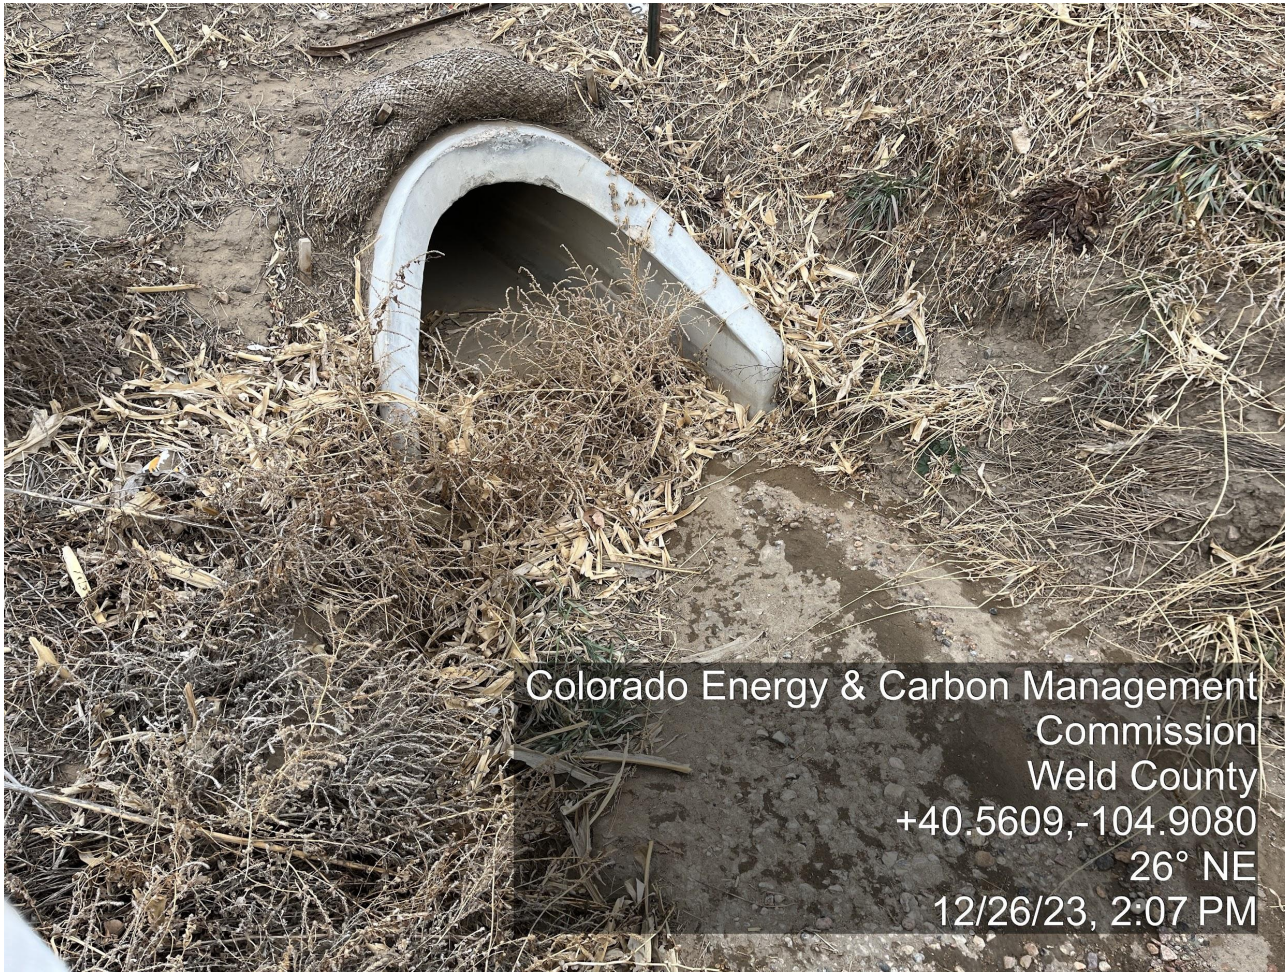
Photo 9. The photo was taken from the tank battery location facing Northeast. The photo illustrates the straw wattle protecting the culvert at the entrance needs repair.
