**KT Resources LLC  
Ant Hill Unit 24-43  
Loc ID: 316314**

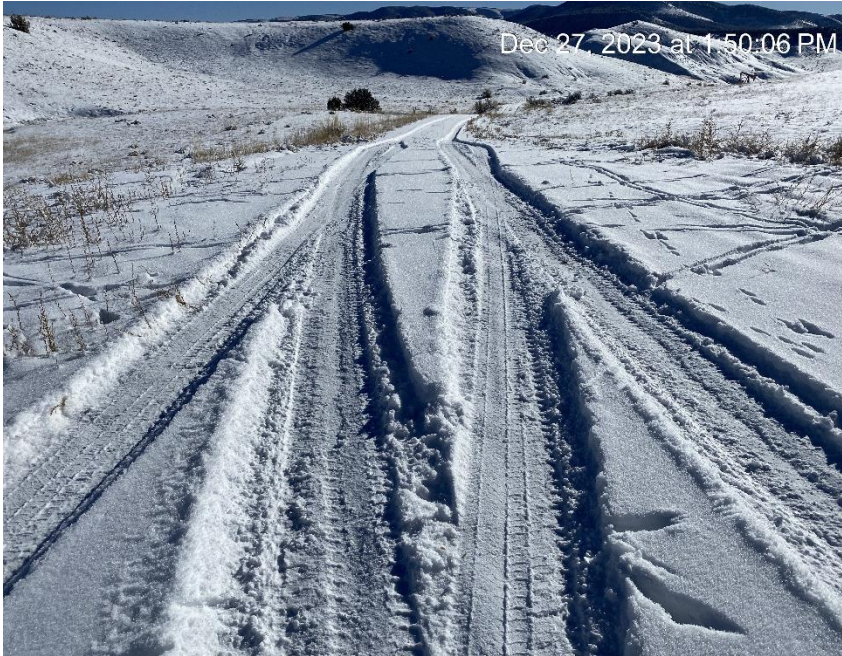
**Access road to location**

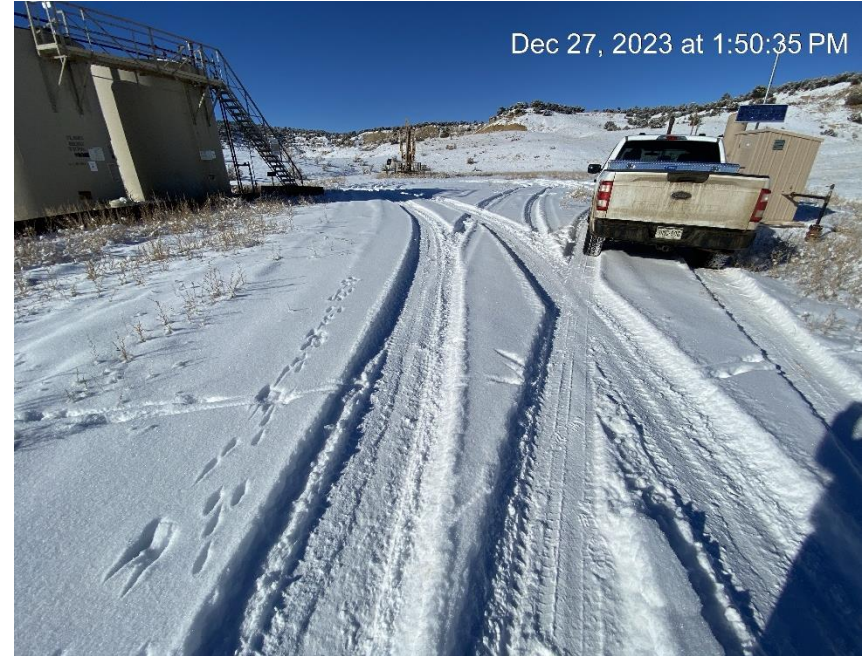
**Entrance to location**

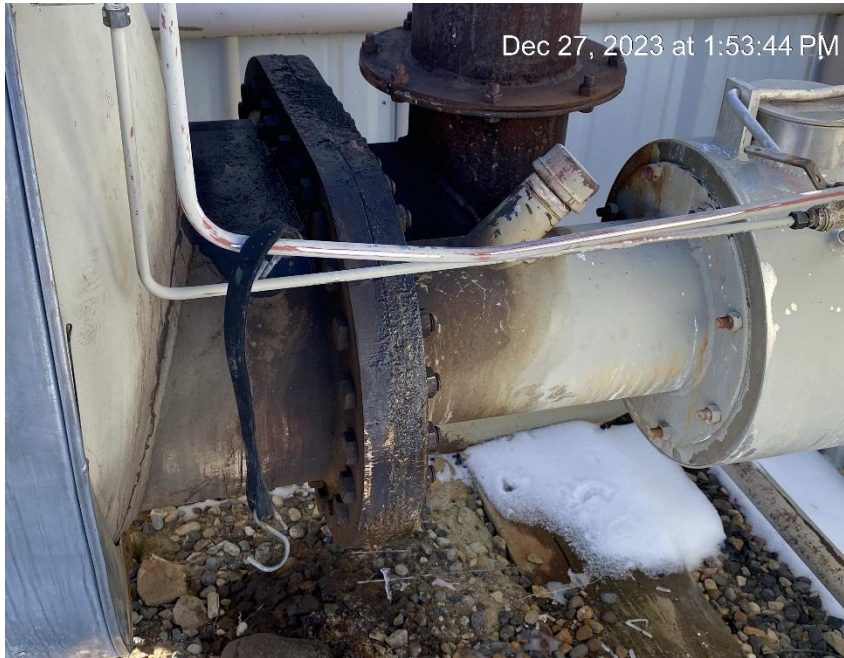
**Debris. Leaking fire tube.**

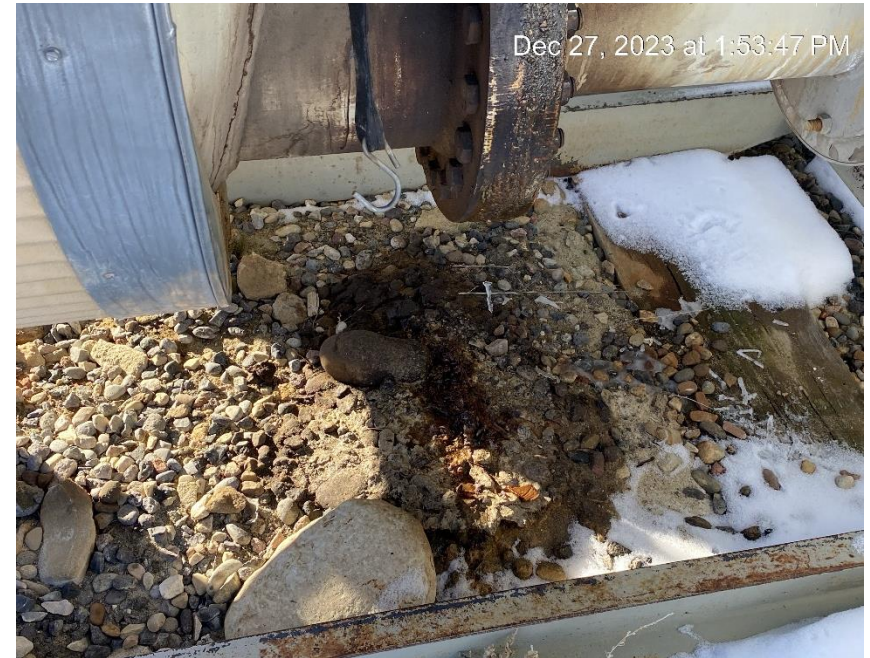
**Staining below fire tube**

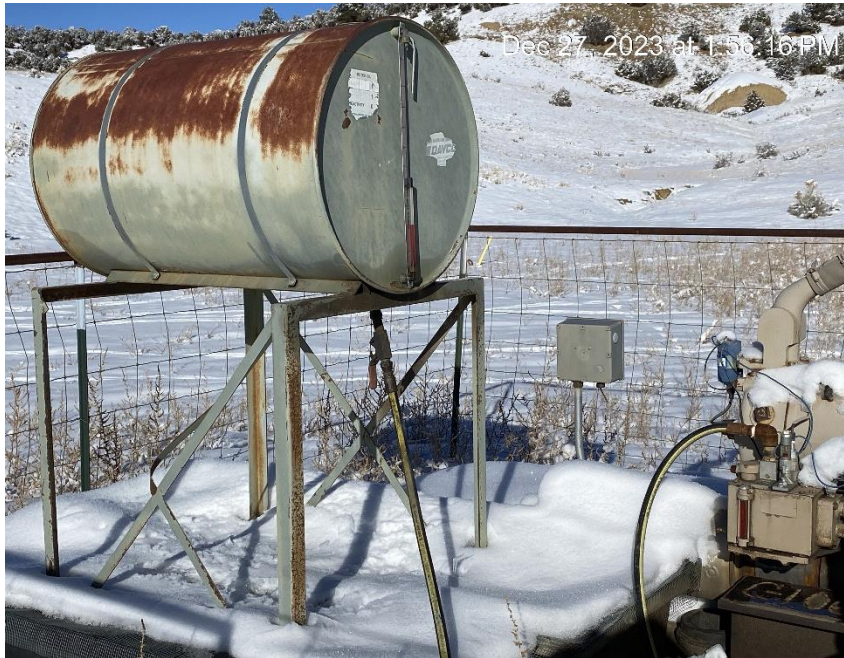
**Lube oil label needs replaced**

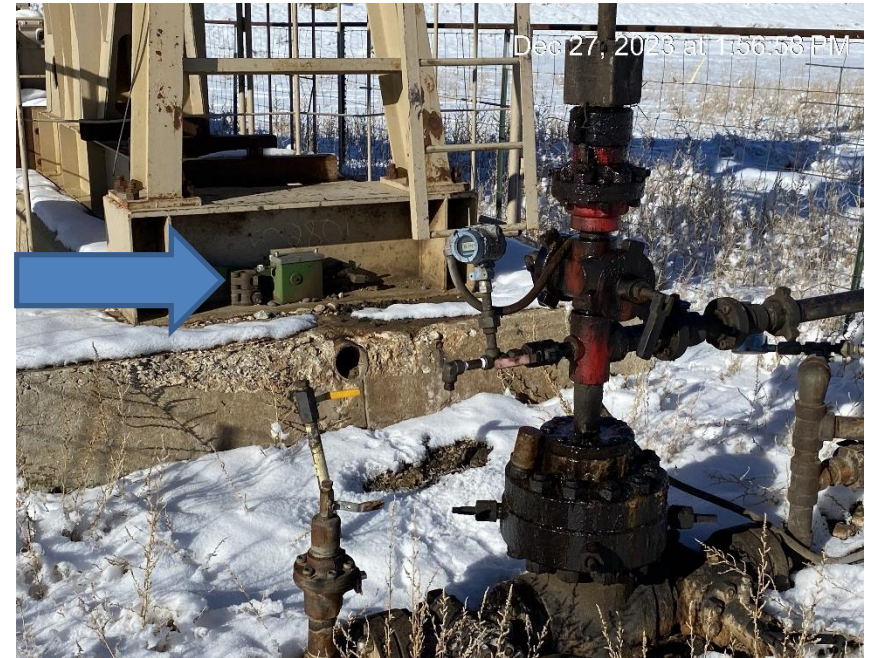
**Debris. Oily waste and staining on and around wellhead.**

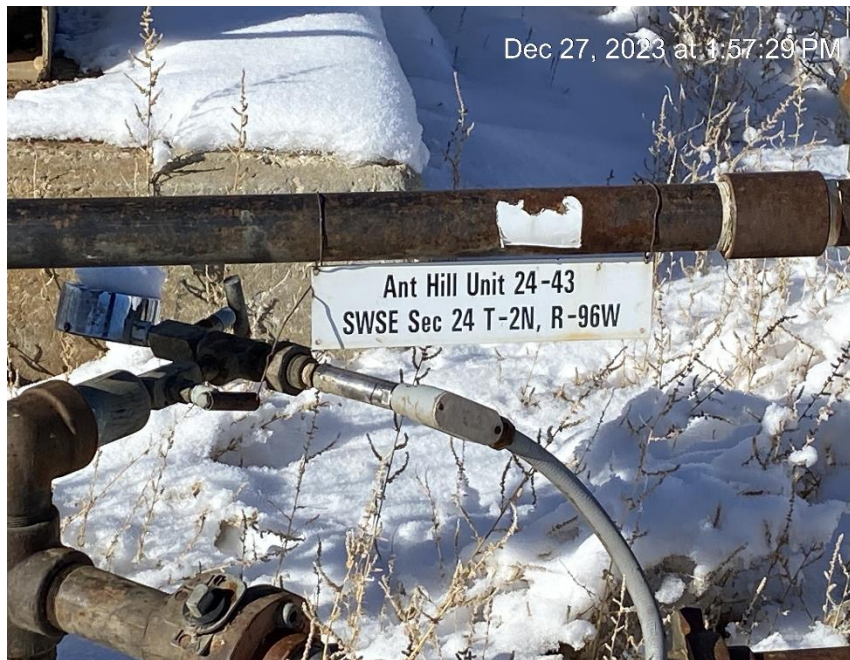
**As signs are replaced additional information will be required**

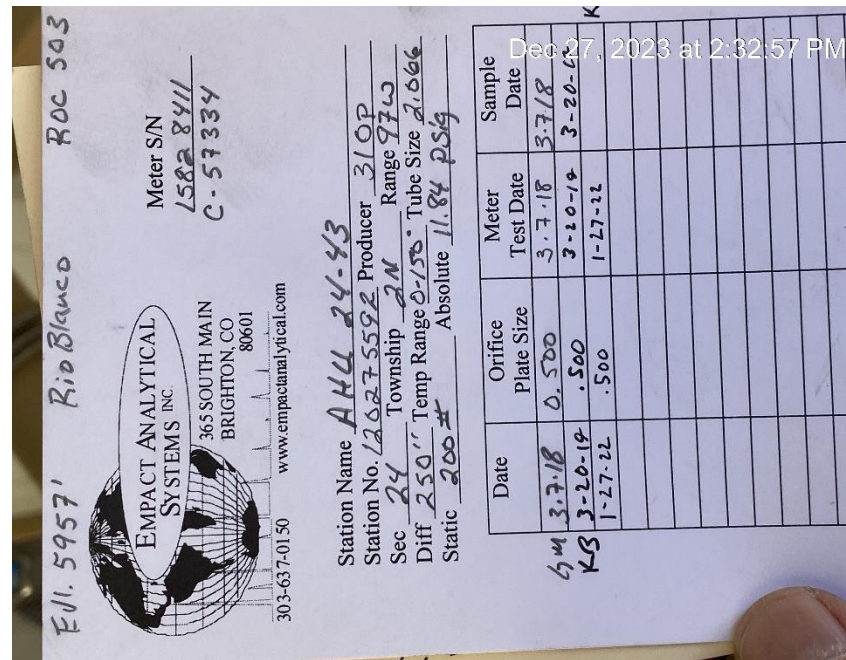
## Gas calibration overdue
