Reclamation Corrective Action Inspection

Date of Inspection	12/18/2023
Inspector Name	Levi Johnson, Fortress DS
Location Name	Tania Blue D 2-14
COGCC Loc ID	328891
County	Weld
Location Directions	FROM CR 53 and CR 34 GO E/ APX 2.5MI TO ACCESS RD CONT N/ 2MI THEN CONT NW/ .28MI CONT SW/ .2MI CONT SE/ APX .2MI TO WELL SITE TANIA BLUE D2-14 @ GPS PT (40.248624,-104.520338)
Weeds or Debris	Location is mowed, annual and perennial vegetation is evident
Visual Est. of Vegetative Cover	Location is in final reclamation phase, perennial vegetation beginning to establish
Stormwater	No stormwater issues observed
Additional Notes	none
Recommendations	Monitor establishment of perennial grasses and forbs, implement weed control plan and mowing for annual weeds
Reclamation/Stormwater Corrective Action Procedure	In response to ECMC Inspection 713900116, location was mowed and inner seeded with Sandy Loam Native Mix applied at 20 lbs/acre.
Photos	Below, show that mowing and innerseeding have been done

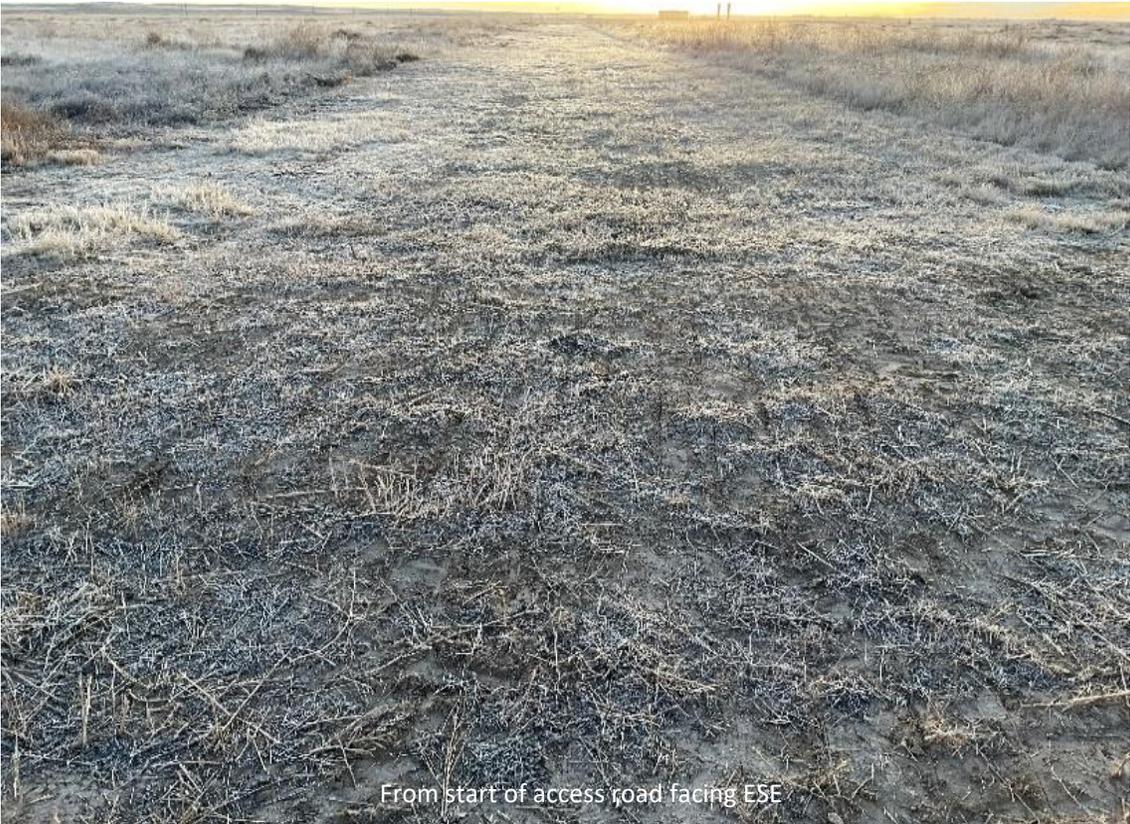
From start of access road facing ESE

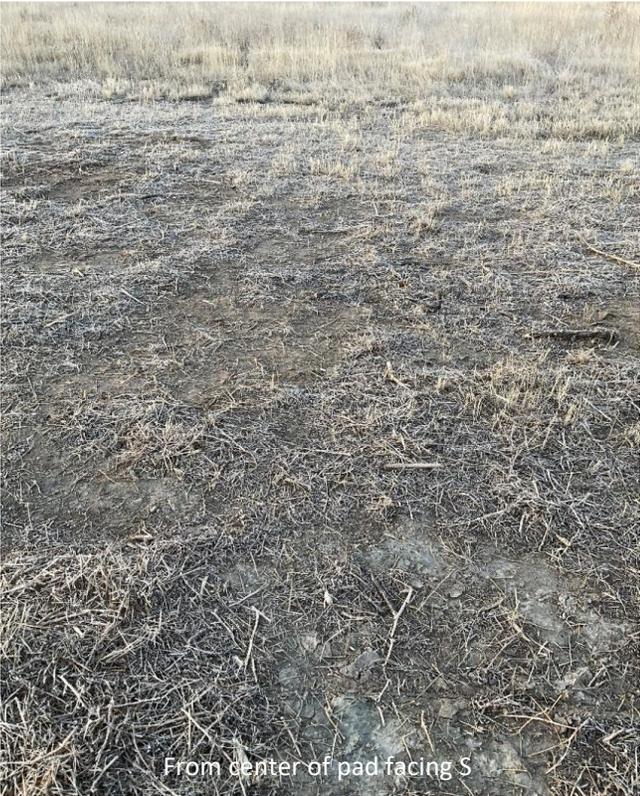
From center of pad facing S

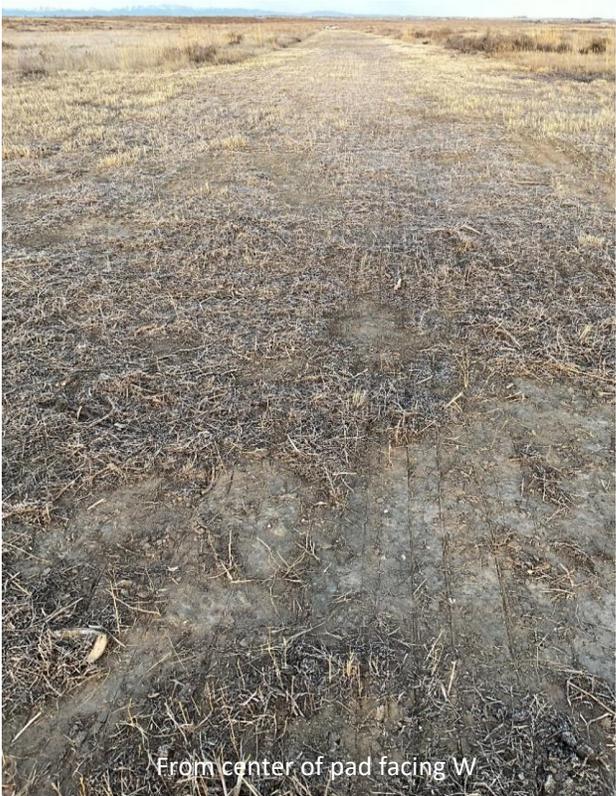
From center of pad facing W
