Interim Reclamation and Stormwater Inspection

Operator: Bayswater Exploration & Production LLC -
10261

Location ID: 454899

Inspection Photos
Location Name: Drake Pad
Location ID: 454899

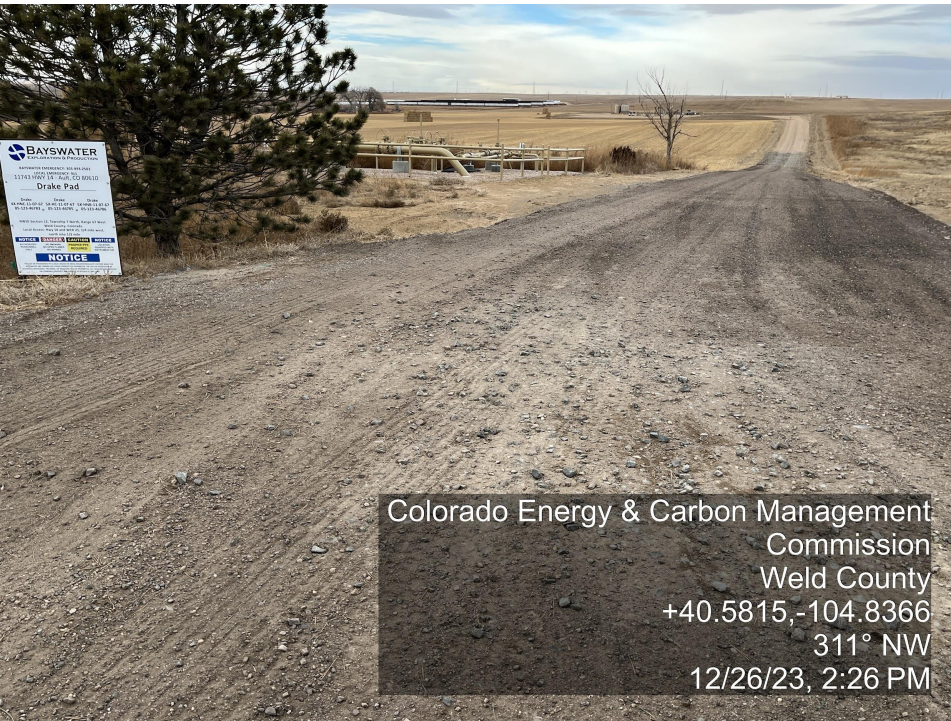
Photo 1. The photo was taken from the entrance of the well location facing Northwest. The photo illustrates the operator sign and access road.

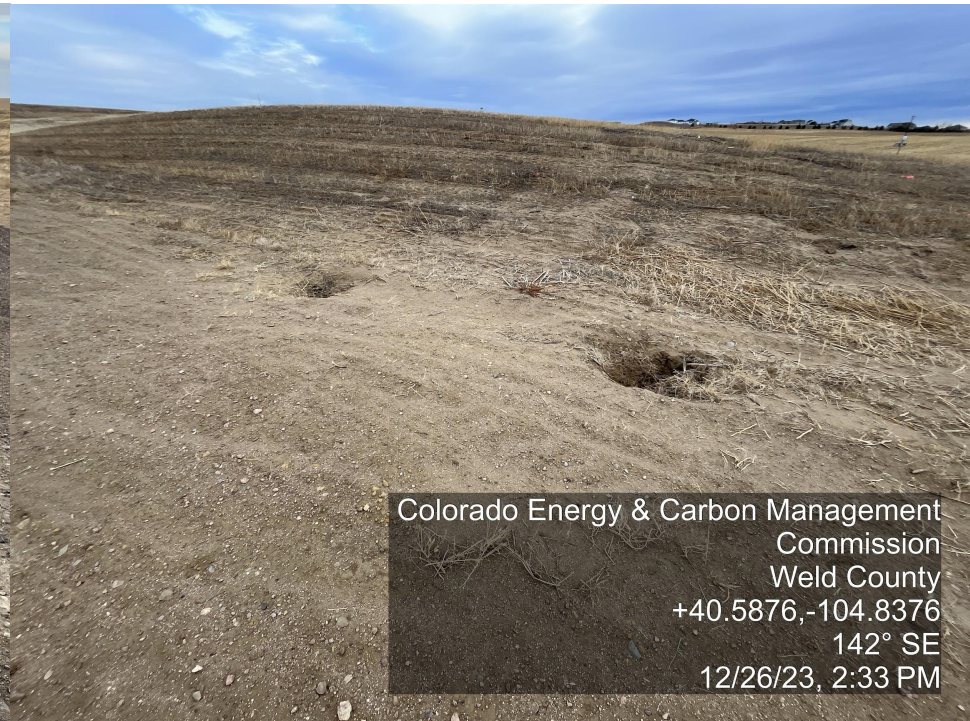
Photo 2. The photo was taken from the well location facing Southeast. The photo illustrates the topsoil stockpile appears vegetated but is mowed.

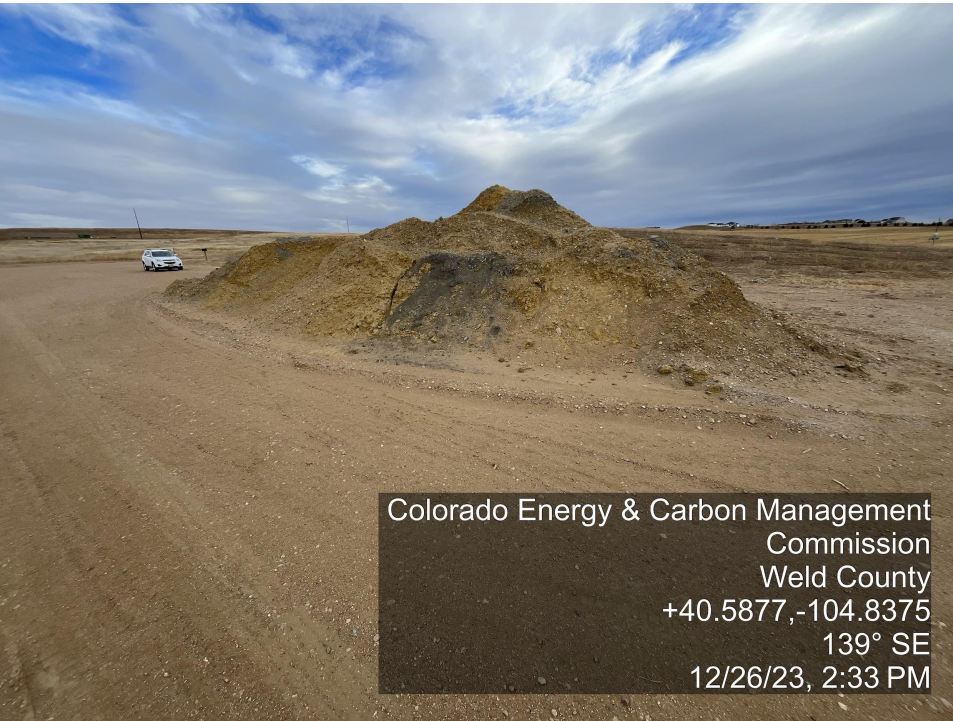
Photo 3. The photo was taken from the the well location facing Southeast. The photo illustrates what appears to a be a gravel spoil pile on the pad.

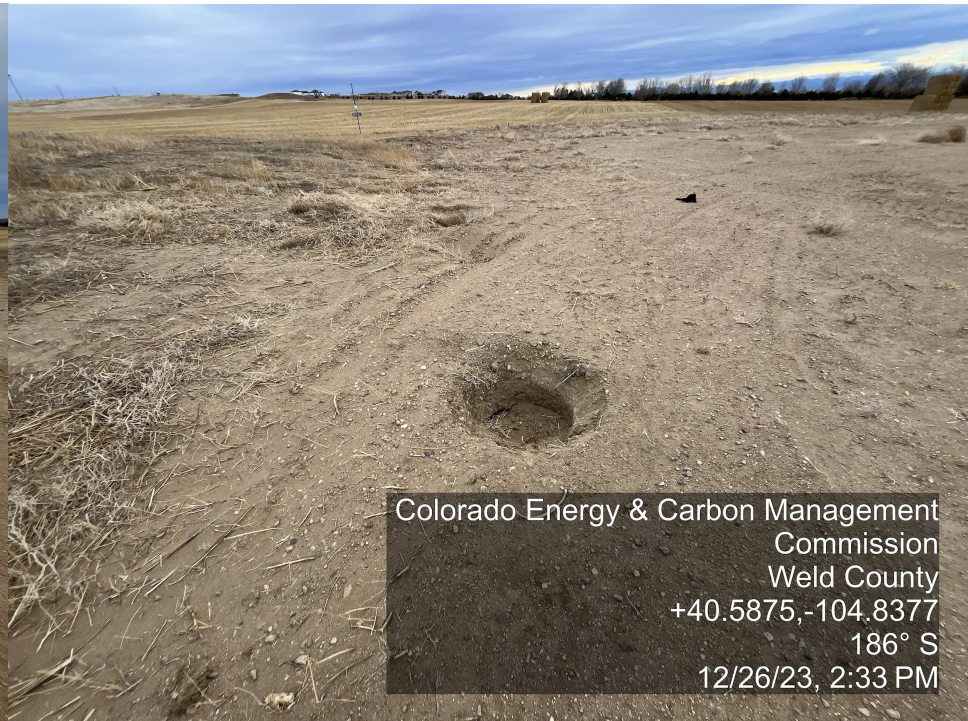
Photo 4. The photo was taken from the well location facing South. The photo illustrates a representative photo of subsidence surrounding the topsoil stockpile likely related to a sound wall.

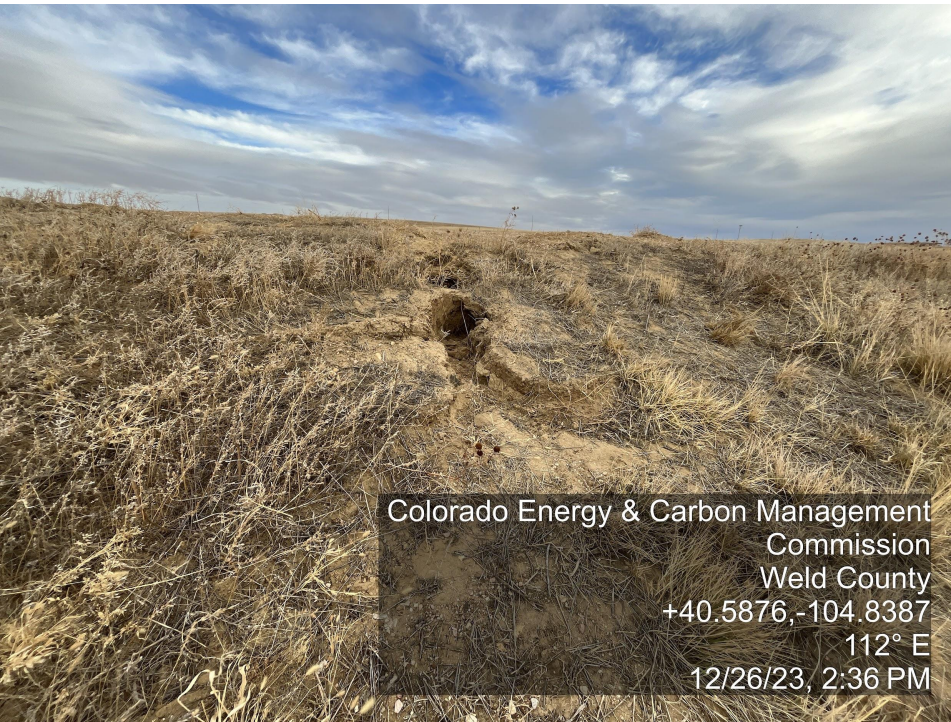
Photo 5. The photo was taken from the the well location facing East. The photo illustrates erosional rills off the pad into the sediment trap.

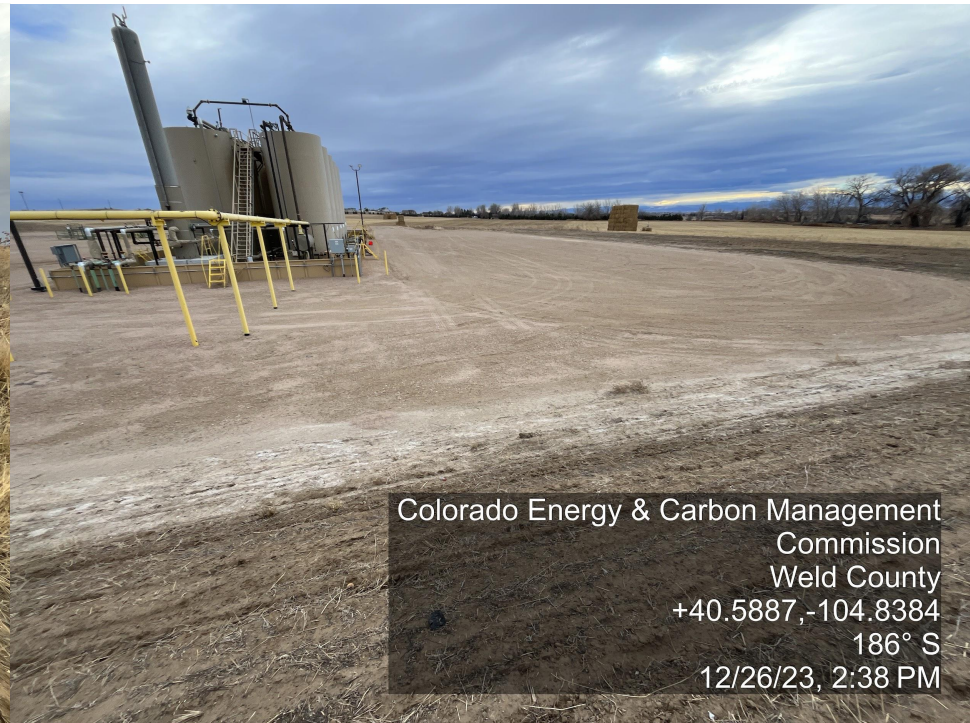
Photo 6. The photo was taken from the well location facing South. The photo illustrates one area of the pad that should be minimized.

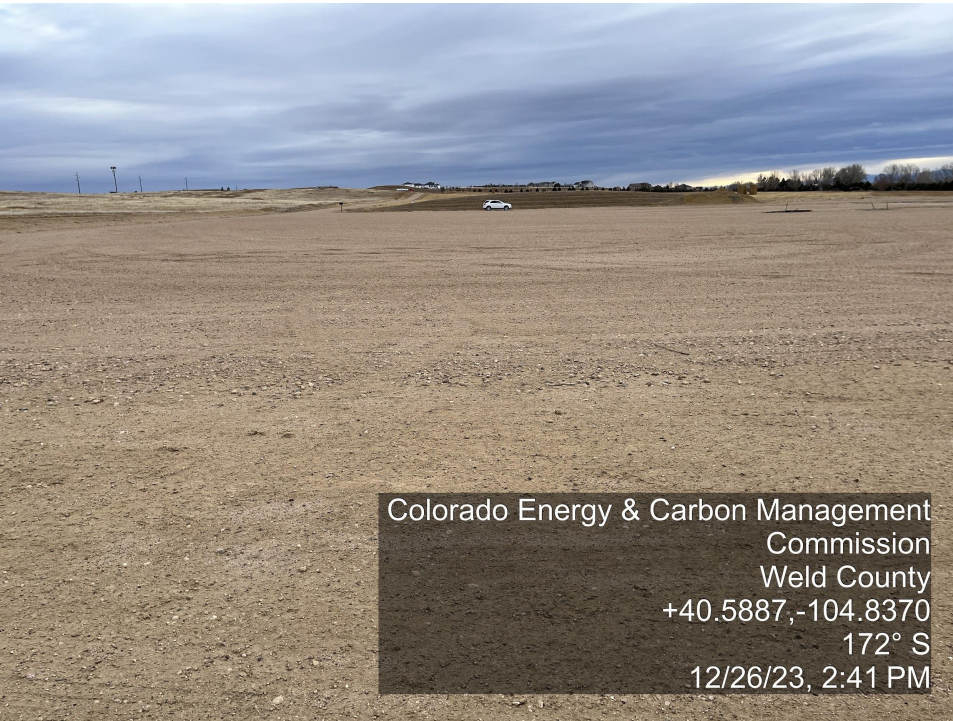
Photo 7. The photo was taken from the the well location facing South. Refer to the comment for photo 6.

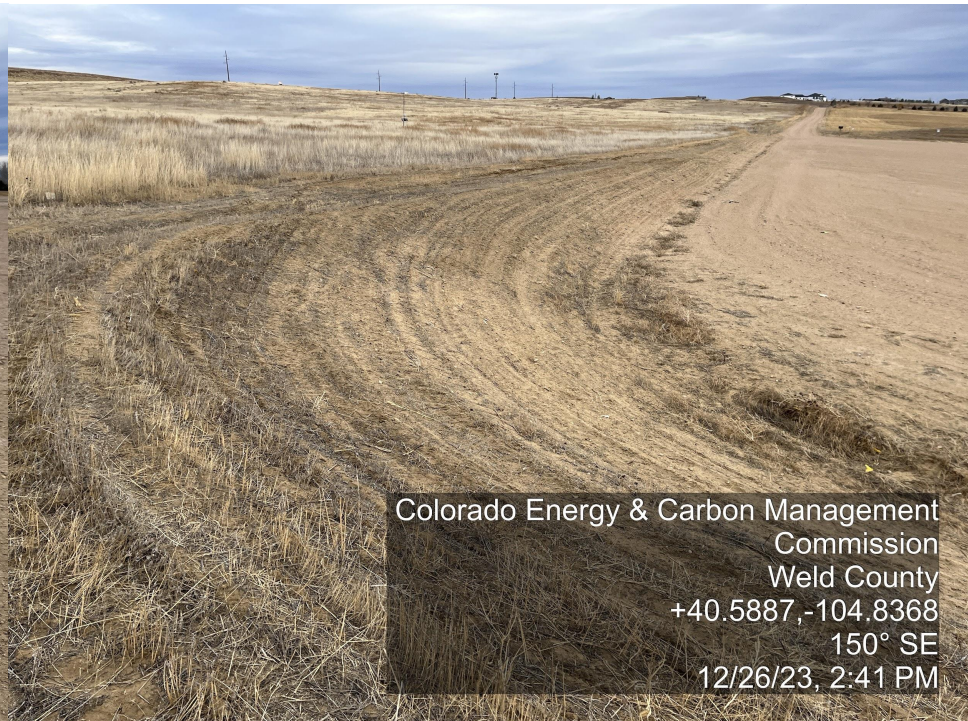
Photo 8. The photo was taken from the well location facing Southeast. The photo illustrates the cutslope around the perimeter of the pad is temporarily stabilized and has very little vegetation.

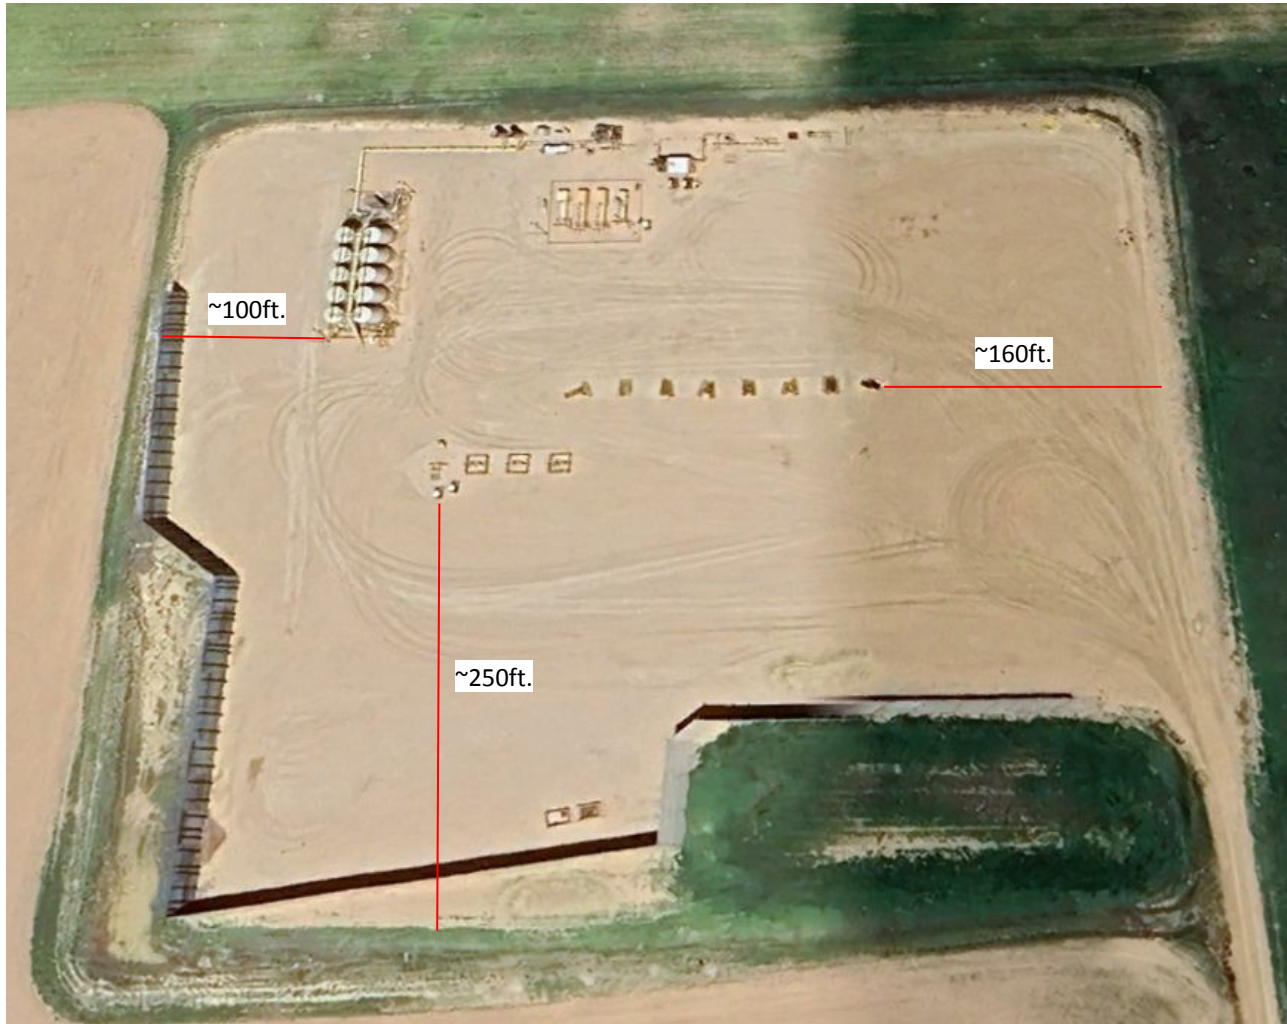
Photo 9. The photo is Google Earth imagery from June of 2023 of the well location. The photo illustrates the Operator has not yet performed interim reclamation.
