Inspection Photos

Location Name: CAERUS PICEANCE LLC N.PARACHUTE EF15D C27 595 Pad

Location #: 335828

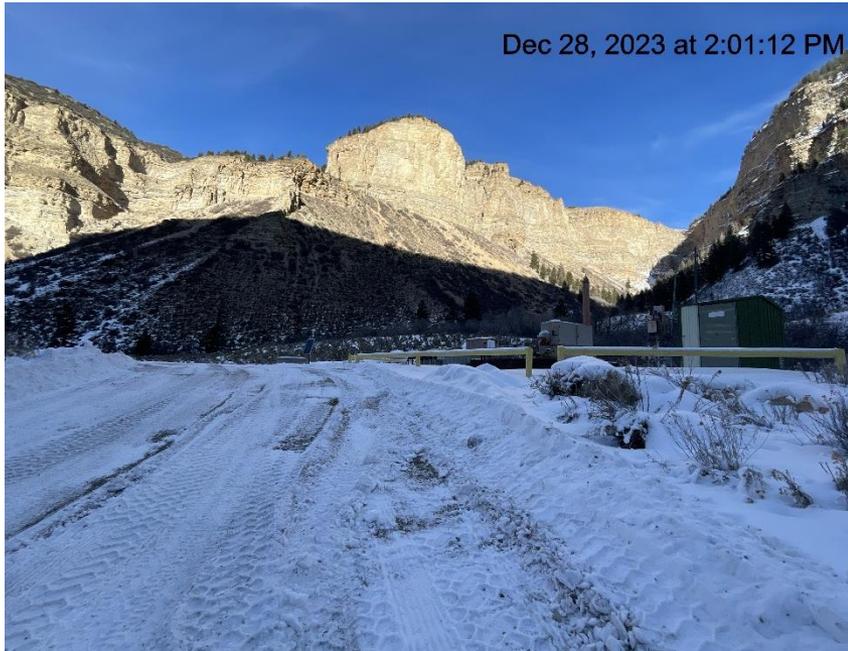
Photo # 1360 From entrance to location

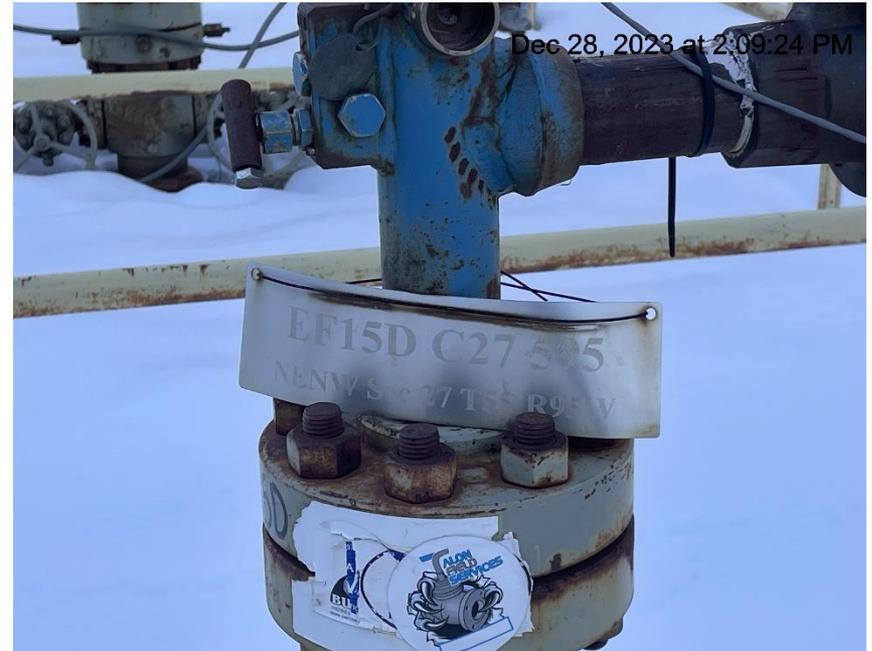
Photo # 1367 Wellhead sign lacks required info

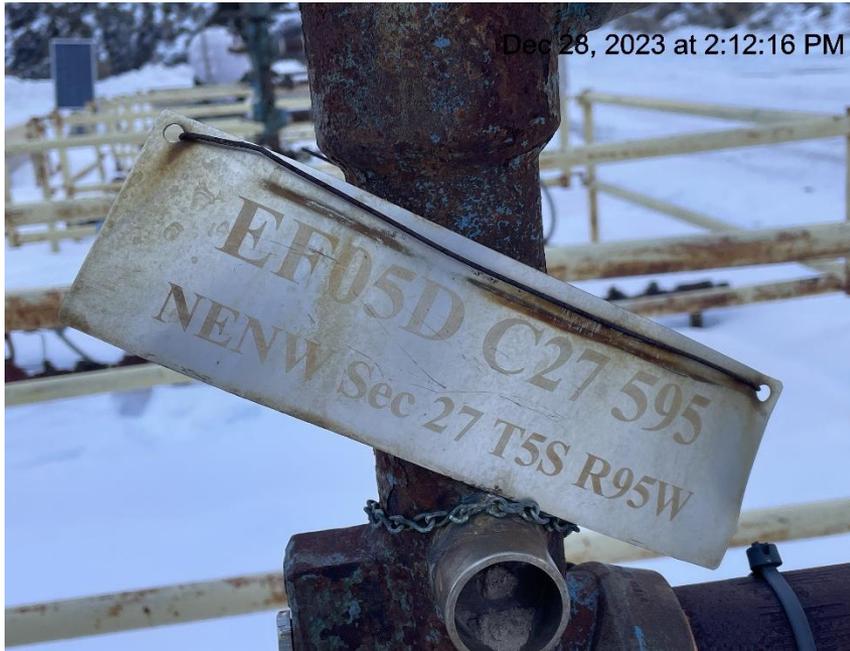
Photo # 1368 Wellhead sign lacks required info

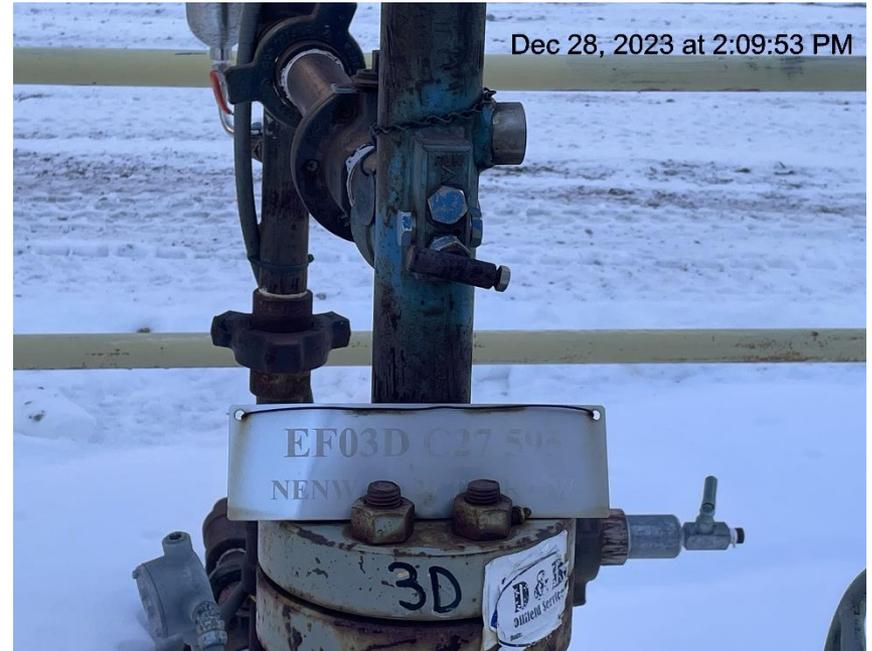
Photo # 1369 Wellhead sign lacks required info
