## Inspection Photos

Location Name: TEP Rocky Mountain LLC WATSON RANCH A Pad

Location # 413055

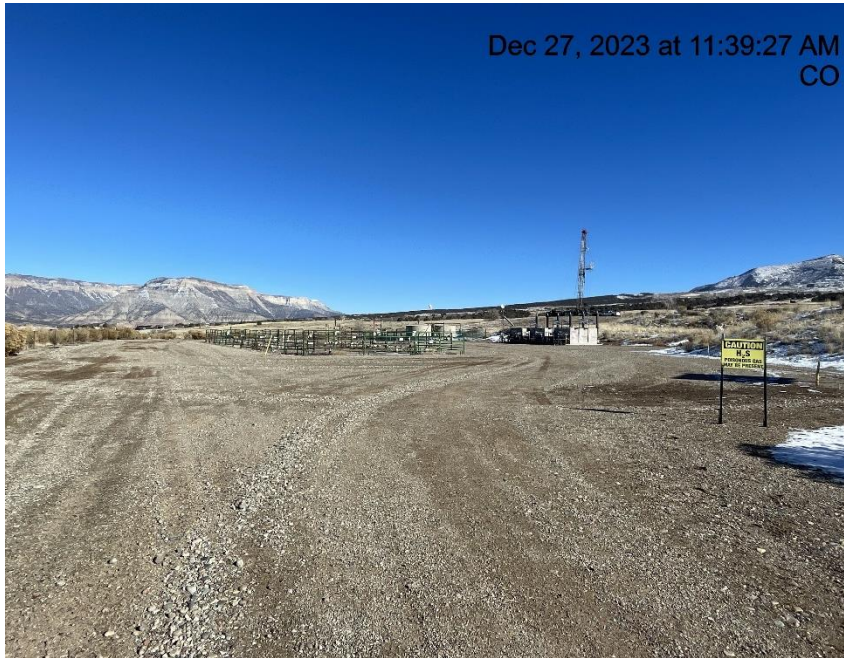
Photo # 881 From entrance to location

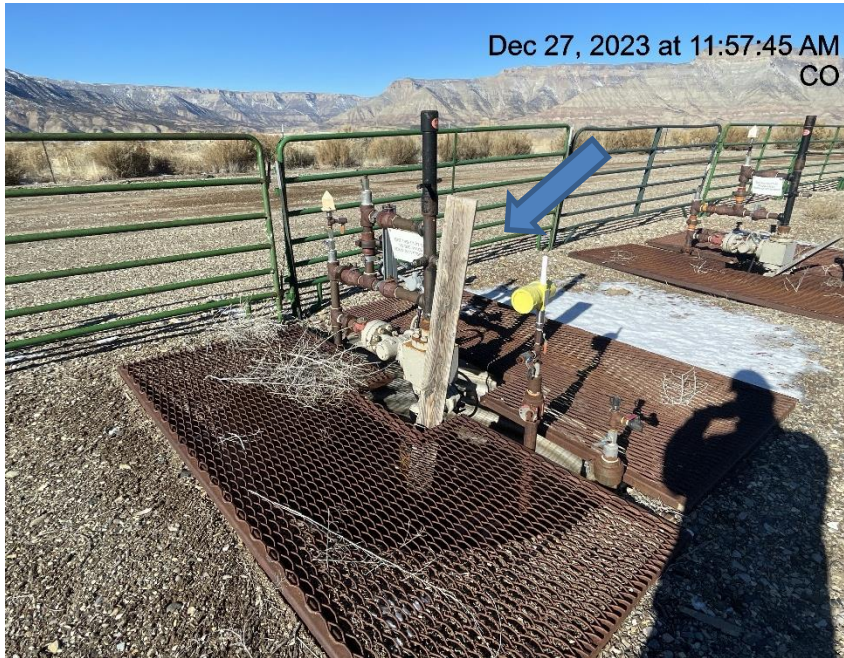
**Photo # 889 Wildlife egress on BAT 14B-17-07-95 well cellar ineffective/needs adjustment**

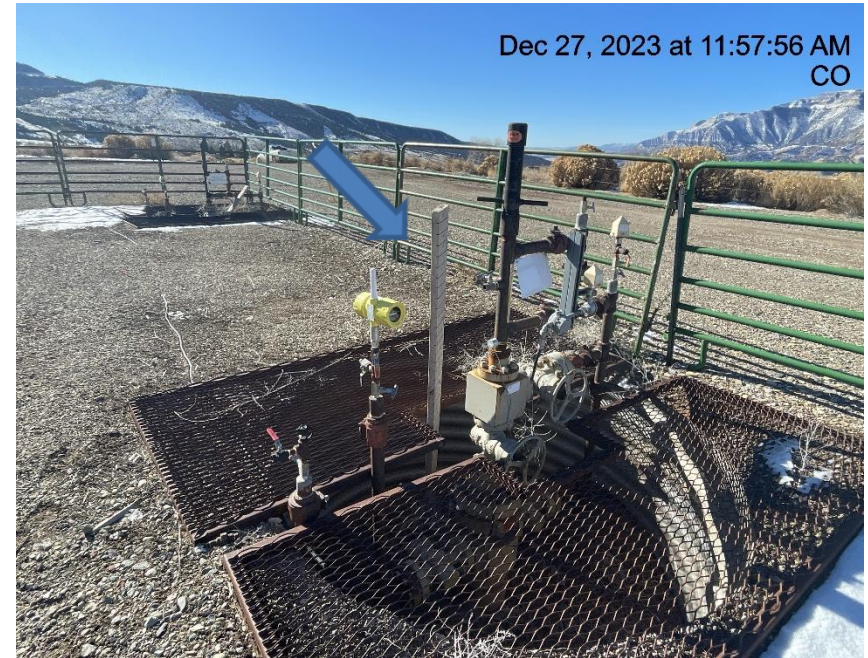
**Photo # 890 Same wildlife egress from a different angle**

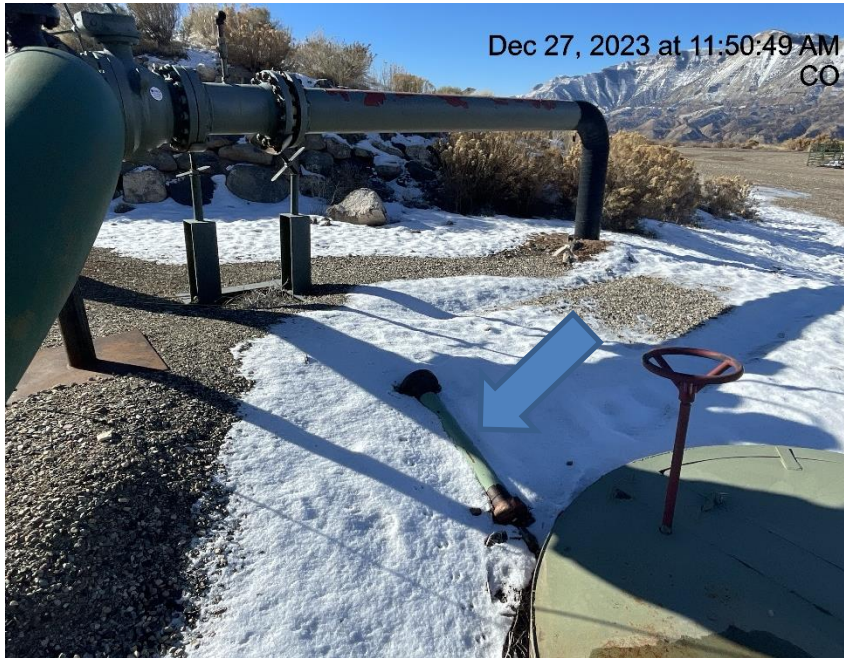
Photo # 891 Debris

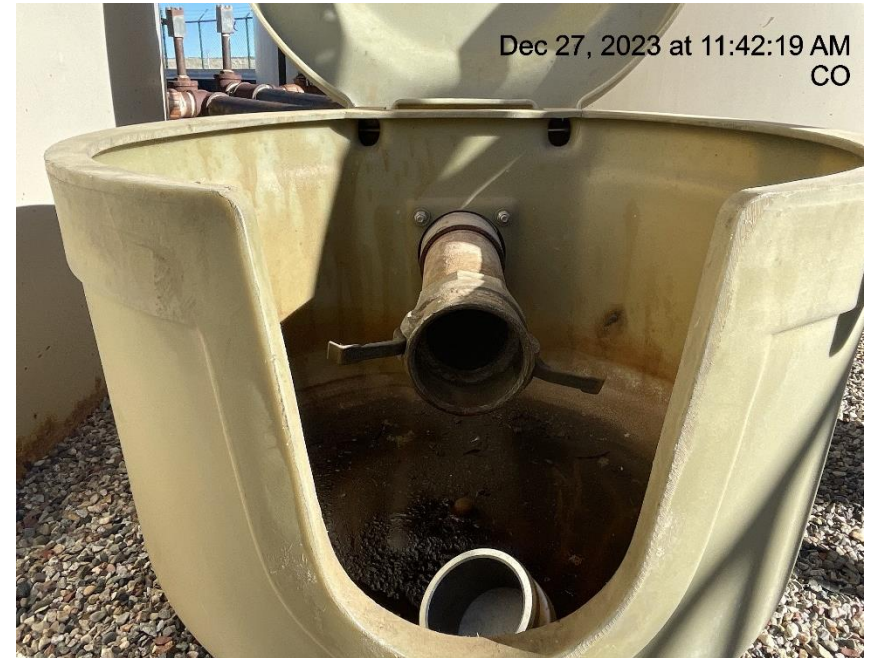
Photo # 892 Open ended load line
