Inspection Photos

Location Name: CAERUS PICEANCE LLC N. PARACHUTE EF06D L29 595 Pad

Location #: 335607

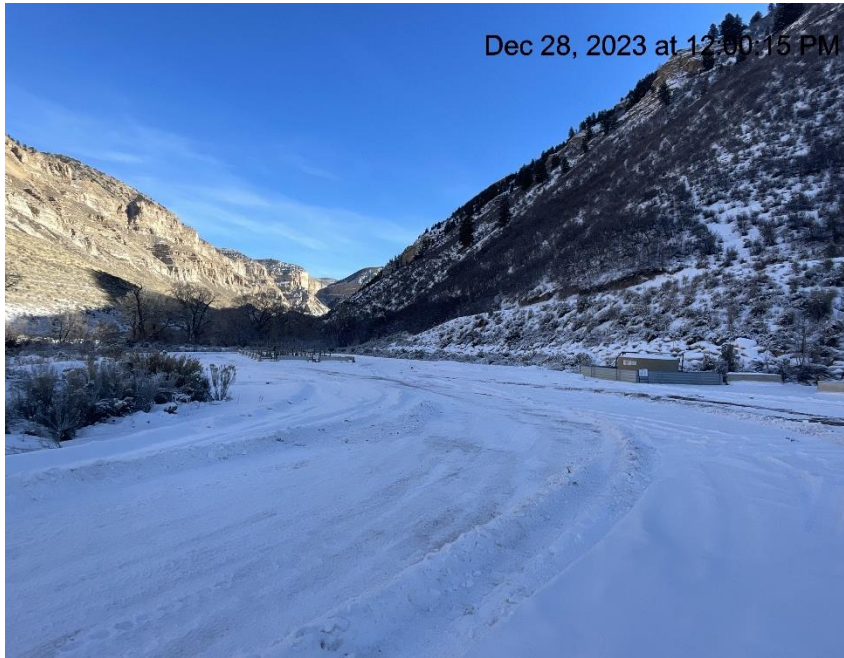
Photo # 1151 From entrance to location

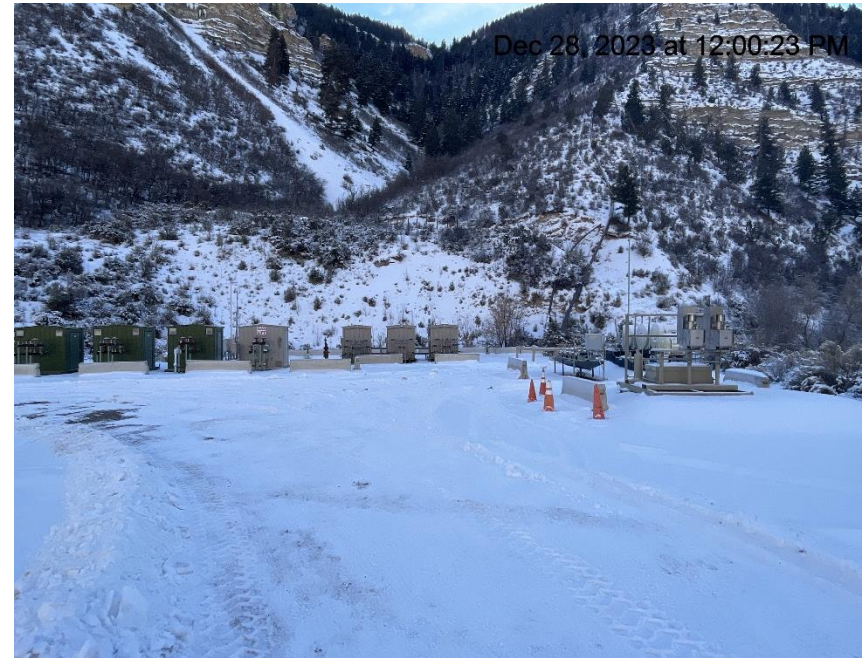
Photo # 1152 From entrance to location

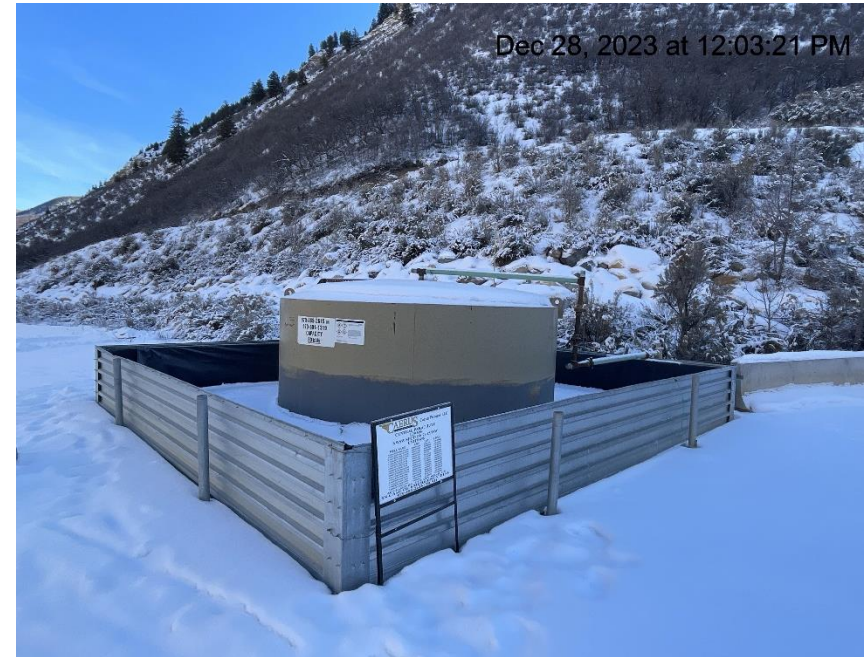
Photo # 1154 Location/blowdown tank

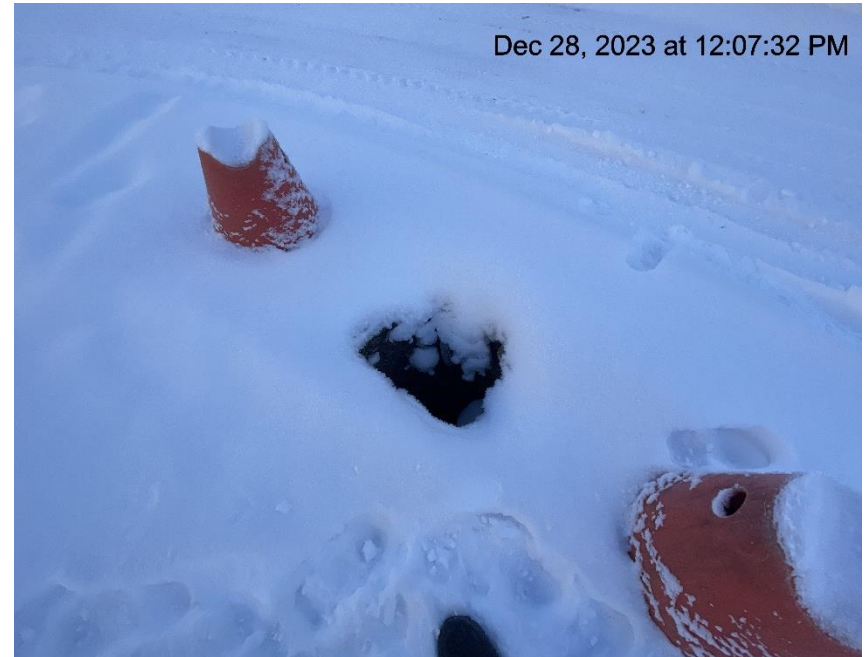
Photo # 1160 Hole near wellheads/wildlife & personnel protections insufficient (hole approximately 4-6ft deep)

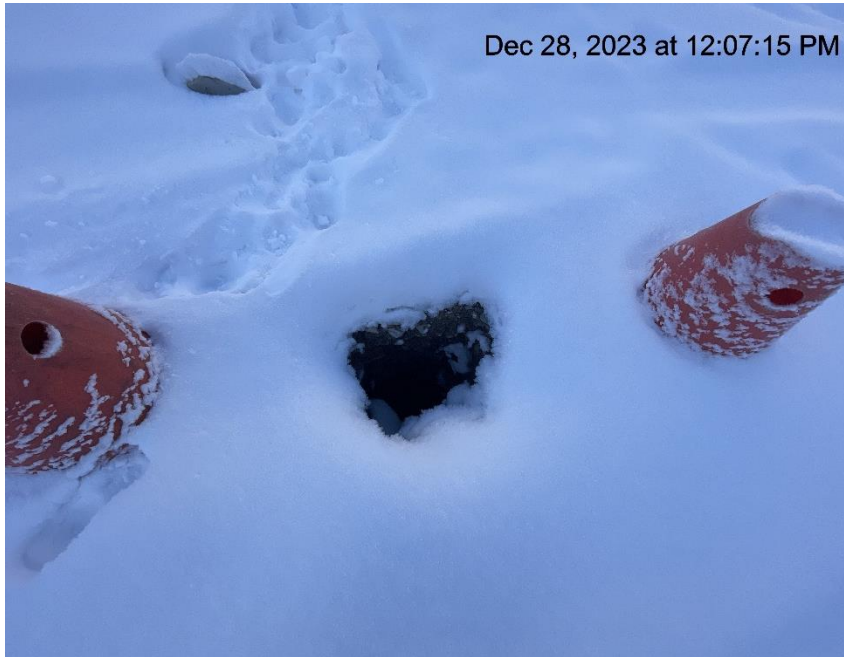
Photo # 1161 Hole near wellheads/wildlife & personnel protections insufficient (hole approximately 4-6ft deep)

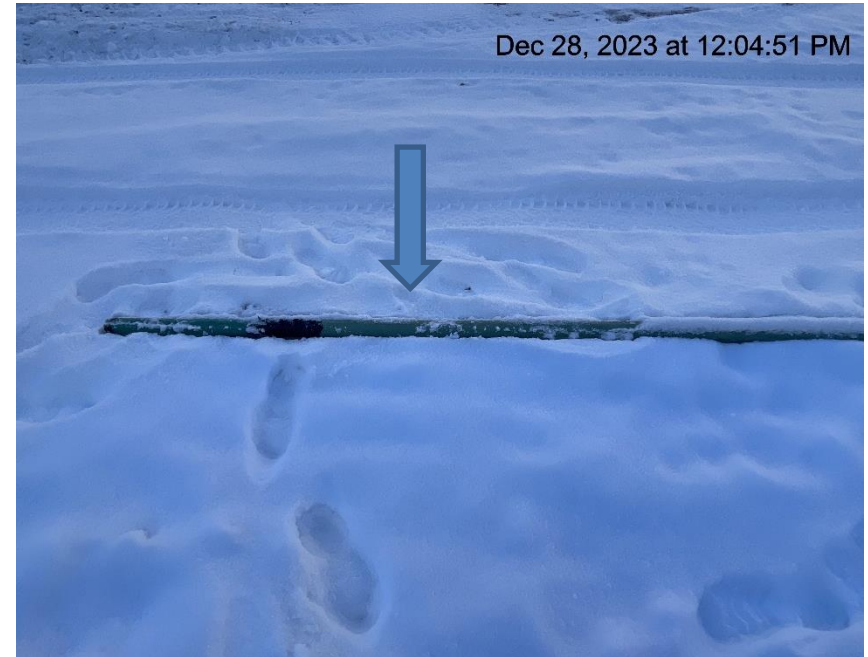
Photo # 1162 Debris

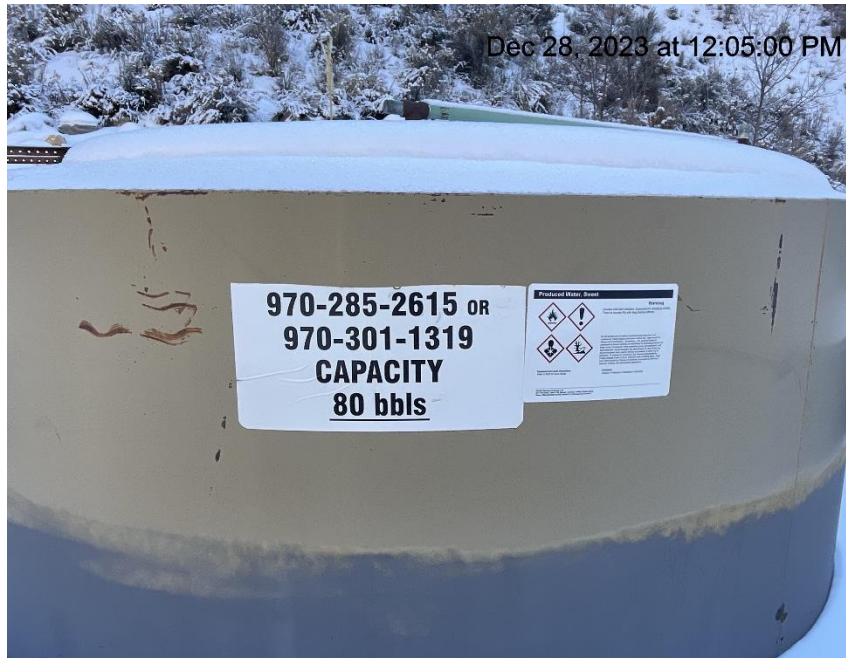
Photo # 1163 Labeling on blowdown tank missing required info

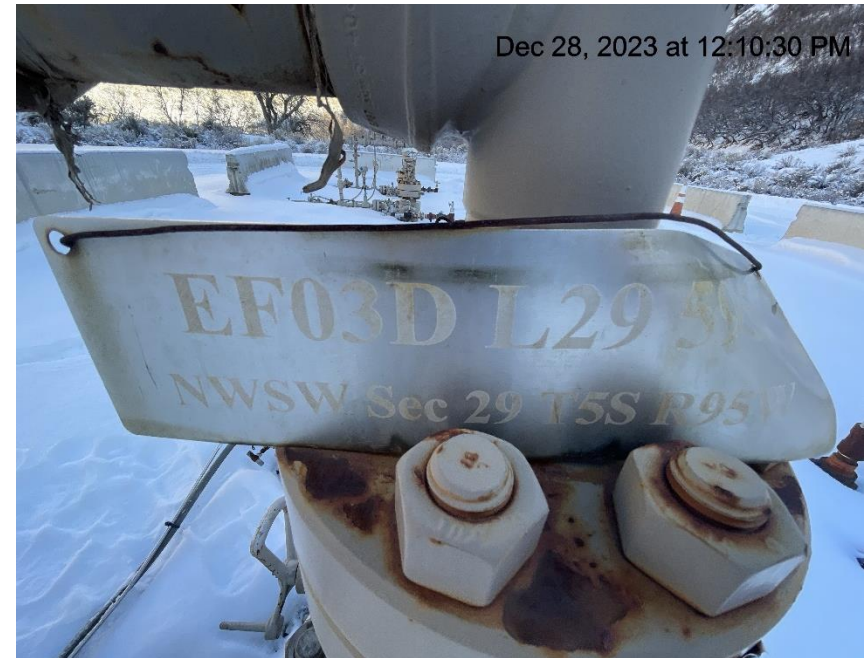
Photo # 1164 Wellhead signs lack required information

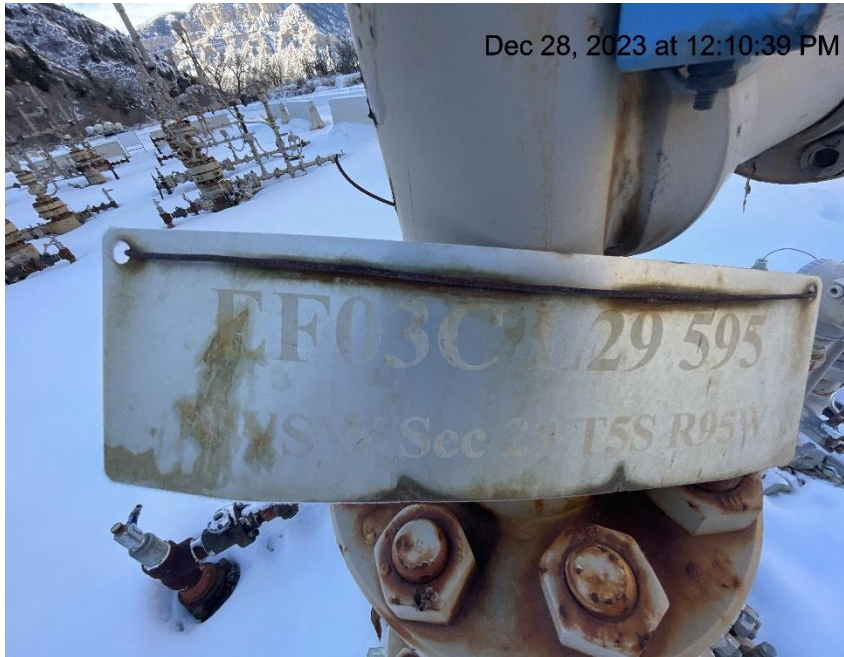
Photo # 1165 Wellhead signs lack required information

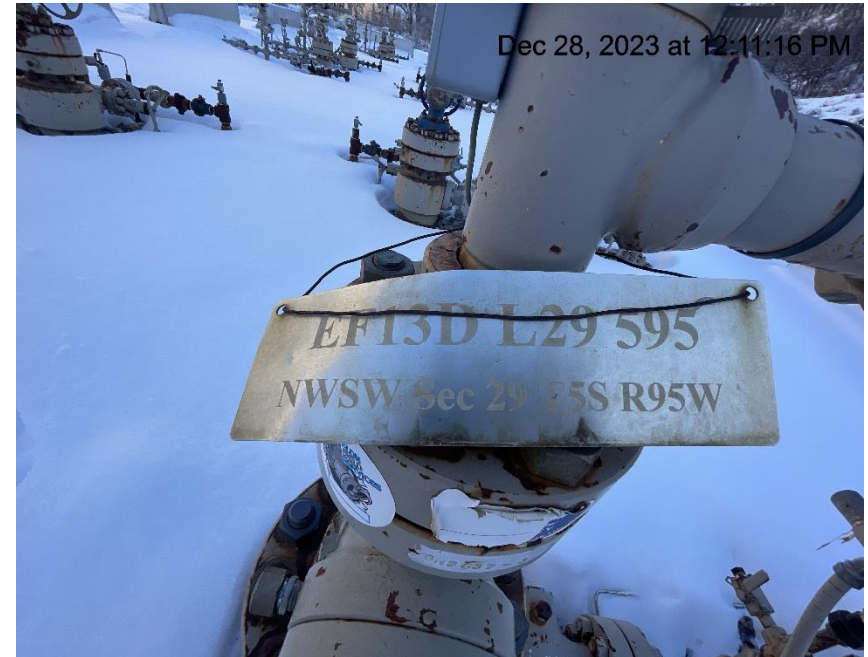
Photo # 1166 Wellhead signs lack required information

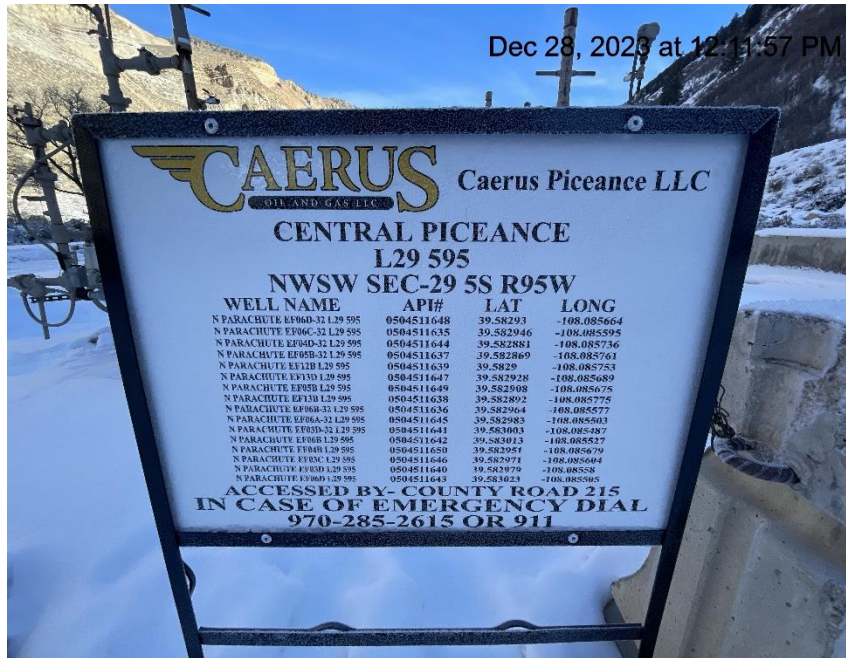
Photo # 1167 Single sign at wellheads insufficient, please refer to signs/marker for observed compliance issue on this & other wellhead signs.
