Inspection Photos
Location Name: McPeek 0-8-10
Location ID: 422467

Energy & Carbon Management Commission
40.14569, -104.76343, 4937.2ft, 314°
01/02/2024 12:38:56

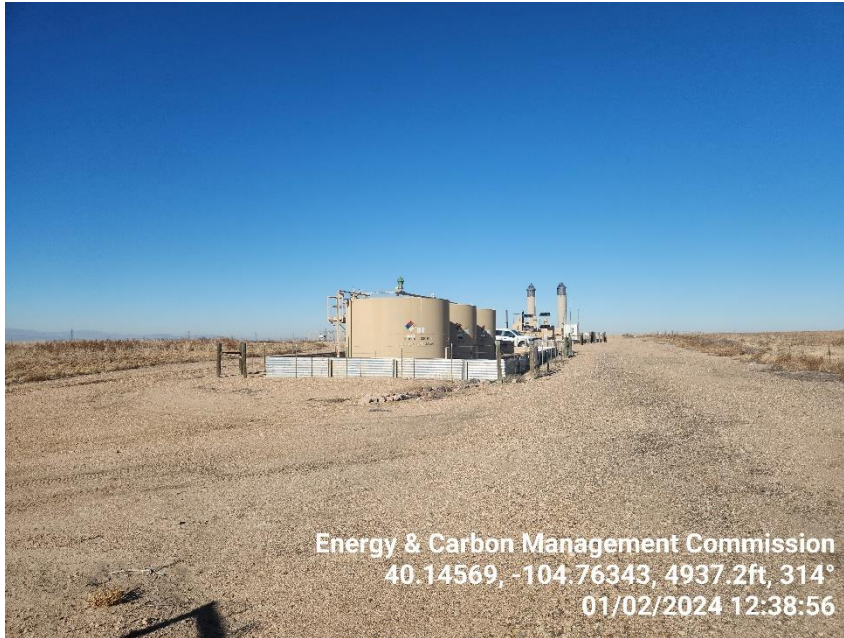
Photo 1 Location.

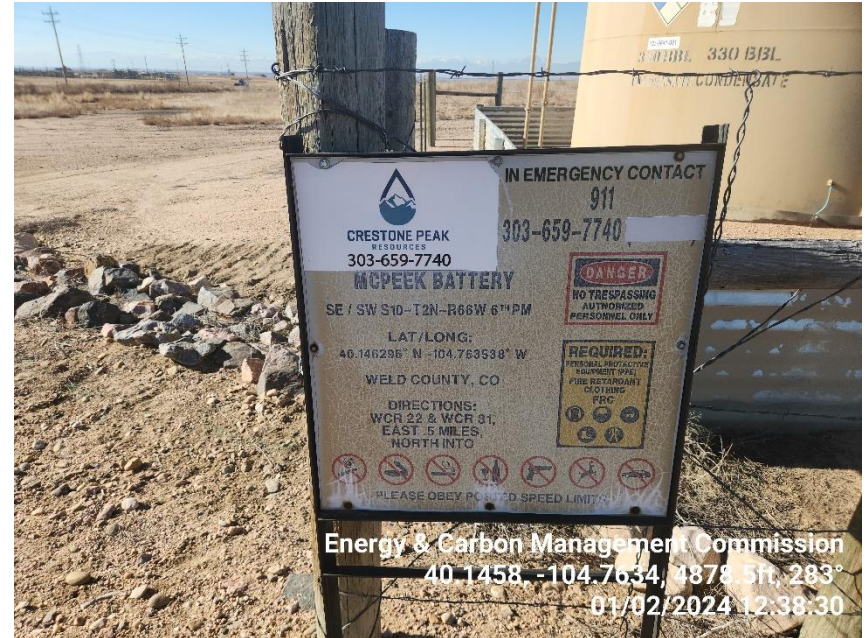
Photo 2 TB sign.

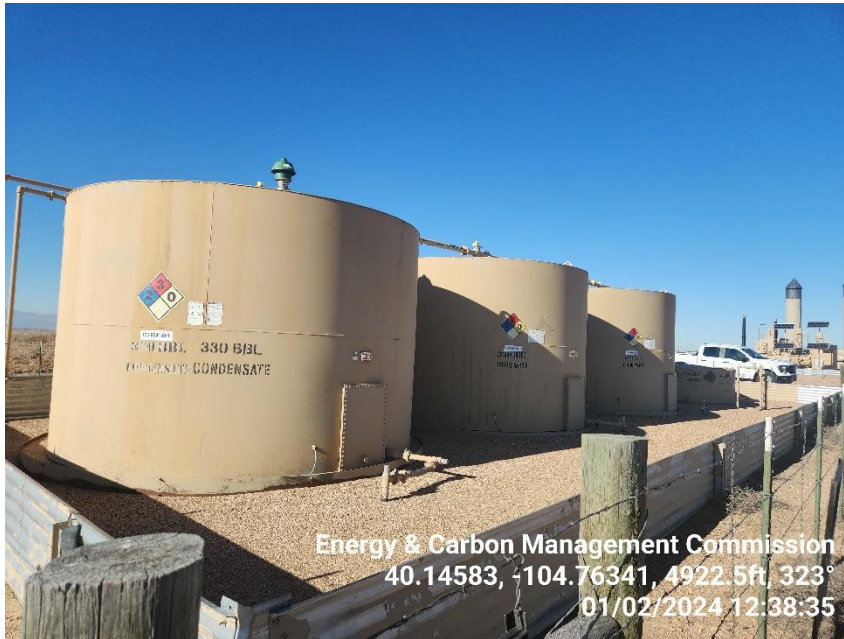
Photo 3 TB.

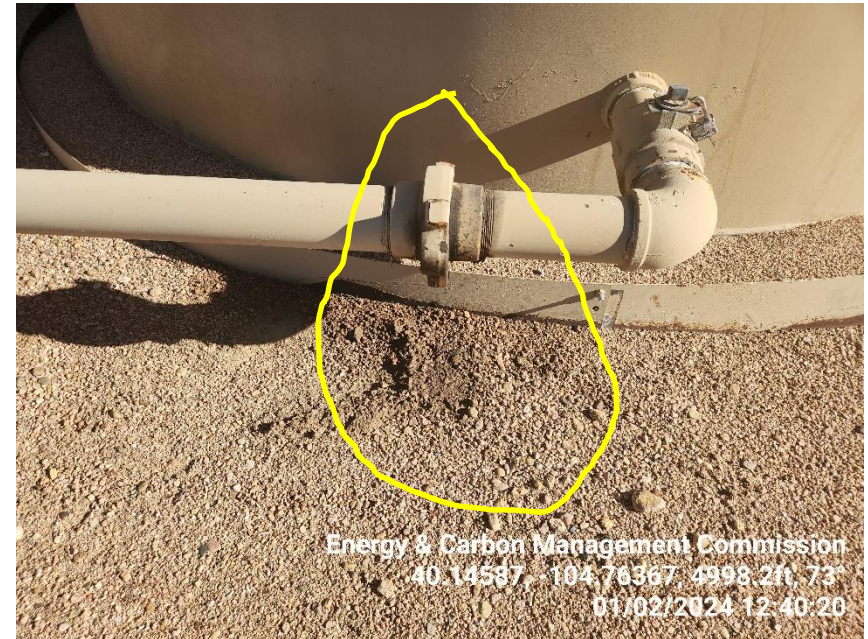
Photo 4 Stained soil on the East side of the condensate tank under the hammer union.

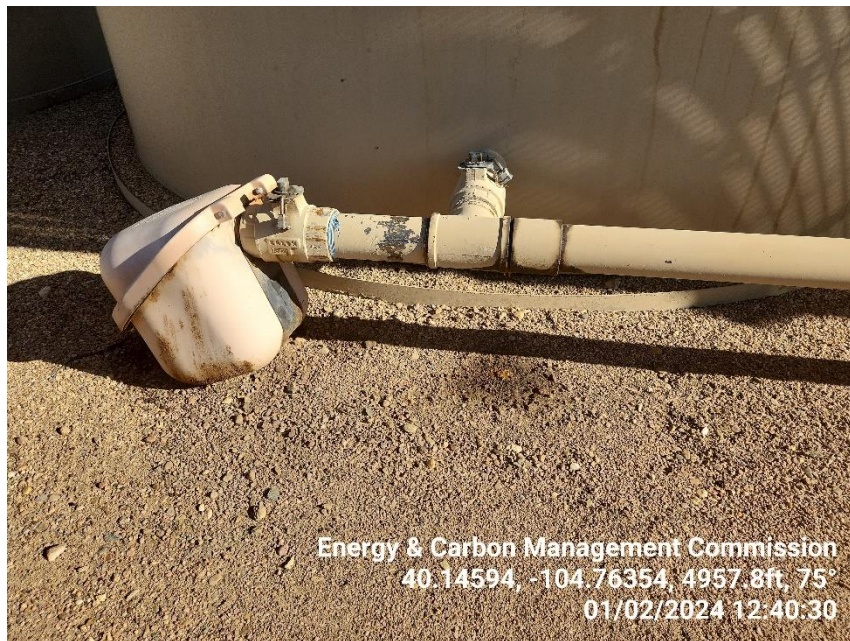
Photo 5 Stained soil on the East side of the condensate tank by the load out line.

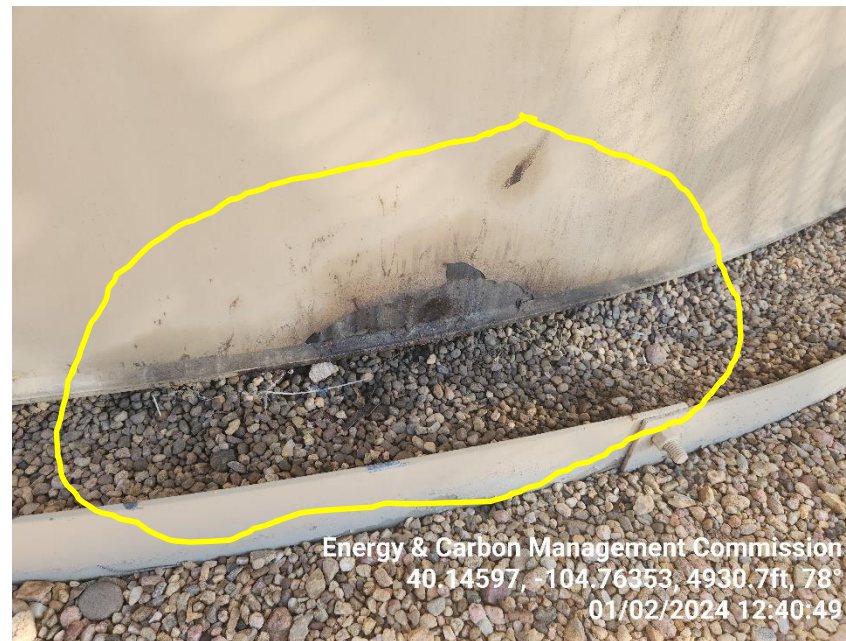
Photo 6 Stained soil on the East side of the condensate tank by the hole in tank.

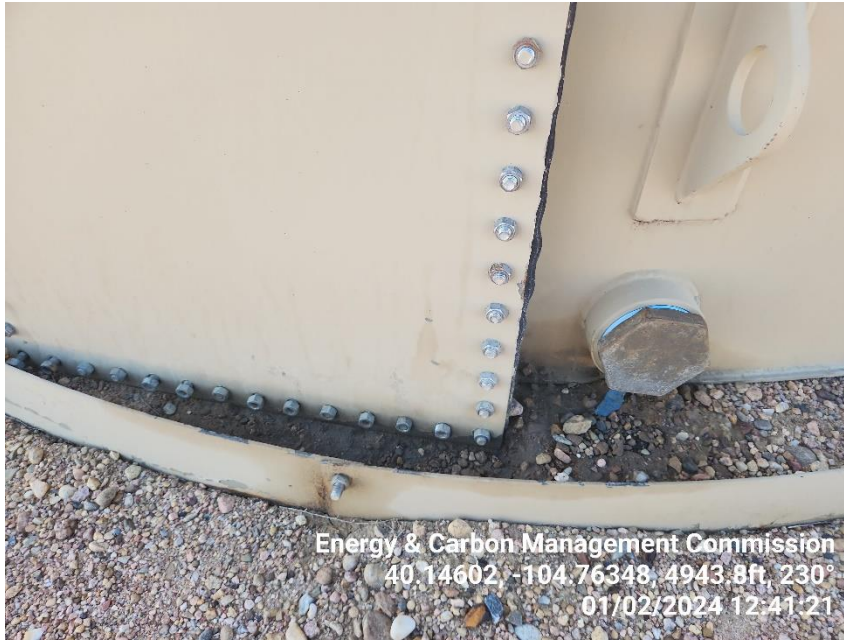
Photo 7 Stained soil on the west side of the condensate tank by the access panel.

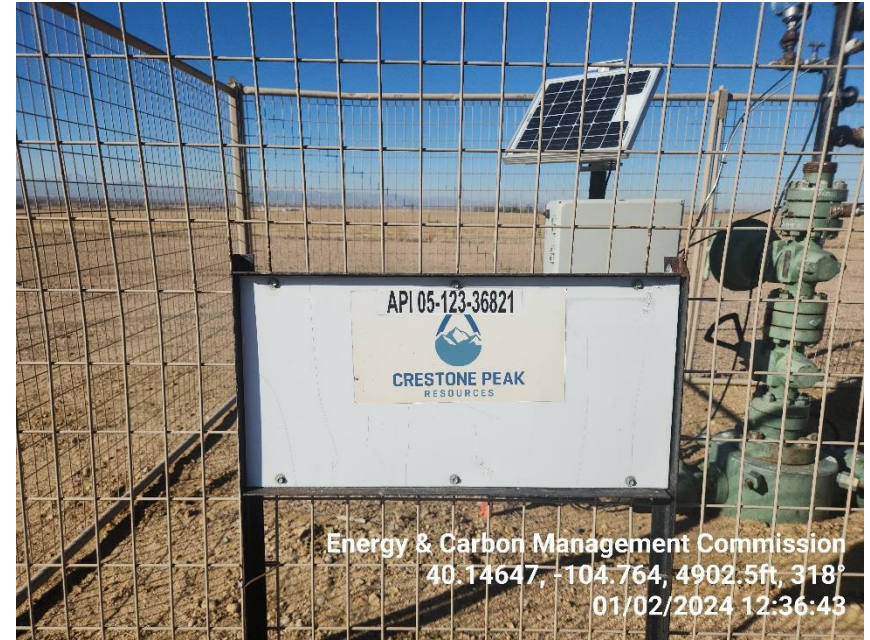
Photo 8 WH sign faded no emergency information.

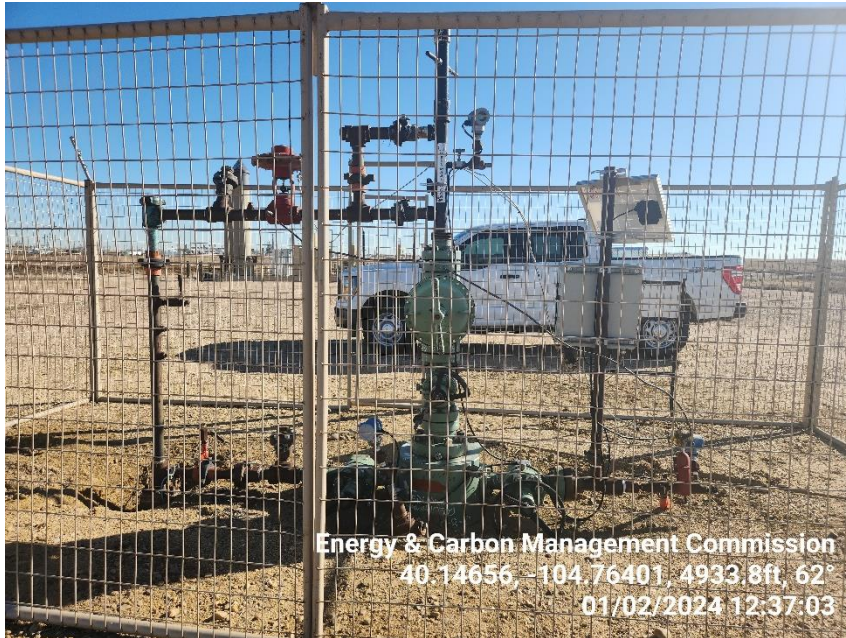
Photo9 WH.

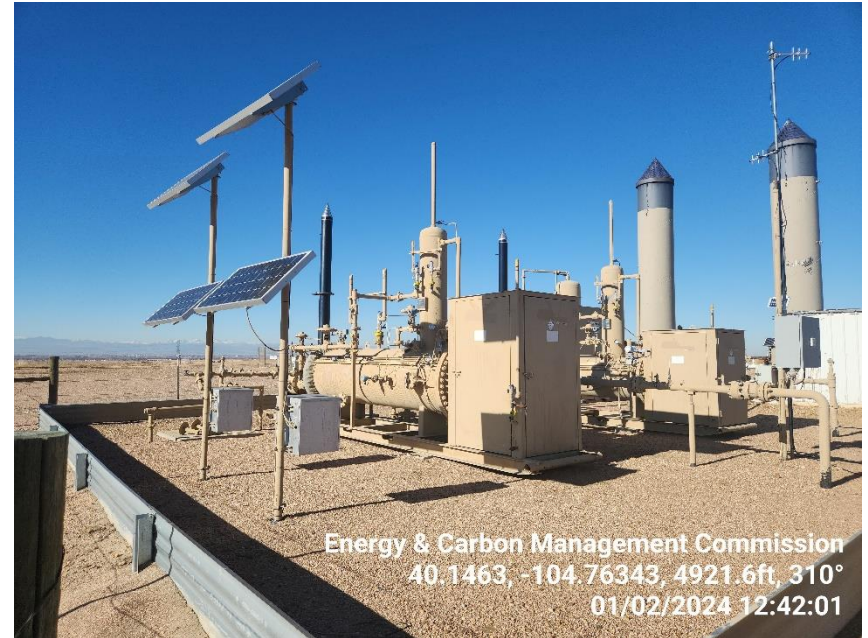
Photo 10 Horizontal Heated Separators.

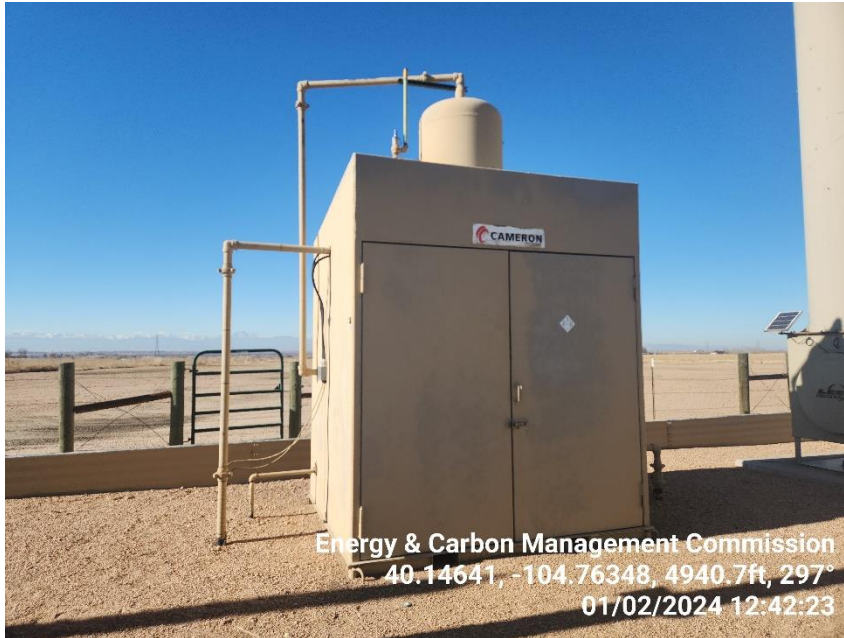
Photo 11 Vertical Separator.

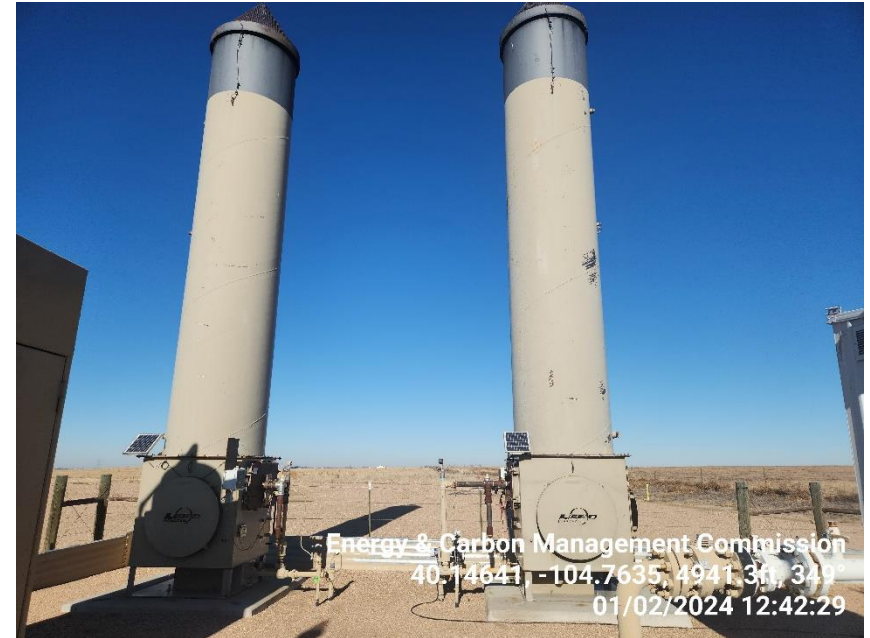
Photo 12 ECDs.

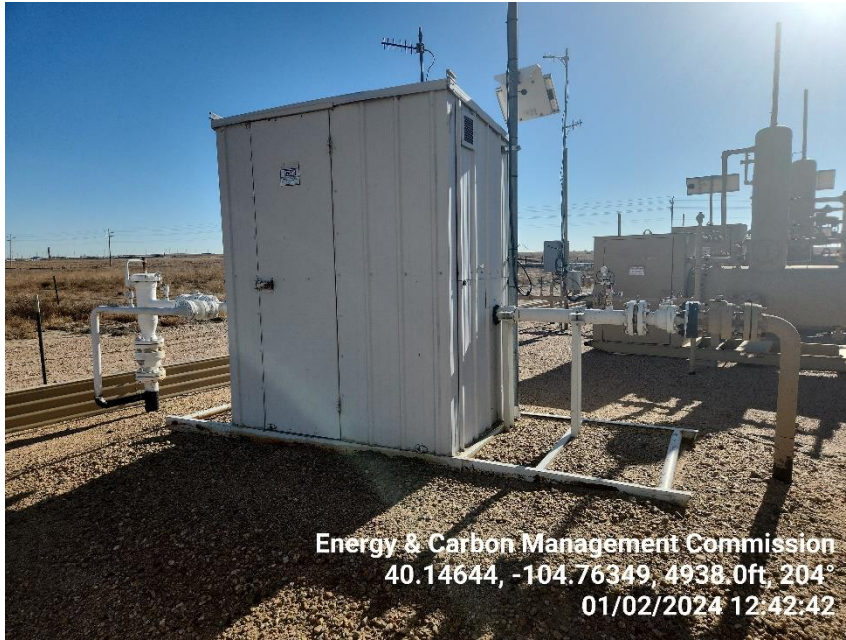
Photo 13 Gas Meter Run, card indicates current calibration.
